STAFF REPORT: AUGUST 13, 2025 REGULAR MEETING

APPLICATION NUMBER: HDC2025-00439

ADDRESS: 1155 CLARK

SCOPE: REPLACE WOOD WINDOWS AND VINYL WINDOWS WITH NEW VINYL WINDOWS

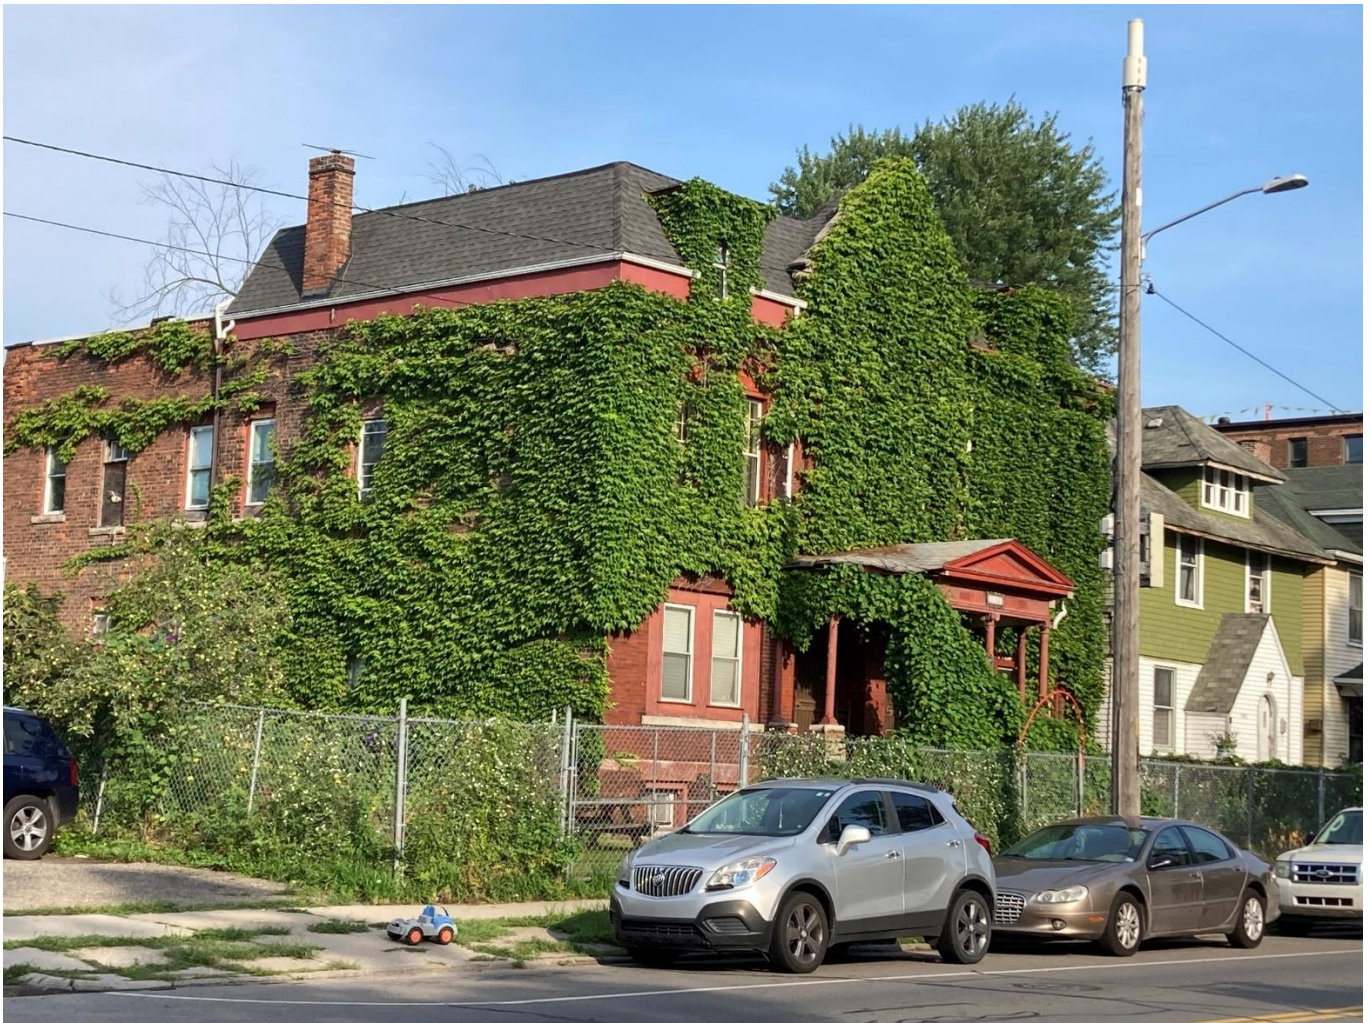
Photo 3, 1155 Clark, front (east) elevation (with a portion of the south wall shown), staff, July 2025. The central projecting bay with gable roof (covered in ivy), the front porch, and the mansard roof are visible.

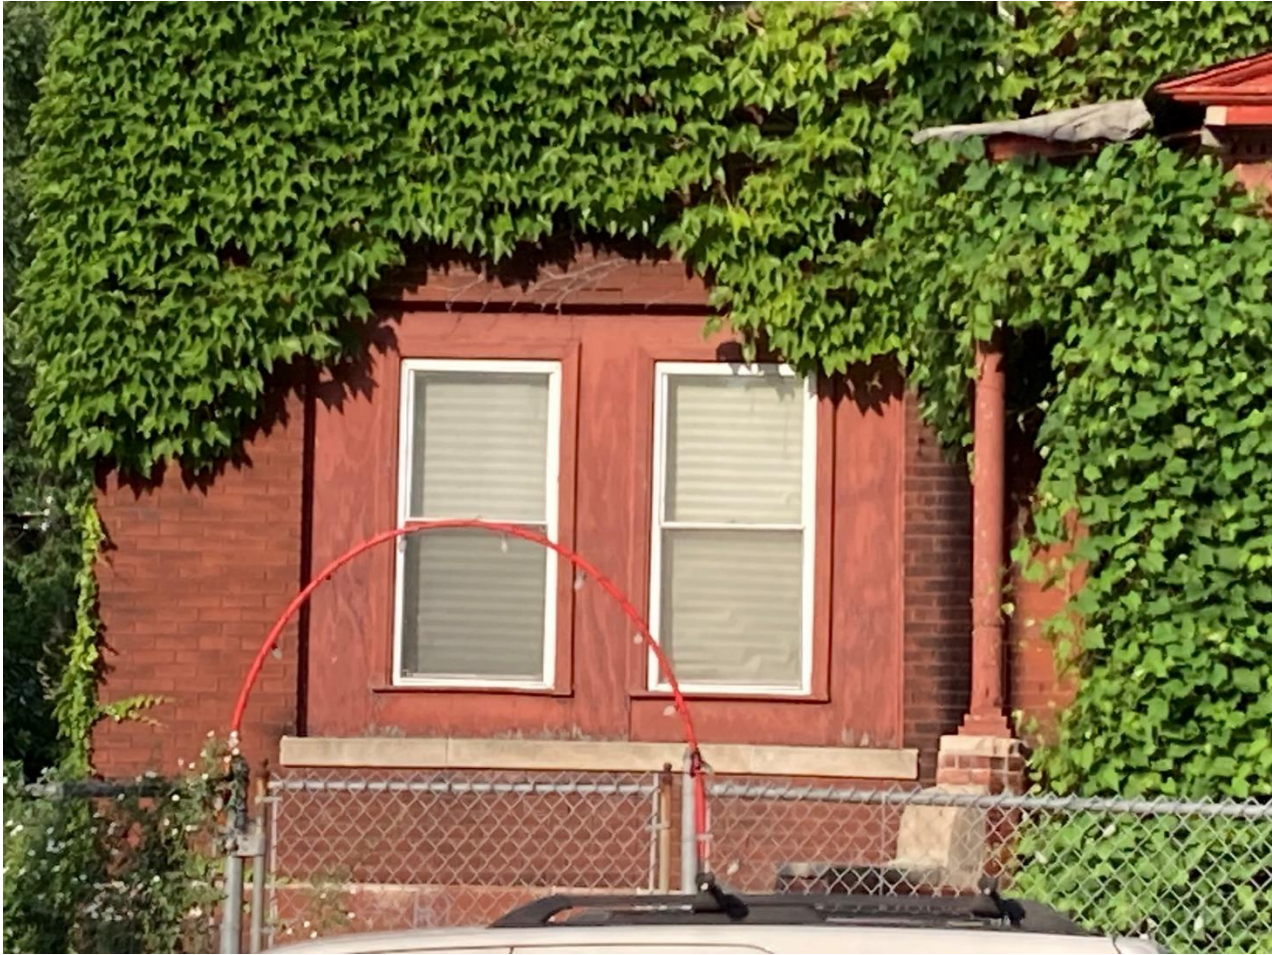
Photo 6, 1155 Clark, detail of two windows on the front of the building near the southeast corner, staff, July 2025. These windows were documented as part of unapproved work in 2006. The board infilling the larger window opening is painted to match the brick. This unapproved 2006 work is not part of the current application.

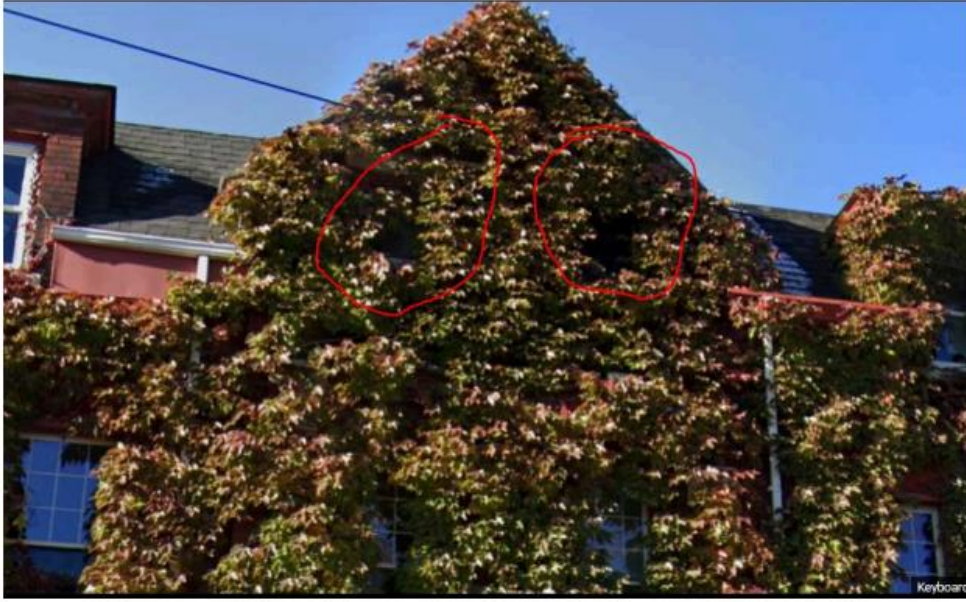
FRONT - EXTERIOR 3RD FLOOR - CENTER WINDOWS (A & B)

Figure 2. Applicant's Windows A and B on the front (east) of the house. From Applicant's Cycle 1 response to staff's request for additional information, June 30, 2025. These two windows are wood.

- The photos of Windows A and B show some deterioration and plastic glazing instead of glass, but staff could not assess complete window conditions, the windows' operability/hinge condition, or repairability from the photos.

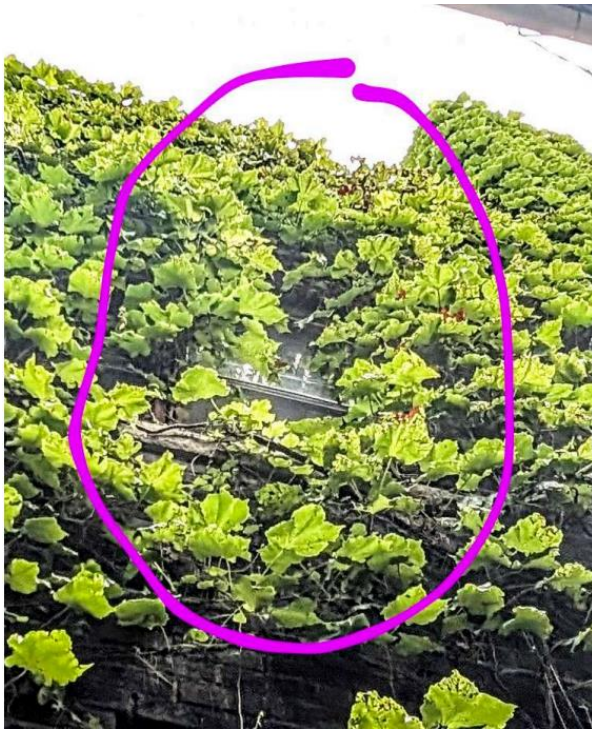
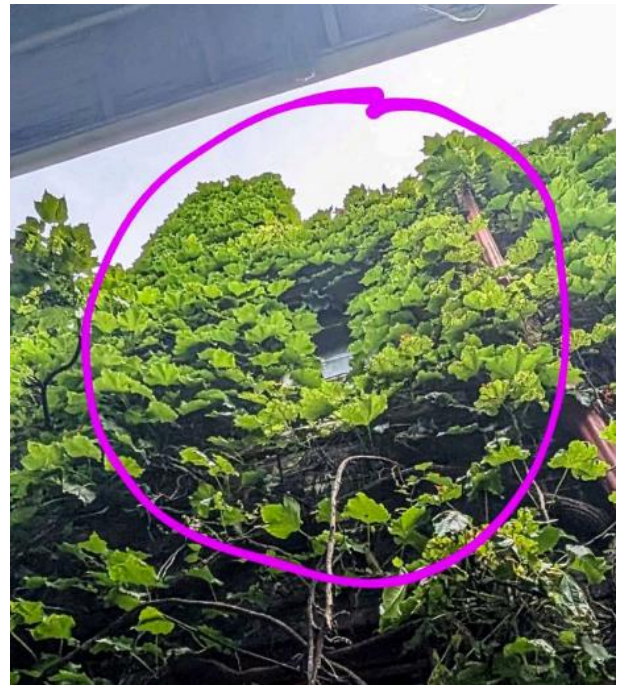
Figure 3. Applicant's Windows C (left) and D (right) on the house's north side. From Applicant's Cycle 1 response to staff's request for additional information, June 30, 2025. Both windows are vinyl.

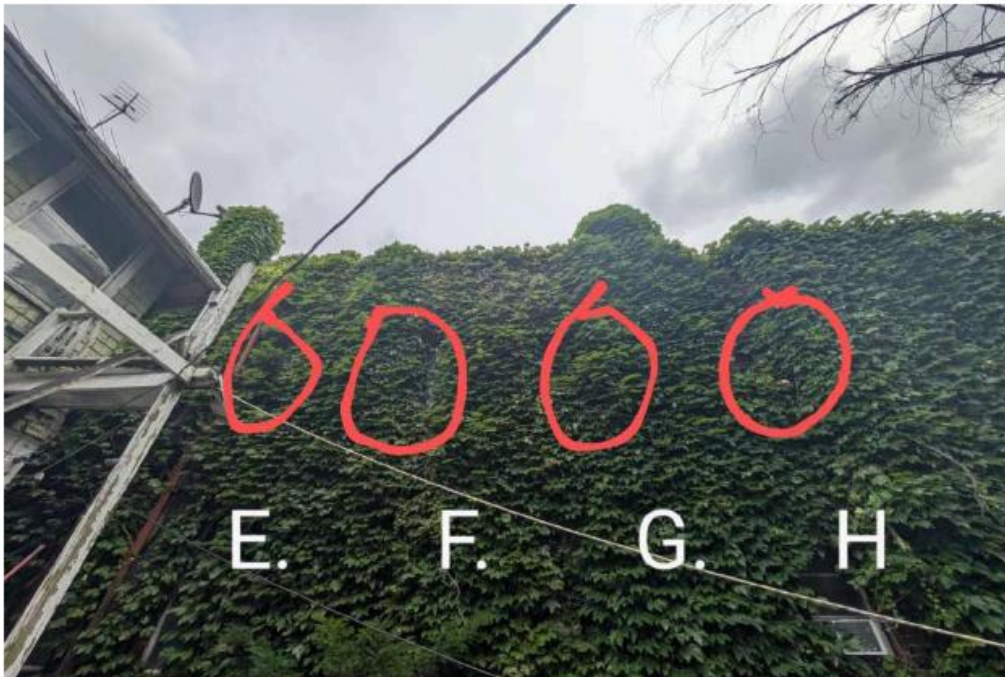
WINDOWS (E, F, G H)

Figure 4. Applicant's Windows E through H on the house's north side. From Applicant's Cycle 1 response to staff's request for additional information, June 30, 2025. Windows G and H are wood.

- The photos for windows G, H, and I also do not show conditions details. Staff can see that

the windows appear not to stay up on their own, so the windows appear to need re-roping, but the Secretary of the Interior's Guidelines for Rehabilitating Historic Buildings state that it is not recommended to replace windows when repair of the window and limited replacement of deteriorated or missing components are feasible. It appears from the photos that the historic windows G, H, and I are protected by storm windows, which would be expected to help preserve them.

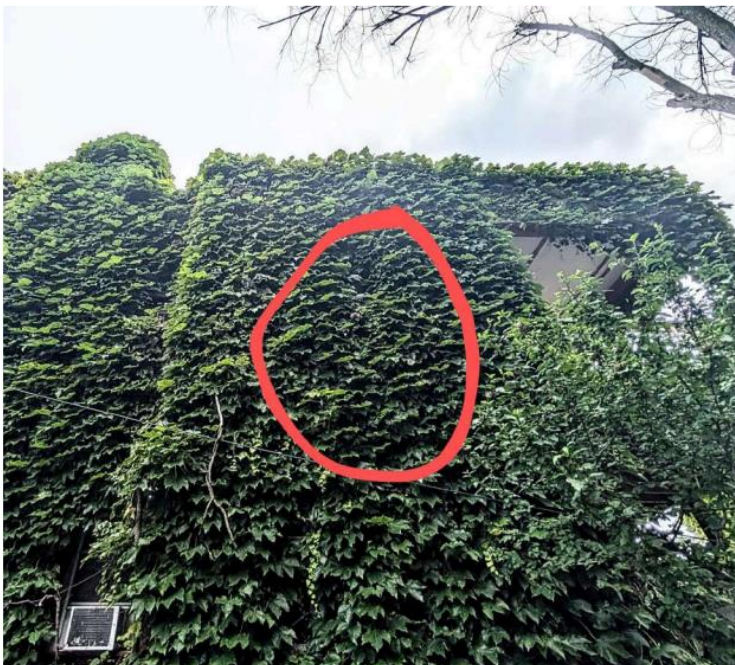
WINDOW (I)

Figure 5. Applicant's Window I, house's north side near rear. From Applicant's Cycle 1 response to staff's request for additional information, June 30, 2025. Window I is wood.
