STAFF REPORT: 08/13/2025 REGULAR MEETING

APPLICATION NUMBER: HDC2025-00489

ADDRESS: 2733 SECOND AVENUE (AKA CASS PARK)

SCOPE: REHABILITATE PARK, REVISE INTERNAL PATH LAYOUT

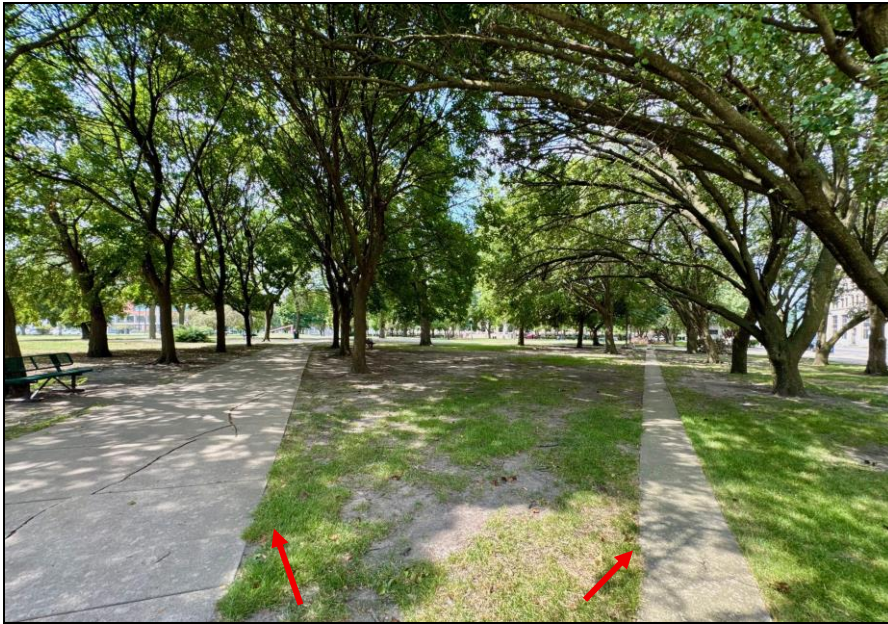
Left: This current photo was taken at the northeast corner entrance and looks west. The wide corner path leads to the center of the park, and the narrow perimeter path (outlined in the 1997 aerial photo on the preceding page) connects seven of the nine park entrances.

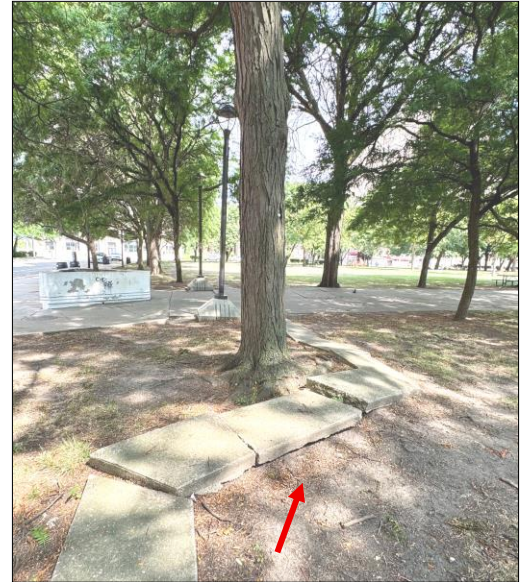
Below: Looking north, this portion of the perimeter path at the southern side of the west entrance was disrupted by the roots of the adjacent tree. According to the applicant's arborist tree survey, this tree is to remain (arrow on tree survey). Staff photos, July 2025.

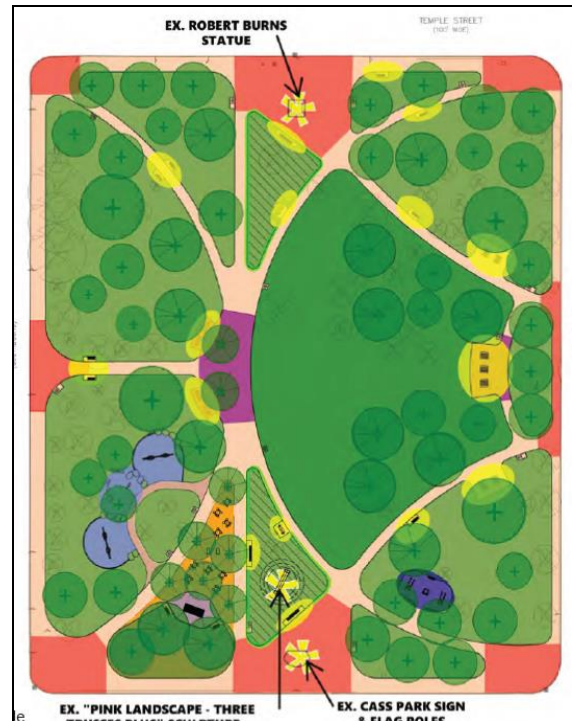
Applicant rendering of proposed design.

Staff: The vista along Second Avenue is not retained, as the main north-south walkway is to be moved to the west and out of alignment with the historic central axis on which the north and south paths and monuments were placed.

Staff: The period of significance for the park is 1860 – 1955. The move away from perfect symmetry in 1934 was a subtle one, by the expansion of pavement at one (of the eight) confluence of two paths, and the addition of a comfort station. The central axis remained in alignment with Second Avenue and the hexagonal path design – all leading to the center of the park - remained undisturbed.

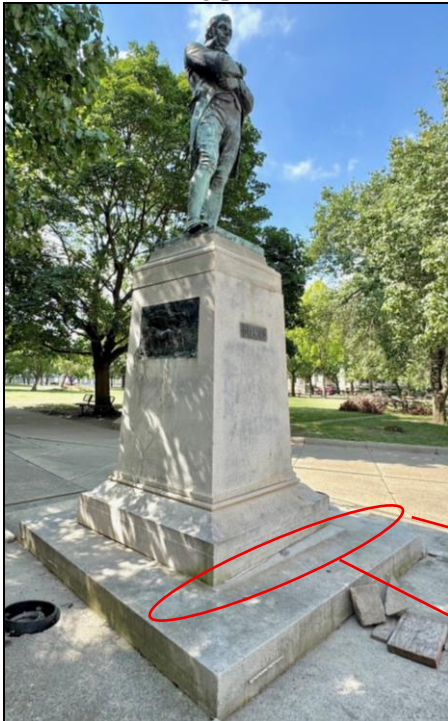
Front and east side.

Staff: Staff noticed the shift of the monument on its base and highlights this issue in the photos below. The base is inscribed and is one of many components that comprise the statue, which is distinctive character-defining feature of the park. A detailed, bulleted scope of work for the “minor repairs” must be submitted for staff review prior to work taking place.

Evidence of monument movement is highlighted. On page 13 of the applicant's Cass Park Engagement document, it is stated the monument has been hit by cars. Staff photos.
