STAFF REPORT: 8/13/2025 MEETING

ADDRESS: 4291 CORTLAND & 4510 CORTLAND

APPLICATION NO: HDC2025-00486 (4291 CORTLAND) & HDC2025-00485 (4510 CORTLAND)

SCOPE: REPLACE HANDRAILS/GUARDRAILS, ALTER PORCH STEPS/WINGWALLS, REPLACE WINDOW

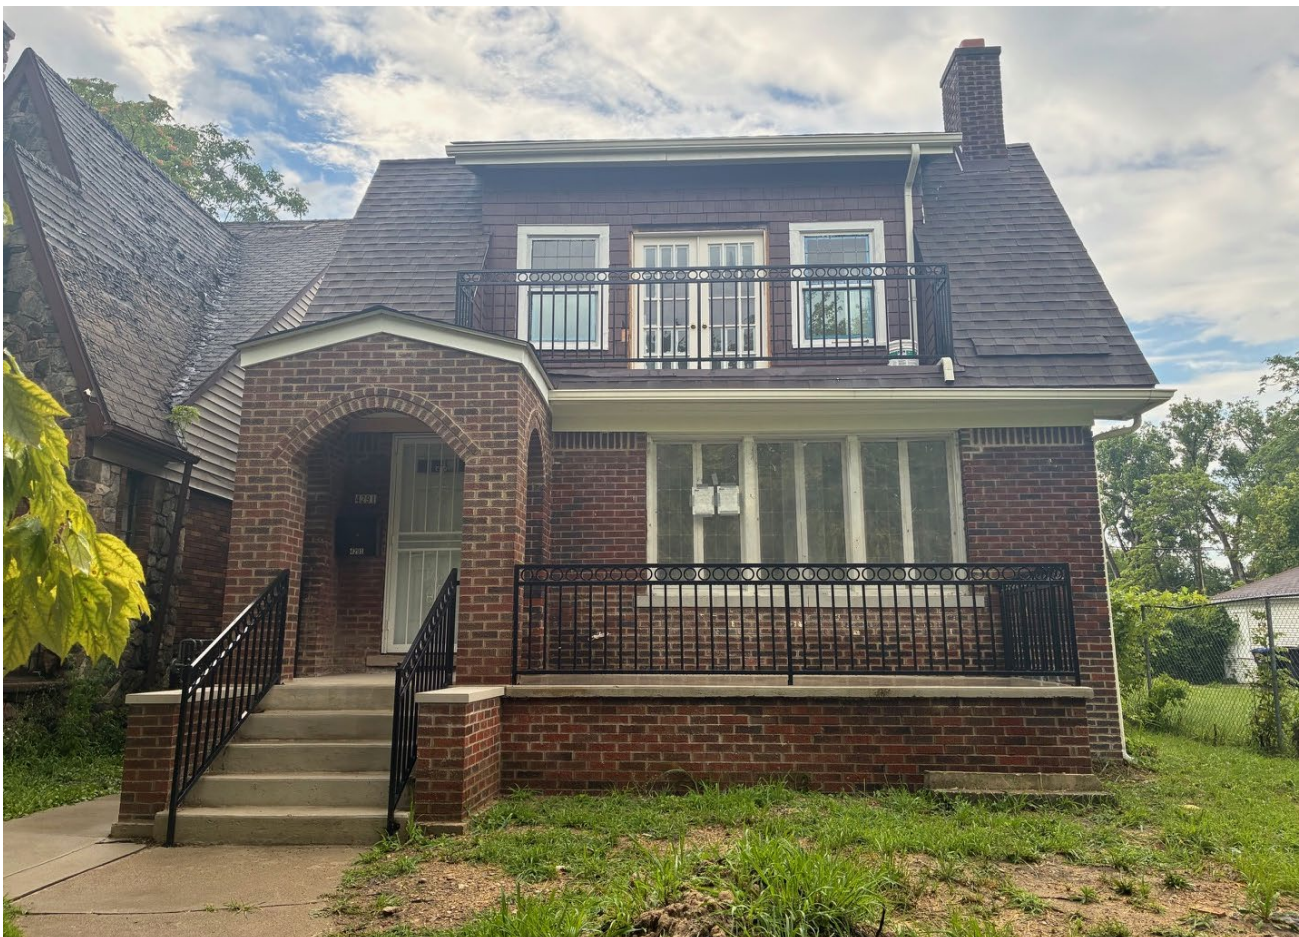
Staff photo of 4291 Cortland, taken by HDC staff on 7/25/2025

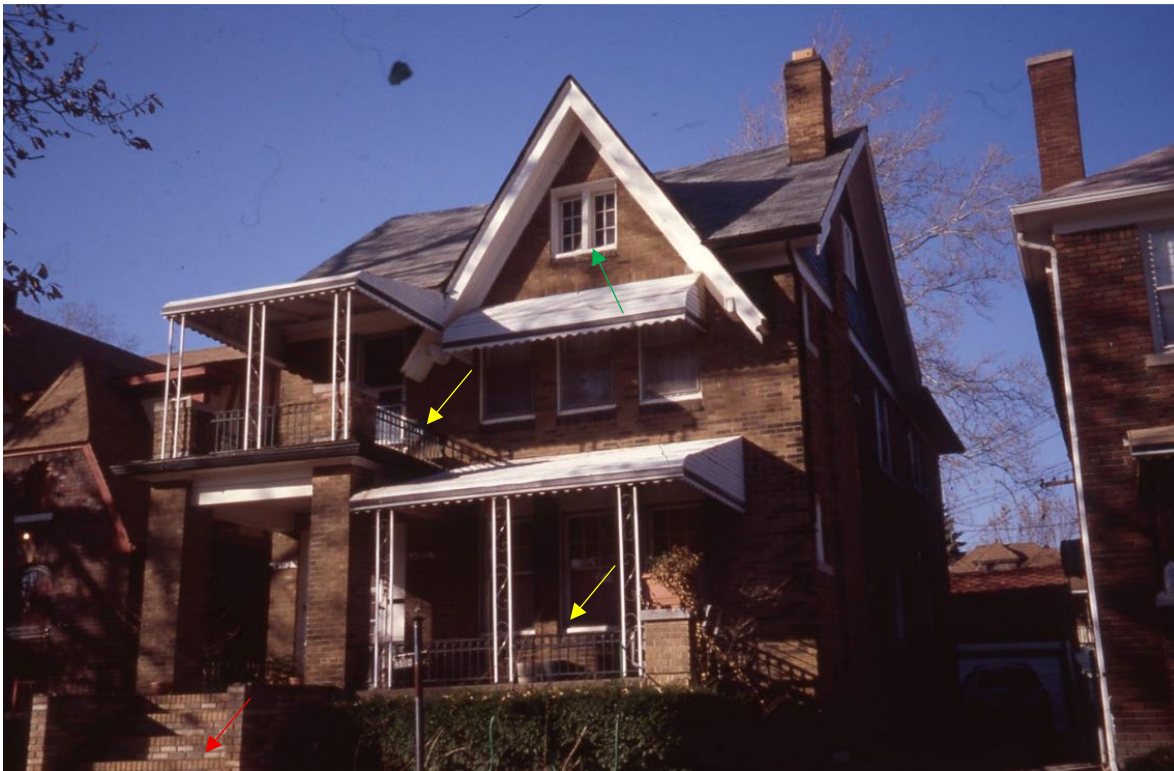
4510 Cortland, designation photo taken in 1999 by HDAB. Yellow arrows indicate historic iron railing, green arrow indicates historic window in gable end, and red arrow indicates historic brick front porch steps and wingwalls

- Note that at the time of designation, both houses had distinctive, character-defining iron railings at the front porches which measured approximately 24” in height (see above photos). 4510 Cortland also retained its historic-age brick front porch steps and the gable end window at the front façade’s attic story
- The photos below indicate the condition of the properties prior to the recent DLBA initiated rehabilitation

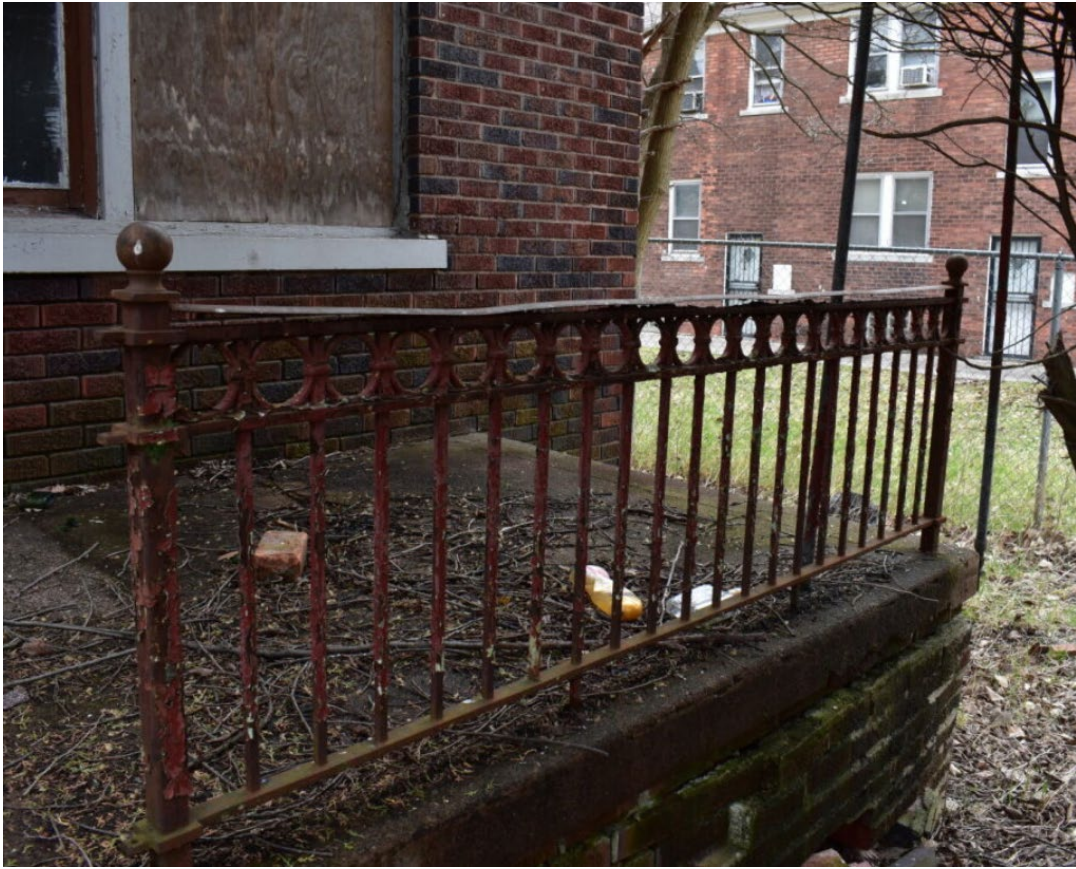
4291 Cortland, photo by staff in 2019 showing remaining iron railing at front porch, first story

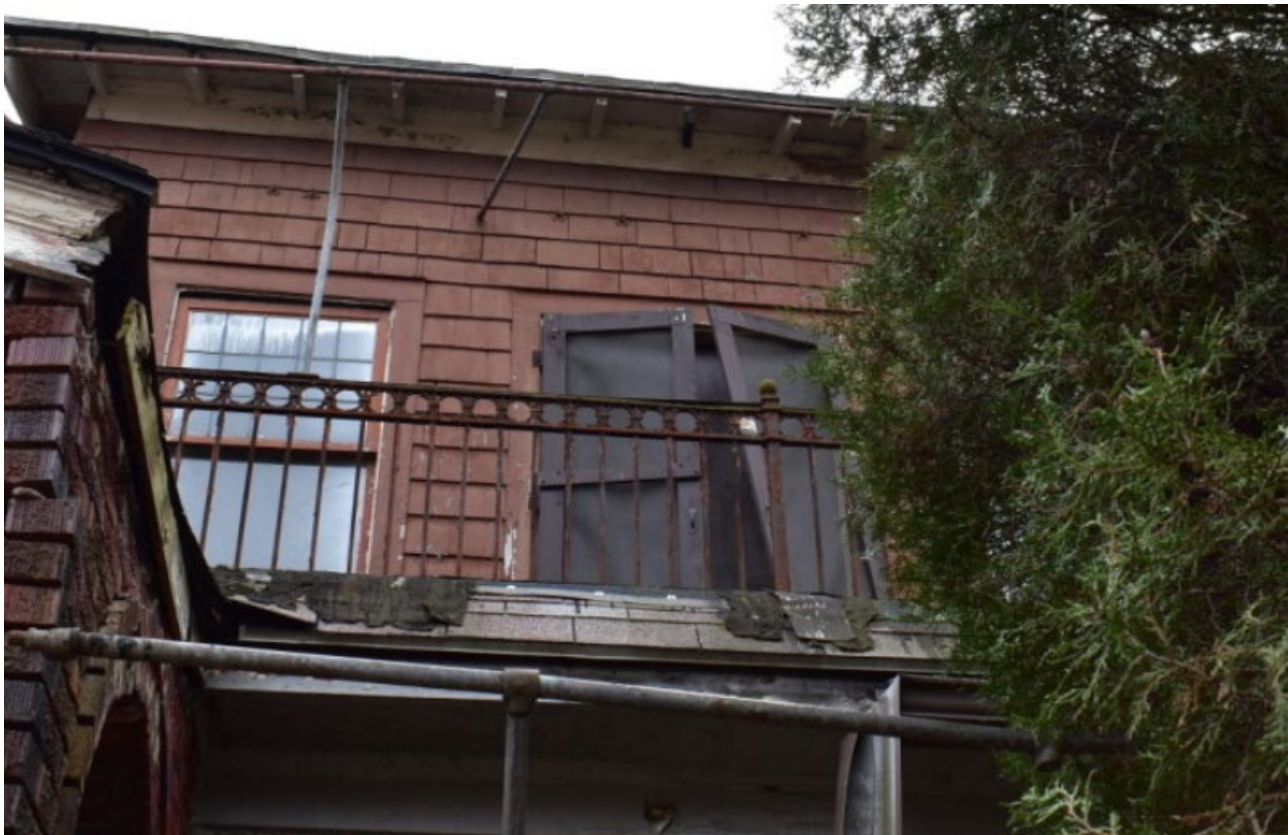
4291 Cortland, photo by staff in 2019 showing remaining iron railing at front façade, second story dormer

Staff notes that the railing scope *was not* completed according to the above-referenced staff issued COA. Rather, the original 24”-high railings were removed at both the first and attic stories and replaced with the current 36”-high metal railings. The new railing generally presents a style that is similar to the historic railing. However, the historic railing that was

- The historic, character-defining railing that was removed without HDC approval from **4291 Cortland**'s front porch and dormer could have been repaired. If the railing needed to be replaced, it should have been matched. The current railing is not an adequate match to the original due to its height

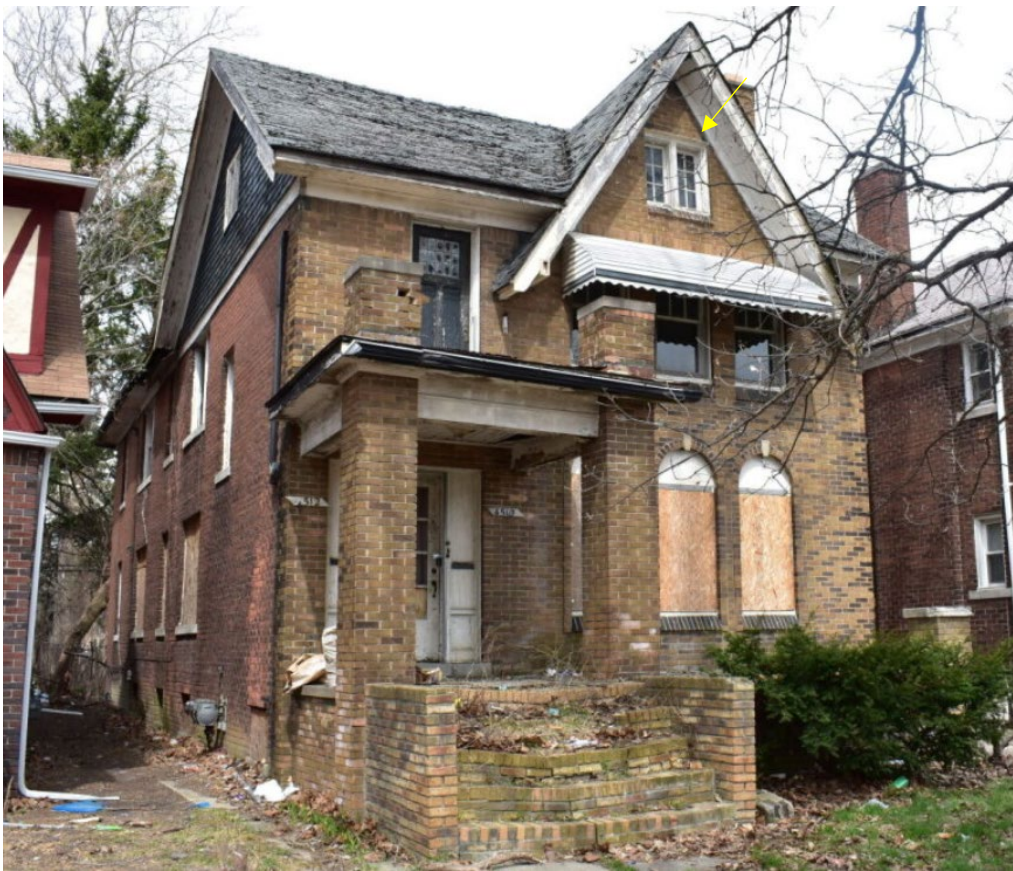
4510 Cortland, photo taken in 2019 by staff. Note that porch railing is no longer extant at either first or second story. Also, the front porch brick steps and wingwalls remain and the casement windows and trim in the attic story/gable end at the façade are extant (yellow arrow)

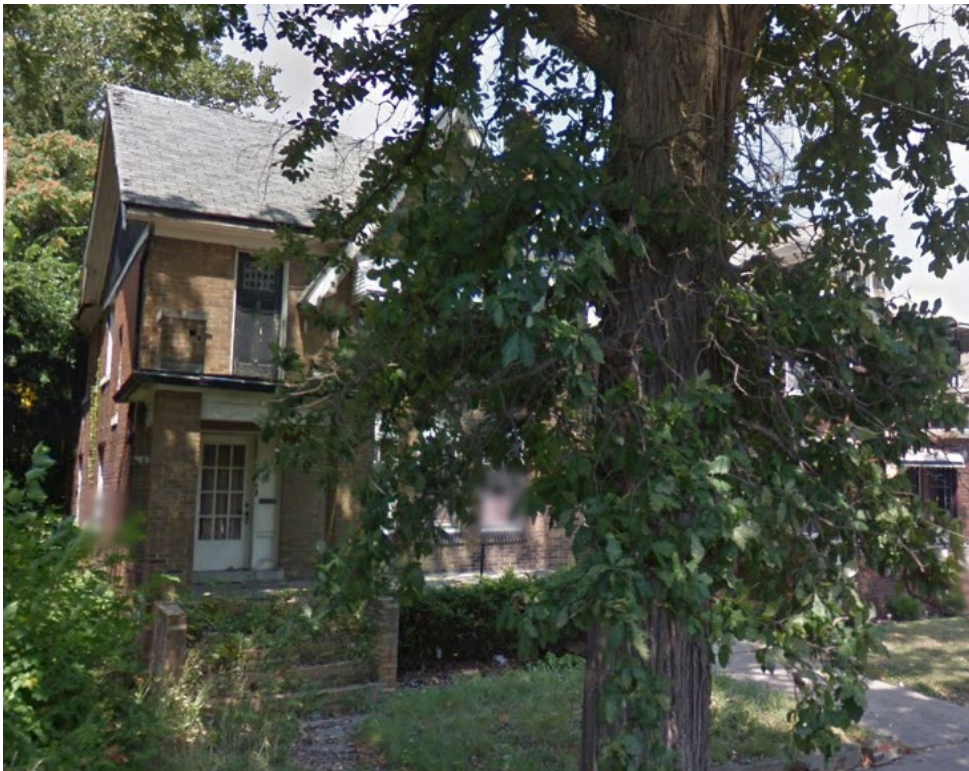
4510 Cortland, Google Streetview image dating from 2013. Note that the historic railing is not extant and the house appears to be vacant

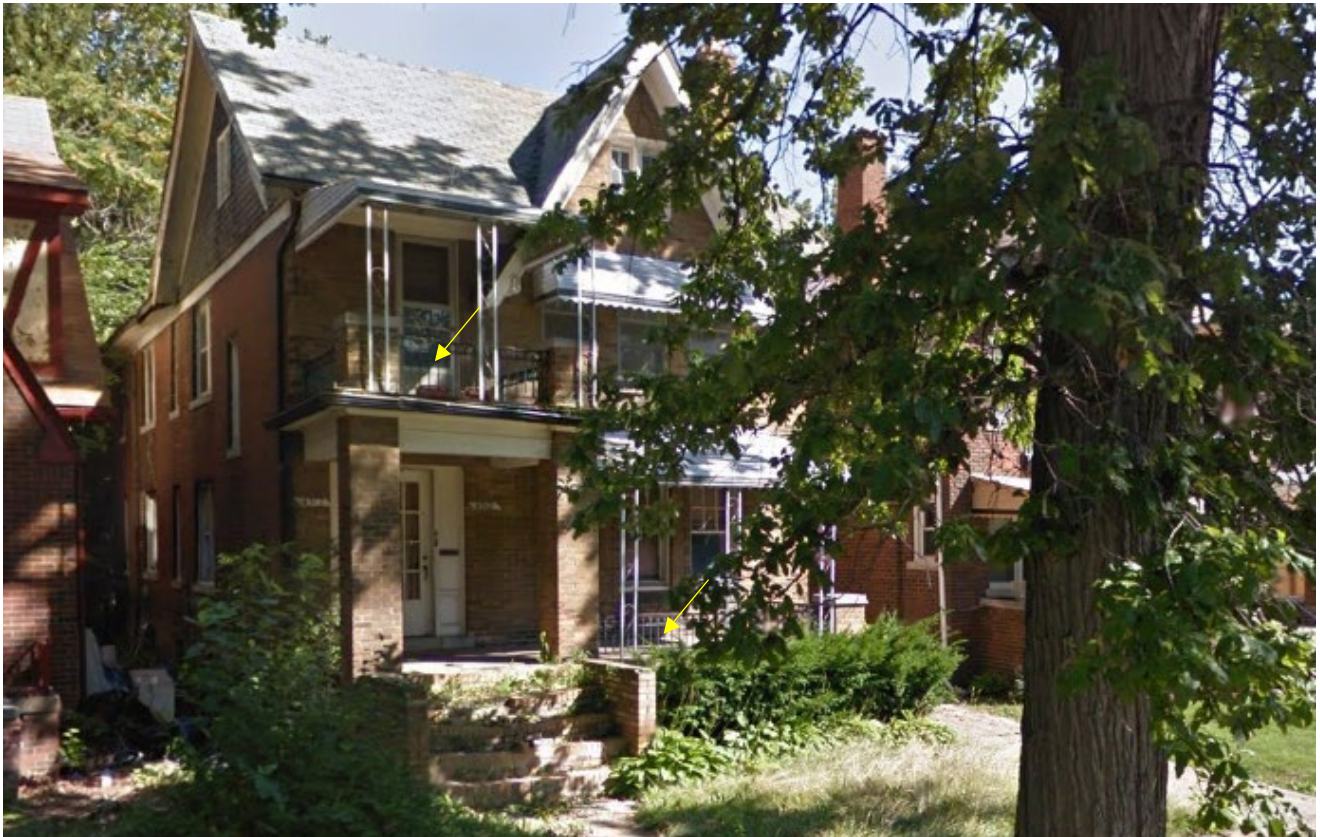
4510 Cortland, Google Streetview image dating from 2011. Note that the historic railing is extant at the time (yellow arrows)

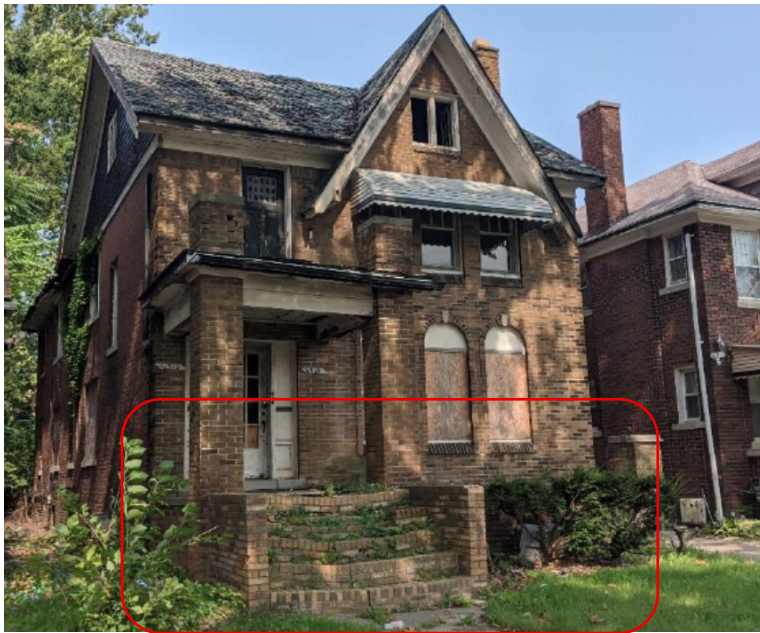
4510 Cortland, appearance in 2020. Photo by applicant. Note the distinctive brickwork at the porch steps and wingwalls

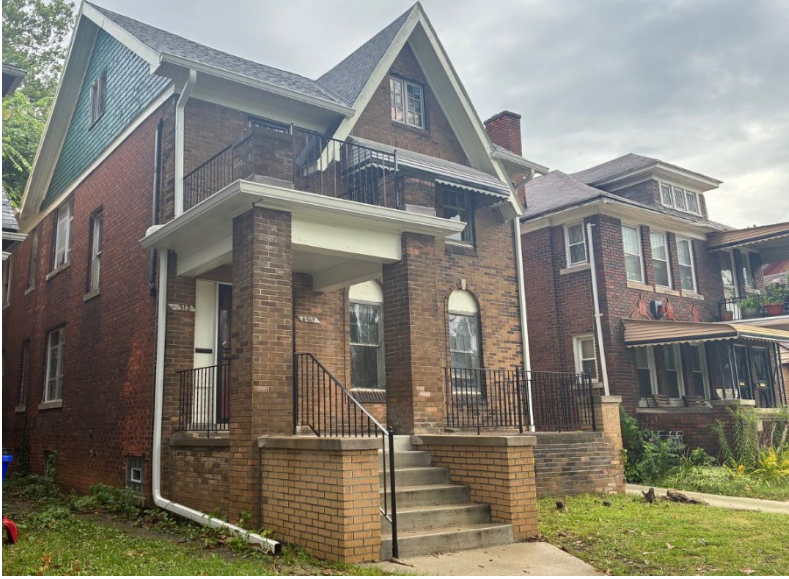
Standards. Staff notes that the porch scope *was not* completed according to the 2019 COA. Rather, the DLBA rehabilitation resulted in the replacement of the historic brick steps with concrete steps. Also, the wingwalls were constructed of new brick which is uniform in color. The new wingwalls also appear to be wider than the original elements. It is staff's opinion that the brick front porch steps and wingwalls were a distinctive, character-defining feature of the property. While conducting her field study for this report, staff did note that full brick front porch steps and wingwalls were rare within the property's near vicinity. As the steps and wingwalls were distinctive, character-defining feature of the property, per the Standards, they should have been retained and repaired. If repair was not achievable, ie, the existing brick could not be salvaged, then a new porch should have been built to match the historic in dimension, using brick that matched the existing in color, dimension, and texture. Staff therefore recommends that the Commission deny this work item because the current steps do not conform to the Standards.

4510 Cortland, photo by staff on 7/25/2025. Note that the wingwalls appear to be wider than the original and the brick does not display the same variation in size, texture, and color as the original. Also, the steps are now concrete.

- The historic brick front porch steps at **4510 Cortland** were a distinctive character-defining feature of the property. As they were highly deteriorated, they should have been rebuilt to match the original in dimension, material, design, and texture. The new porch and wingwalls are not an adequate match to the historic as the steps are concrete, the wingwalls appear wider than the original, and the color, texture, dimension, and design of the original brickwork has not been replicated.

- The historic brick front porch steps at **4510 Cortland** were a distinctive character-defining feature of the property. As they were highly deteriorated, they should have been rebuilt to match the original in dimension, material, design, and texture. The new porch and wingwalls are not an adequate match to the historic as the steps are concrete, the wingwalls appear wider than the original, and the color, texture, dimension, and design of the original brickwork has not been replicated.

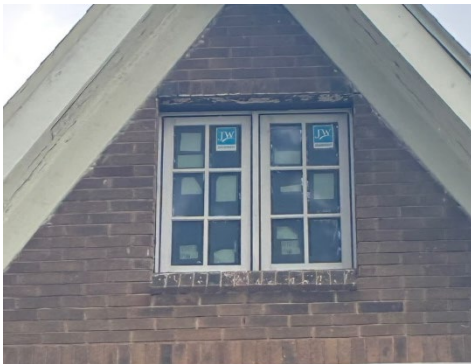
Current aluminum-clad wood replacement windows, brickmould, and mullion.

approval appeared to be in good condition prior to their removal. As such, the elements should have been retained and repaired in kind as required by the Standards. Also, new the brickmould and mullion are thinner and narrower than the original. As a result, the new window unit appears inappropriately flatter than the original narrower and appears to be set more deeply into the opening versus the original

- The historic, character-defining wood brickmould, mullion and remaining window at **4510 Cortland** front façade, attic story gable end which were removed and replaced without HDC approval appeared to be in good condition prior to their removal. As such, the elements should have been retained and repaired in kind. Also, the new brickmould and mullion are thinner and narrower than the original. As a result, the new window unit appears inappropriately flatter than the original narrower and appears to be set more deeply into the opening versus the original.

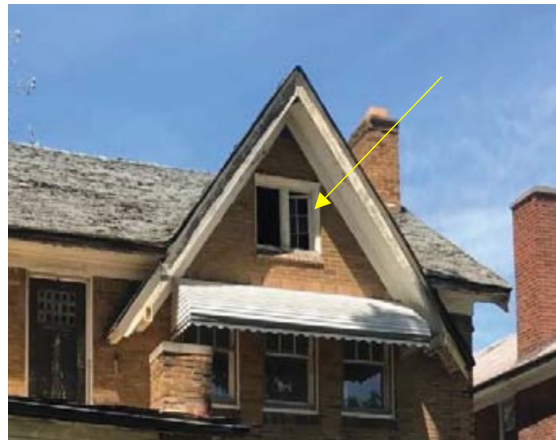
Window, brickmould, and mullion as they appeared in 2020 (yellow arrow). Note that the casement on the left (west) was missing at the time, while the casement window at the right (east) was still extant. Staff approved the installation of a new casement window in the opening to the left to replace the missing casement window, while maintaining the existing historic casement window to the right, the brickmould and the mullion. The recent DLBA rehabilitation did not conform to the staff issued COA as it resulted in the unapproved removal of the remaining historic window to the right.

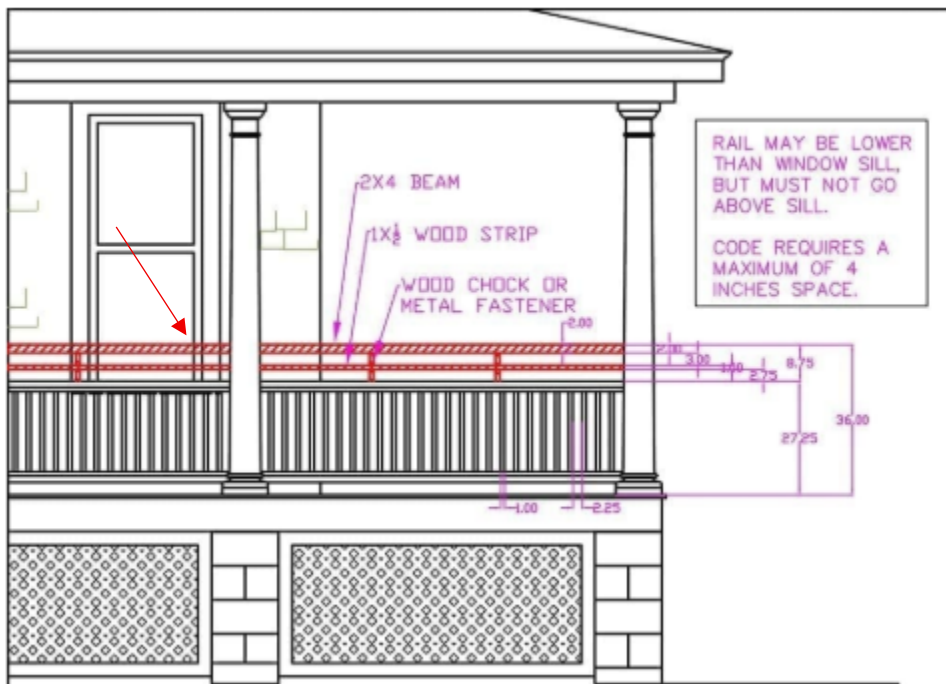
- The applicant noted that the new porch railing at both properties was installed at the current height in order to meet the building code. However, staff does note that the Michigan rehabilitation code establishes that extant railing at historic structures can remain in the configuration in which they were originally installed. Also, the historic railing could have been maintained or replicated at its original height and booster rails installed above (per the below drawing) to achieve the desired 36" height.

Drawing depicts a 24"-high porch railing with booster rail (red arrow) installed above [Porch Railing Height, Building code vs curb appeal](#)
