**STAFF REPORT: 09-10-25 REGULAR MEETING**

**APPLICATION NUMBER: HDC2025-00433**

**ADDRESS: 467 W. ALEXANDRINE**

**SCOPE: ALTER AND REHABILITATE EXISTING FOUR-STORY APARTMENT BUILDING FOR MIXED USE**

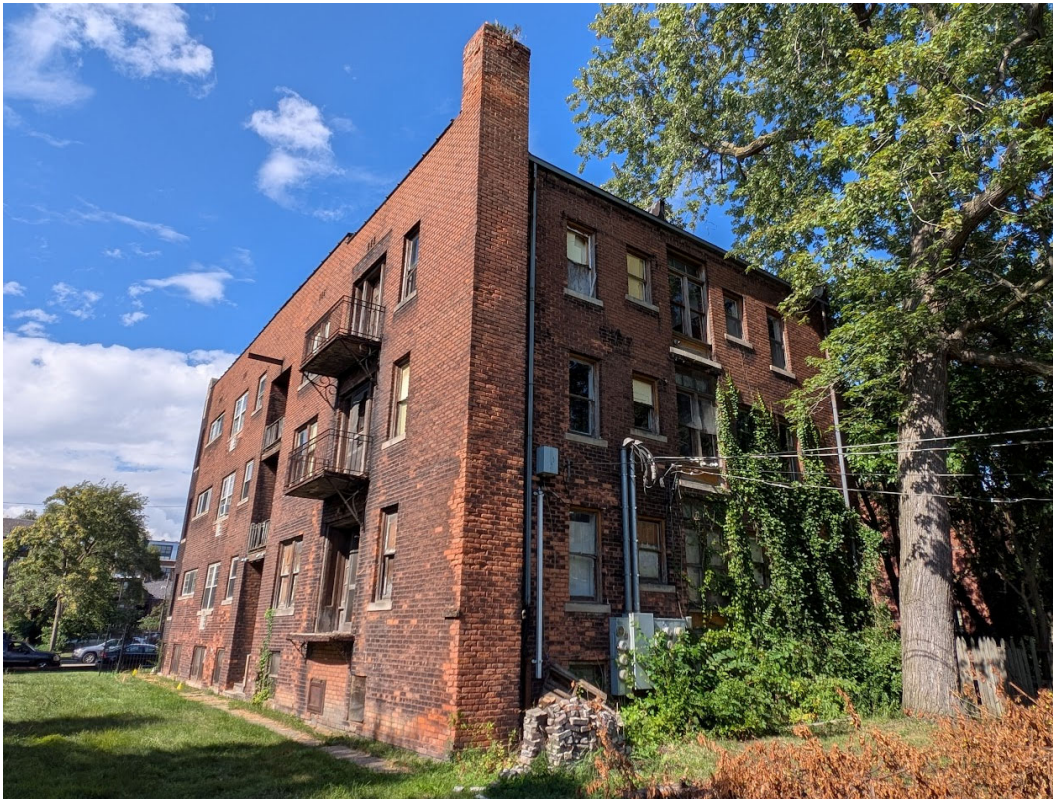
*View of 467 West Alexandrine, rear quarter view looking back towards street. Note advanced deterioration of common brick in this area. Staff photo, August 28, 2025.*

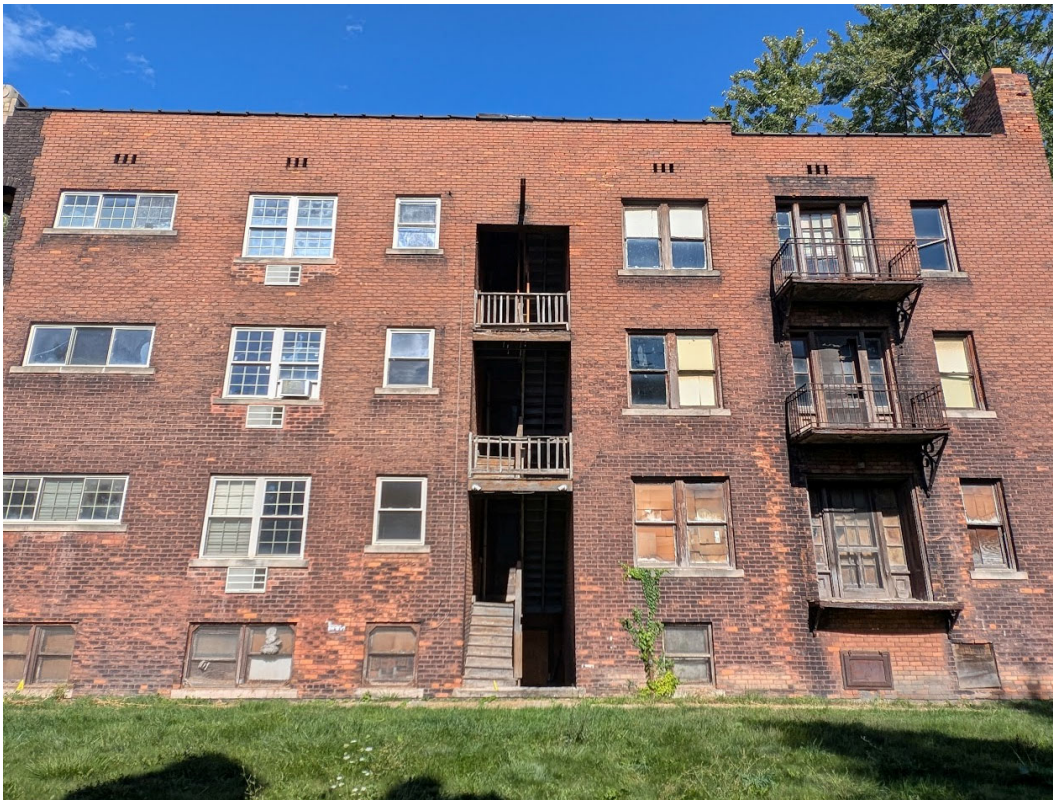
*View of 467 West Alexandrine, to the east, showing west-facing side. Note wooden windows/doors on right side (towards building rear). The ornamental face brick (brown) at front of building, wrapping around, is just visible in upper left of photo, distinguishing it from the common brick at this utilitarian side. Staff photo, August 28, 2025.*

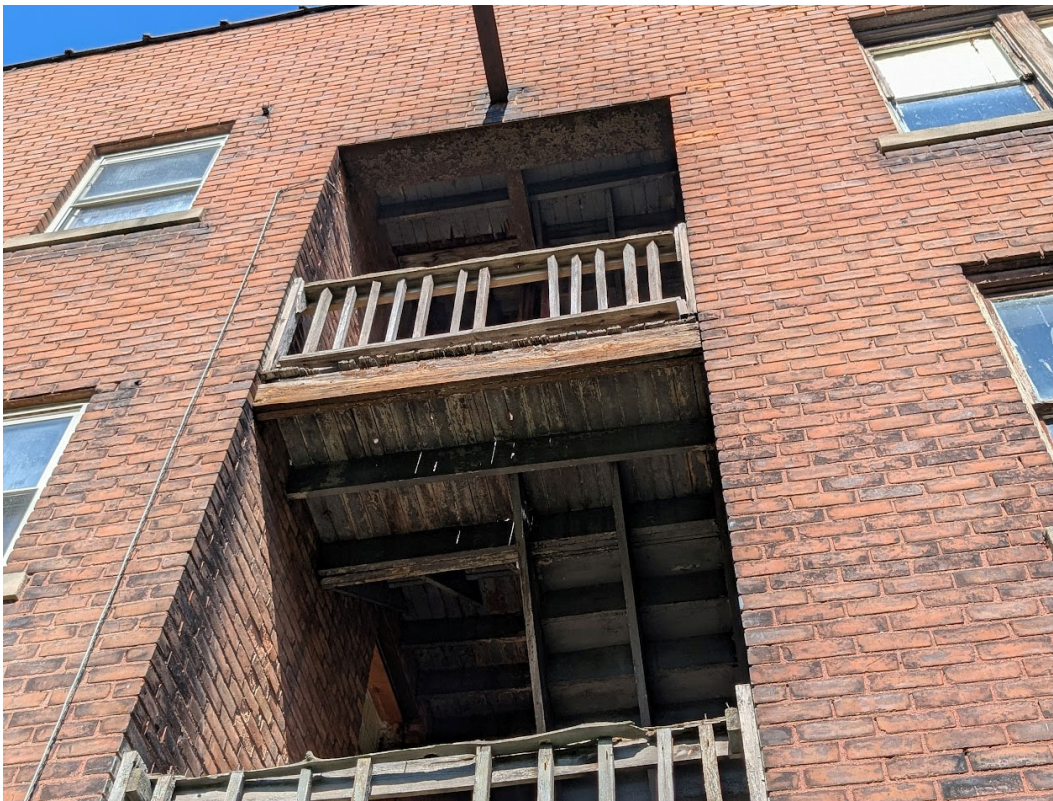
*Detail view of west side stairwell void. Staff assesses that the preservation of this opening (and the matching one on the opposite side) is not critical to the building's historic character under the Standards. Staff photo, August 28, 2025.*

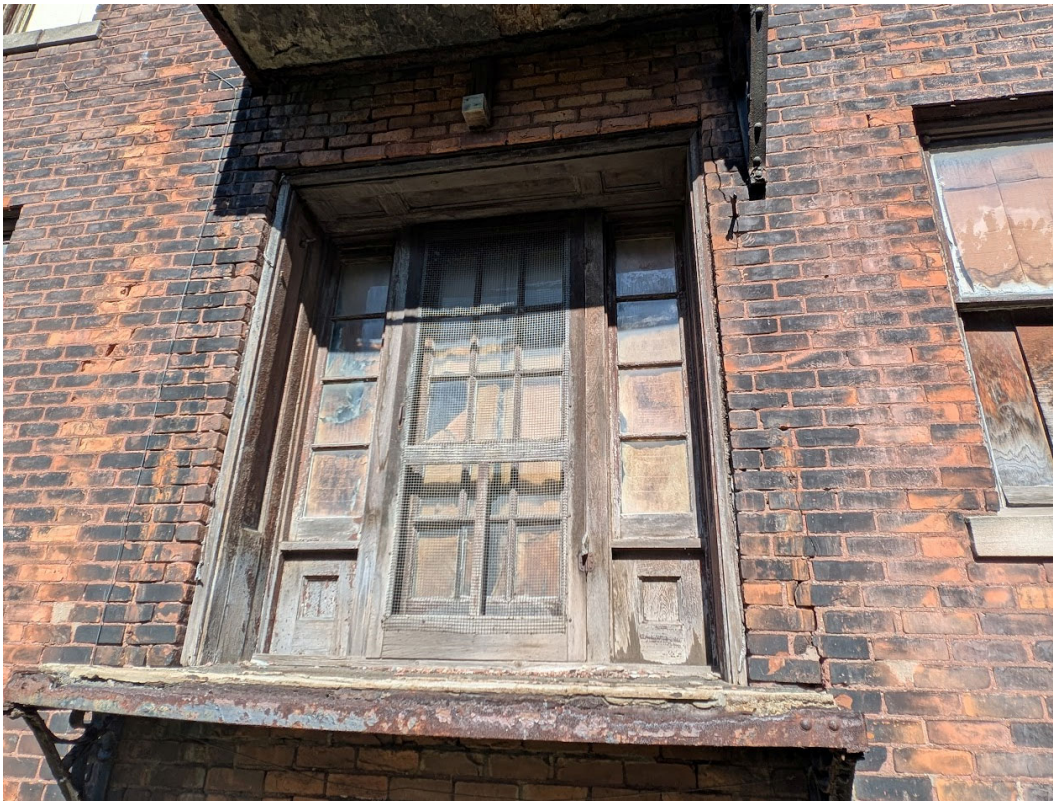
*Detail view of west side “balcony” historic-age entrance system, a single 15-lite in-swing door flanked by 3-lite sidelites. Staff photo. These units are proposed for replacement by the applicant. August 28, 2025.*

- However, staff assesses that the “balcony” window/door systems, as pictured above, are both character-defining and not beyond reasonable repair, and should therefore be retained.

- The six (6) surviving wood window/door systems at the rear sides be preserved, repaired, and retained in the rehabilitation design, as they do not appear to be beyond reasonable repair, and they provide important historic character. Additionally they may serve as a guideline for restoration of the lost front-facing balcony entrances at the primary facade.

- The six (6) surviving wood window/door systems (15-lite doors flanked by 3-lite windows, and all associated trim/elements) at the rear sides be preserved, repaired, and retained, as they do not appear to be beyond reasonable repair and they provide important historic character. Additionally they may serve as a guideline for restoration of the lost front-facing balcony entrances at the primary facade.

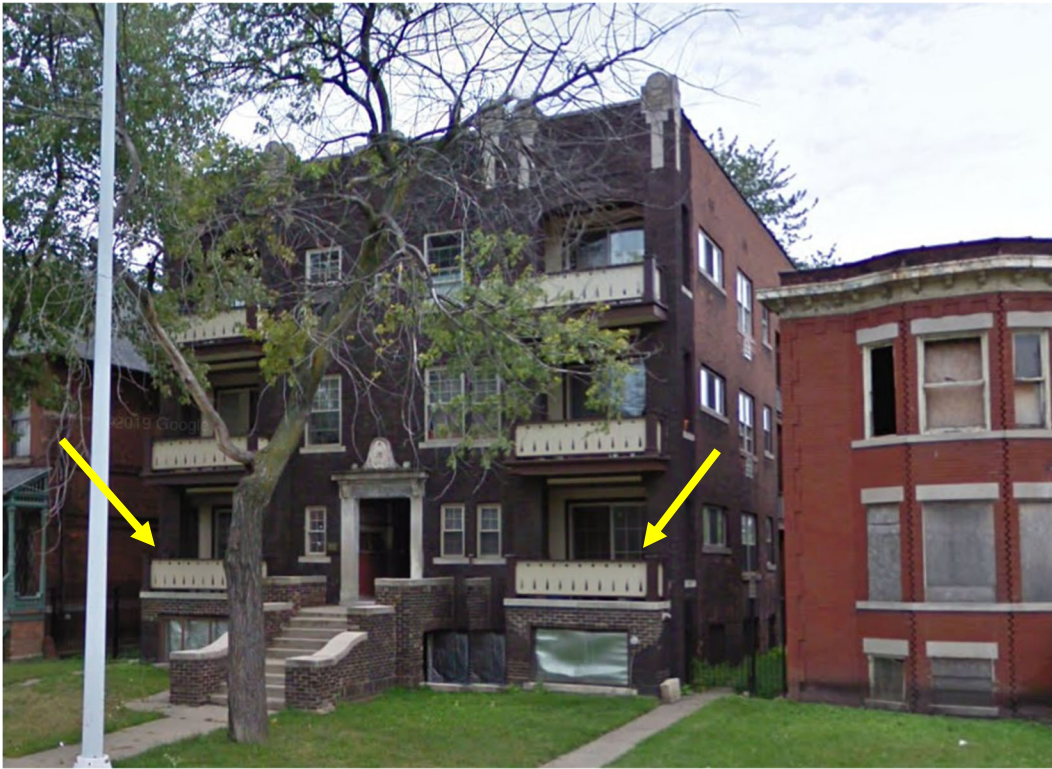
*Note the consistent height of all the balcony enclosures, including those at the lowest level (yellow arrows), shown here in August 2009 per Google Street View. 477 West Alexandrine, the shorter apartment building to the west, is still extant in this view, showing the reduced visibility of the west-facing side of the building.*

- The two lowest balcony enclosures, per the front elevation on the drawings excerpted above, appears to accept the height created in violation and retain it. This is not appropriate. The original historically correct lower height and expression must be recreated, in wood, with a booster rail if necessary/desirable hidden behind it.

- The six (6) balcony enclosures/wooden jigsawn balustrades at the primary façade must be retained and repaired at their original historic height on all sides. The two (2) lowest level balustrades, removed and replaced in violation of the historic ordinance with incorrect height reproductions, must be removed and replaced with a lower height, historically correct reproduction, also in wood, exactly matching the original elements. Booster rails, mounted inconspicuously behind the historic elements to provide a modern code height enclosure, can be approved by staff.
