STAFF REPORT: OCTOBER 8, 2025 MEETING

APPLICATION NUMBER: HDC2025-00305

ADDRESS: 6108 28th STREET

SCOPE: REPLACE 42 STEEL WINDOWS WITH ALUMINUM-CLAD WOOD WINDOWS, REPLACE WINDOW WALL

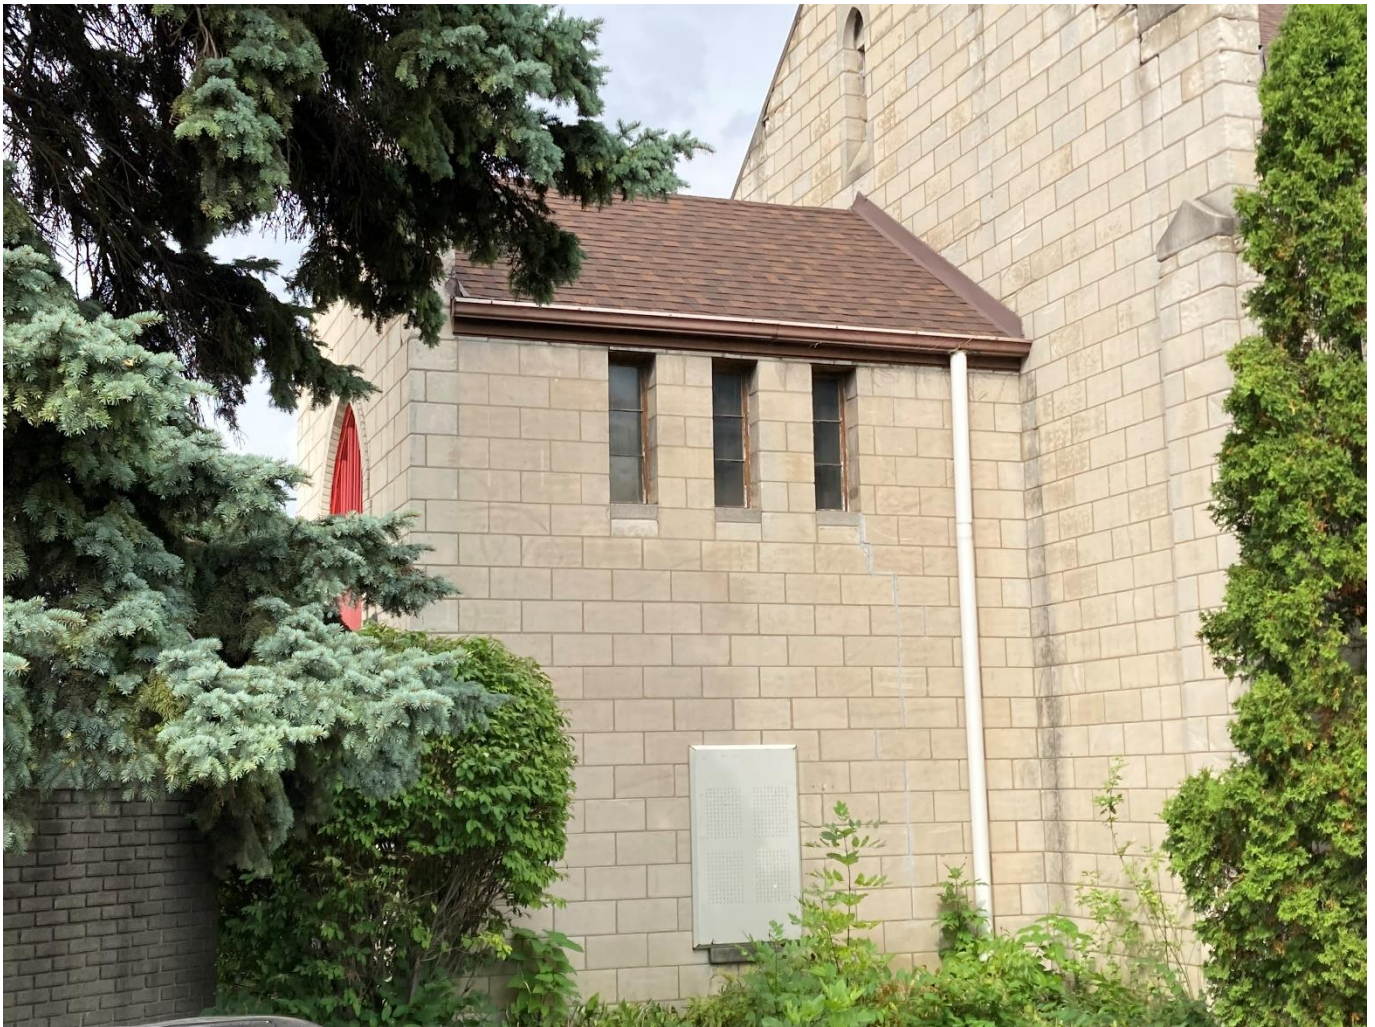
The south side of the 1938 entry hall with three steel windows. These windows are mirrored on the north side of the entry hall and are referred to as W7s on the architect's drawings. These windows are proposed for replacement. This covered basement window is not mentioned in the application materials. (Staff photo, September 2025.)

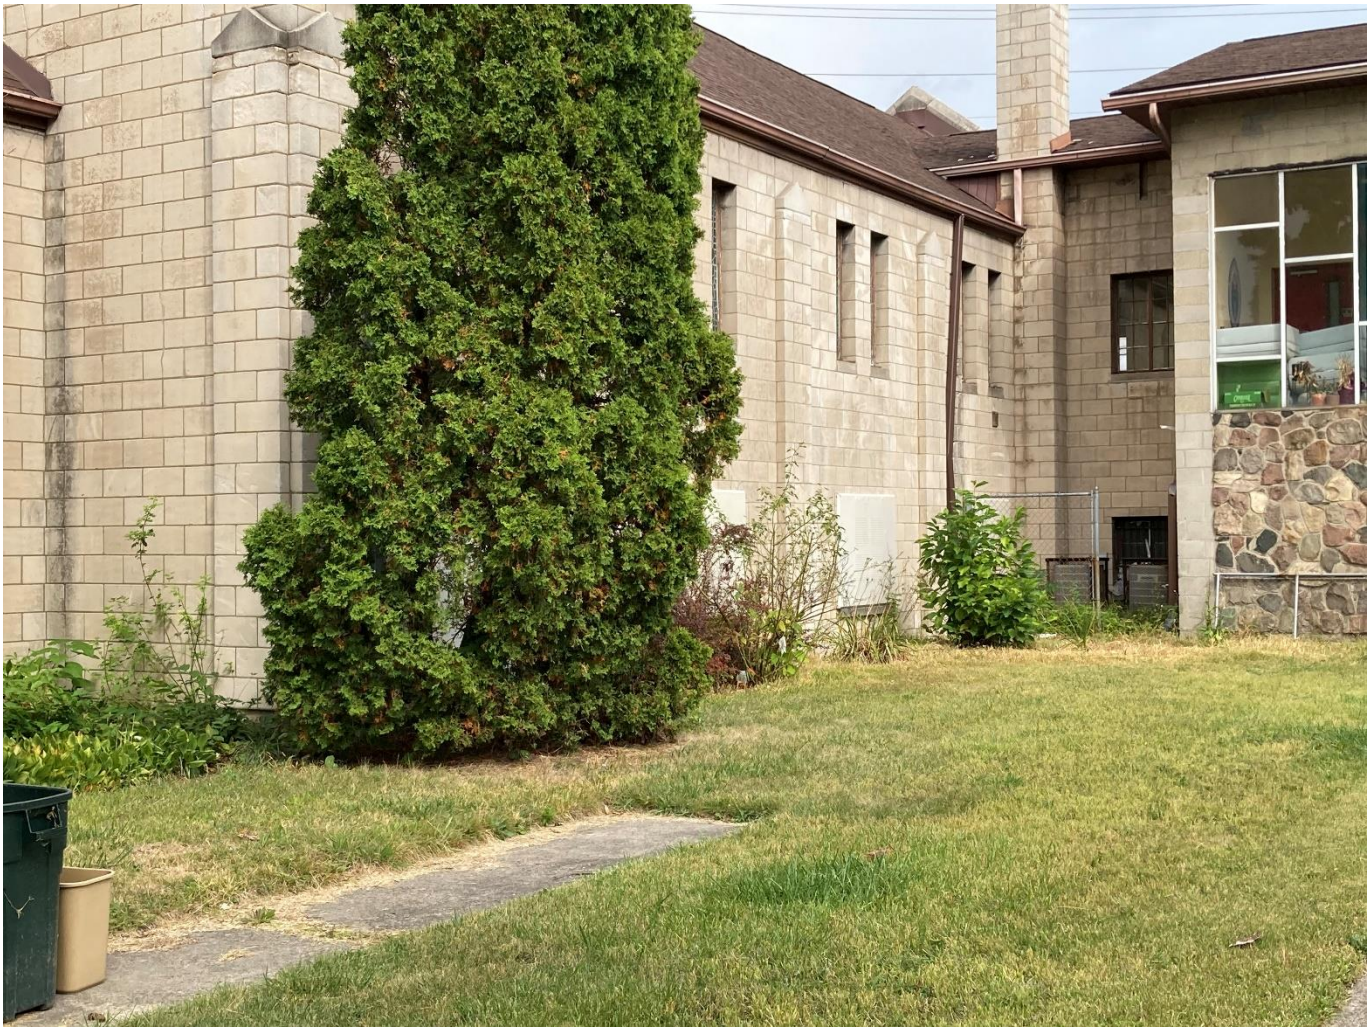
South side of the 1938 sanctuary, staff photo, September 2025. The unboarded sanctuary windows are not proposed for replacement. The covered basement windows in this photo (labeled W5s on the architect's drawings) are proposed for replacement. The 1963 addition is just visible to the right of the image, and just between the 1938 and 1963 portions are two steel windows. These windows are referred to as Window types W8 and W4 on the architect's drawings and both are proposed for replacement.

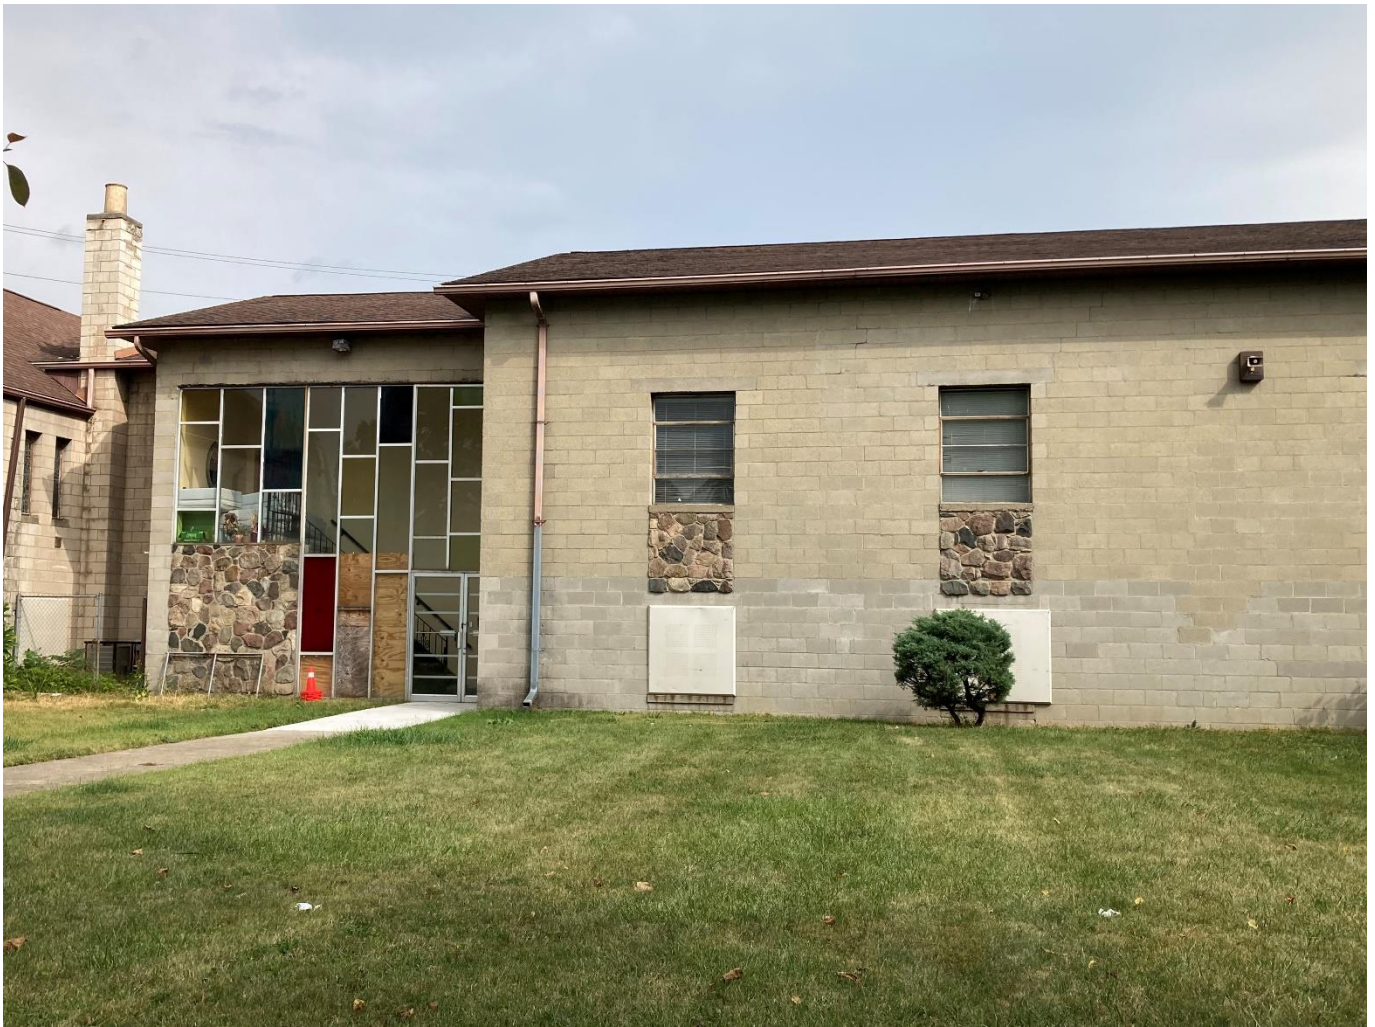
Most of the west façade of the 1963 addition shown, staff photo, September 2025. The stone veneer panels on the glassed-in vestibule and below the windows are visible. The glassed-in vestibule and the four windows shown in this photo on the 1963 addition are all proposed for replacement. The windows with the stone below are labeled W2s on the architect's drawings, and these basement windows are labeled W9s.

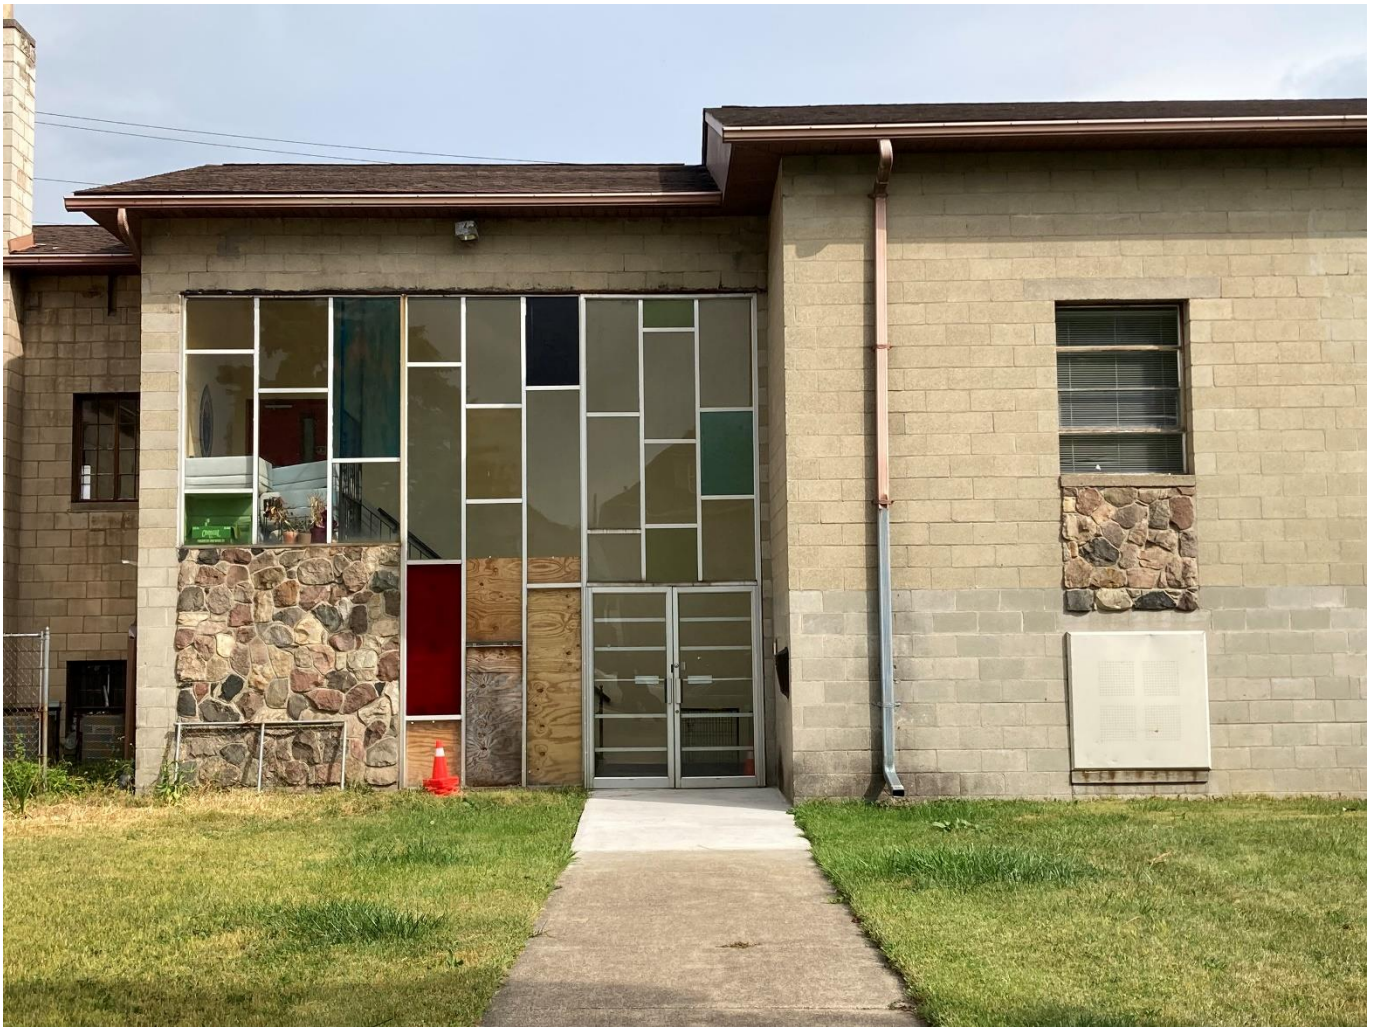
Detail, 1963 glassed-in vestibule. Window wall with aluminum doors shown and the rest of the 1963 addition is to the right of the image. The 1963 window wall, entry doors, and windows shown here are all proposed for replacement. (Staff photo, September 2025.)

The **1963 window wall** is composed of 3-inch-wide aluminum framing and 1'11" x 4' 11" glass rectangular panes (some cut to fit) installed in a staggered layout. Some panes have colored film applied or non-glass inserts to appear as stained glass. Staff is not clear as to whether the glass panes in the existing window wall are flush with the aluminum framing or (more likely) recessed. The proposed replacement aluminum framing for the new window wall is 2" wide. It is not clear to staff if the proposed storefront can replicate the existing window wall's staggered pattern or if the new storefront system for the window wall would require all the glass to be in a straight stacking grid-like layout. In the new proposed replacement, the glass can be recessed up to 3.5" into the frame, or the panes can be installed flush with the frame. It is not clear if the stained glass effect will be replicated in the proposed replacement.

The **1963 aluminum doors** have horizontal members (rails) that measure 3.5" tall and vertical members (stiles) that measure 3.5 wide, and the remainder of the door is glass. It appears to staff that the bottom rail of the 1963 door might be a little taller than the top rail—perhaps it is 4" tall. In the proposed replacements, the door's top rail is 2 1/8" tall, the stiles are 2 1/8" wide, and the bottom rail is 4" tall in the standard door, but that can be customized.

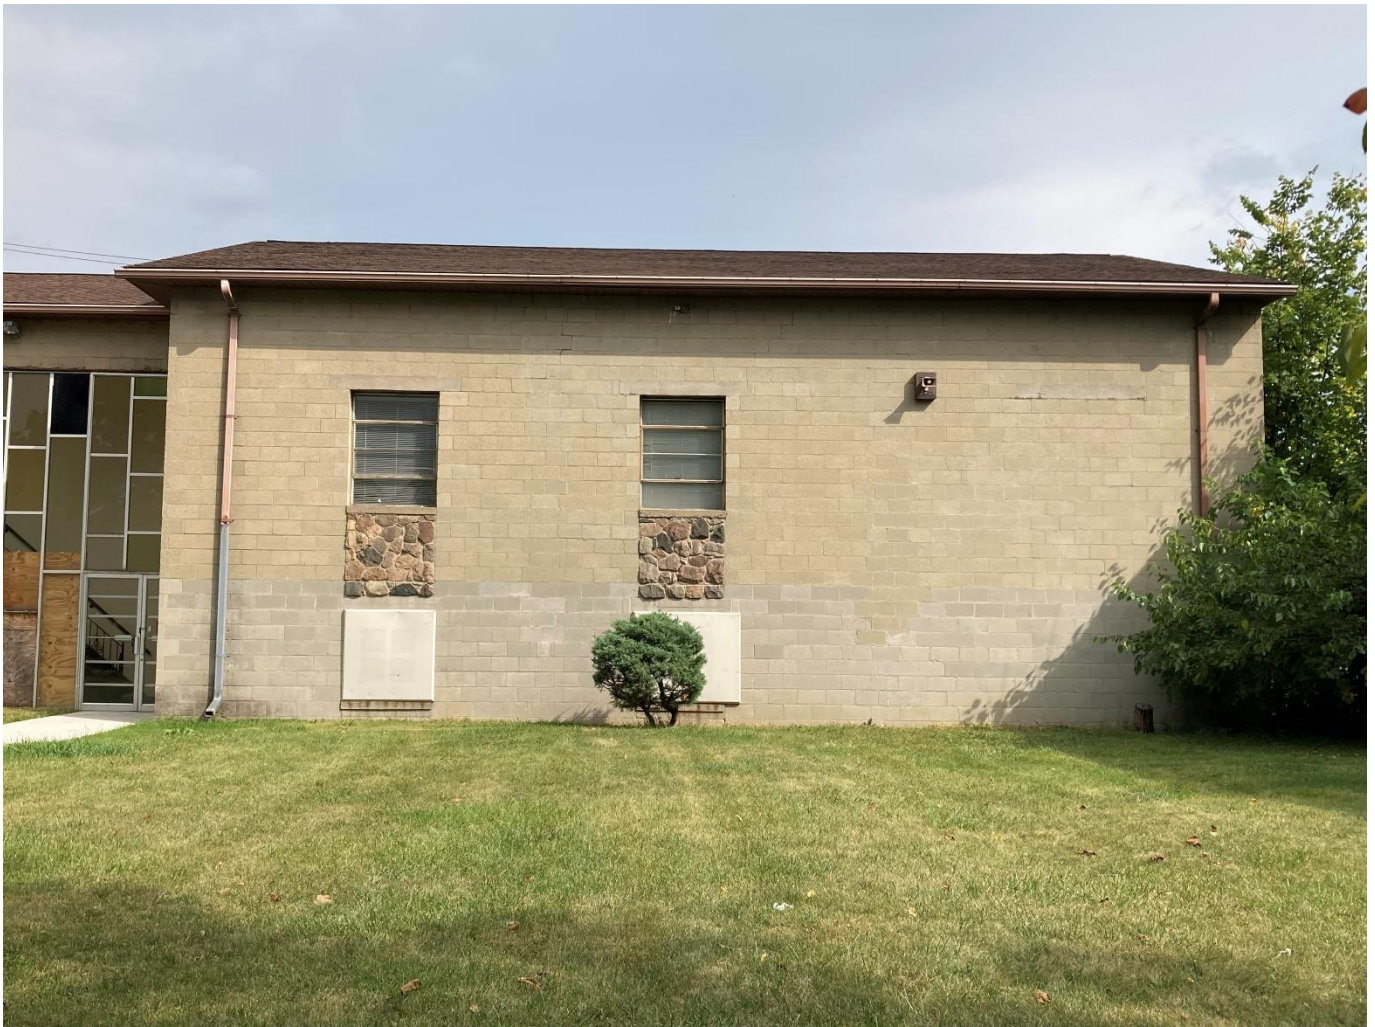
Complete block portion of the west wall of the 1963 addition shown, September 2025, staff photo. All four windows on the block portion of the building (two W2s and two W9s) are proposed for replacement.

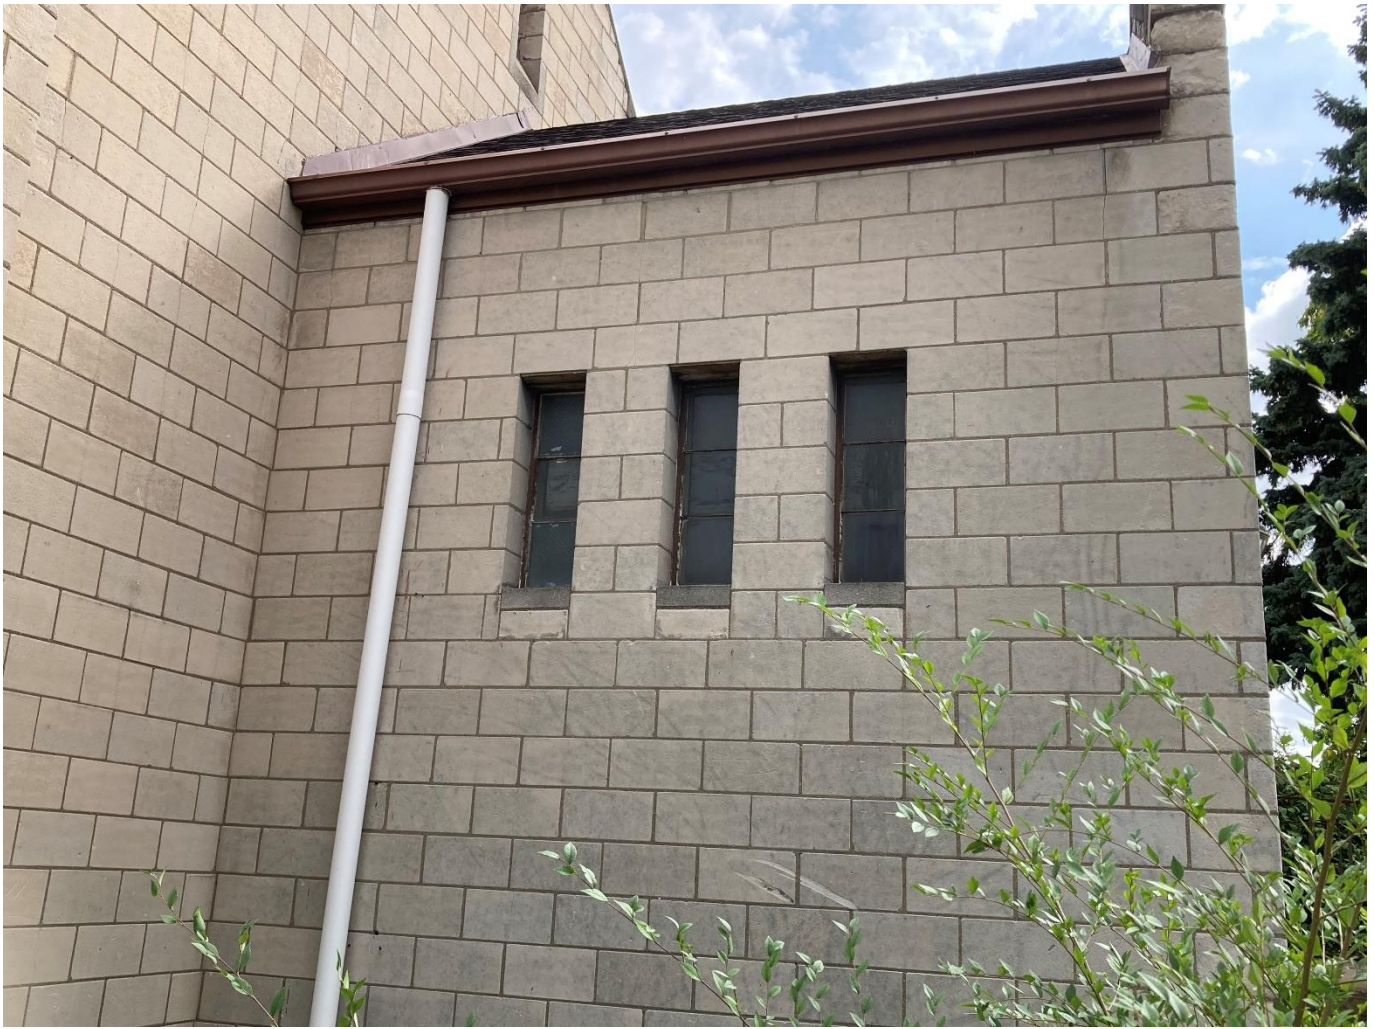
North side of the 1938 entry hall with three narrow windows, staff photo, September 2025. These three windows are proposed for replacement and are labeled Window W7s on the architect's drawings.

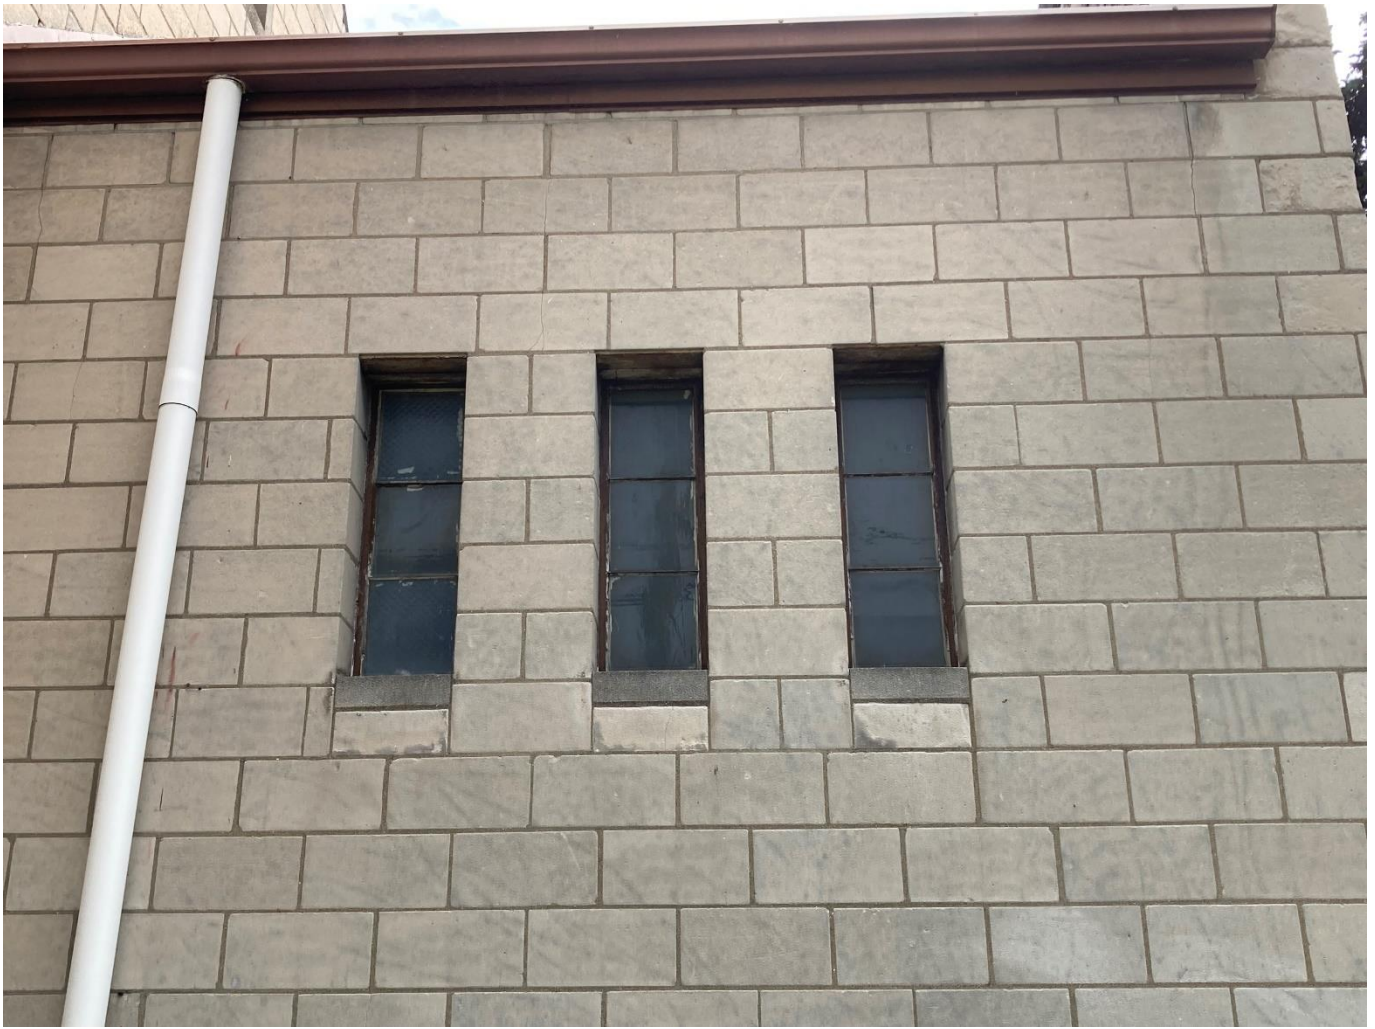
Detail of the three north-side windows on the 1938 entry hall. Windows are steel with narrow muntins. Staff photo, September 2025.

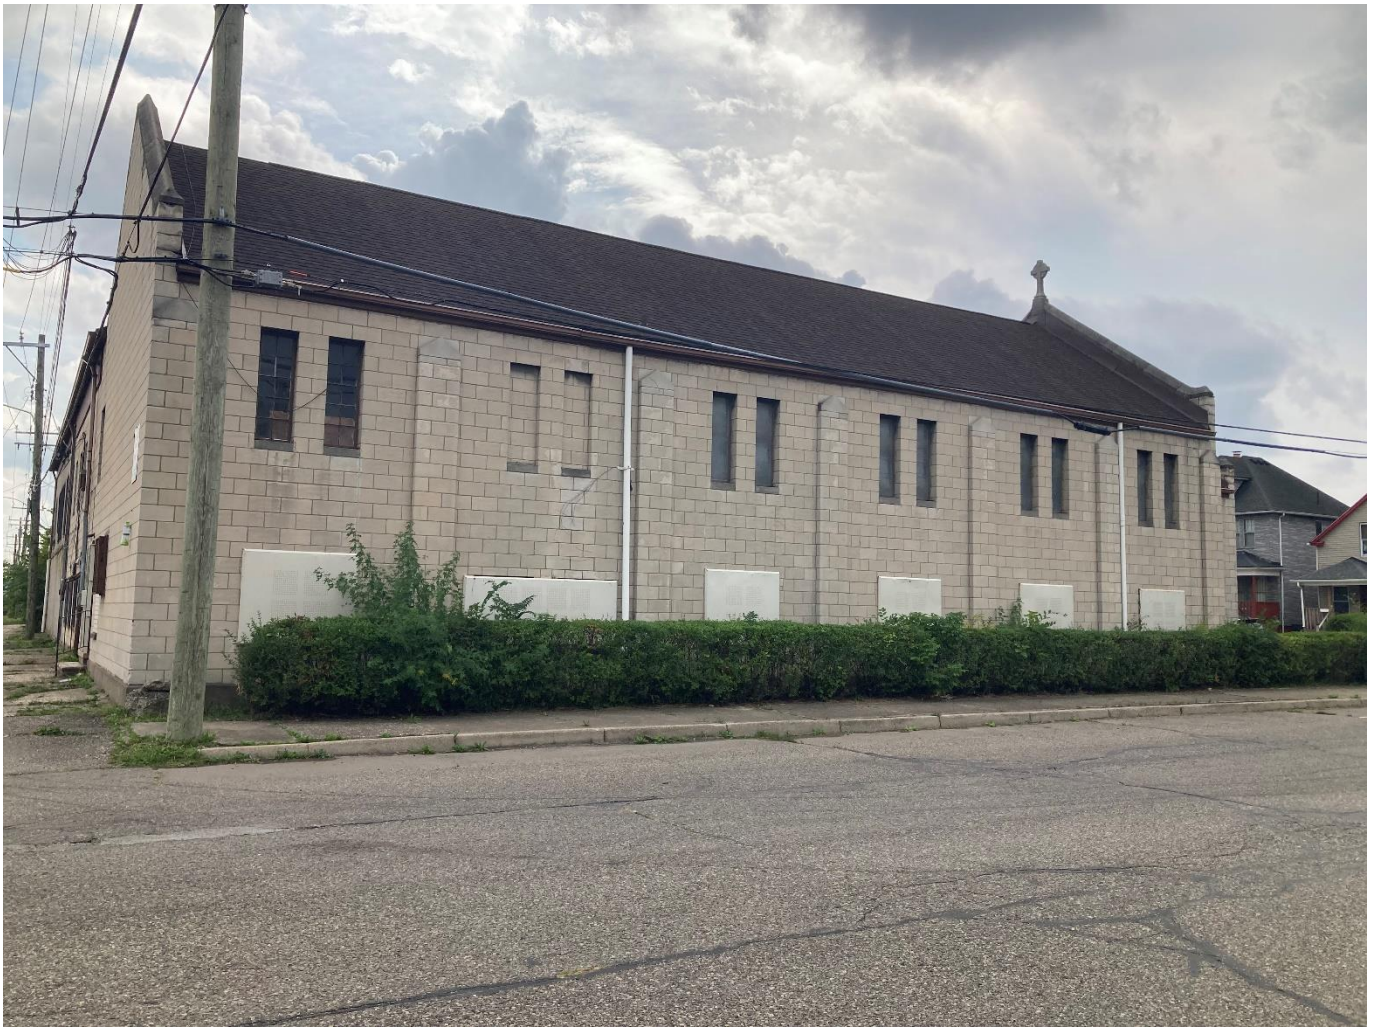
North side of the church, along Milford Street, staff photo, September 2025. Sanctuary windows and covered basement windows are visible. The covered basement windows in this photo are proposed for replacement and are labeled Window 5s and 8s on the architect's drawings. The 8 sanctuary windows will remain in place, but the two narrow windows closest to the northeast corner are 2 W11s on the architectural drawings and they are to be replaced.

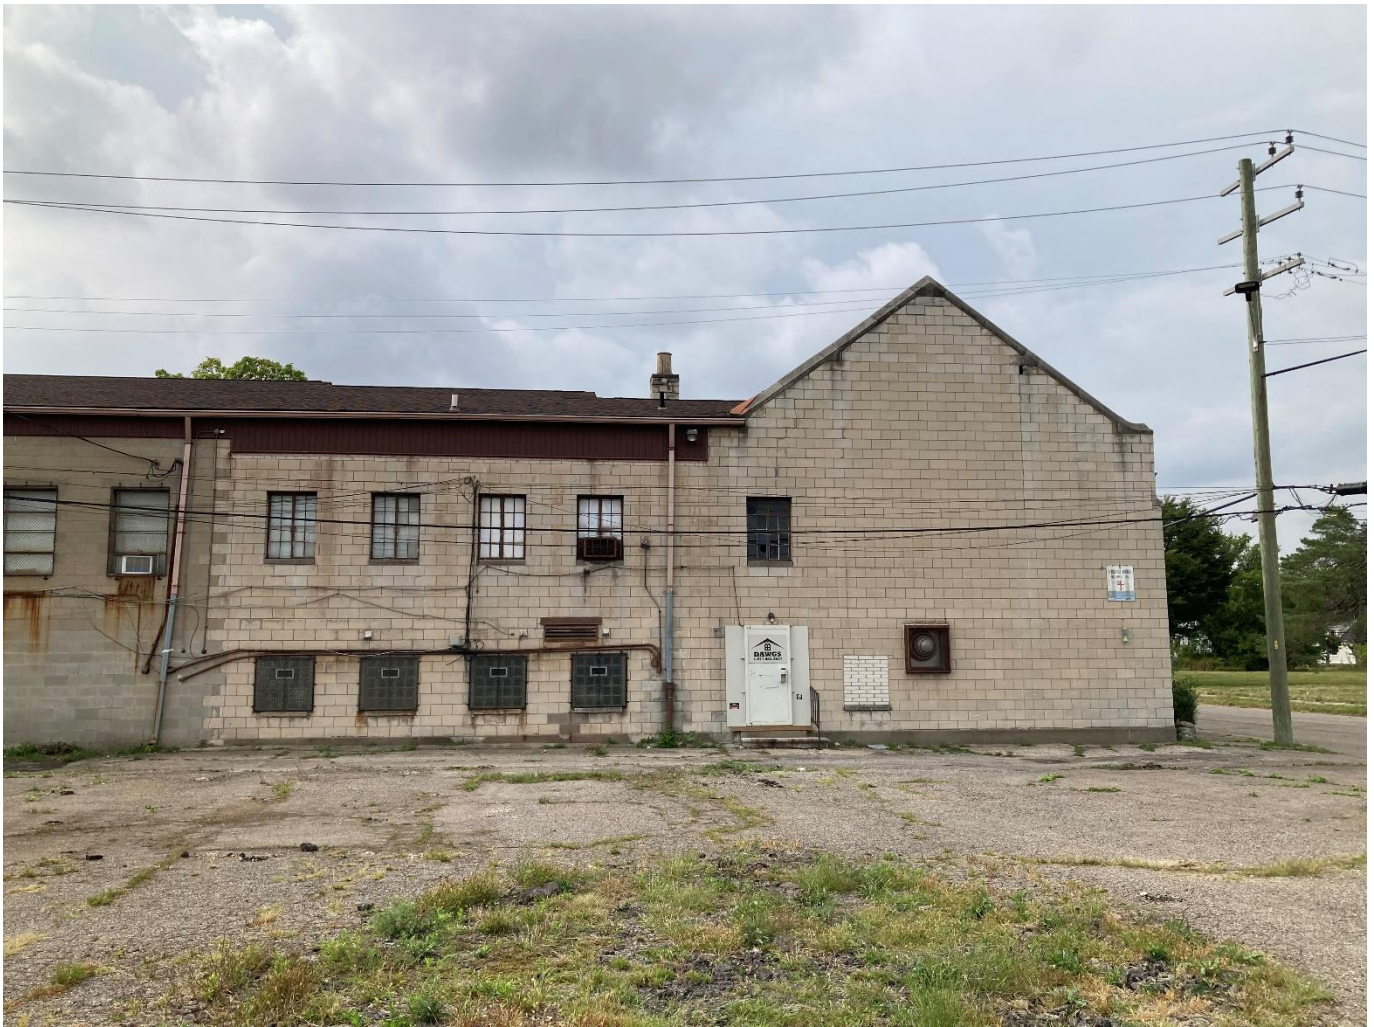
East wall of 1938 portion/ east end wall of the sanctuary. A modern door, bricked-in opening, nonhistoric fan, and steel windows are visible. Some cracking in the masonry near the gable is also visible, perhaps caused by a water drainage issue. Historic steel windows are visible, basement windows with glass block are also visible, and the joint with the 1963 portion can be seen to the left. The four basement windows here that have been infilled with glass block will remain in place. All other windows shown here are proposed for replacement and are labeled Window W1s on the 1963 portion and W4s on the 1938 portion on the architectural drawings with this application. (Staff photo, September 2025.)

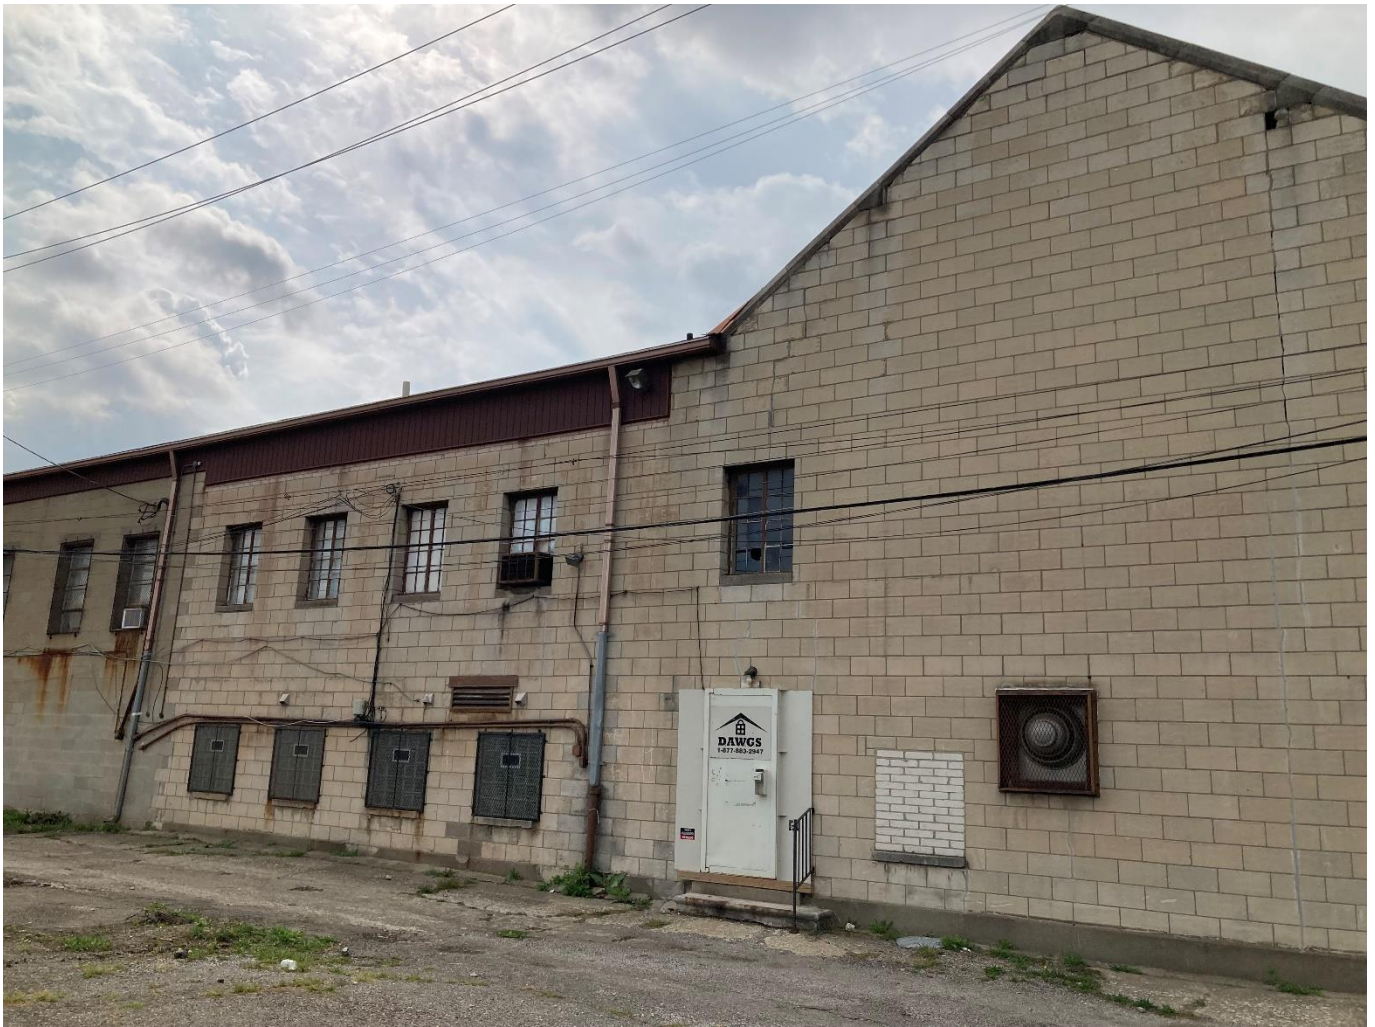
East wall of the 1938 portion and some of the 1963 portion just visible, staff photo, September 2025. Masonry cracking is more visible here. The basement windows shown here will remain in place, All other windows pictured here are proposed for replacement. The 1963 windows are referred to as W1s on the architect's drawings, and the 1938 casement windows here are W4s.

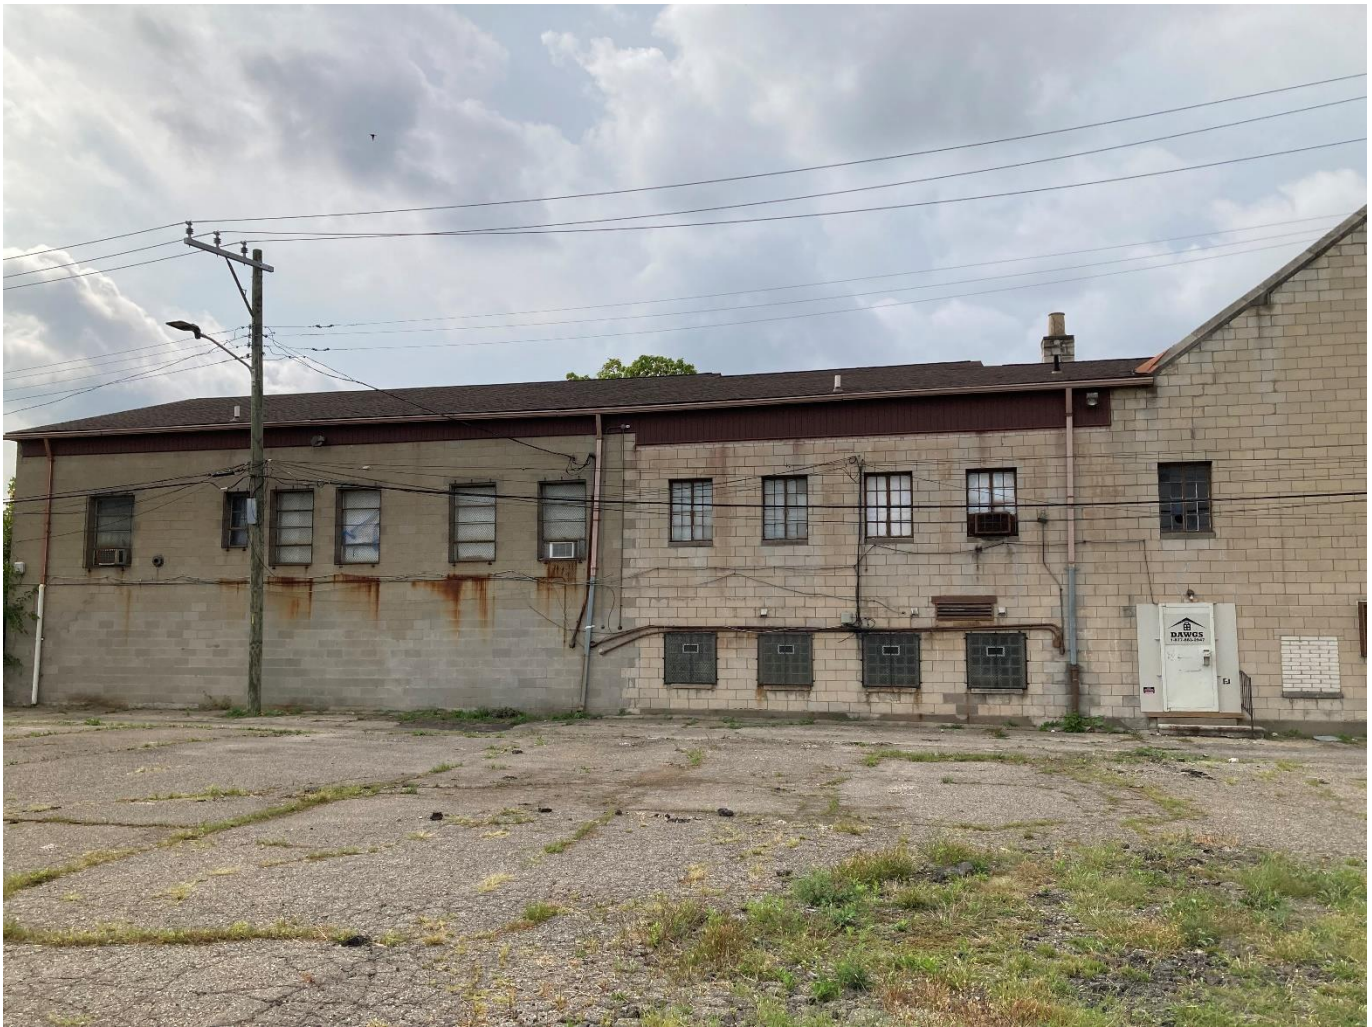
East wall from parking lot behind church, staff photo, September 2025. 1963 portion to the left and the 1938 portion on the right. The 1963 windows with the three horizontal muntins (Window types W1, 2 and 3 on the architect's drawings) and the 1938 steel windows with the narrow horizontal and vertical muntins (Window W4s) are both visible. The basement windows have been infilled with glass block and covered with metal security screens. The basement windows shown will remain, and all other windows shown in this photo are proposed for replacement.

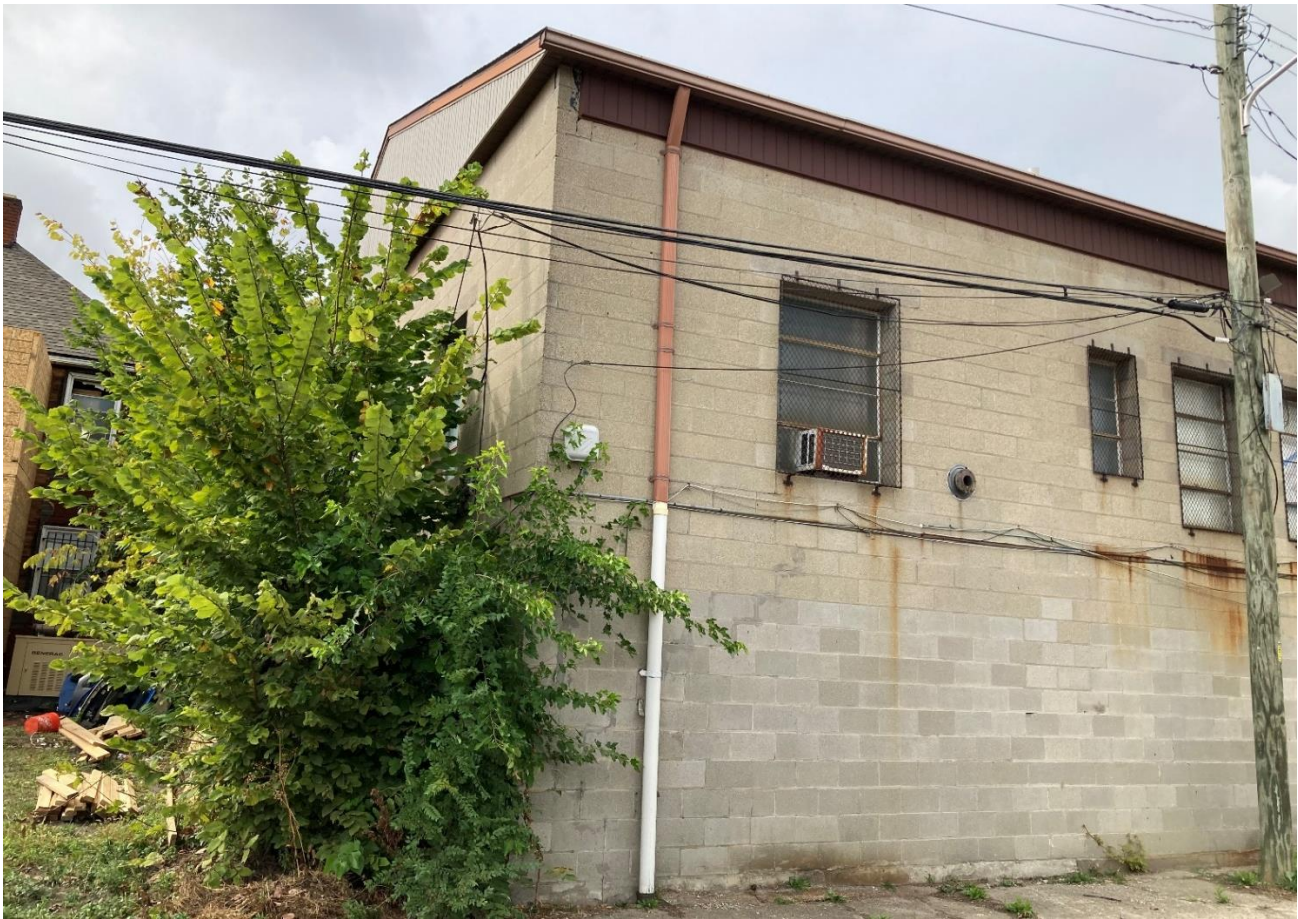
Southeast corner of 1963 addition. September 2025, staff. All windows shown are proposed for replacement. From left to right, the architect's drawings label these window types W 2, 3, and 1.

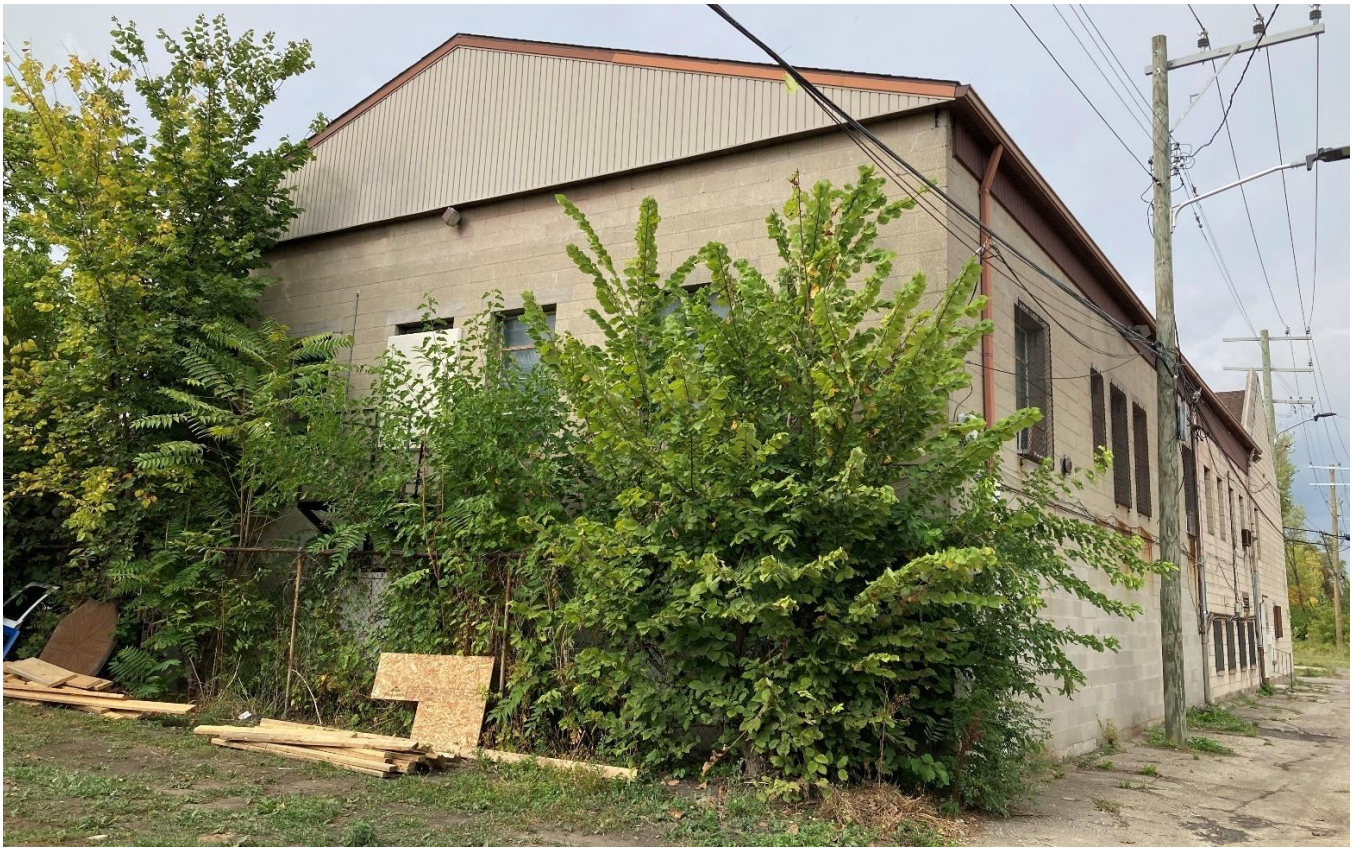
South end of the 1963 addition, staff photo, September 2025. Windows here are proposed for replacement but are difficult to see because of the overgrowth. Architect's photos show seven windows on this end of the building proposed for replacement. The architect's drawings label the basement window on this end a Window Type W1, and the others on this end are W2s.

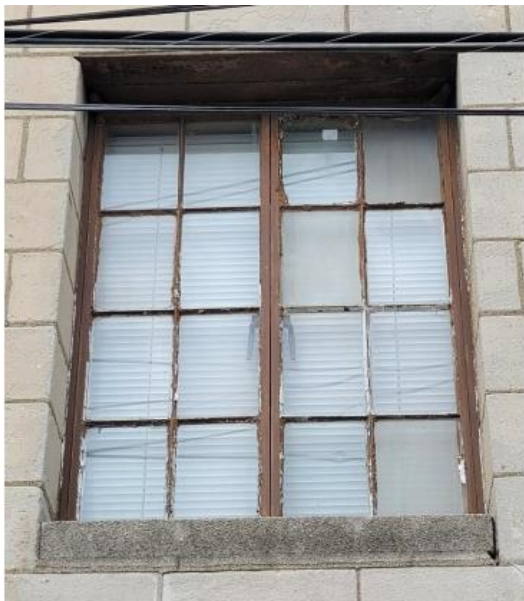
Sample W4-type window from the window conditions document in the Cycle 2 file.

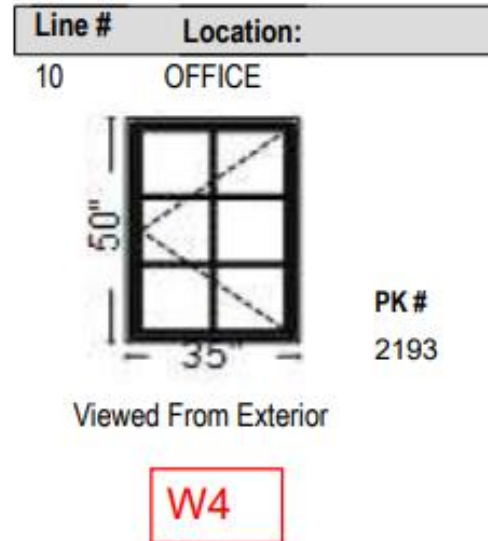
Sample W4-type window shown on the draft window order form.
