**REVISED: 10/7/2025**

**ADDRESS: 264 WATSON**

**APPLICATION NO: HDC2025-00592**

**SCOPE: ERECT PORCH AT FRONT AND SIDE AND REPLACE WOOD WINDOWS**

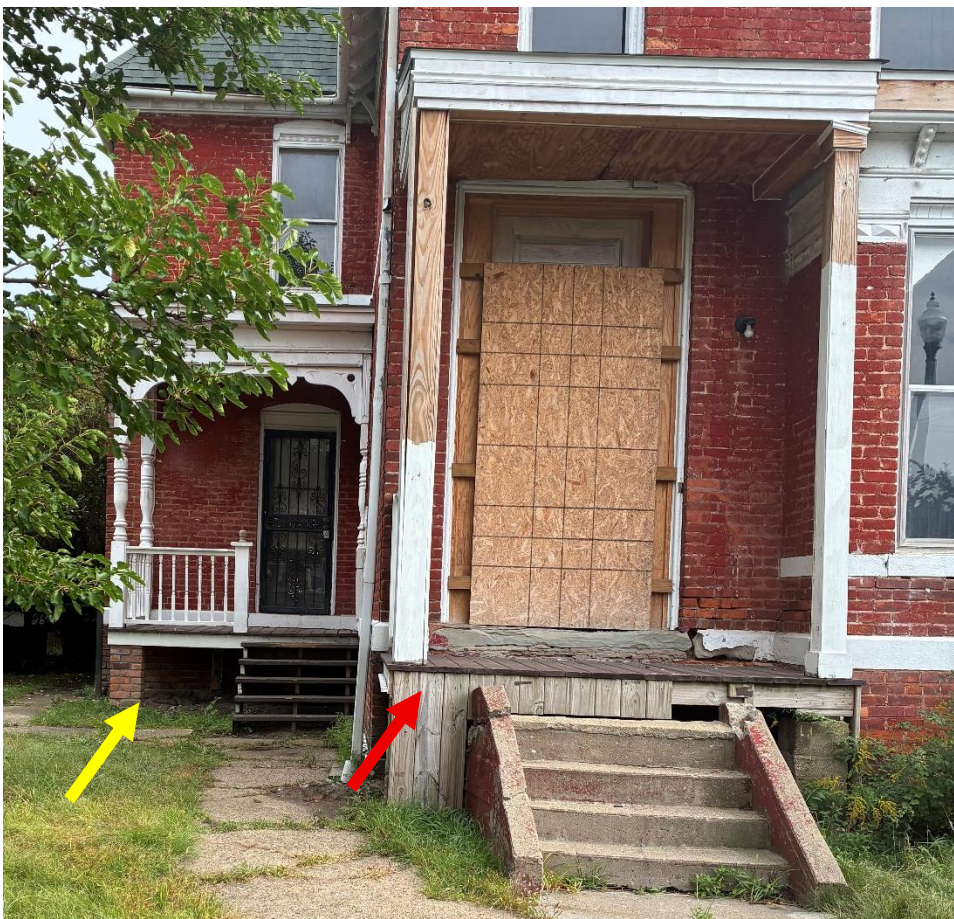
**264 Watson, current conditions. Showing non-historic front porch (red arrow) and historic east side porch (yellow arrow). Photo by staff taken 9/22/2025**

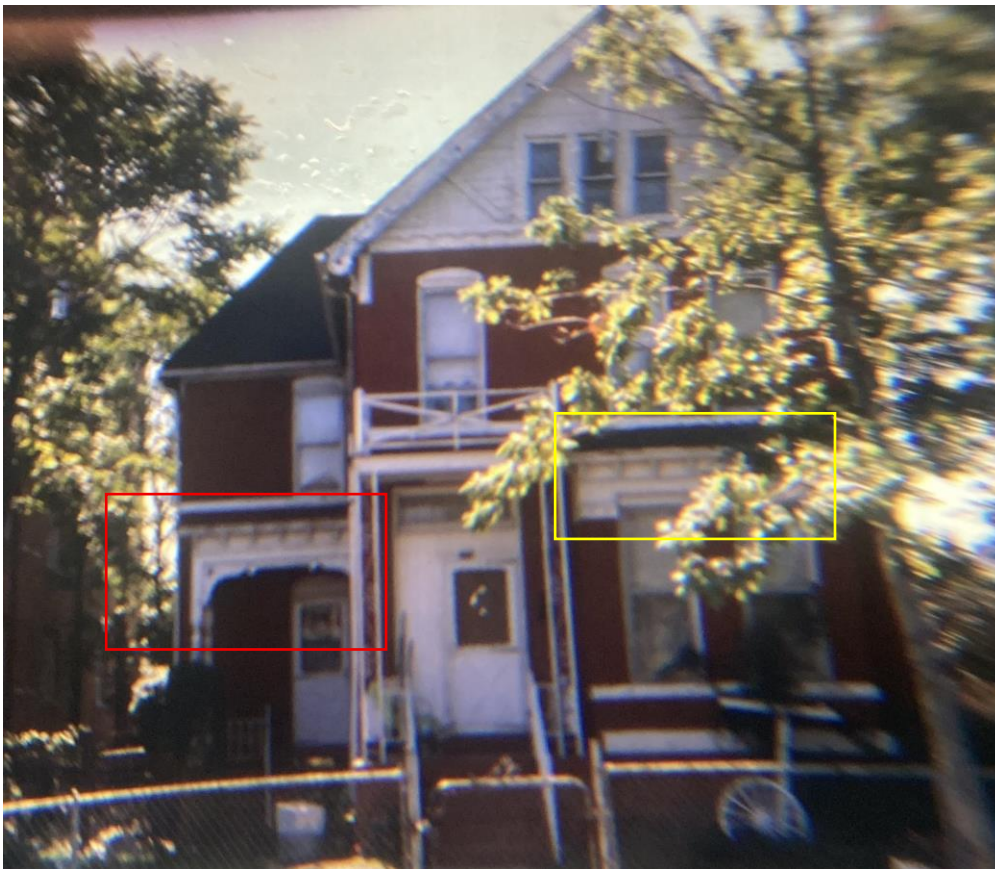
264 Watson, designation slide dating from 1980. Note that the side porch displays decorative detailing (outlined in red) which is consistent with the detailing at the front façade's bay (outlined in yellow)

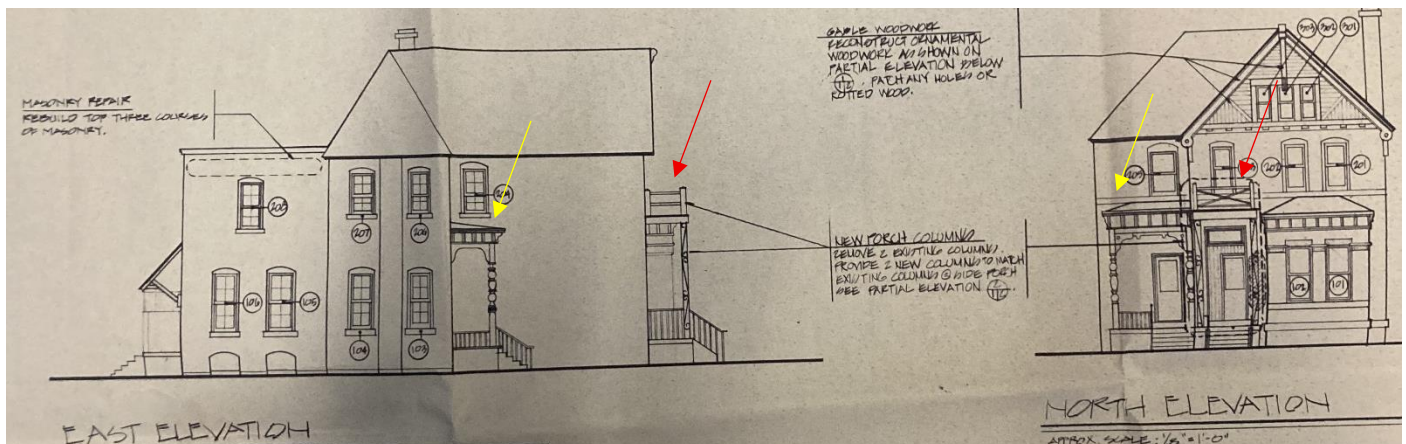
Rehab drawings from 1981 showing the front (yellow arrow) and side porch (red arrow) conditions at that time. The project proposes to replace the non-historic front porch with a new porch which takes design cues from the historic east side porch. Note that the side porch was not proposed for repair, likely because it was in good condition and retained elements that were consistent with the building's historic character.

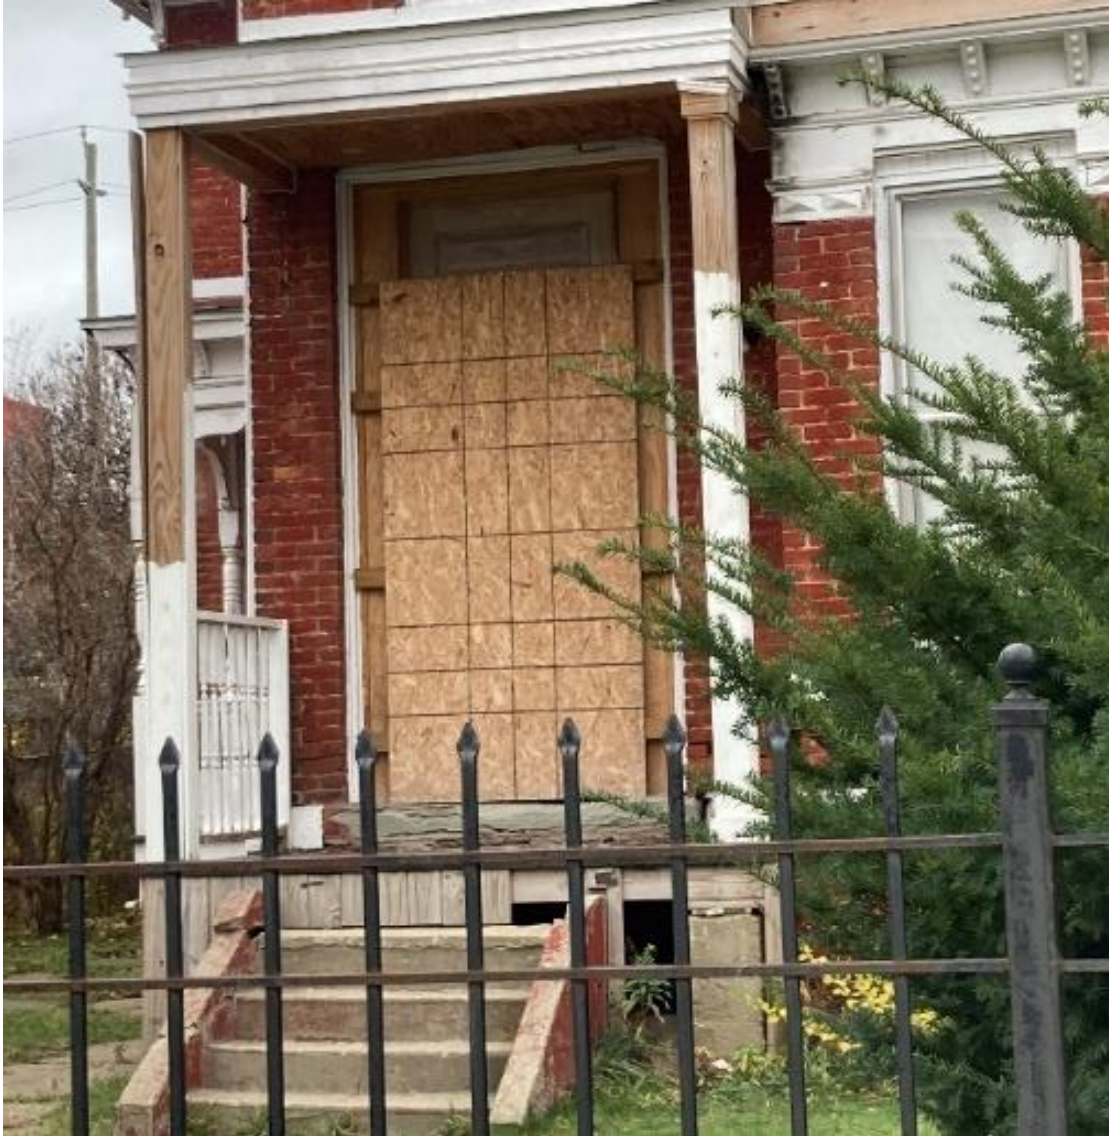
- Google Streetview images indicate that the later, non-historic front porch which was added in 1981 was removed sometime between 2011 and 2013 without HDC approval, leaving the masonry steps. The current front porch columns, roof, and railings were installed in 2021 without HDC approval (see below). Staff supports the proposed removal of the current front porch as it is not of historic age and does not contribute to the property's historic character.

**Front porch, current conditions. Photo by staff, 11/25/2024**

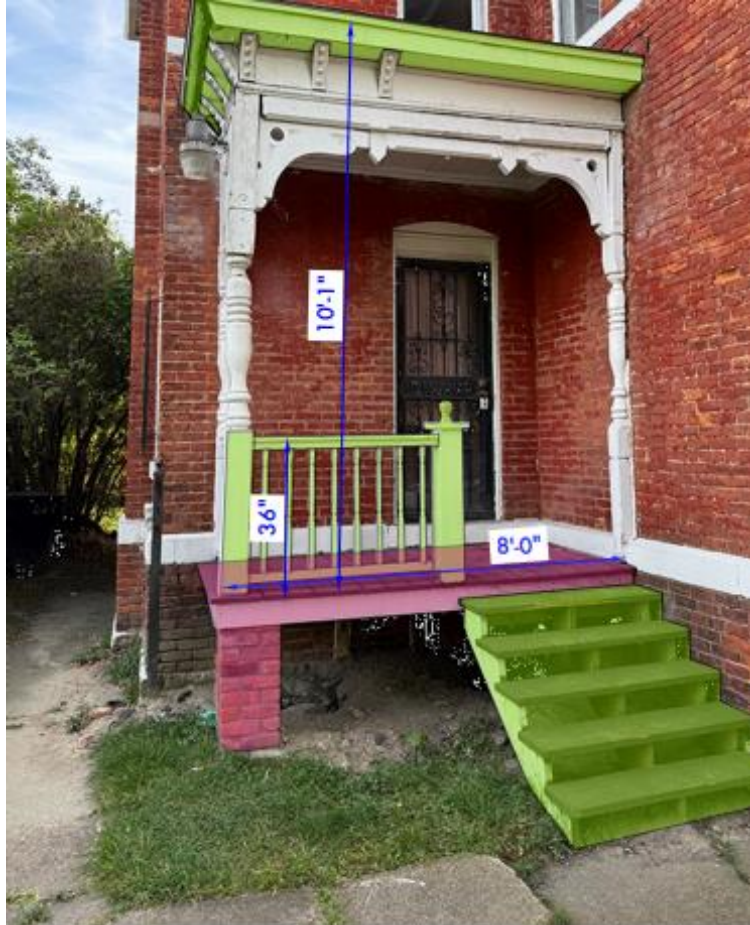
- With respect to the historic east side porch, staff notes that it currently appears much as it did at the time of local designation/when the building was identified as Contributing to the historic district. It is staff's opinion that the side porch is a distinctive character-defining feature of the building as it displays historic-age details which are associated with the Queen Anne style and are reflective of decorative detailing elsewhere on the building. A review of Sanborn maps (provided above) indicates that the porch has been extant since 1887. Also, note that the Commission determined that the east side porch was a distinctive, character-defining feature of the property at their 12/11/2025 regular meeting. The Commission upheld this position at their 02/12/2025 meeting. The porch also appears to remain in relatively good condition and therefore should be kept and, where deteriorated, repaired using in-kind materials. The below indicates the the areas/elements of the porch that are in poor condition and the elements that do not date from the building's original construction as noted by the applicant.

Existing historic side porch. Diagram by applicant

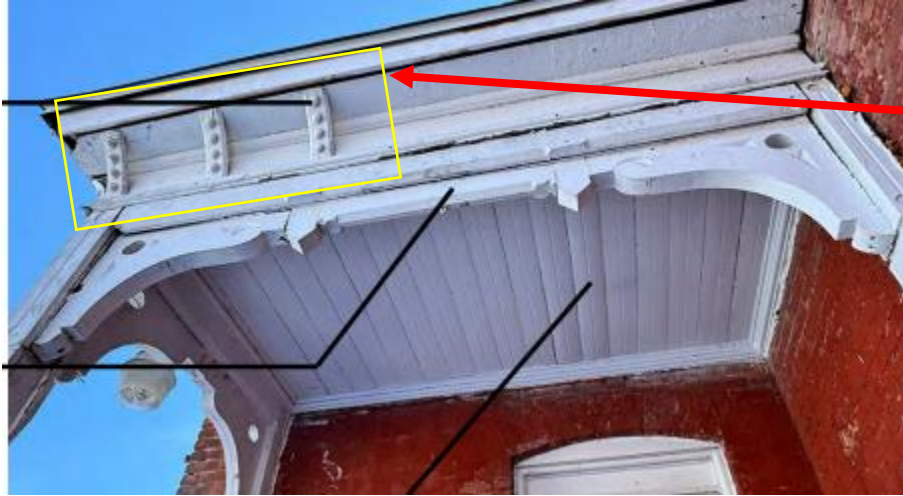
East side porch, current appearance. Note that the east side porch's decorative details match those at the front façade's bay window. Specifically, the brackets at the porch soffit/eave area match those at the front facade bay (outlined in yellow). Provided by applicant

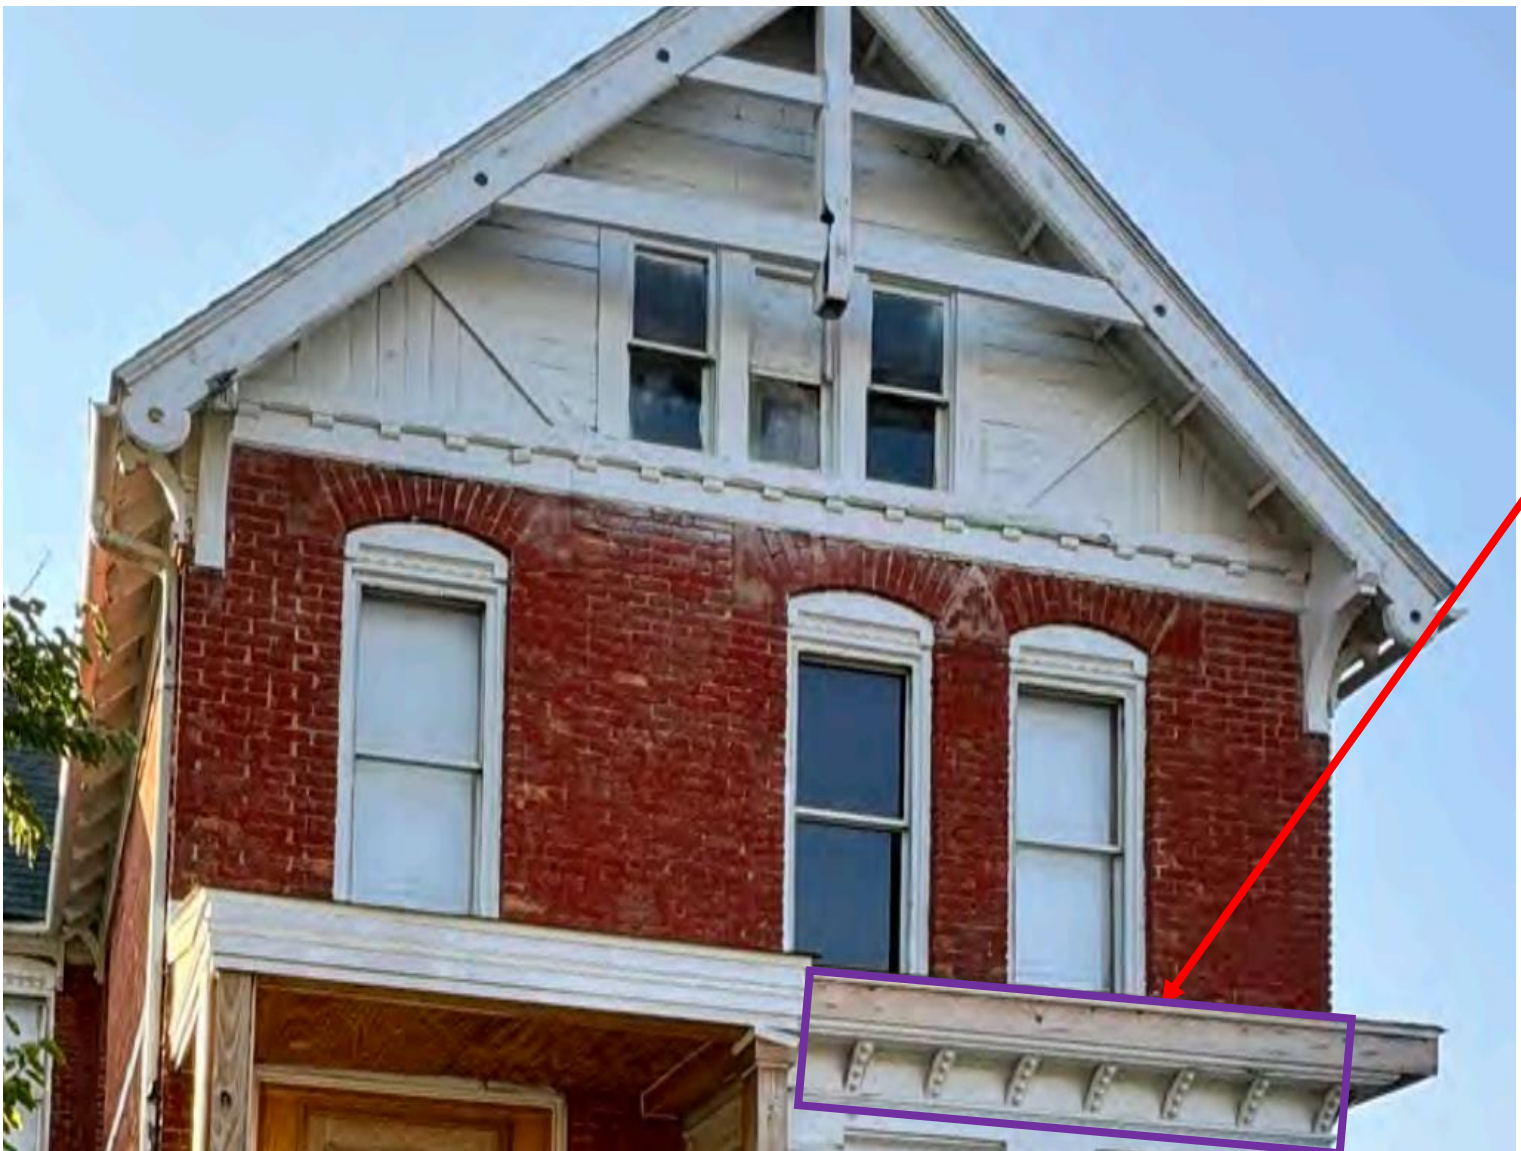
Front façade, current appearance. Note that the east side porch's decorative details match those at the front bay window. Specifically, the brackets at the porch soffit/eave area match those at the front facade bay (outlined in purple). Provided by applicant
