STAFF REPORT: 10/08/2025 REGULAR MEETING

APPLICATION NUMBER: HDC2025-00561

ADDRESS: 14635 E. JEFFERSON

SCOPE: ALTER AND REHABILITATE BUILDING, CONSTRUCT NEW PARKING LOT

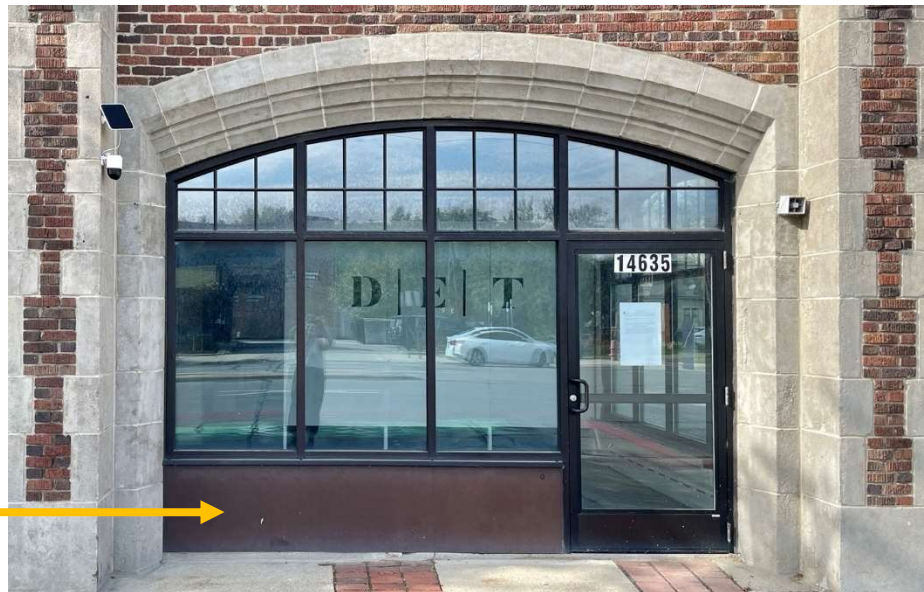
Staff photo, 09/24/2025

Staff would like to note that the board-and-batten was never installed at the panels below the storefront systems.

- The proposed storefront system panel design, materials, and specifications shall be provided to staff for review and approval.
- The proposed material for the gate shall be provided to staff for review and approval.
- The existing historic door at the E. Jefferson Avenue entrance shall be restored, and not painted, instead of replaced.
- A historic mortar mix shall be used for the proposed repointing, as the mortar must be softer than the historic brick and match the composition of the existing historic mortar.
- A photo of the sample of the infill brick next to the existing historic brick shall be provided to staff for review and approval to ensure that it is suitable for exterior use and is compatible in texture, color, and dimension with the adjacent historic brick.

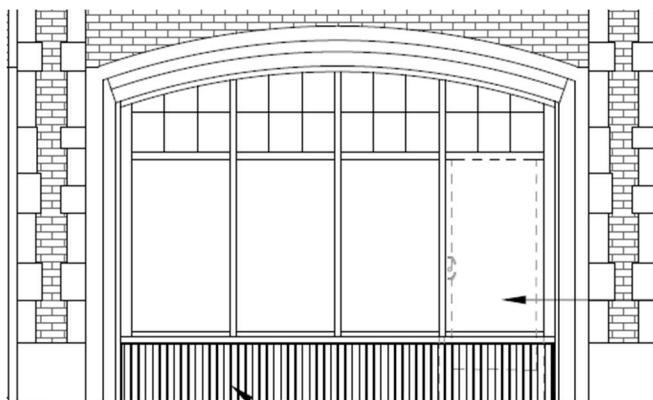
Drawing from current application

- The existing storefront panels, with their flat surface and lack of details, appear to reflect a more modern design, contrasting with the ornamental details, like panels, typical of historic storefronts of that era.

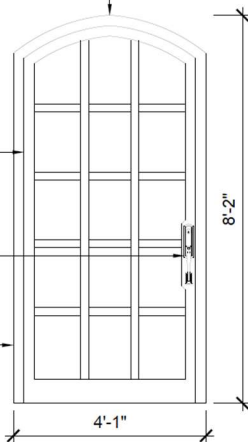
Drawings from application

- The applicant proposes to replace the door with a replica wood door and paint it B6: Moderate Brown.

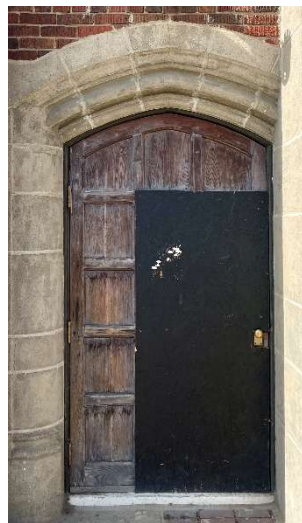
Staff photo, 09/24/2025

- The existing, historic wood door is a distinctive, character-defining feature and has not been proven to be beyond repair.

- The historic wood door at E. Jefferson is a distinctive, character-defining feature of the property that has not been proven to be beyond repair.
- The proposal is missing the design, material, and specifications for the storefront system panels, the material for the gate, the type and color of mortar to be used for any repointing, and the infill brick specifications.

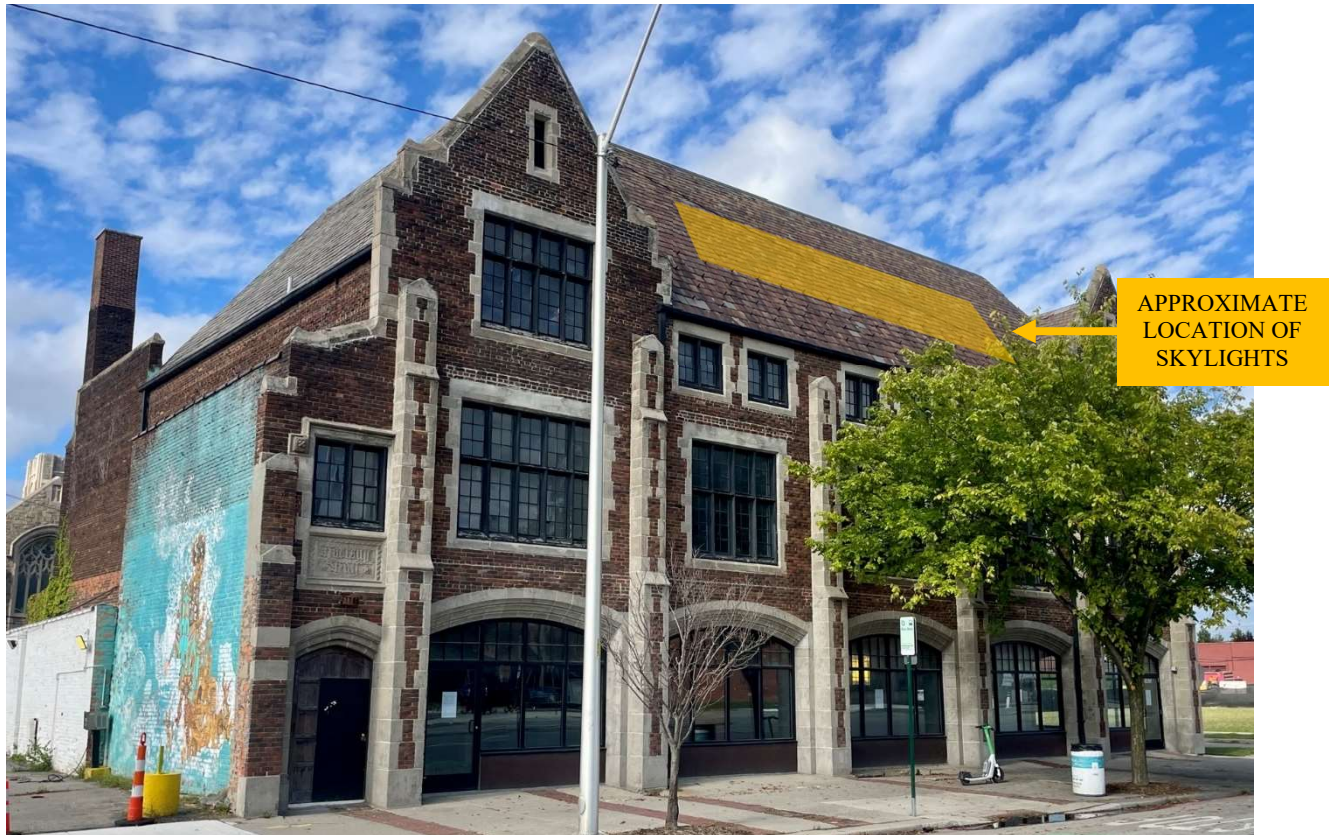
Staff photo, 09/24/2025

- The slate roof is certainly historic and unambiguously a distinctive character-defining feature that is important to the historical character. Slate used as a roof material is described in the Elements of Design #3 (Sec. 21-2-2). It is also described in the Historic District Advisory Board (HDAB) designation report for the historic district (emphasis by staff):

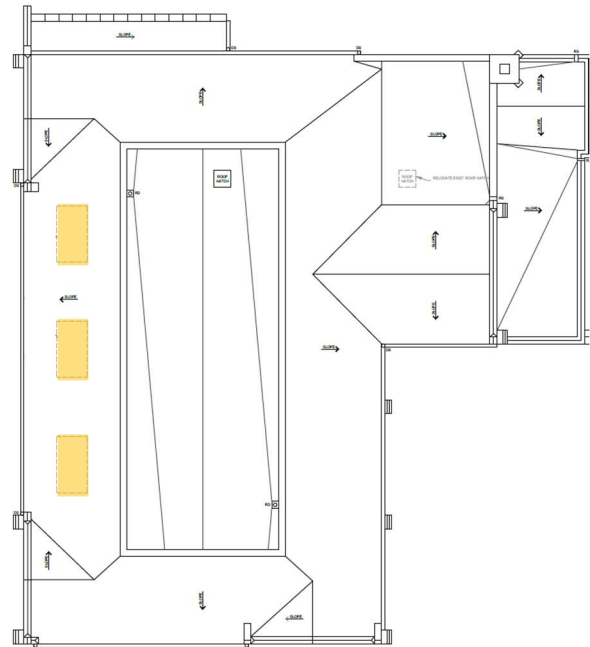
Roof drawing from application

- The application proposes to install skylights at the south roof surface, facing E. Jefferson. The submitted materials for the product indicate that the skylights will be steel, fixed, and flush mounted. Although we do not have the measurements of the proposed skylights, the applicant is seeking to install three groupings of skylights, which will extend nearly the full length of the south roof surface. When viewed from the public right-of-way, especially from E. Jefferson, the proposed skylights will present as a highly visible modern intrusion that is not compatible with the building's historic character. Considering this building is on the corner, staff does not recommend the installation of skylights on any of the sloped roof surfaces, as they will be visible from the public right-of-way.

- The installation of the skylights is inappropriate, especially given the distinctive materiality and high public right-of-way visibility of the slate roof. The Secretary of the Interior's Standards for Rehabilitation (quoted in full below) require that historic materials and distinctive features be retained. Additionally, the NPS' guidelines state that "Adding skylights or dormers on primary or highly-visible roof elevations where they will negatively impact the building's historic character." and "Buildings that have prominent roofs or highly visible roof elevations are usually not good candidates for skylights."

- The new skylights will be highly visible from the public right-of-way as they will extend nearly the full length of the south roof's surface and will diminish the historic building's character.

Recommendation 1 of 2 – Denial – Install skylights

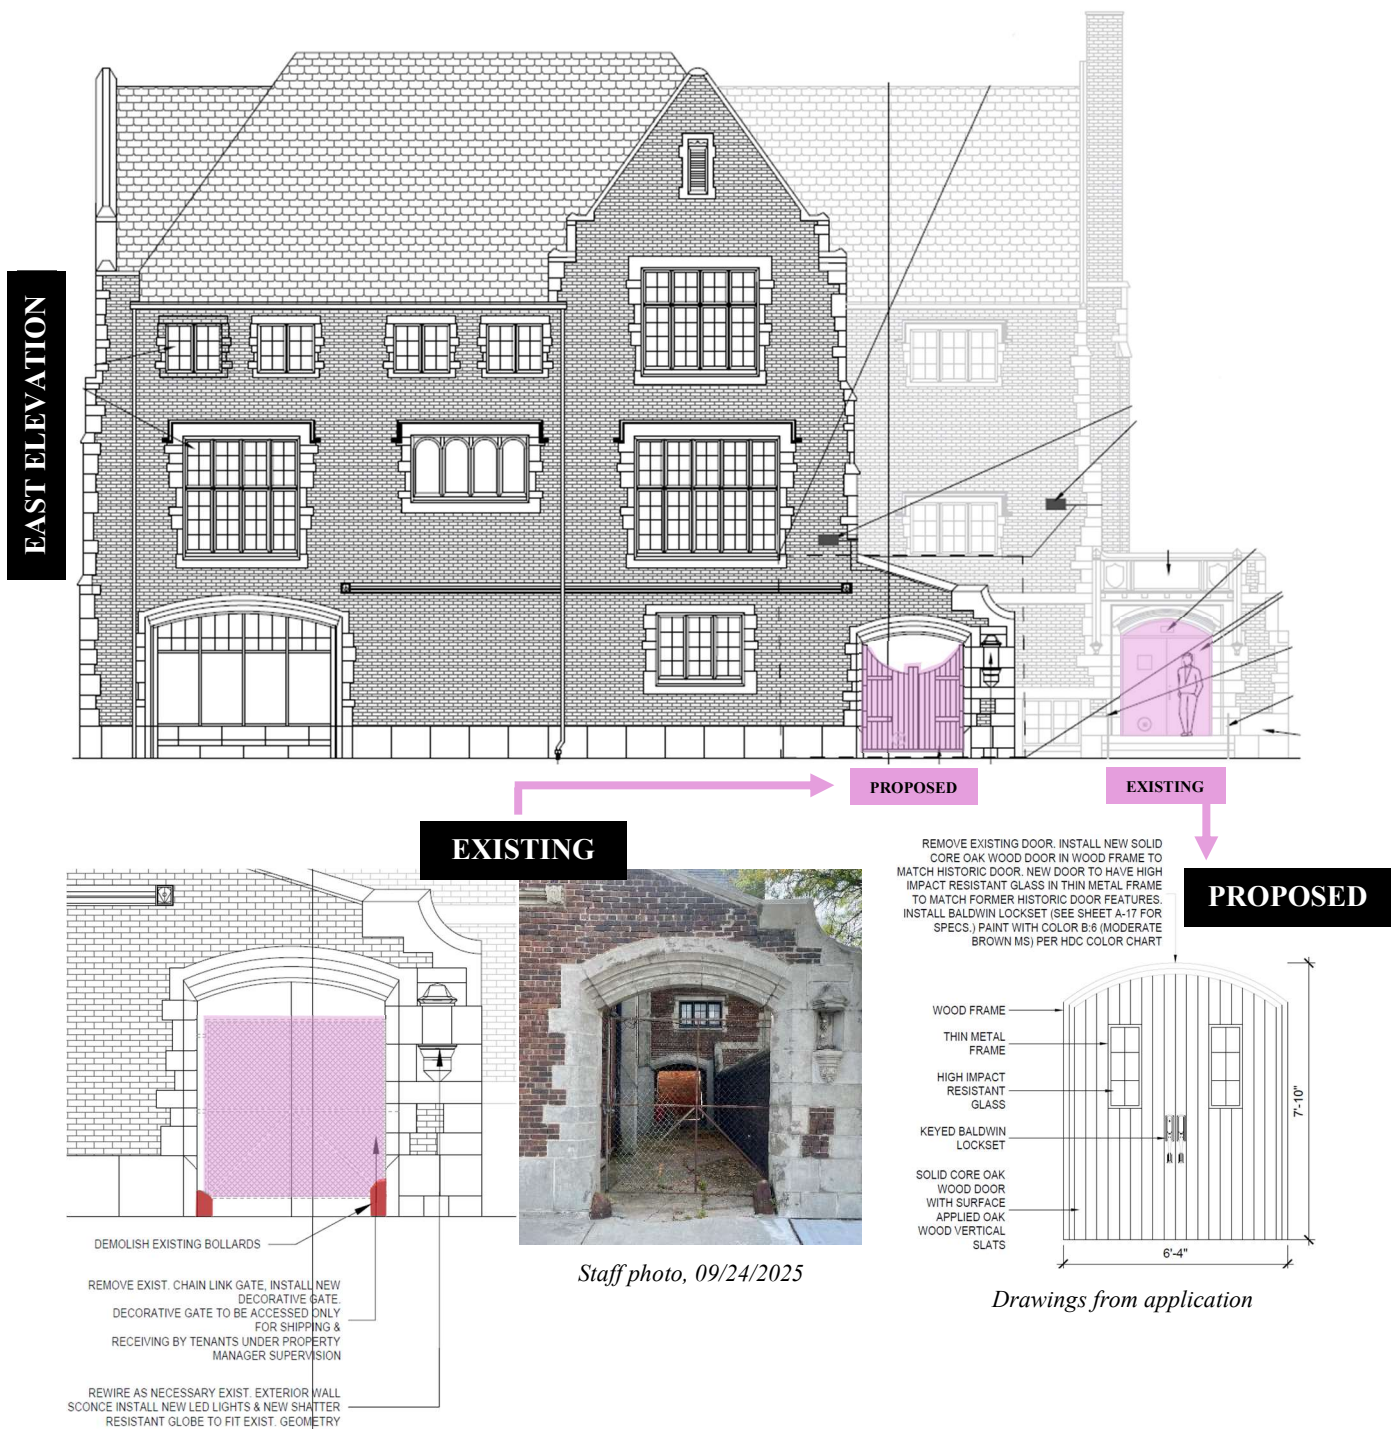
- Staff would like to note that the application doesn't specify the material or finish of the proposed gate.
- Considering the existing conditions for both entrances are not historic, it is staff's opinion that the proposed replacements are appropriate due to their material and style.

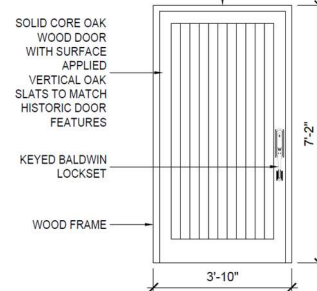
Drawings from application

- This corridor is partially visible from the public right-of-way with the existing chain-link gate. With the applicant's proposed gate (see previous page), this corridor would not be visible from the public right-of-way. Considering its rear location and proposed privacy gate, it is staff's opinion that the alterations to the existing openings are appropriate because the current doors and windows do not reflect the overall design features which distinguish this building regarding detailing and instead present a more utilitarian appearance than the character-defining doors and windows which are present at the building's façade and other sides.

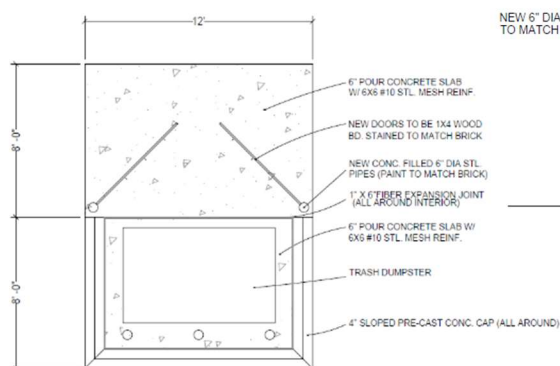
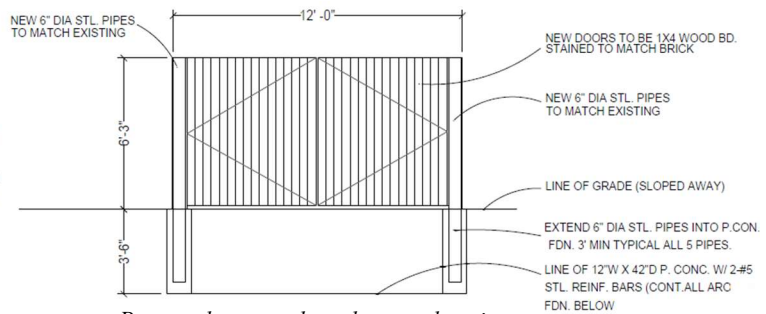
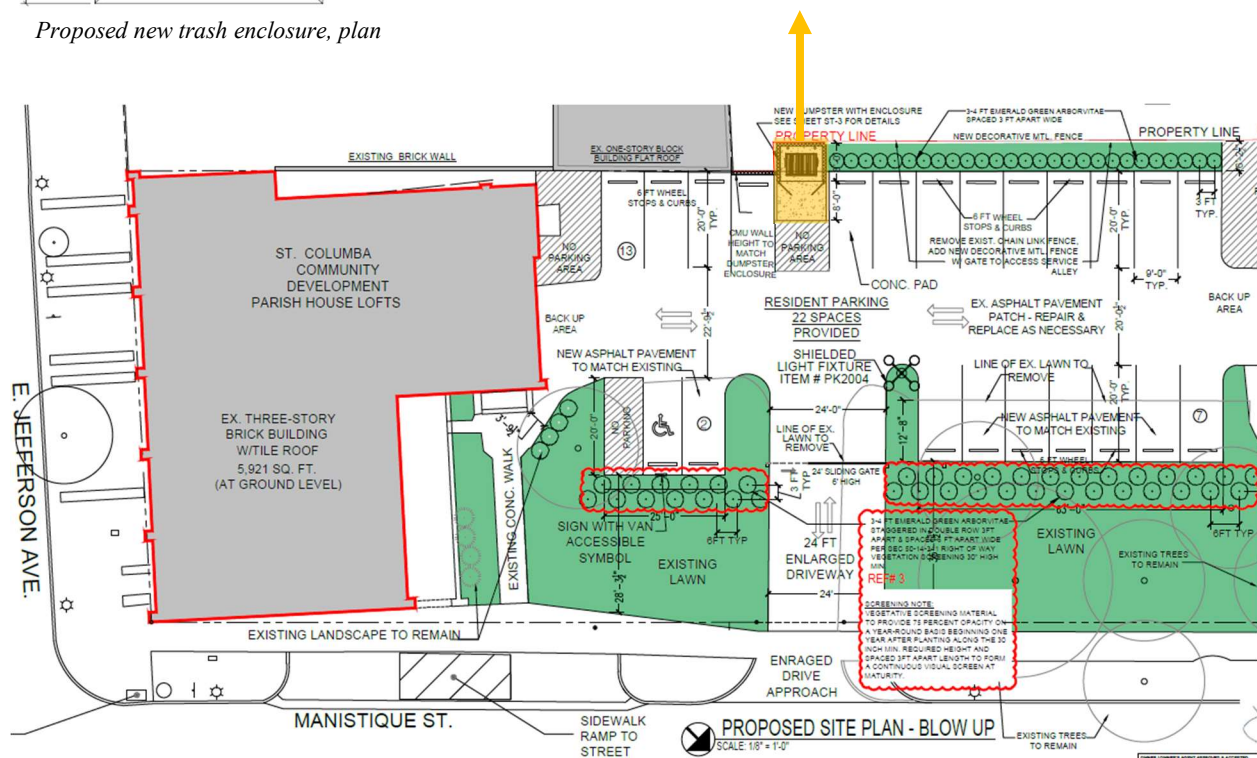
Drawings from application

- Staff does not have the authority to approve the construction of new trash enclosures requesting foundations. Therefore, this portion of the project has been submitted to the Commission for review and approval via the current application.

It is staff's opinion that the proposed parking lot and trash enclosure does meet the NPS Secretary of the Interior's Standards for Rehabilitation with respect to new additions, specifically Standard #9:
