**STAFF REPORT:** 10/08/2025 REGULAR MEETING

**APPLICATION NUMBER:** HDC2025-00551

**ADDRESS:** 255 E. FERRY

**SCOPE:** ALTER AND REHABILITATE DWELLING, ERECT SIDE PORCH

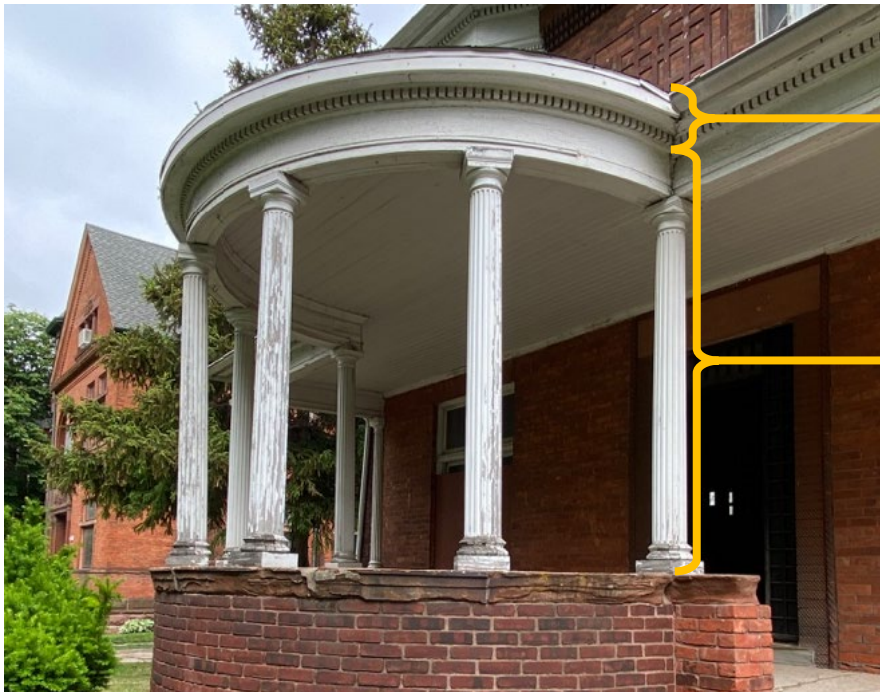
- Any damaged areas of the fascia and columns are to be restored. The porch trim is proposed to be painted B:8 Grayish Brown and the fascia and columns B:11 Grayish Olive Green.

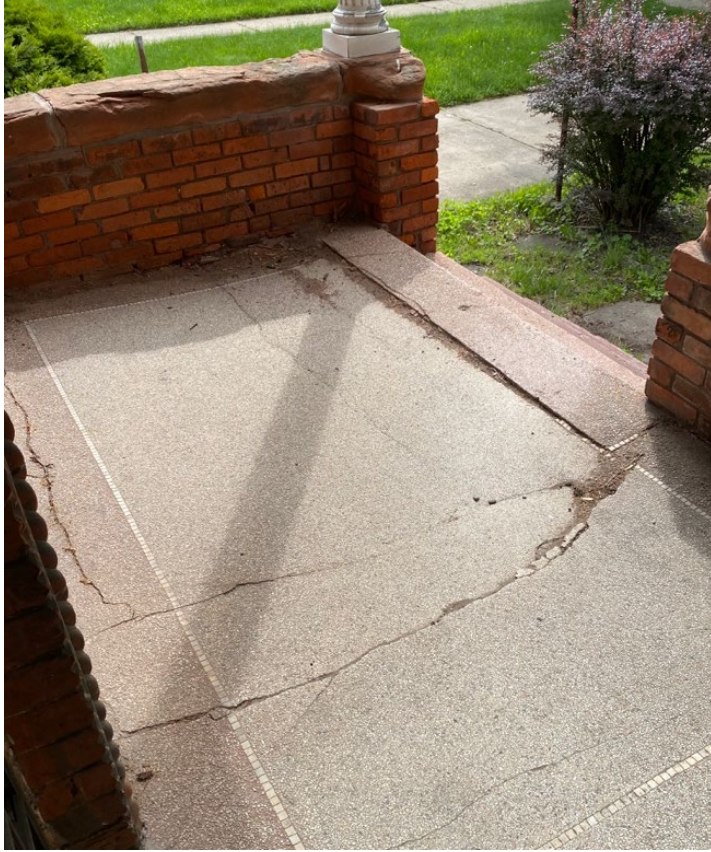
- The applicant states that most of the existing porch floor, which is a structural slab, is cracked and caved in. Staff agrees, as this is evident from the condition shown in the photos provided with the application.
- With the porch floor, the applicant is proposing to “remove the entire floor and install a concrete porch in-place. The existing floor has a terrazzo finish. We proposed to provide a new crushed limestone finish to emulate the terrazzo finish.”

- The two-tone terrazzo and tesserae flooring on the front porch shall be replicated.
- When the vinyl siding is removed, photos of the existing conditions shall be submitted for staff review before moving forward with any work. Any existing historic siding is to be restored, with any damaged or missing siding to be replaced in-kind.
- The following shall be submitted for staff review and approval:
  - The height of the proposed wood railing along the edge of the new porch roof
  - The finish/color of the aluminum-clad windows
  - The material of the proposed custom doors
  - The design and materiality of the attic dormer door
  - The design and materiality of the storm windows

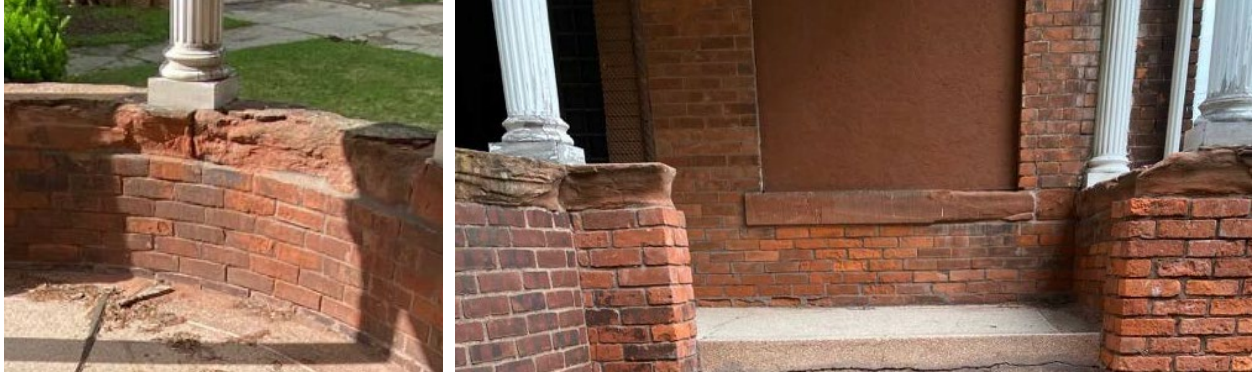
- It is staff's opinion that the existing, two-toned terrazzo, separated by a tesserae border, is a distinctive and historic character-defining feature.

- Due to the extent of deterioration to the existing red sandstone porch cap, the applicant proposes to replace it with cementitious stucco dyed red to match the color of the existing red sandstone, in the sizes and dimensions of the existing to be replaced original configurations.
- Staff finds the existing red sandstone at the porch to be deteriorated beyond repair, as the [National Park Service \(NPS\) Preservation Brief 6: Dangers of Abrasive Cleaning to Historic Buildings](#) states "...some types of sandstone ...will weather at an accelerated rate once their protective "quarry crust" or patina has been removed." Replacement of deteriorated sandstone or brownstone with dyed cementitious stucco is a common and satisfactory historic preservation treatment. Additionally, per the [NPS Rehab Yes & No Learning Program No. 1](#):

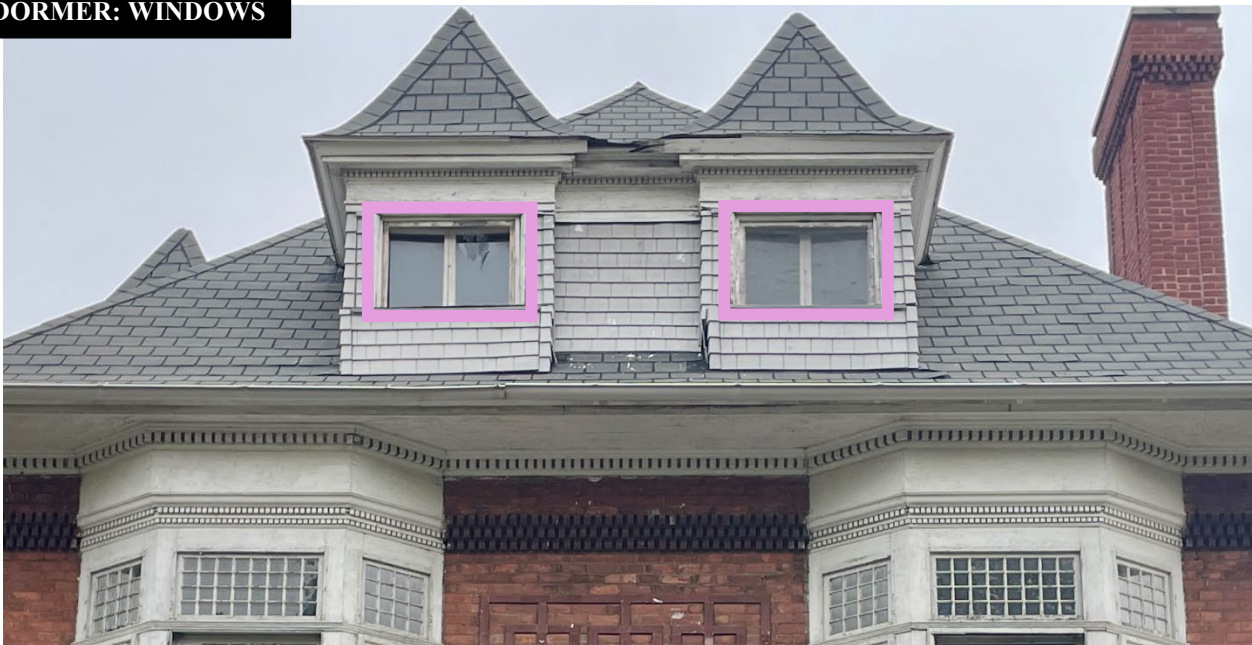
#### **DORMER: WINDOWS**

- Per the [National Park Service's \(NPS\) 'Queen Anne Style 1880s – 1910' article](#), “the windows were often multi-paned” – it is staff’s opinion that the existing single-paned “French window,” which is like standard casement window where they are attached by a hinge to the window frame on one side, but they differ from casements in that they don’t have a central post or mullion, is likely not the original window style and operation for the dormers. They were likely multi-pane sashes, possibly fixed or casement in operation. However, as the existing windows were there at the time of designation, the replacement windows, per the [NPS's 'Replacement Windows that Meet the Standards,'](#) must only be compatible with the historic appearance and character of the building and not necessarily exact matches: “Although replacement windows may be based on physical or pictorial documentation, if available, recreation of the missing historic windows is not required to meet the Standards. Replacement of missing or non-historic windows must, however, always fill the original window openings and must be compatible with the overall historic character of the building.” Should the property owner obtain a photo of the home showing the original windows and are interested in putting new windows in to match the lite-configuration and operation, staff has the authority to approve the installation administratively.

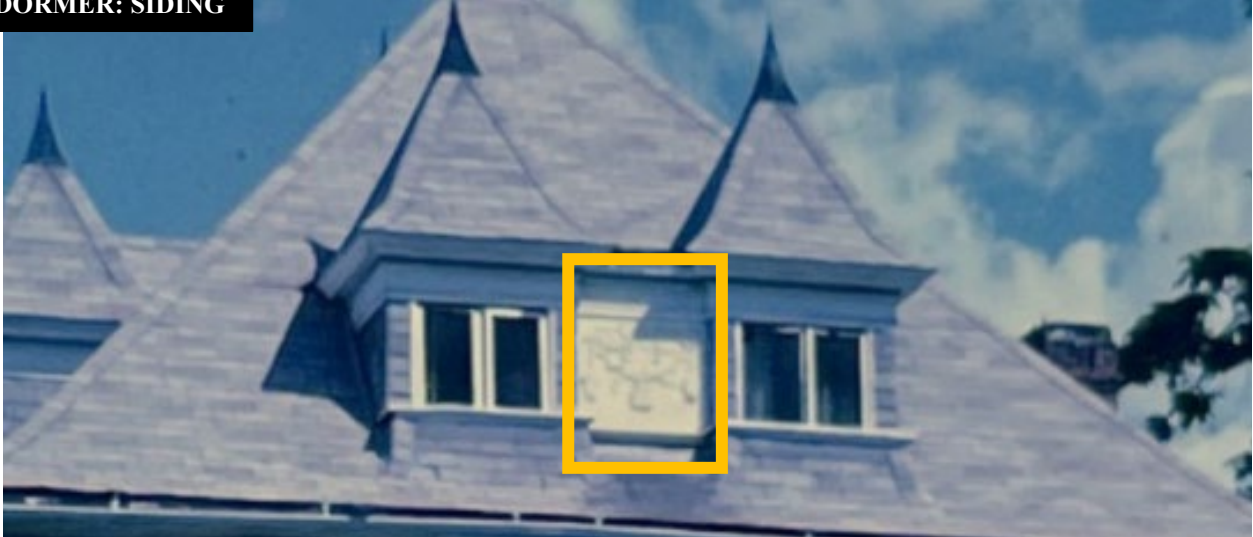
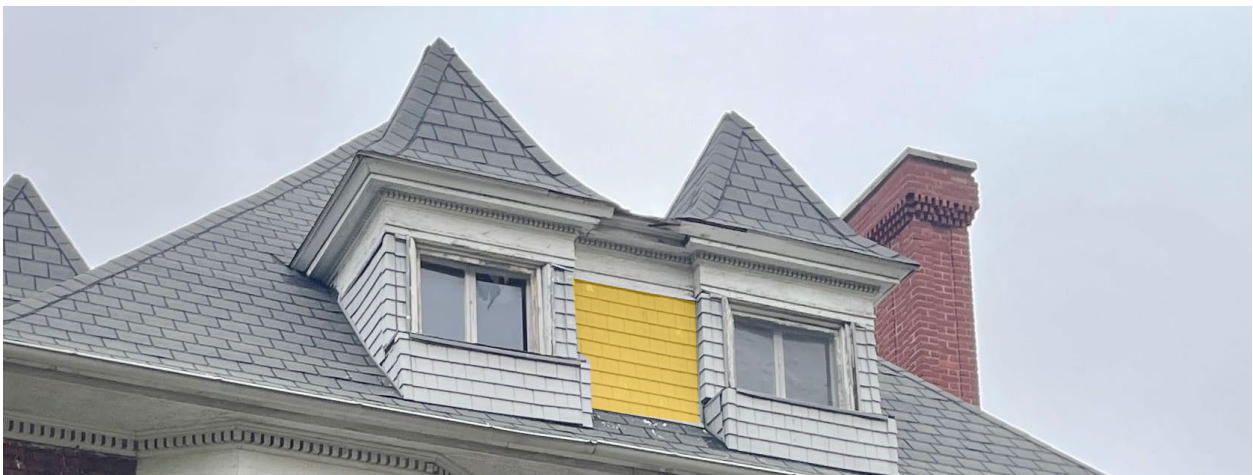
- The applicant proposes to remove the faux vinyl shingles currently covering the sides of the dormers. The original wood shingles underneath will be repaired where possible, replaced in-kind where deteriorated, and then painted B:11 Grayish Olive Green. However, staff does note the following:
  - The application elevation drawings, in contrary to application narrative, state “Remove vinyl siding and other existing material down to original sheathing from dormer sides. Install new wood cedar shake siding.”
- Staff notes that, based on a 1981 designation photo, there appears to have been a decorative moulding between the two dormers on the façade. It is staff’s opinion that, if any portion of this historic moulding remains when the vinyl siding is removed, it should be restored.

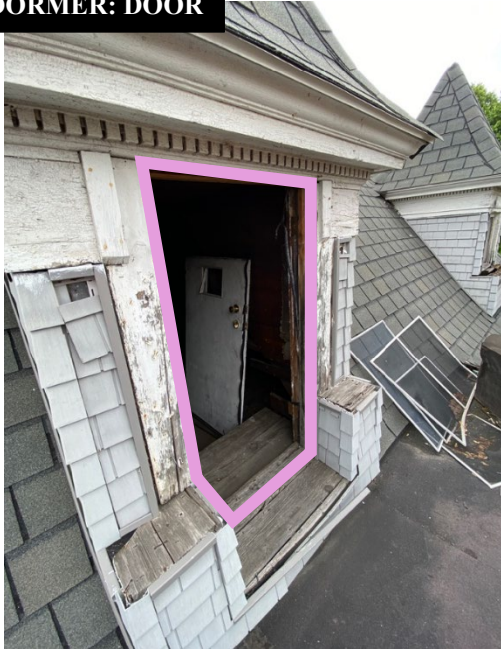
- The applicant proposes to replace the existing, non-historic door at the attic dormer, but staff notes that they do not specify what the replacement door is.

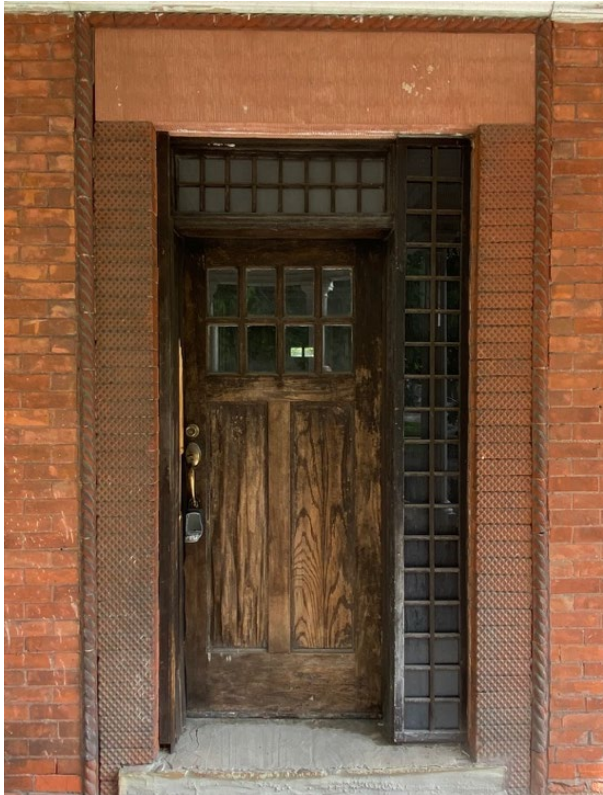
EXISTING FRONT DOOR

- For the front door and two new side porch doors, the applicant proposes custom doors with paneling and multi-lites. Staff would like to note that the applicant does not specify a material for the doors.
- Staff agrees that the existing front door is most likely not original and believes the style and materials of the proposed new doors are appropriate.
