**STAFF REPORT: NOVEMBER 12, 2025 MEETING**

**APPLICATION NUMBER: HDC2025-00635**

**ADDRESS: 12512 BROADSTREET**

**SCOPE: REPLACE WOOD WINDOWS WITH FIBREX WINDOWS**

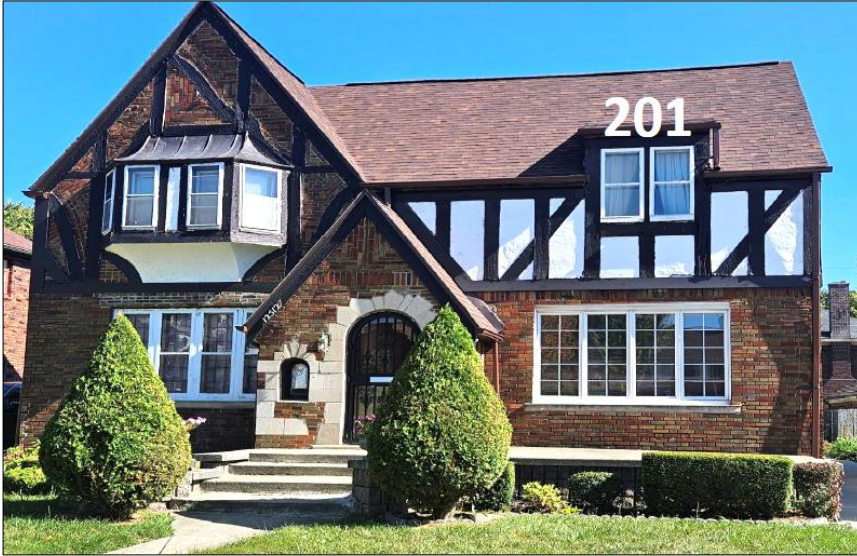
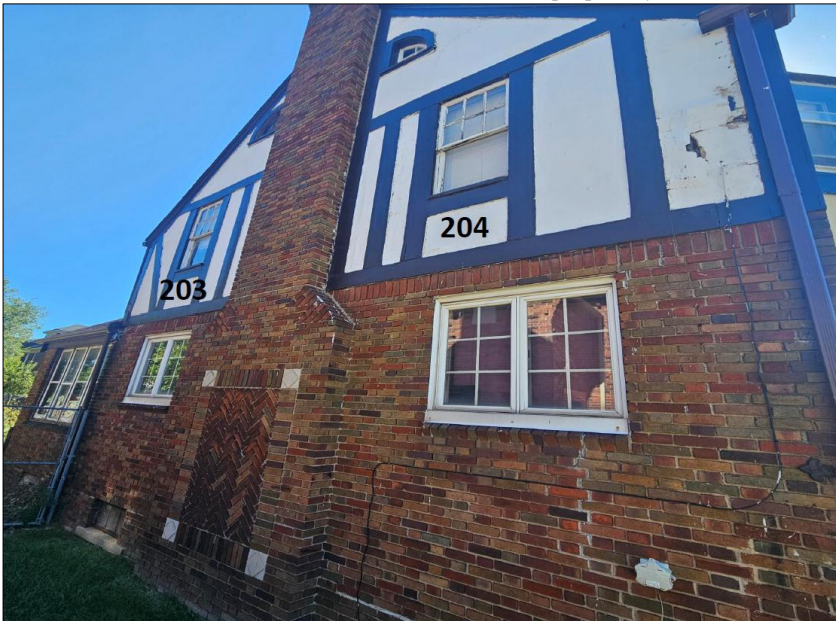
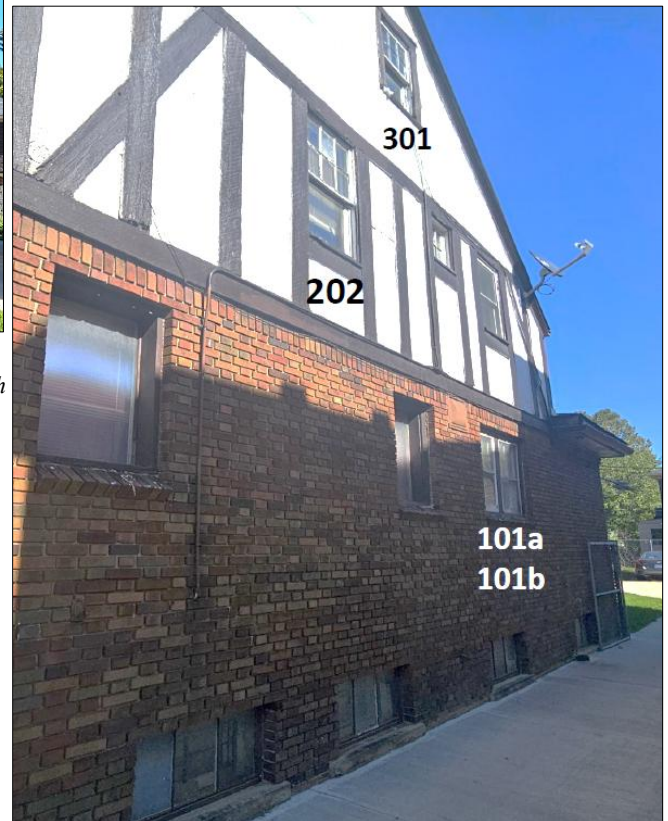
*Clockwise from above: Façade, right/south side wall, left/north side wall.*

*Applicant photos – window proposed for replacement are identified by number (which correlates with the submitted window order). No work is proposed for the rear elevation.*

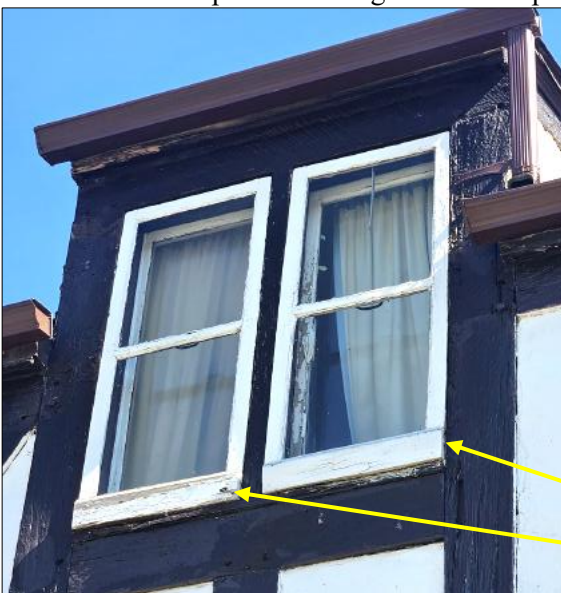
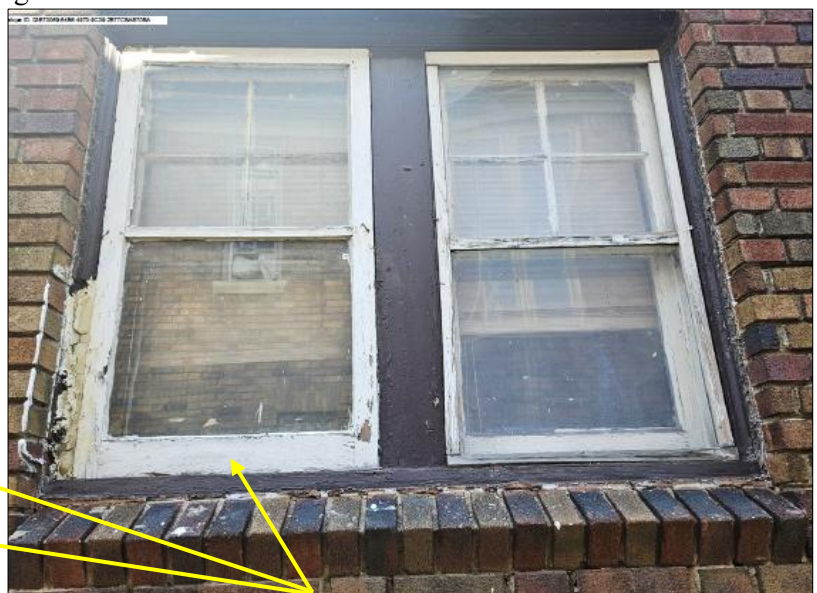
- Replacement windows at the first floor, right of the entrance are visible in the designation photo. Based on this image, staff assumes that the other existing replacement windows on the side walls pre-date the district.
- Leaded glass casement windows to the left of the front entrance are distinctive character-defining features, remain intact, and not part of this application.
- The windows on the façade at the second floor are casement units, with wood frames and undivided glass. The storm windows with a central meeting rail obscure the casement operation.
- The double-hung wood windows on the side walls, four with a six-over-one pattern and two with a four-over-one pattern are proposed for replacement.
- Two openings: front, second floor shed dormer and south side wall, first floor near the rear, have wood mullions that are part of the larger window opening.

*Above: Façade dormer opening; Right: South/side wall opening. These windows are covered with wood storm windows (likely original) Applicant photos.*

- Based on the written description and photos provided, it is staff's opinion that the existing windows need repair (including the wood sills), but the frames remain intact and are not demonstrated to be deteriorated beyond repair.
- The Russell Woods-Sullivan historic district's Element of Design (Sec. 21-2-168) that relate to this proposal are:

- As discussed on the previous page, the wood mullions on the front and south walls are part of the wood trim of the larger window opening and is a distinctive character-defining feature which should remain intact. Therefore, the double casement window should be changed to two (2), single casement units (regardless of window manufacturer).

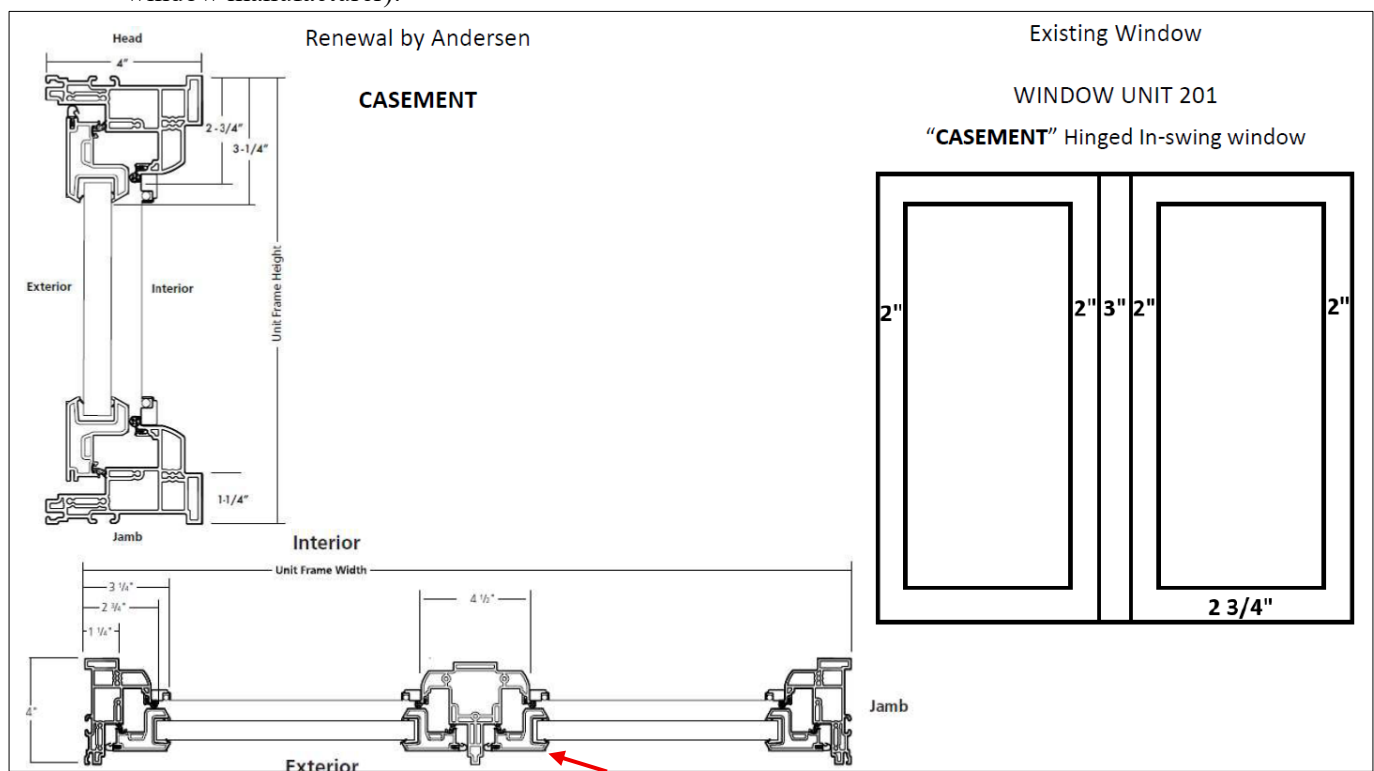
*These casement window sections illustrate staff’s concerns over the manufactured mullion that would be fabricated as part of the double casement window opening. Applicant document.*

- Additionally, the proposed replacement windows do not match the dimensions, dimensionality nor appearance of the existing windows.
  - The proposal includes the removal of the historic wood mullion from the façade window opening.

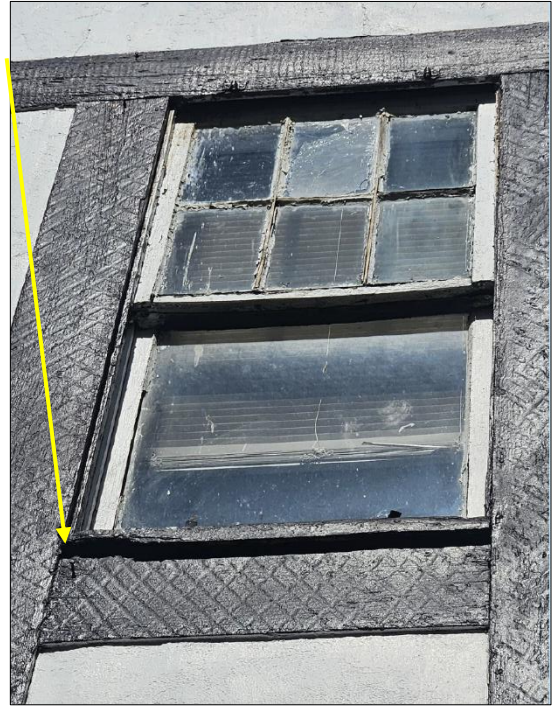
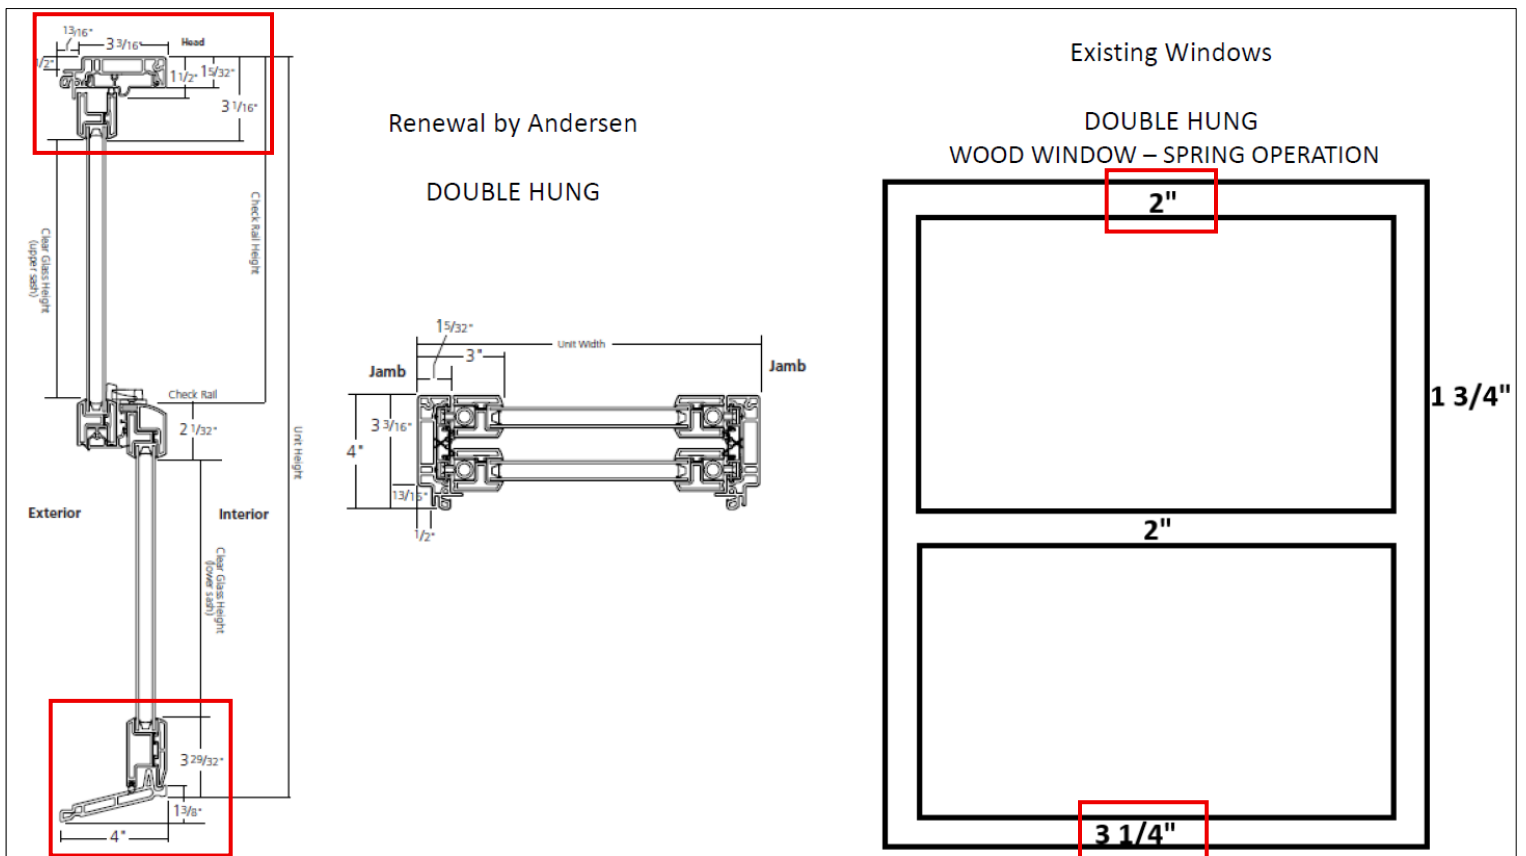
- It is not clear to staff that the proposed replacement double-hung units are compatible in dimension to the existing windows. The below section drawing shows the replacement double-hung windows have an integrated sloped sill that would add an additional 1-3/8" height to the bottom rail, altering the design, features and proportions of the historic window openings of this house.

*These double-hung window sections illustrate staff's concerns over the manufactured sill that would be fabricated as part of the double-hung window opening. The existing bottom rail measures 3-1/4" high, while the bottom rail and sill of the proposed windows measures approximately 5-1/2" high. The measurement of the existing top rail is 2", while the replacement window measures just over 3". The meeting rail dimensions between existing and proposed almost match. Applicant document and photo.*

- The sloping sills fabricated as part of the proposed double-hung windows would introduce a new element to most of the window openings and expand the dimension of the lower frame of the window from 3-1/4" to 5-1/2".

- Each window opening within this application has a thin, flat protruding wood sill. This is a character-defining feature that is integral to each window opening and a key feature of the English Revival design of the dwelling. The wood sills must remain or be replaced in-kind if additional documentation is submitted to substantiate that they are deteriorated beyond repair. A dimensioned drawing of a window opening (hand drawn is fine) confirming the wood sill's existing dimensions, profile and painted finish as documentation for the fabrication of new wood sills should be submitted to staff for review as part of any future replacement window application.

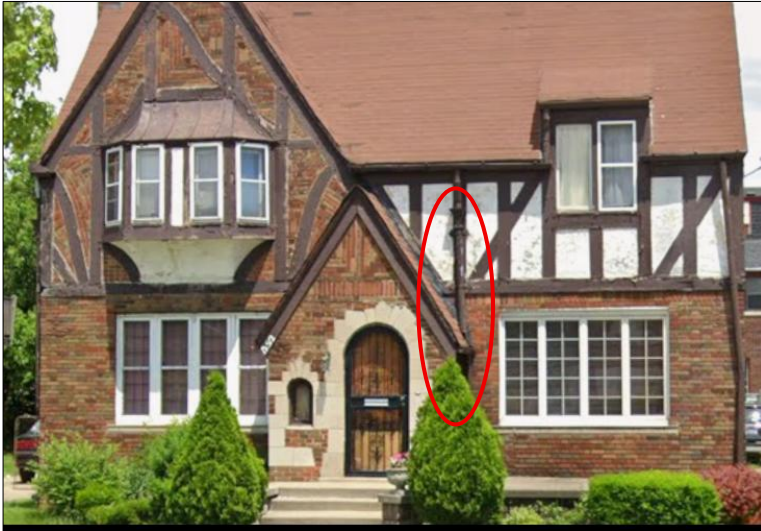
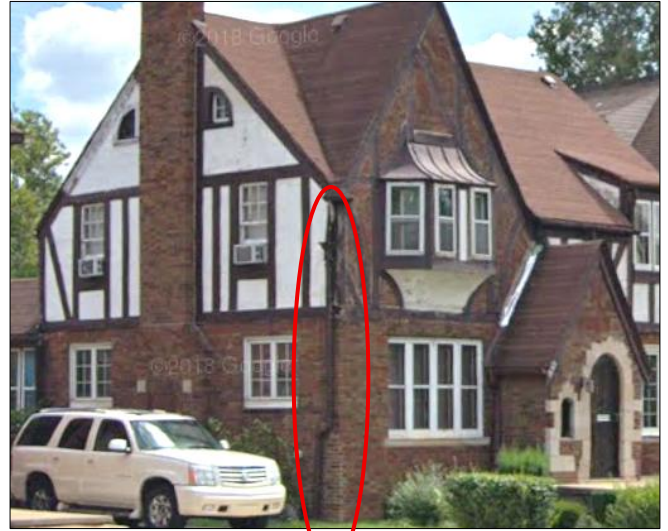
*Google street view, June 2019 (l) and June 2018 (r)*

- During staff's research of the property for this application, the following alterations were identified:
  - Replacement of asphalt shingle roof with new asphalt shingle roof
  - Removal of downspouts (which appear to be round) and collector boxes.
- Staff will notify the applicant of the unapproved work and to see if they would like add the roof and gutter/downspout scope of work to this application.
