**STAFF REPORT: NOVEMBER 12, 2025 MEETING**

**APPLICATION NUMBER: HDC2025-00641**

**ADDRESS: 3460 IROQUOIS**

**SCOPE: INSTALL GATE (WORK COMPLETED WITHOUT APPROVAL)**

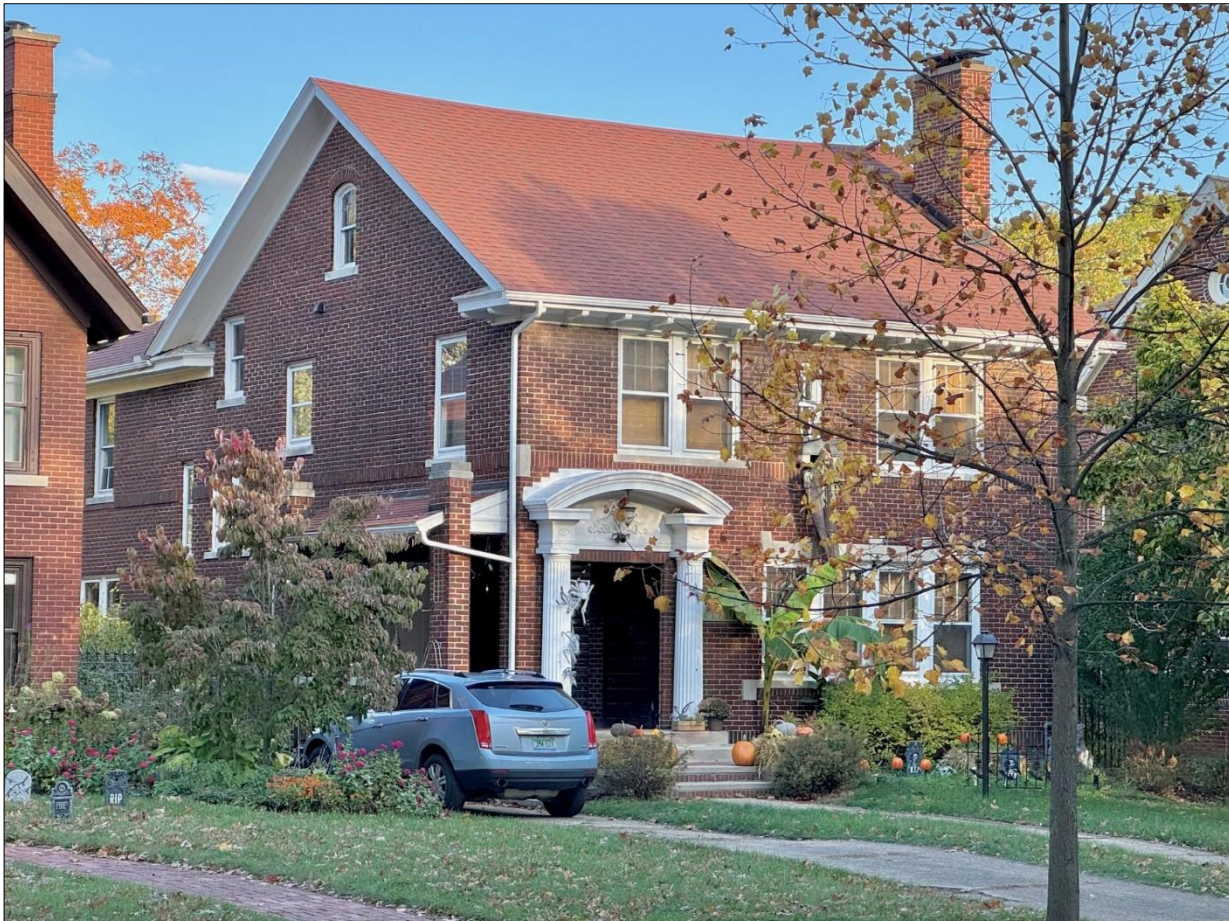
*Façade. Staff photo, October 29, 2025.*

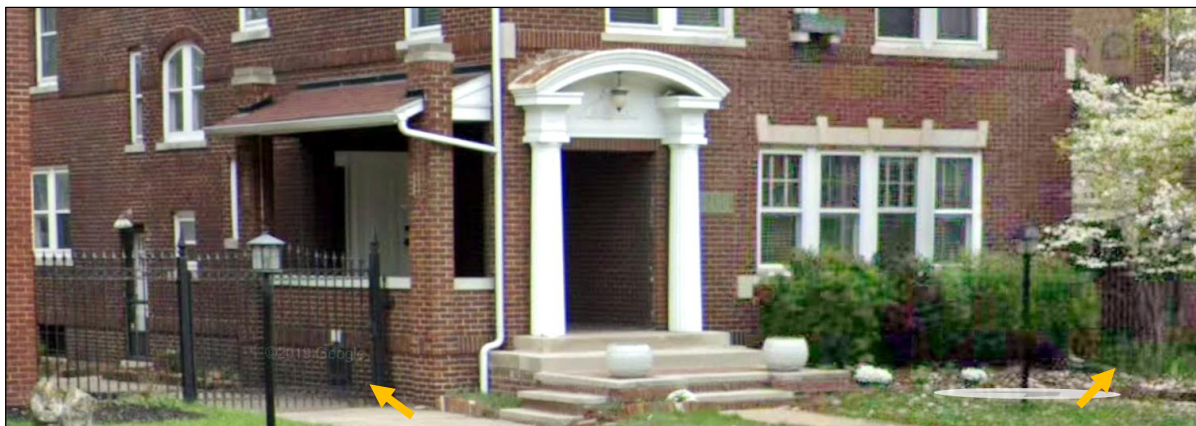
*The jalousie windows and front door/sidelights were removed by 2019. Google streetview.*

- The 2019 photo shows the reopened porch after the door/sidelights and windows were removed. The HDC has no record of this alteration. The wrought-iron style fence (enclosing the rear yard at the southern side of the property) and driveway gate remain in place.

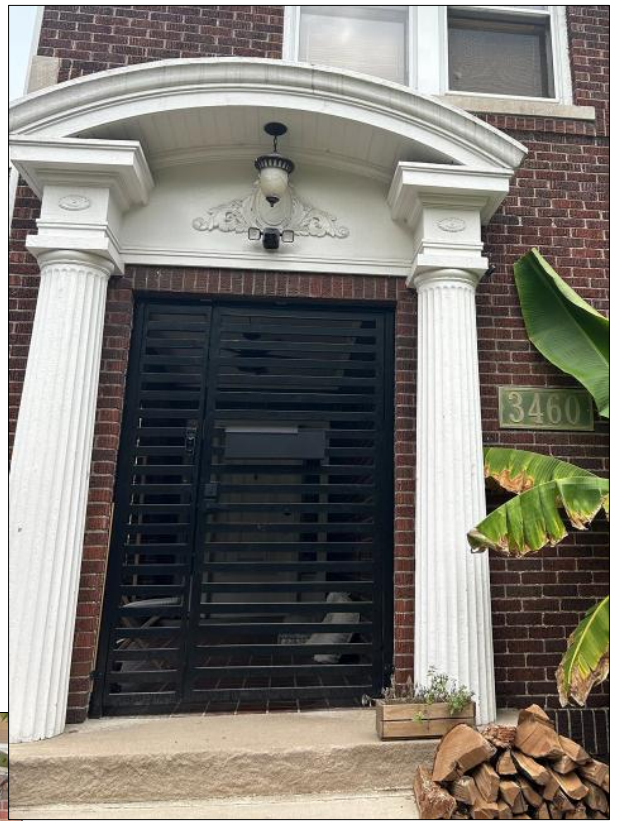
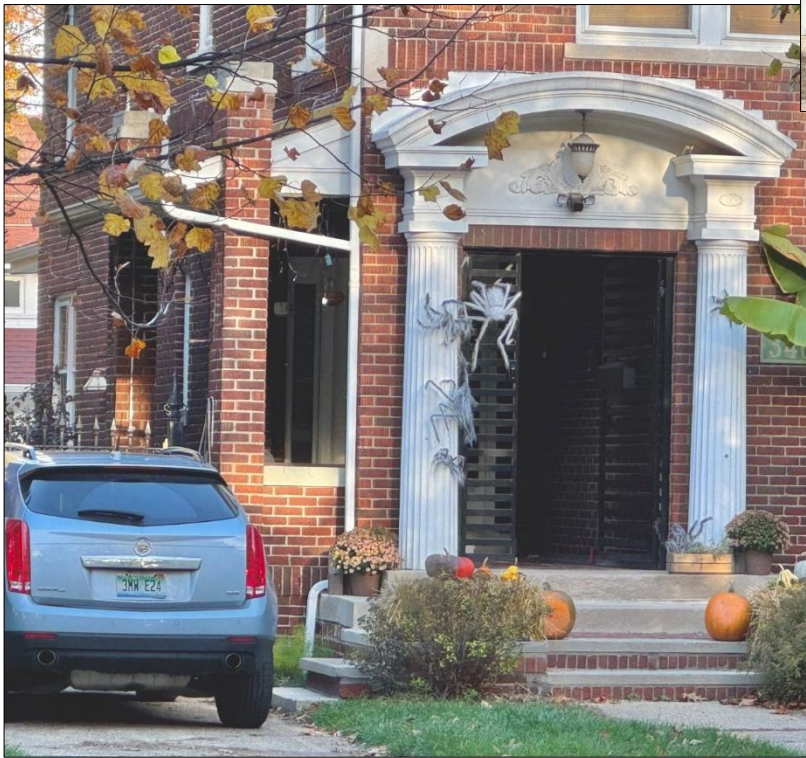
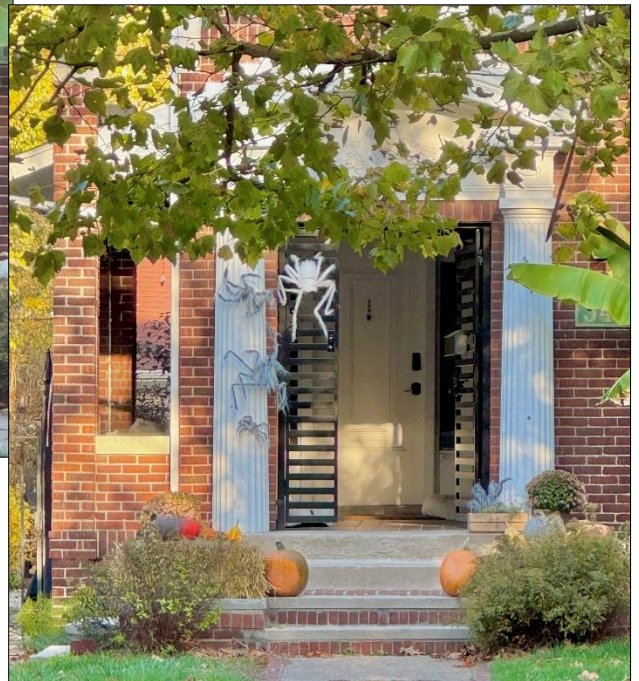
- A new painted steel gate was recently installed at the porch entrance. The porch's masonry half-walls remain open.
- Alterations should be differentiated from the historic building to preserve its character; however, it should remain subordinate to the historic structure and not be in extreme contrast to the building's features, materials and finishes.

- The steel gate, consisting of flat horizontal bars with a dark glossy finish, is a starkly modern design that was installed within the classically designed porch entrance surround.

- Additionally, the thickness of the bars significantly reduces the transparency into the porch and the glossy surface contrasts with the muted finishes of the painted surfaces and masonry walls.

- It is staff's opinion that the installation of this gate is not a compatible design at this primary entrance and has altered features and spaces that characterize the dwelling.

- The front porch is a distinctive, character-defining feature of the house. The installed gate's thick horizontal bars, dark glossy finish, limited transparency and starkly modern design is not compatible with, nor subordinate to, the historic house's massing, scale, architectural features and finishes and has altered the features and spaces that characterize the dwelling.

### **Recommendation 1 of 1, Denial**
