**STAFF REPORT:** NOVEMBER 12, 2025 MEETING  
**APPLICATION NUMBER:** HDC2025-00498  
**ADDRESS:** 3768 TYLER

**HISTORIC DISTRICT:** RUSSELL WOODS-SULLIVAN HISTORIC DISTRICT  
**APPLICANT:** STEPHEN WASHINGTON, GRANDIOSE REAL ESTATE SOLUTIONS LLC  
**PROPERTY OWNER:** GRANDIOSE REAL ESTATE SOLUTIONS LLC  
**DATE OF PROVISIONALLY COMPLETE APPLICATION:** 10/17/25  
**DATE OF STAFF SITE VISIT:** 9/15/25; 10/24/25

**SCOPE:** INSTALL FRONT PORCH NEW GUARDRAIL, REBUILD GARAGE ROOF, REPAIR GARAGE'S CONCRETE BLOCK WALLS, REPLACE GARAGE HINGED DOOR AND OVERHEAD DOORS

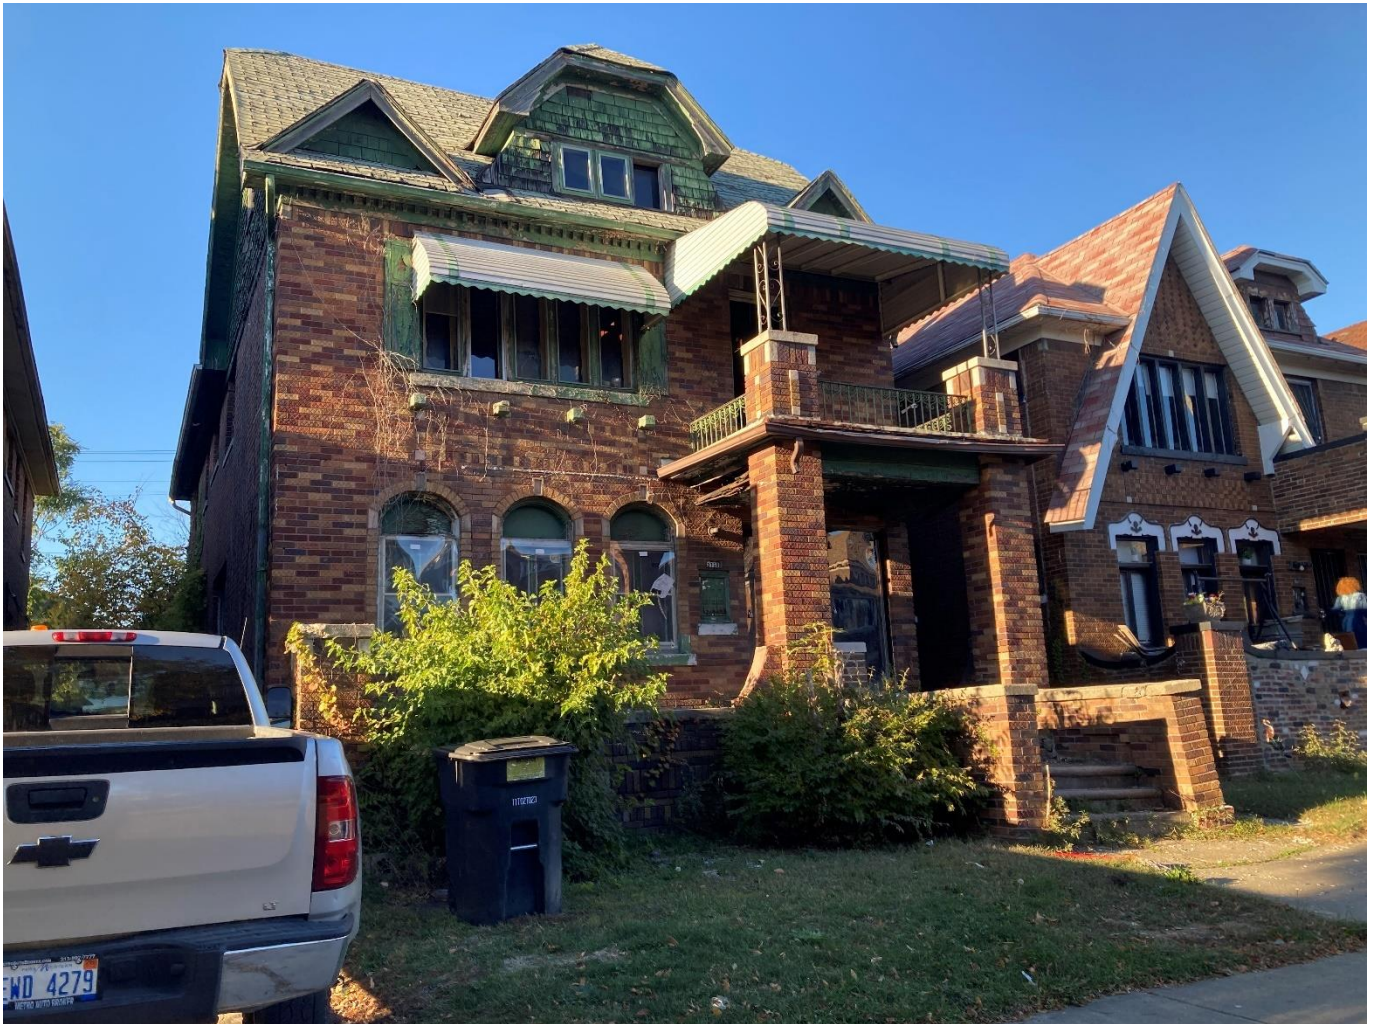
*3768 Tyler, south end and some of the west side. The decorative curved brickwork at the front edge of the front porch originally had cast stone coping and the iron guardrail was installed between these curved features. Staff photo, October 2025.*

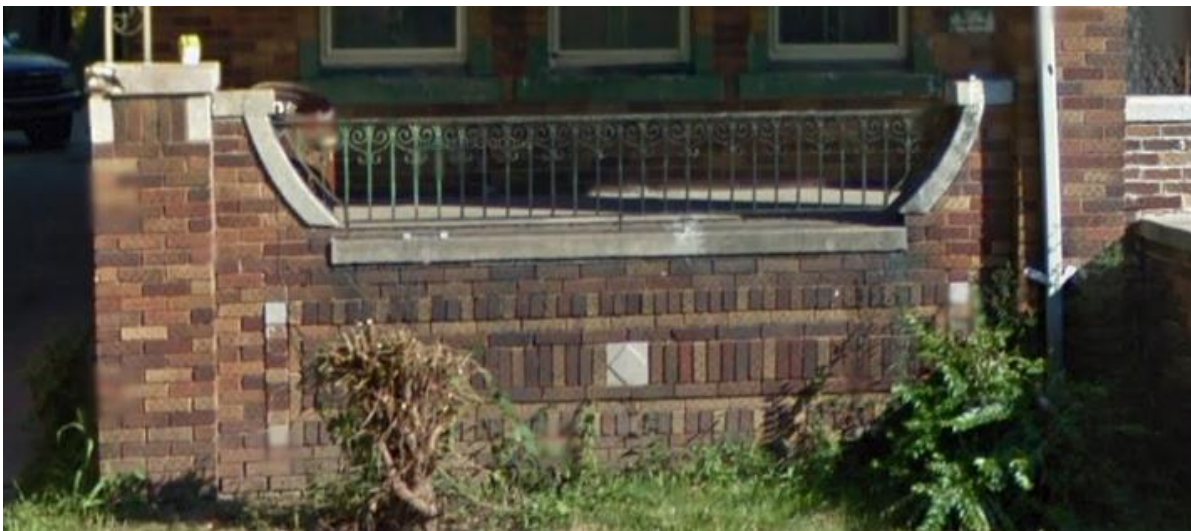
*Front porch detail from August 2011, courtesy of Google Street View. Railing is now missing.*

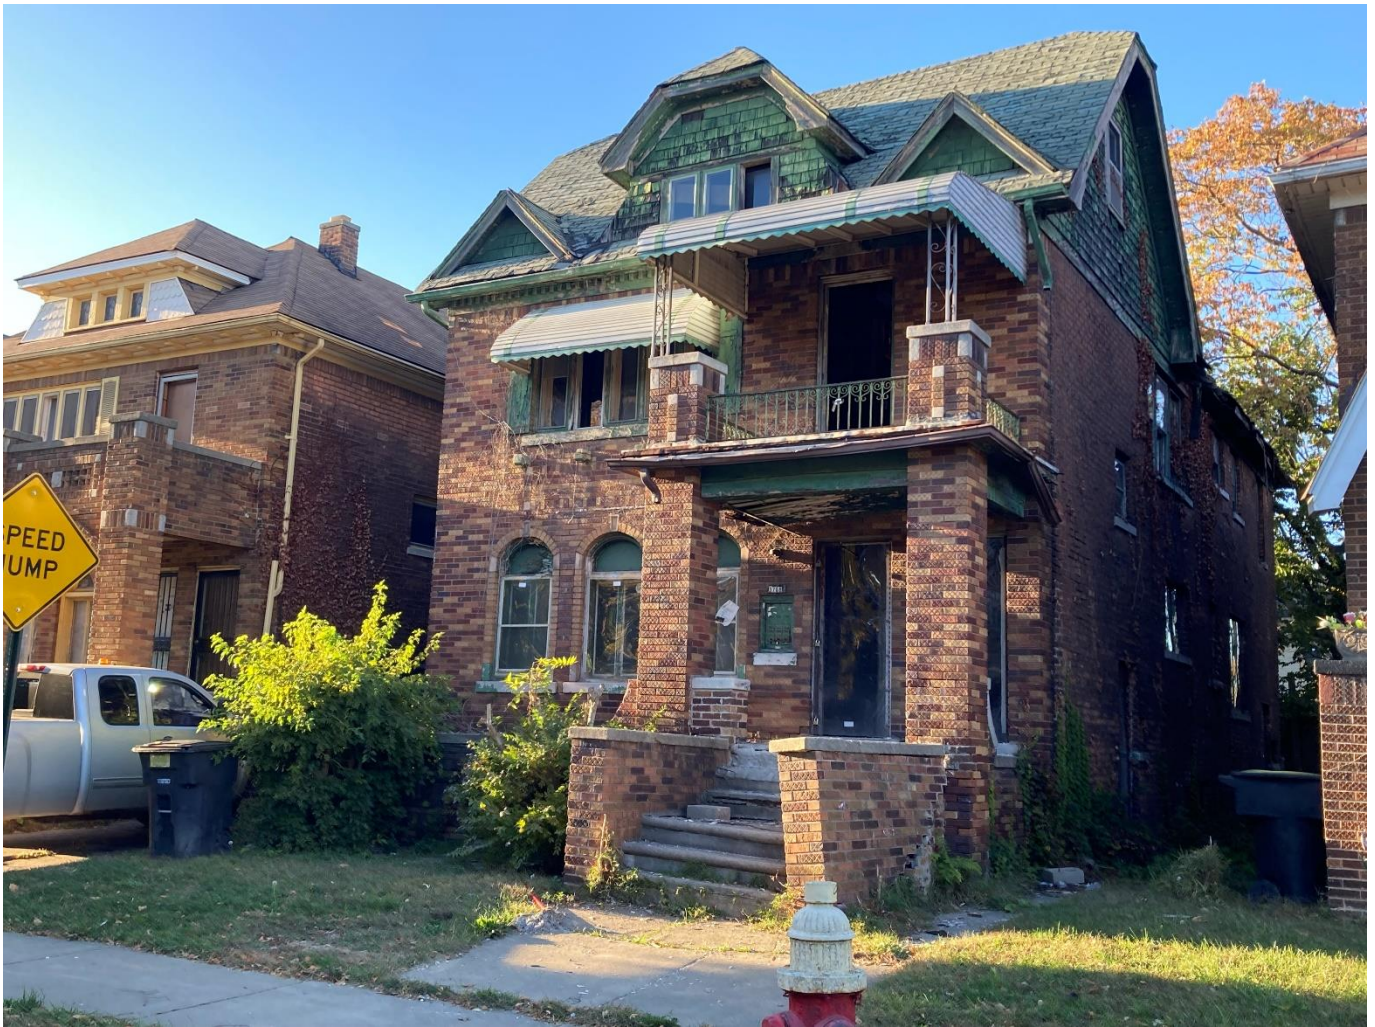
*3768 Tyler, south end and east side, staff photo, October 2025. The eastern wing wall next to the front steps is leaning and the front steps and porch cap are deteriorated. These conditions will be addressed as part of the approved front porch rebuild.*

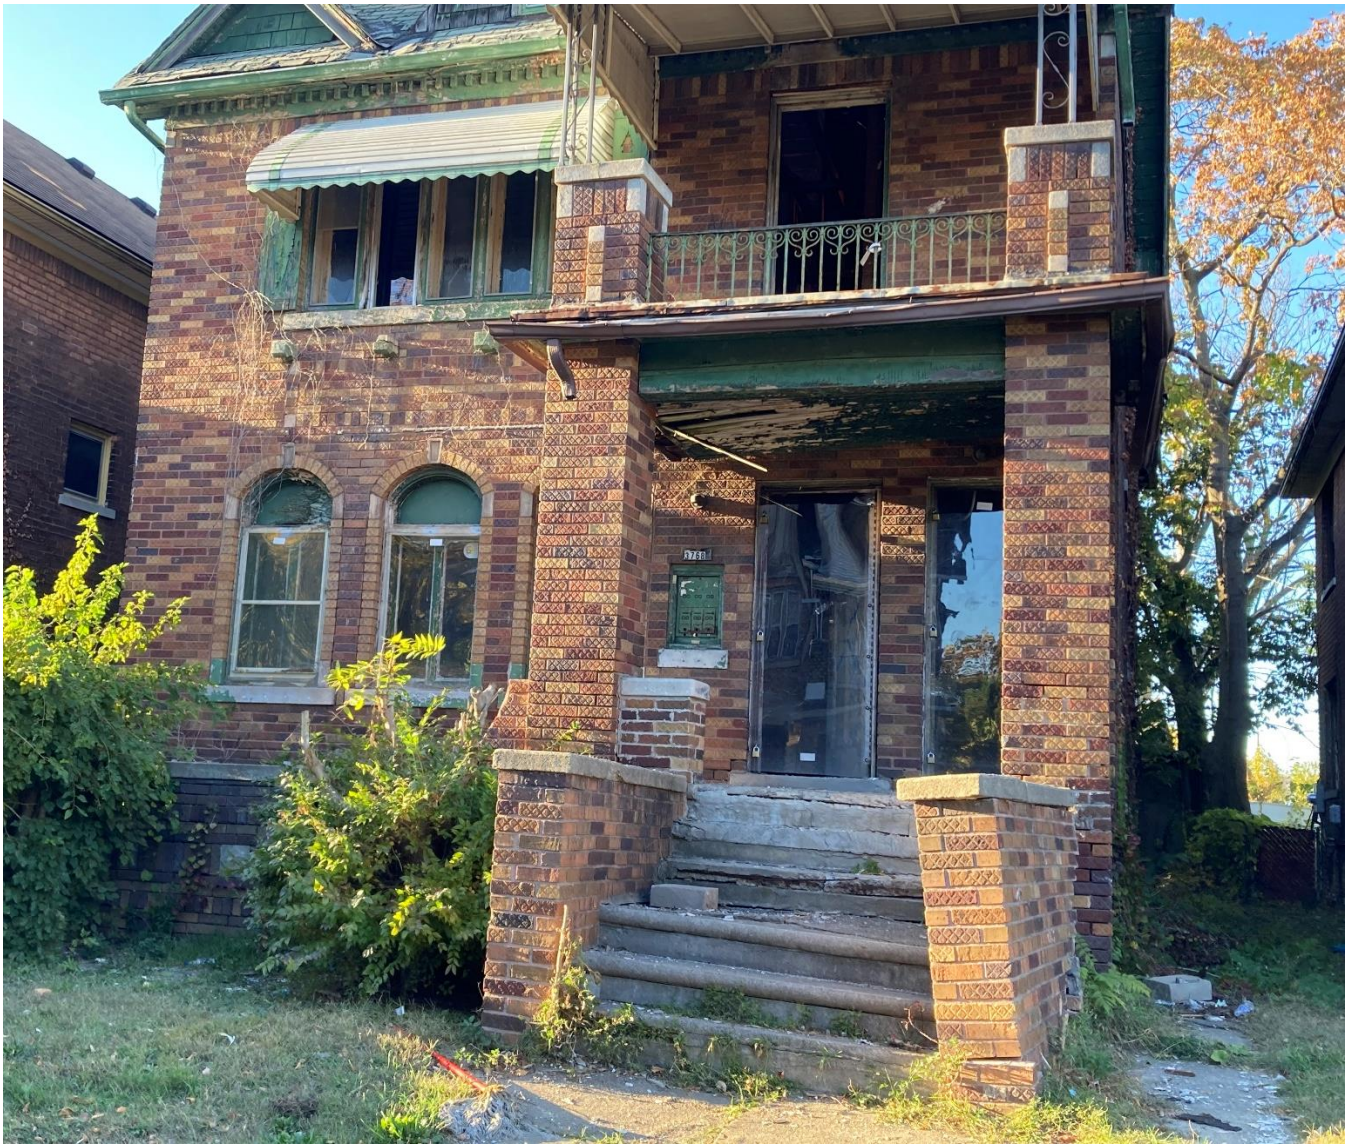
*3768 Tyler, south end, staff photo, October 2025. The eastern wing wall next to the front step is leaning and the front steps and porch cap are deteriorated. These conditions will be addressed as part of the approved front porch rebuild, and the porch ceiling will be repaired in kind. New gutters and downspouts, painted to match the wood trim, were also approved. The aluminum awning over the front porch has been removed. The diamond-patterned brick can be seen in the sunlight.*

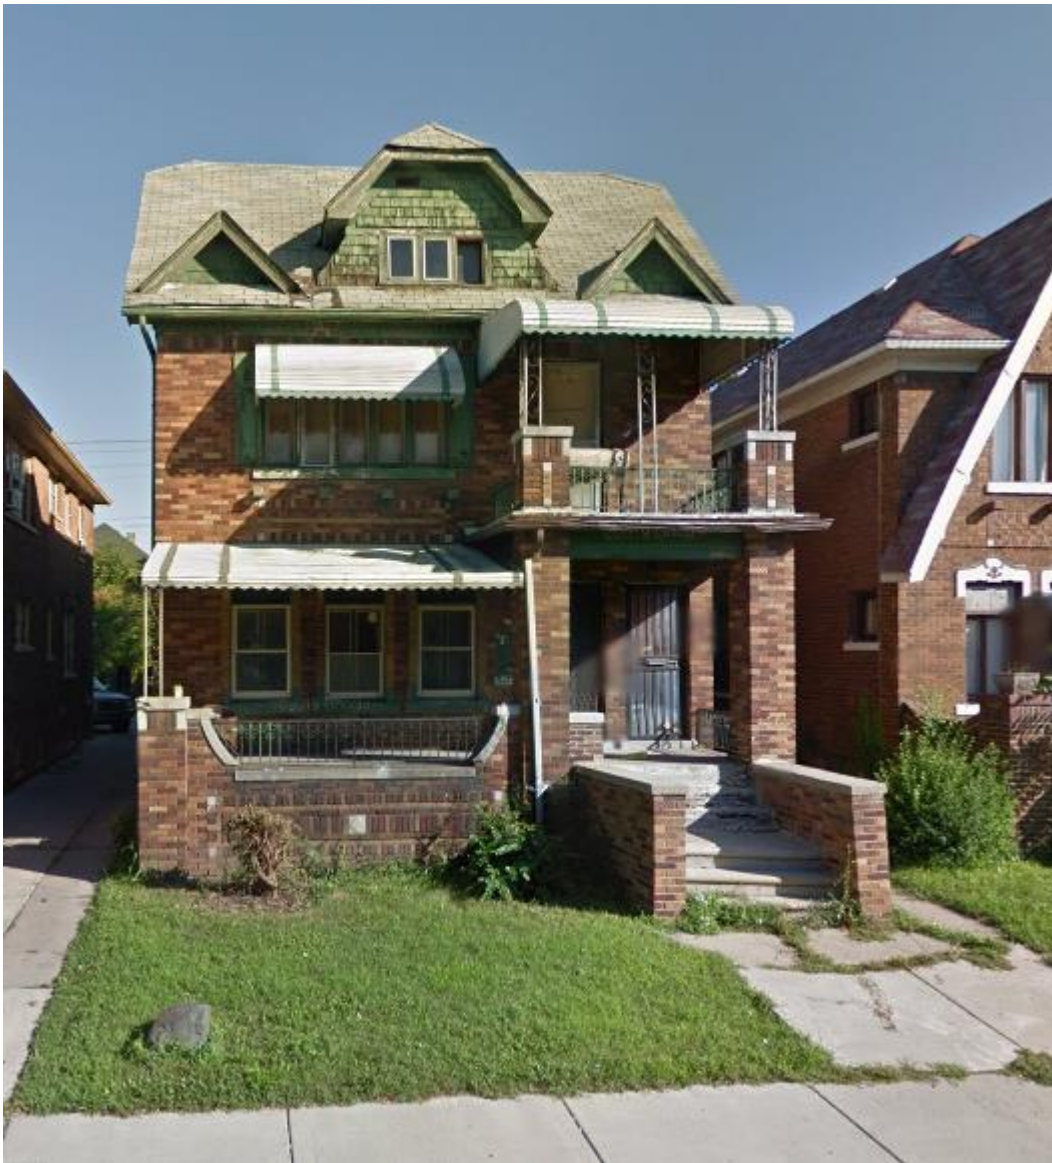
*3768 Tyler, Google Street View, August 2011. First-floor porch railing visible; matches second-floor railing above. 1960s-era aluminum awnings were shown on the first and second floors.*

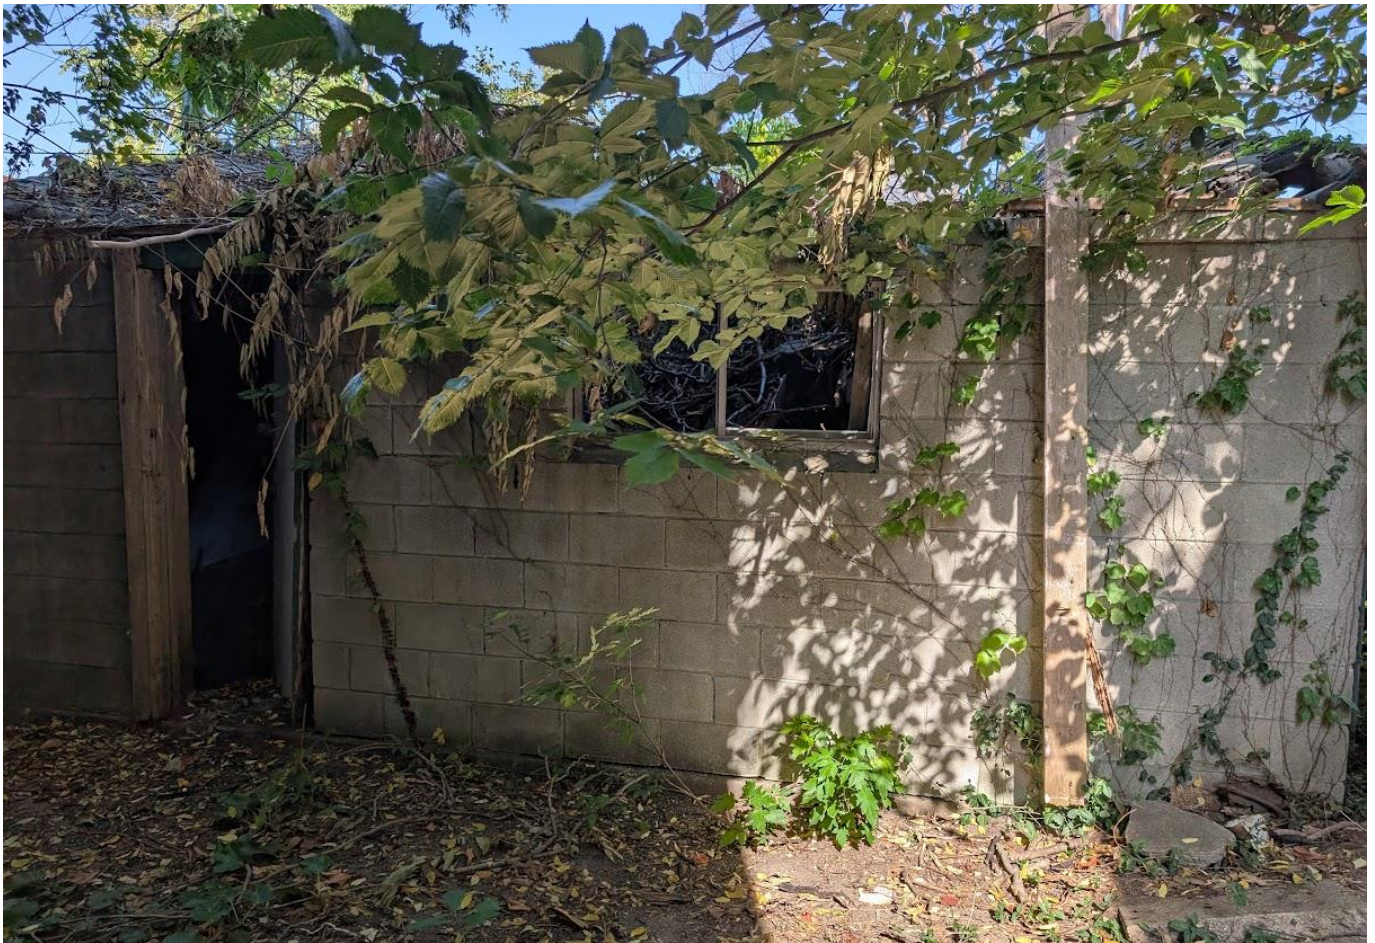
*3768 Tyler, garage, south end, facing the rear of the house. Applicant has labeled this elevation “EAST” on their drawing and has included a gable roof on the drawing. The service door is to be replaced with a similar steel door, and the window is proposed to be repaired. If it is beyond repair, the applicant proposes to block the opening with concrete blocks to match existing. (Staff site visit, September 2025)*

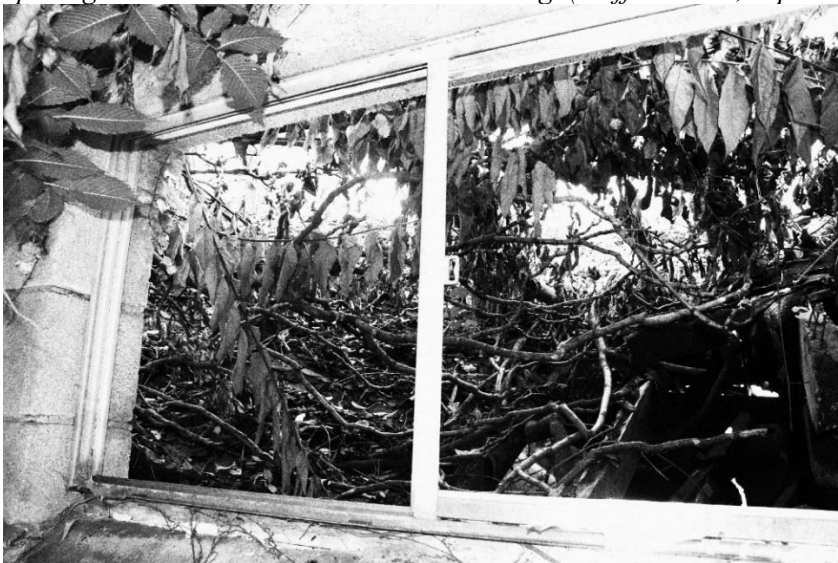
*3768 Tyler, garage, south end sliding window, but lacks glass. Applicant plans to repair it and insert new glass, but may ultimately remove the window frame and block in the opening. Because the garage dates from 1966, it is outside the period of significance.*

- If the applicant would like to propose a new garage window, staff would recommend that staff review and approve the window selection.

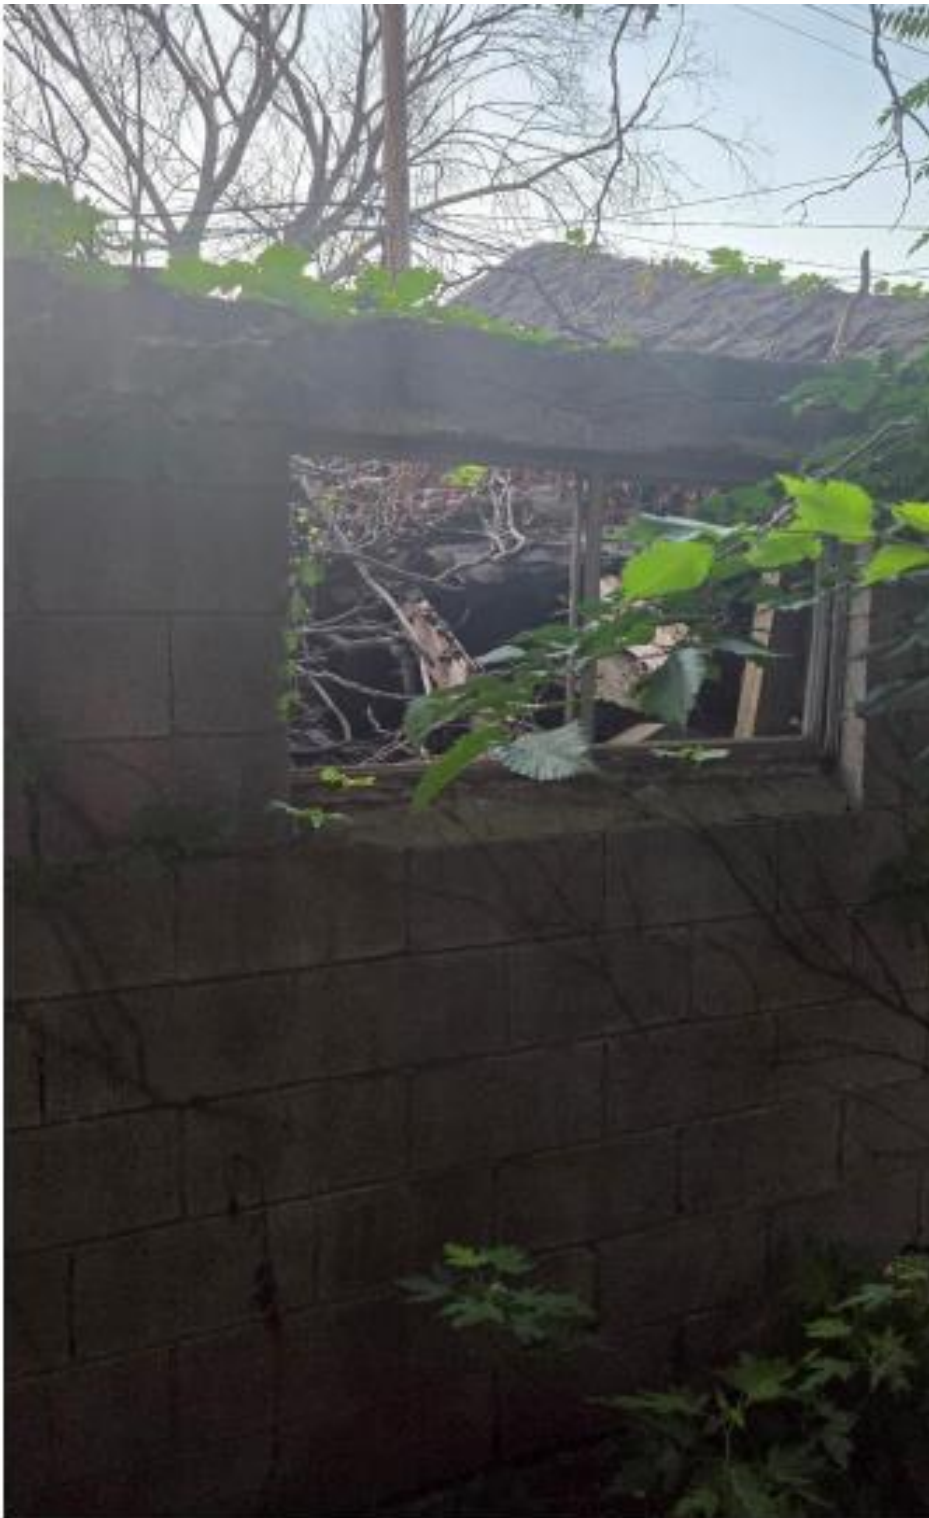
*3768 Tyler, garage, south wall, applicant-provided photo from materials. Currently, there is no roof on this portion of the structure. The applicant's drawing shows this south wall with a gable roof, but if the garage is to be rebuilt as it was, the peak of the gable roof would be centered over the east and west sides instead.*

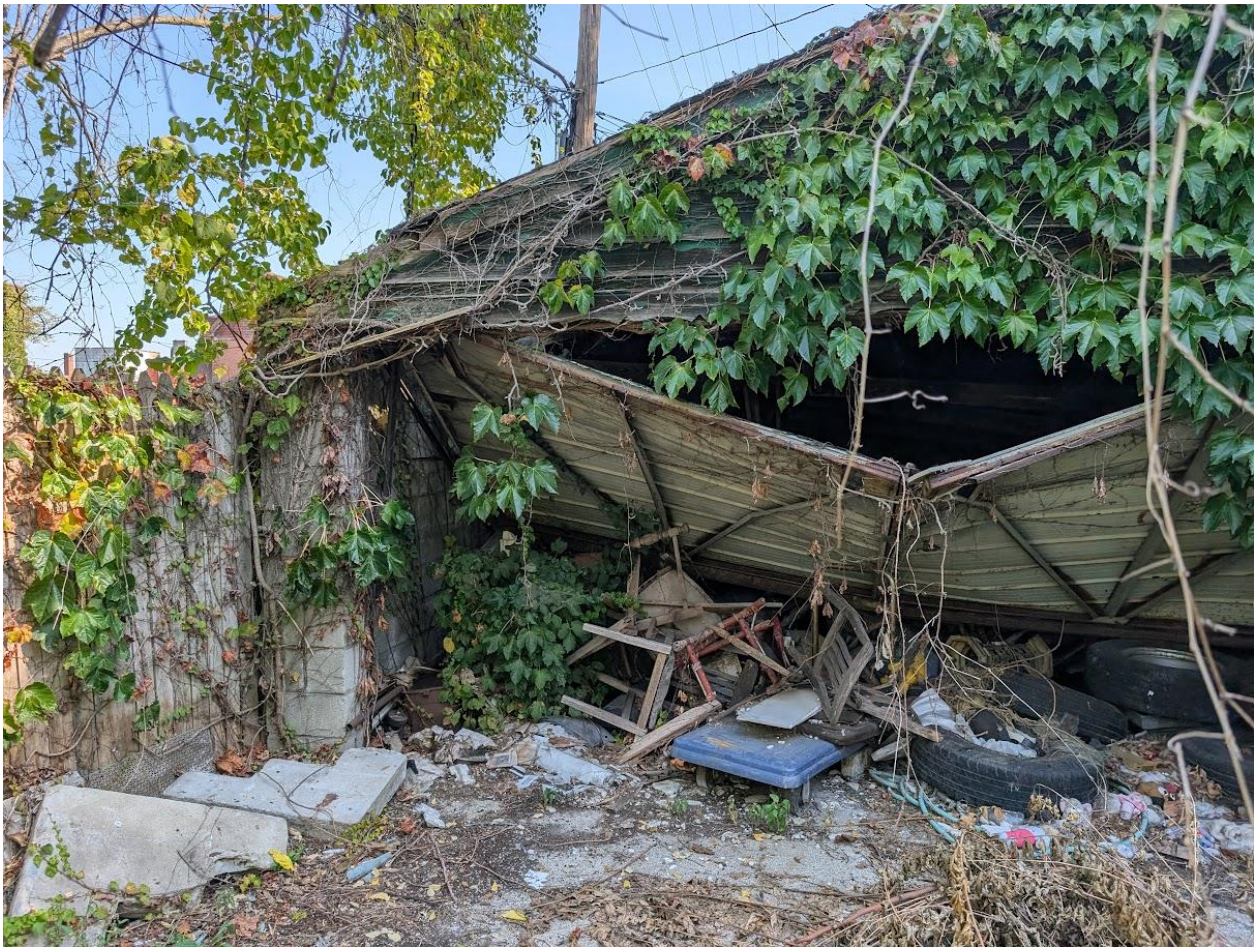
*3768 Tyler, garage, west side near the northwest corner. This overhead door was shown in the 2006 aerial photo, before the roof collapse. Applicant has labeled the long sides of the garage on their drawing as "NORTH" and "SOUTH." The applicant's drawing labeled "WEST" has a peak and a garage door, but is clearly a short end of the structure (either the north or south). (Staff site visit, September 2025)*

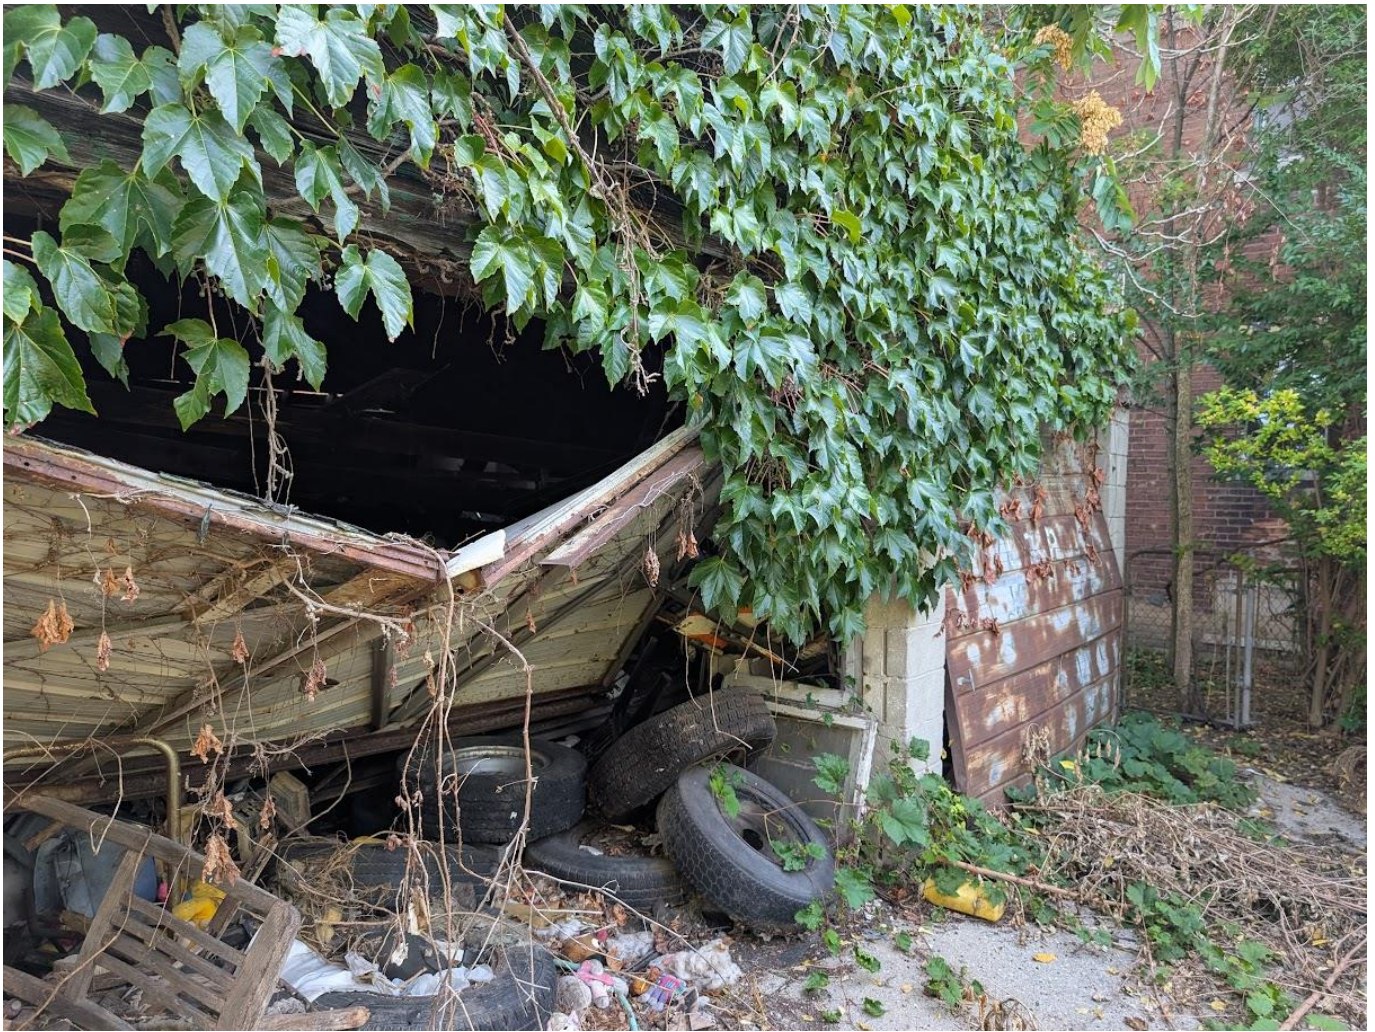
*3768 Tyler, garage, west side from near the northwest corner looking toward the southwest corner. The non-collapsed garage door is at the southwest corner. These overhead doors were shown in the 2006 aerial photo, before the roof collapse. Applicant has labeled the long sides of the garage on their drawing as "NORTH" and "SOUTH." The applicant's drawing labeled "WEST" has a peak and a garage door, but is clearly a short end of the structure (either the north or south). (Staff site visit, September 2025)*

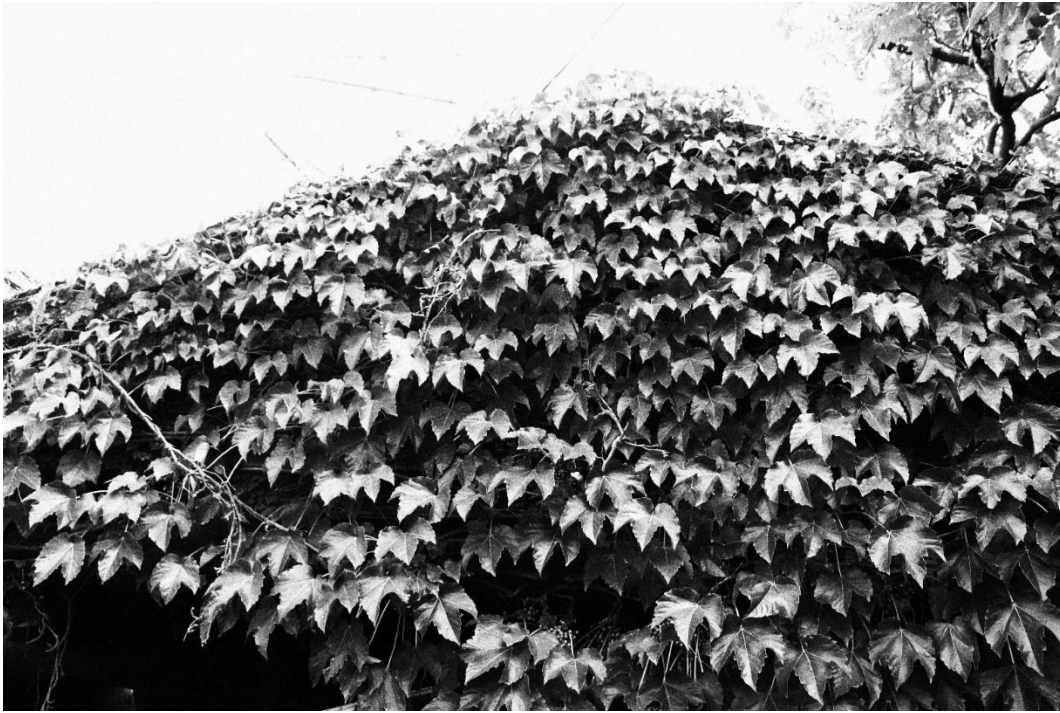
3768 Tyler, garage, extreme overgrowth visible at the peak of the gable on the west side. (Staff site visit, October 2025)

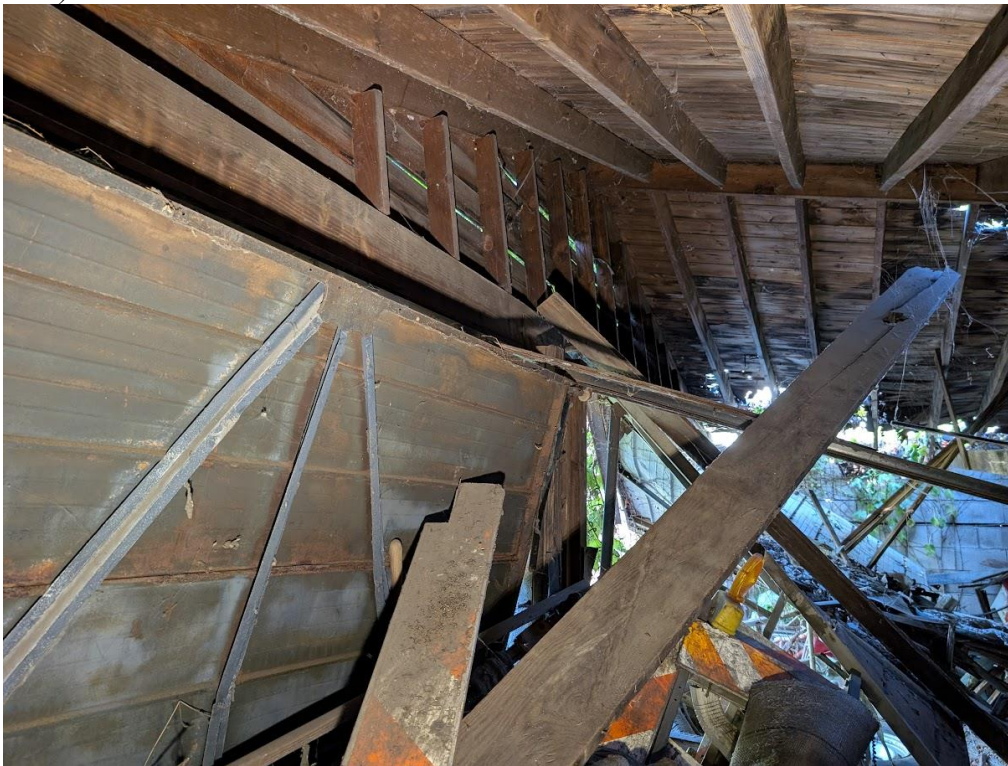
3768 Tyler, garage interior, standing near the southwest corner facing north. The garage door closest to the southwest corner is visible in the foreground, and the collapsing garage door is further to the north. It is evident that the garage's gable roof peaks over the west (on the viewer's left) and east walls. (Staff site visit, September 2025)

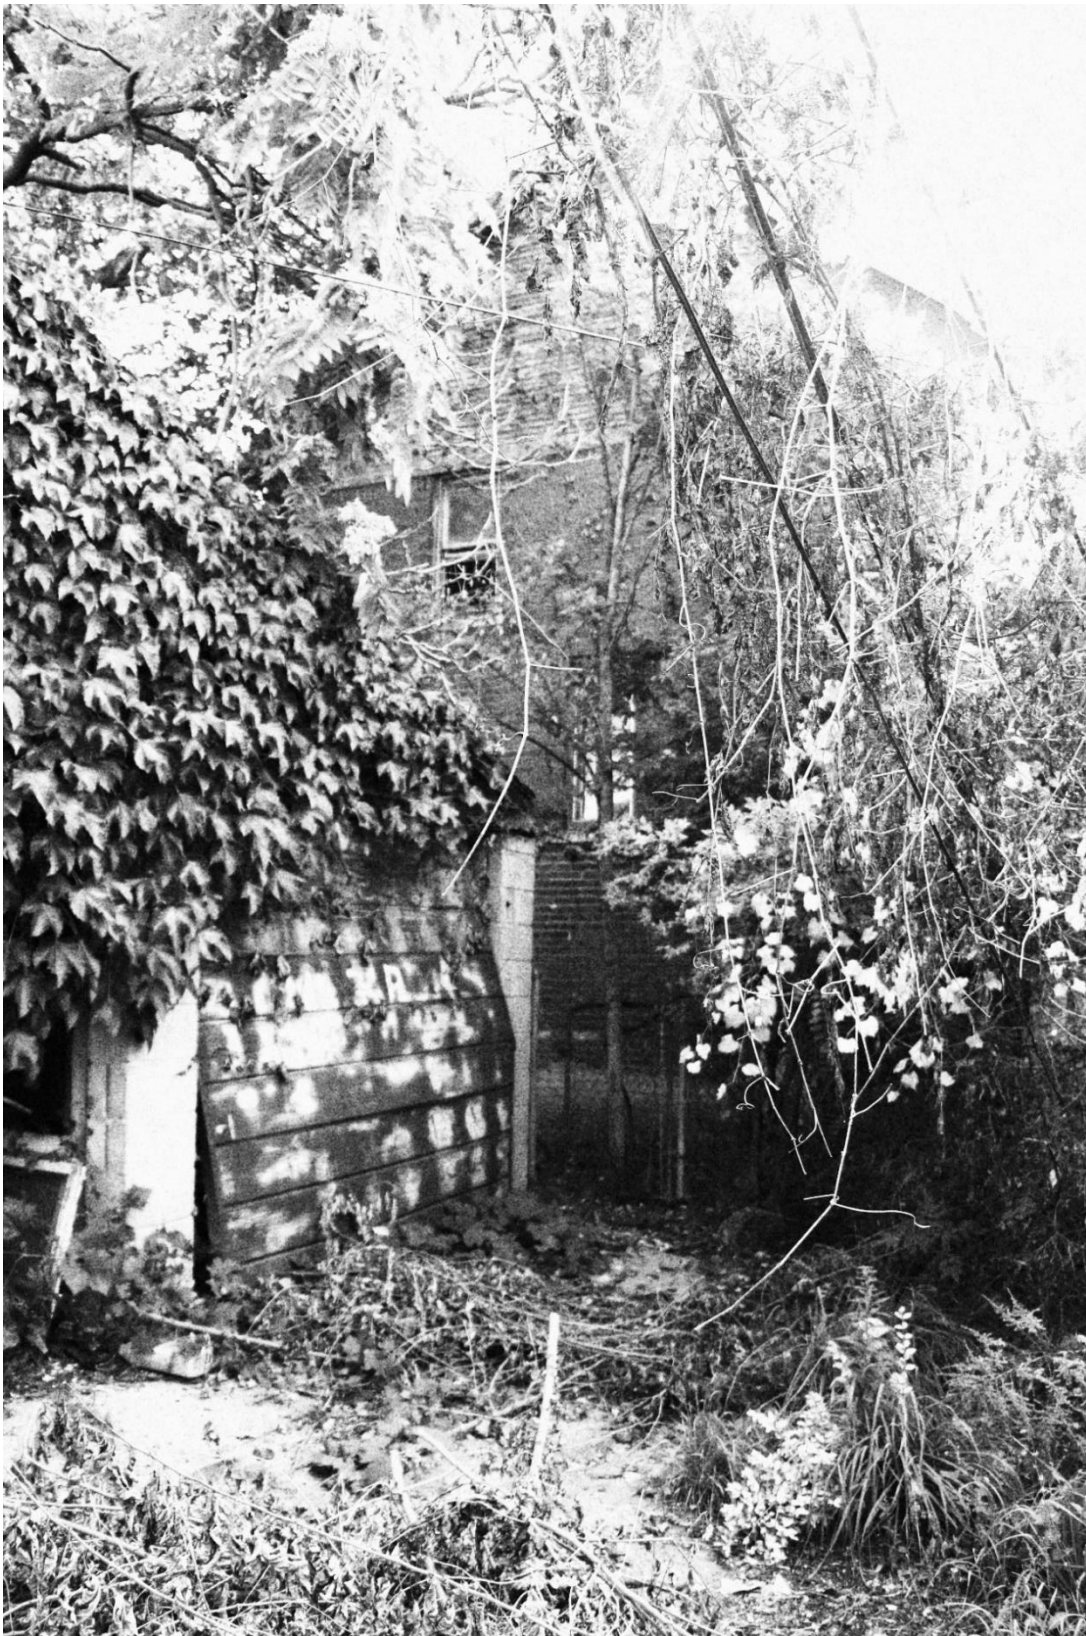
*3768 Tyler, garage, southern portion of the west side shown, along with the overgrowth and state of driveway/pad adjacent to the alley. An overall photo of the garage was difficult, even for staff, given the extreme overgrowth around the structure. (Staff site visit photo, October 2025)*

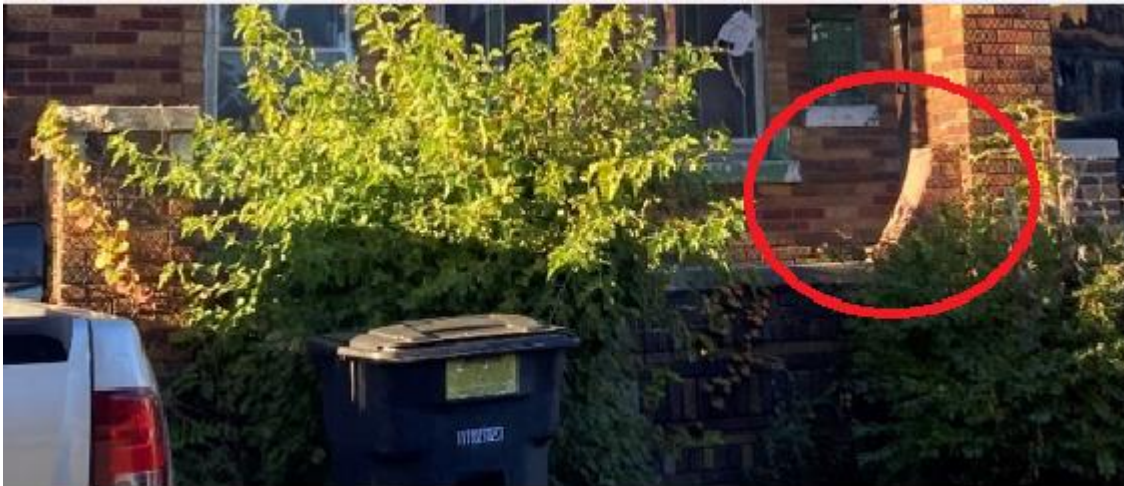
*As part of the porch work, the curved inset shown here (without its stone coping, staff photo detail from October 2025) will be rebuilt as a brick pier to match the same feature on the left (partially hidden by the shrub). The guardrail will be installed between the brick piers.*

- To meet the Secretary of the Interior's Standards for Rehabilitation, the front porch guardrail should be duplicated from the balcony guardrail, and the curved masonry sections that originally held the guardrail should be preserved, along with the other masonry details above and below the front porch.

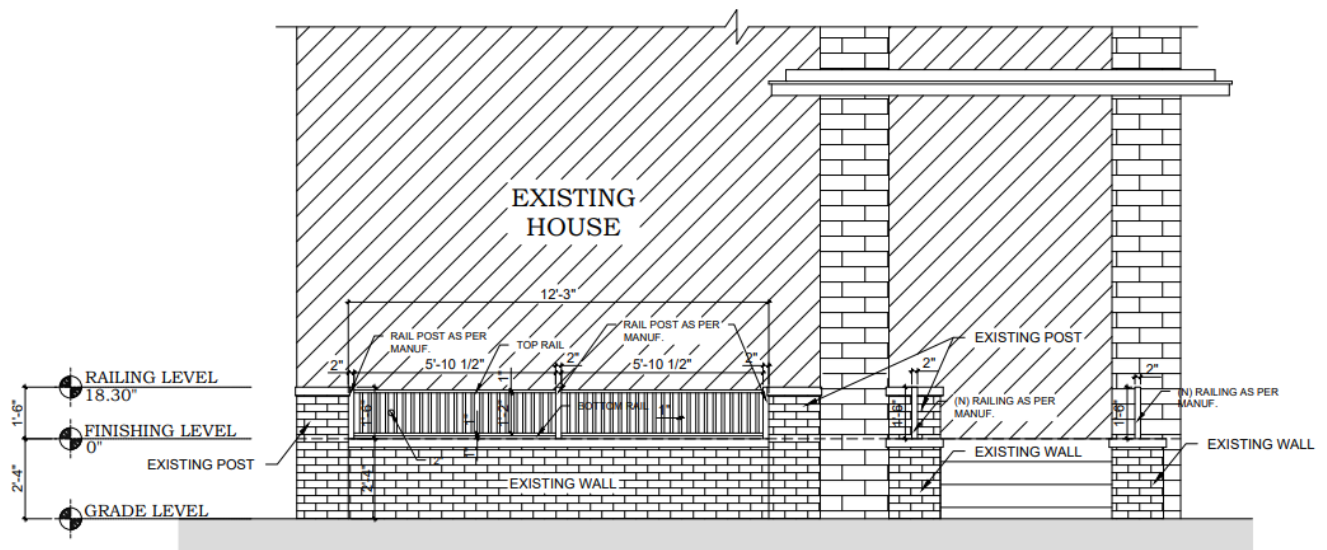
*Drawing from applicant's materials, showing the existing pier/post on the left, the rebuilt pier to the right, next to the tall column, and the new proposed guardrail. Also shown are new matching handrails on both sides of the front steps.*

- The proposed rail is simple, black, custom-welded aluminum, and 18" tall like the balcony guardrail. Worth noting is that the drawing shows the existing square brick pier at the house's southwest corner as just slightly taller than the 18-inch railing, but that is not actually the case. The existing brick pier is taller than shown on the drawing because the existing curved masonry inset tapers in height to meet the 18-inch rail, and that feature has been removed in the drawing. The second-floor brick piers/columns stand quite a bit taller than the 18-inch rail on the balcony, and that relationship, as proposed, would be similar at the first floor as well.

- the applicant will submit corrected front porch drawings for staff review and approval that preserve the historic, character-defining features including the curved masonry sections between the brick column and pier and the brick and stone details below the front porch concrete cap, and the applicant will duplicate the missing porch guardrail based on the historic second-floor balcony guardrail.
- the applicant will submit corrected garage elevation drawings for staff review and approval that accurately reflect the proposed design.
- product cut sheets for the garage doors (both overhead and service doors) and any garage window will be submitted to staff for review and approval before the work begins.

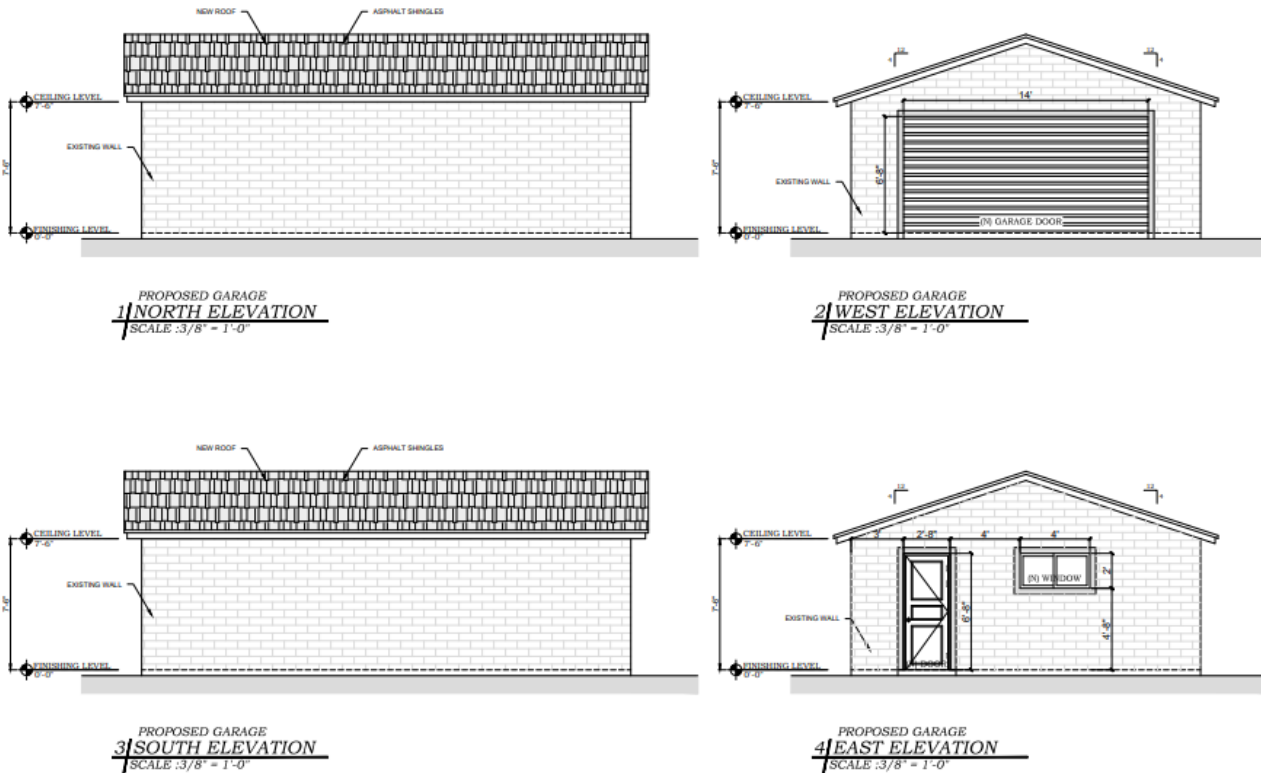
*Drawing from applicant's materials showing repaired garage with rebuilt roof. Replacement garage doors and window products have not been selected. Staff believes these elevations are mislabeled. The longer sides should be west and east elevations and the shorter ends should be north and south. If the former roofline will be reproduced, the gable ends should be on the long sides (the west and east).*

- The applicant has indicated that his plan is to rebuild the garage as it was, with the same footprint, height, and roof pitch, but the elevation drawings do not seem to indicate that. Staff believes them to be mislabeled and is unclear as to which direction the proposed gable roof will be oriented.
