**STAFF REPORT: 11/12/2025 MEETING**

**ADDRESS: 8002 KERCHEVAL**

**APPLICATION NO: HDC2025-00640**

**SCOPE: REPLACE SIDING WITH FIBER CEMENT SIDING**

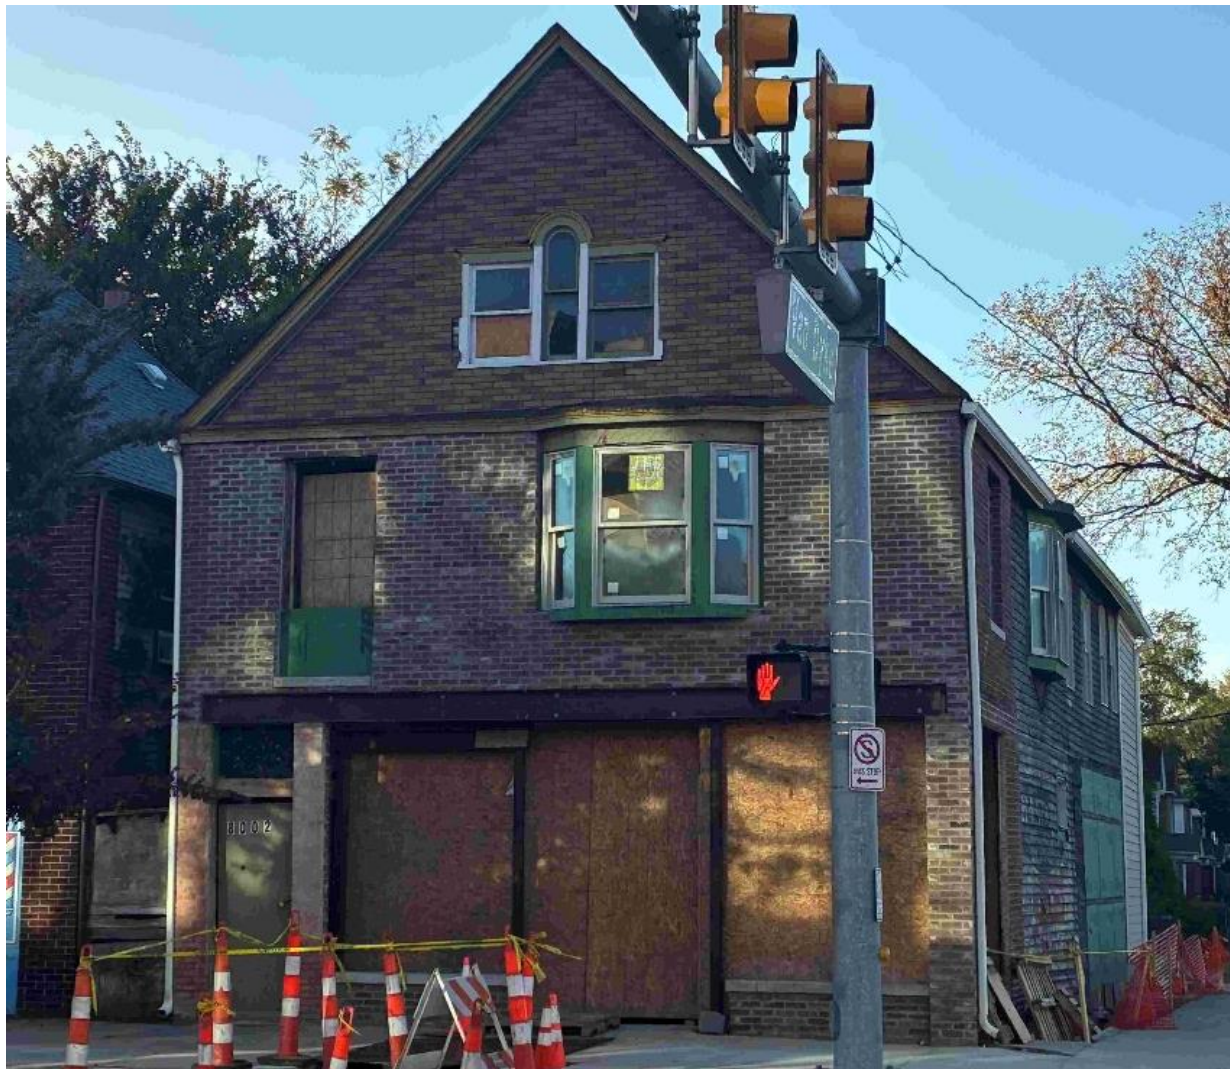
**8002 Kercheval, current appearance. Photo by HDC staff on 10/27/2025**

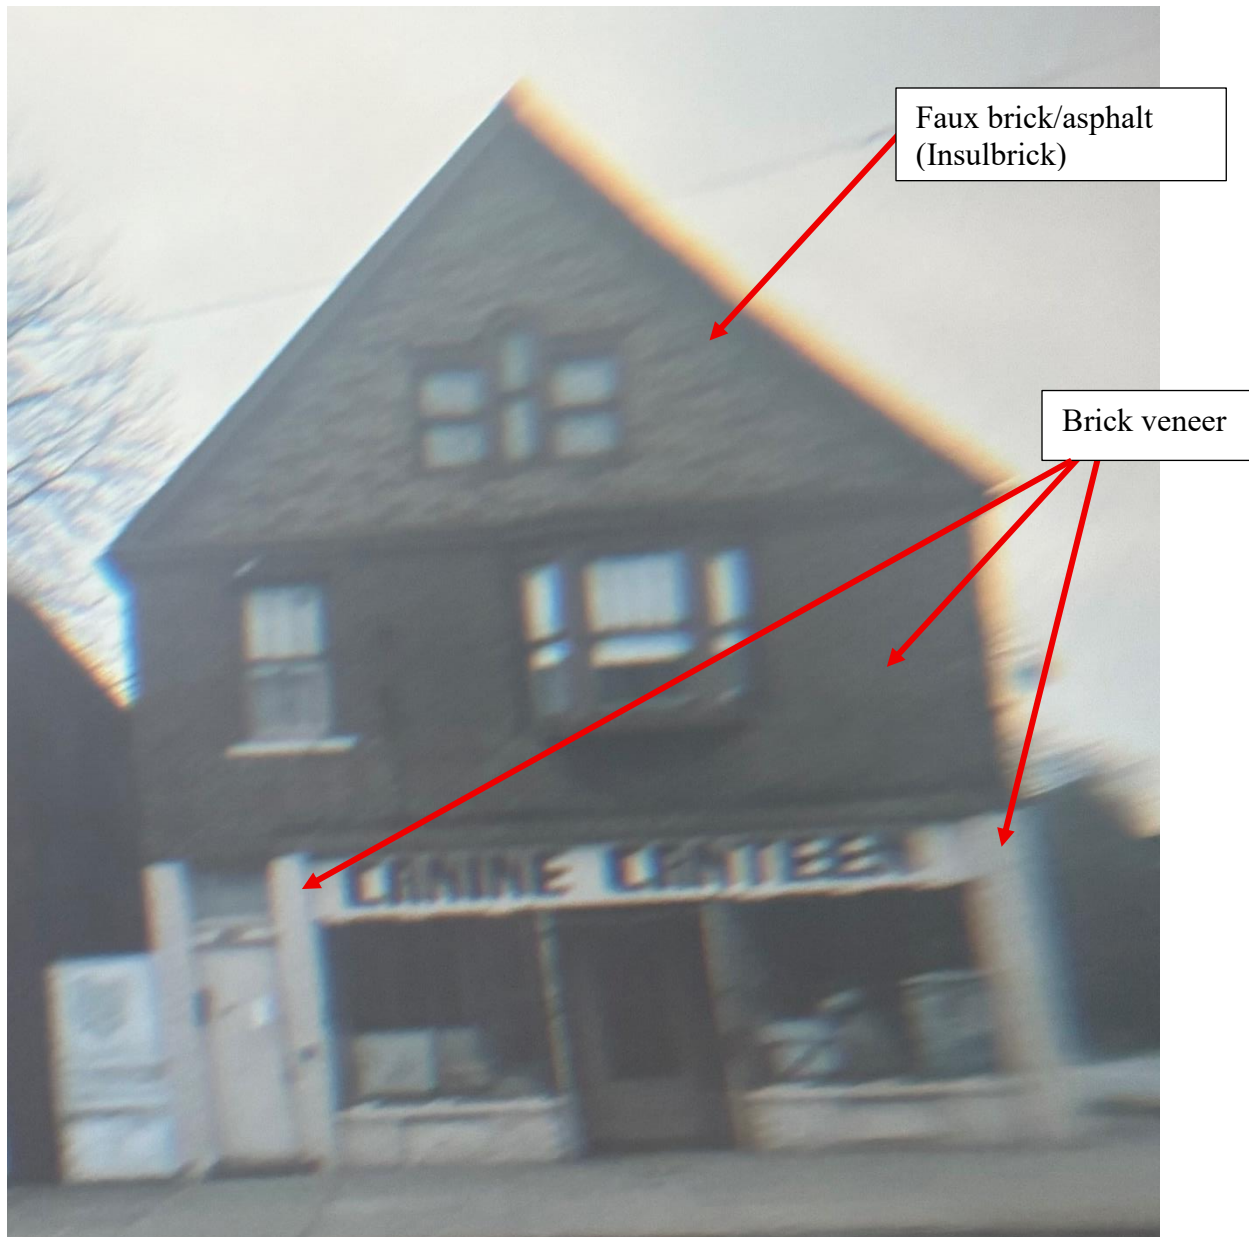
Photo by HDAB, 1983. Showing north-facing front façade along Kercheval

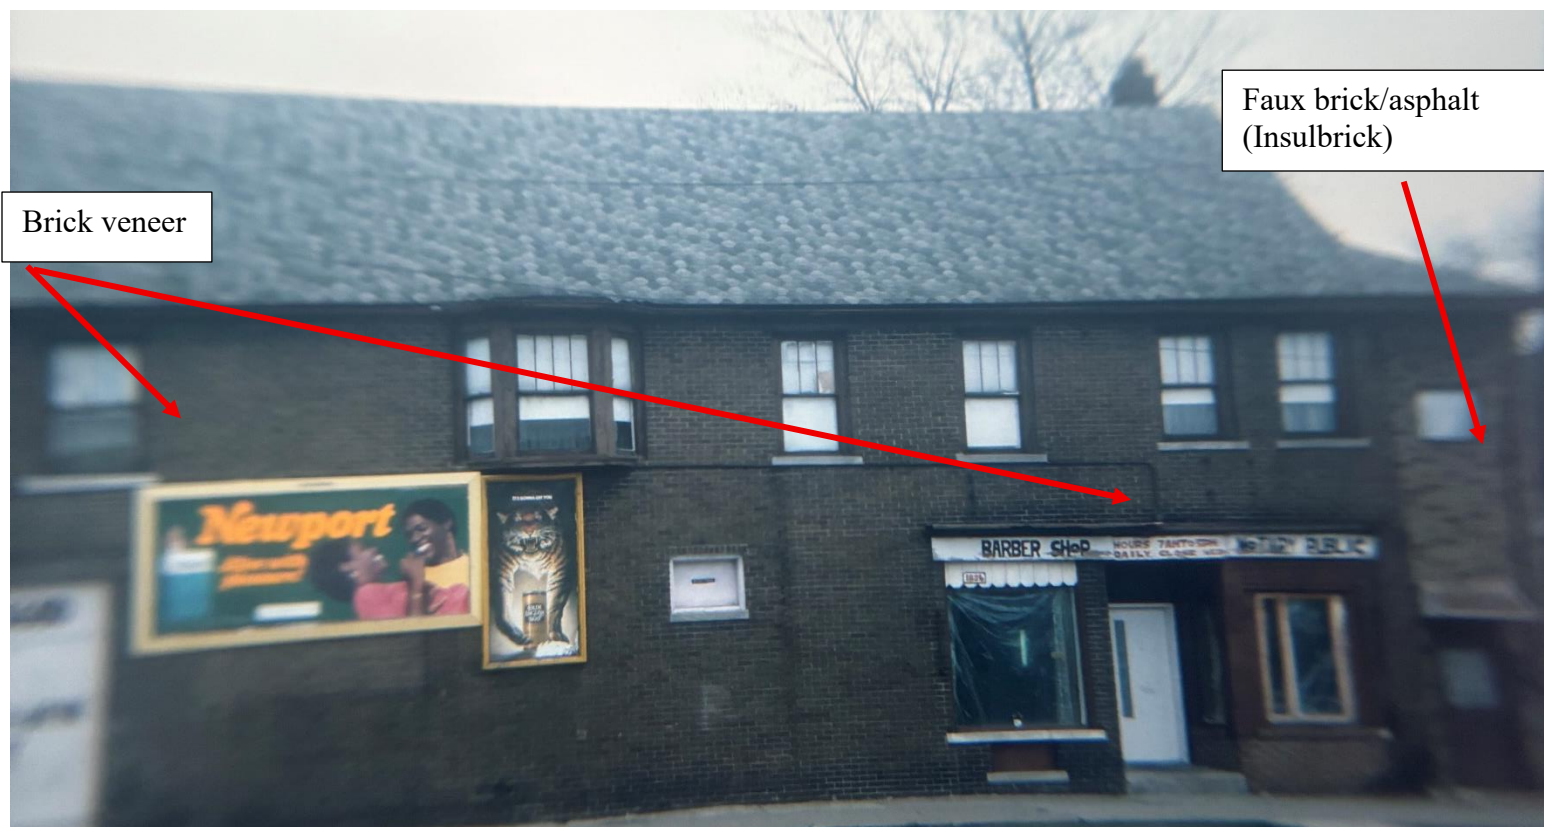
Photo by HDAB, 1983, showing west wall along Van Dyke

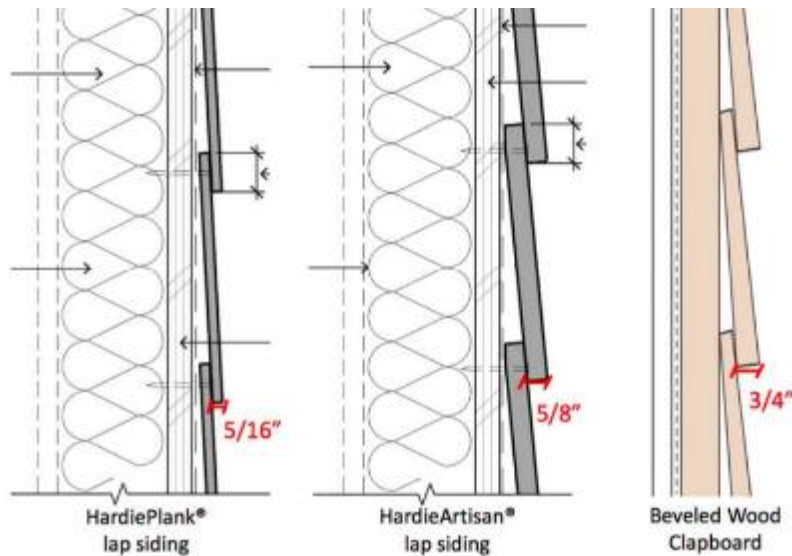
**Note that the Hardi Artisan cement fiber siding provides a profile that better matches that of tradition lapped wood siding. This is an image from the 2018 staff report**

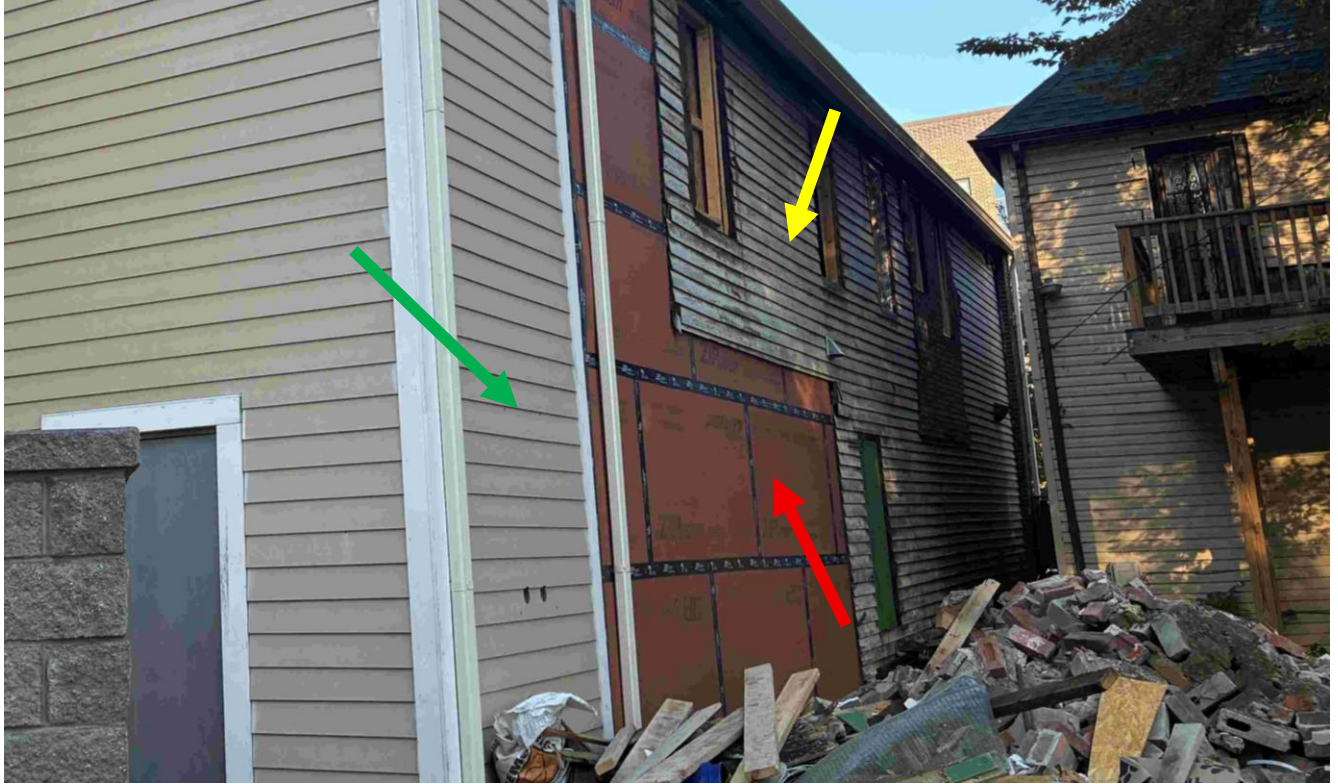
8002 Kercheval, east/side elevation. Showing historic wood siding (yellow arrow) which was revealed when Insulbrick/asphalt siding was removed ca. 2021; Zip sheathing, installed ca. 2021 (red arrow); and composite/Smartside LP siding installed ca. 2021 (green arrow) when rear addition was erected. Current condition. Photo by HDC staff, 10/27/2025.

- The historic wood siding at the side elevations has only recently been revealed after the removal of the brick veneer and asphalt/Insulbrick siding. Staff was able to view the condition of the siding from the public right-of-way and did not find that it was deteriorated to an extent that merits its wholesale removal as proposed. Also, the application does not provide documentation that the historic wood siding is deteriorated beyond repair.

- Staff concludes that retaining and repairing the original siding, if possible, is the most appropriate treatment for the siding at this property, will greatly enhance the building's historic character, and will further restores historic character to the West Village Historic District.

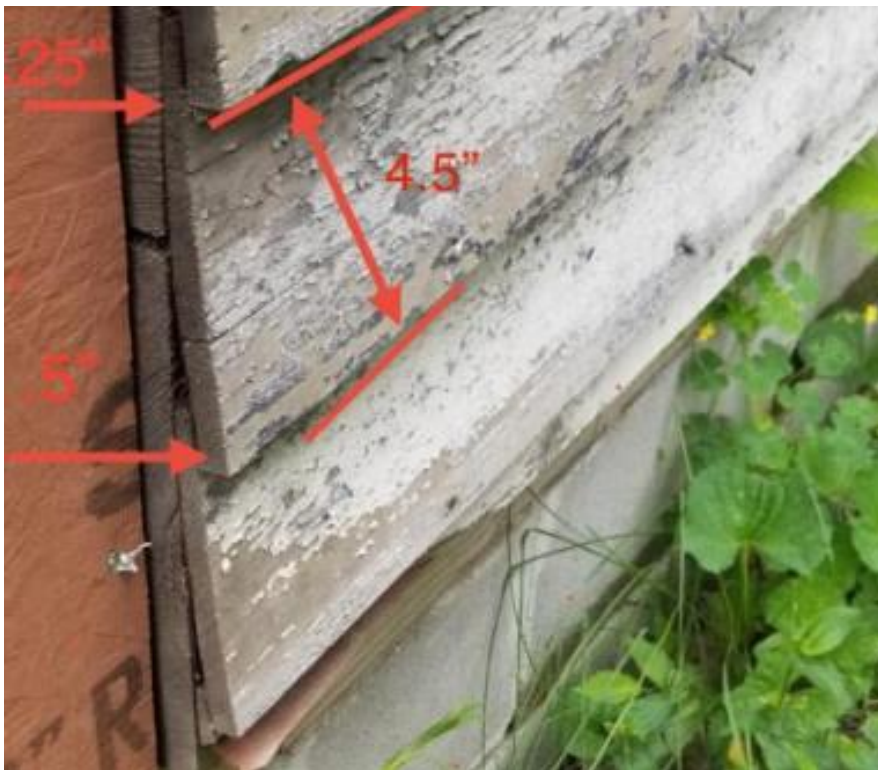
Detail, showing extant historic lapped wood siding at east/side wall. Dimensions noted in red. Image by applicant.

- The current historic wood siding displays a profile of 1/4"–1/2". As such, the proposed 5/16" thick siding provides an inadequate match to the building's historic wood siding.
