**STAFF REPORT:** NOVEMBER 12, 2025 REGULAR MEETING

**APPLICATION NUMBER:** HDC2025-00655

**ADDRESS:** 1613 LEVERETTE STREET

**SCOPE:** DEMOLISH GARAGE, ERECT CARRIAGE HOUSE

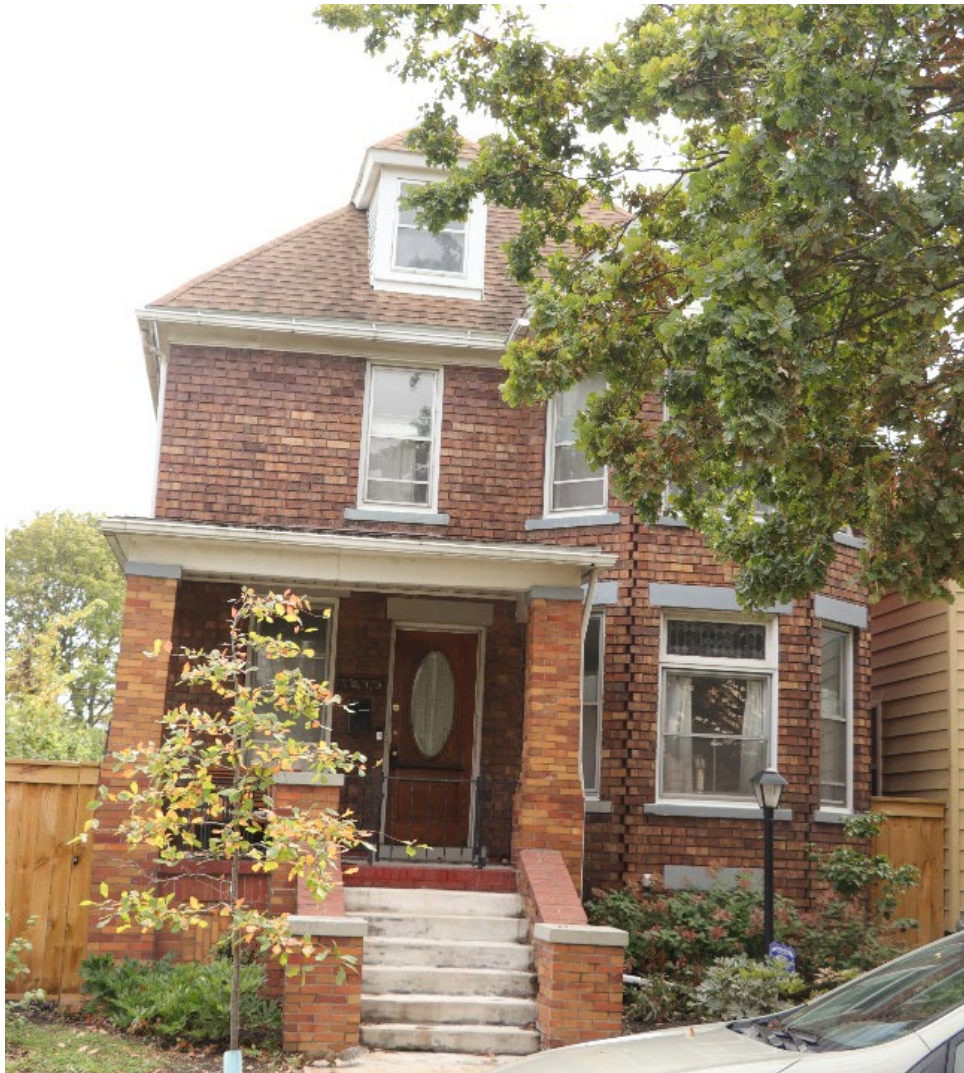
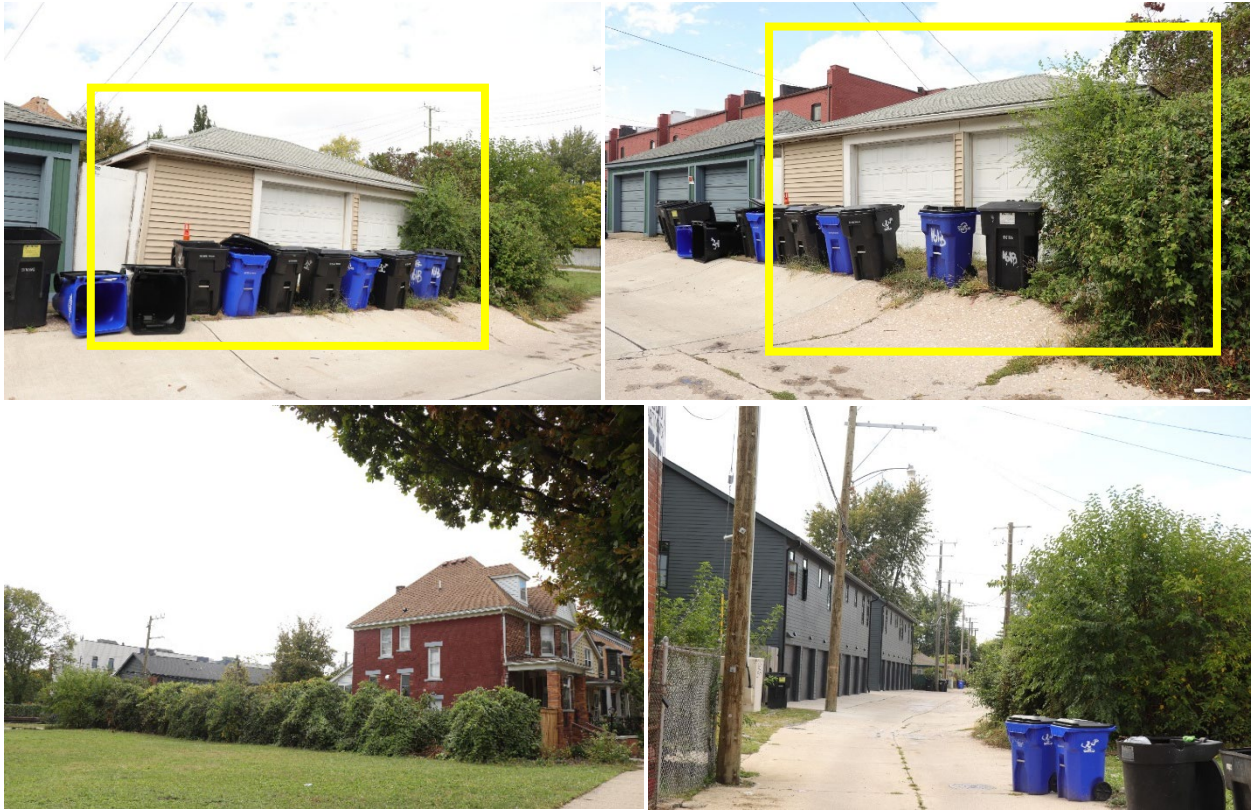
Built in 1910, 1613 Leverette sits on a 0.099 acre lot in the Corktown historic district, between 10<sup>th</sup> Street and Rosa Parks Boulevard. The two-and-a-half story, Victorian style house is characterized by its red brick veneer and steeply pitched roof. The parcel also includes a one-story, hipped roof garage which was erected in 1925. The garage's exterior walls are clad with vinyl siding.

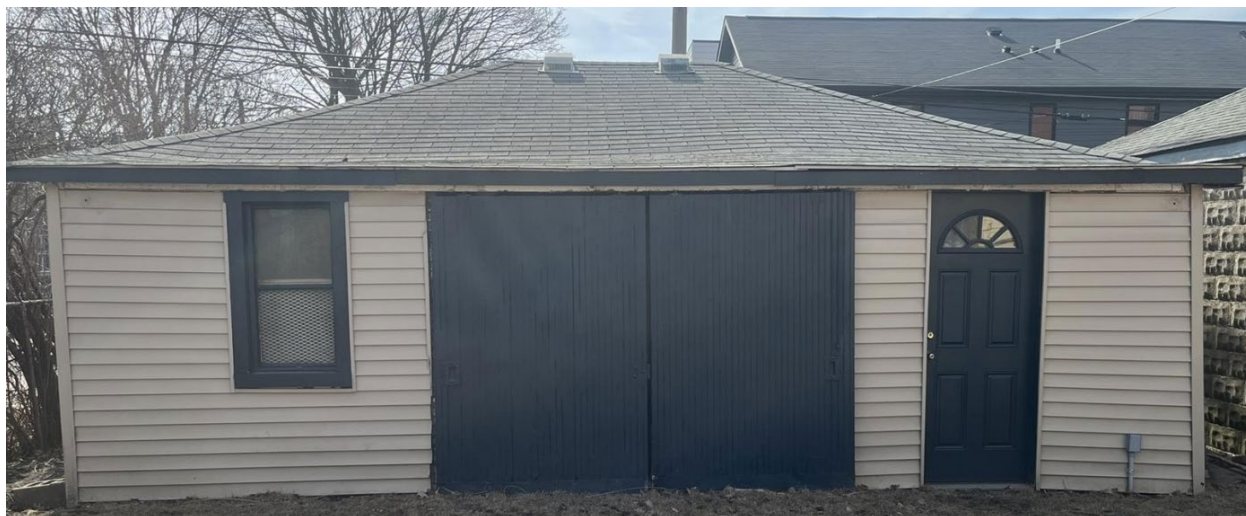
- The garage has undergone many changes since the time it was erected in 1925. This includes the modification of the overhead garage doors and windows, its exterior walls have been clad with vinyl siding, and a asphalt shingle roof has been added.

*1613 Leverette garage, current appearance. Side facing the rear of the house, not visible from the alley. Photo provided by the applicant.*

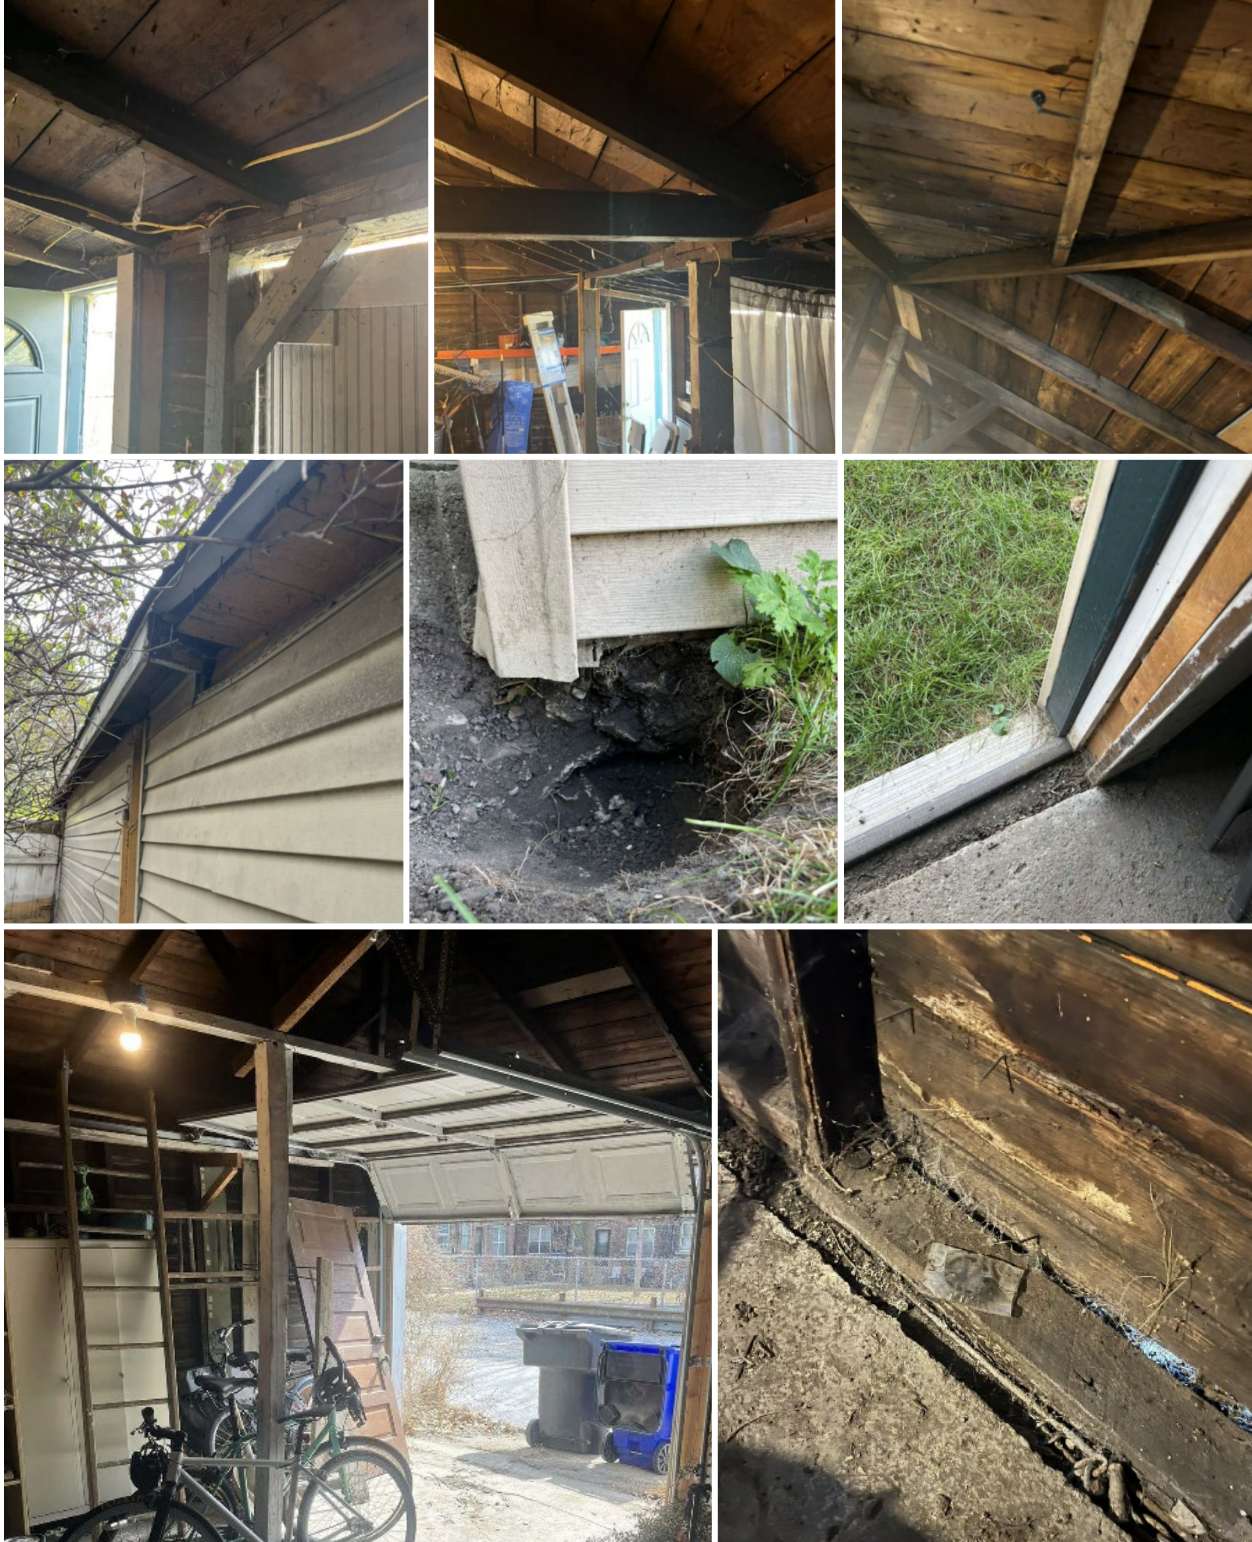
*Photos provided by applicant, shows interior condition of the existing garage*

- **Exterior Walls:** The architect assesses the condition of the exterior walls as poor. Sill plates did not appear to be anchored to the foundation (though this can be remedied), but

approximately half of the sill plates are rotting and deteriorated. Additionally, sill plates were up-heaving in one corner. Most critically, in staff architect's opinion, the west wall is 8" out of plumb and leaning toward the south. The other three walls are between 2-4" out of plumb. At least one wall would need to be completely rebuilt. It is doubtful that the current racked structure could reasonably endure a partial rebuild.

- **Roof:** The architect also assesses the condition of the roof as poor. Creditable deficiencies include the overloading of the roof's lightly built original structure, which has suffered substantial deflection and failure in the roof structure to the point that additional support is clearly necessary and present in the form of a temporary column. Though this could have been caught earlier and reinforced, the opportunity for such a remedy has clearly passed and the roof needs to be rebuilt.

- **Foundation:** Differential settlement of original slab, no evidence of footings. Deficiencies observed include cracking, separation, and spalling.
- The architect additionally notes the interdependency of the roof, wall, and foundation systems, which complicates any good faith repair effort.

- Based on the above observed deficiencies, and without accepting arguments that historic structures must be held to modern code standards, staff architects assess that the garage is beyond reasonable repair, as repair would in effect require a complete rebuild, eliminating most of the building's historic integrity, or else require an unreasonably complex and surgical historic preservation treatment exceeding the structure's apparent economic, architectural, and historic value.
