REVISED 12/10/2025**ADDRESS: 1815 SEMINOLE****APPLICATION NO: #HDC 2025-00473-#HDC2025-00705****HISTORIC DISTRICT: INDIAN VILLAGE****APPLICANT: ALISSA JACOBS (4545 ARCHITECTURE)****OWNER: RACHEL AND TROBAUGH NELSON****DATE OF STAFF SITE VISIT: 11/20/2025****DATE OF PROVISIONALLY COMPLETE APPLICATION: 11/17/2025****SCOPE: REPLACE WINDOWS****EXISTING CONDITIONS**

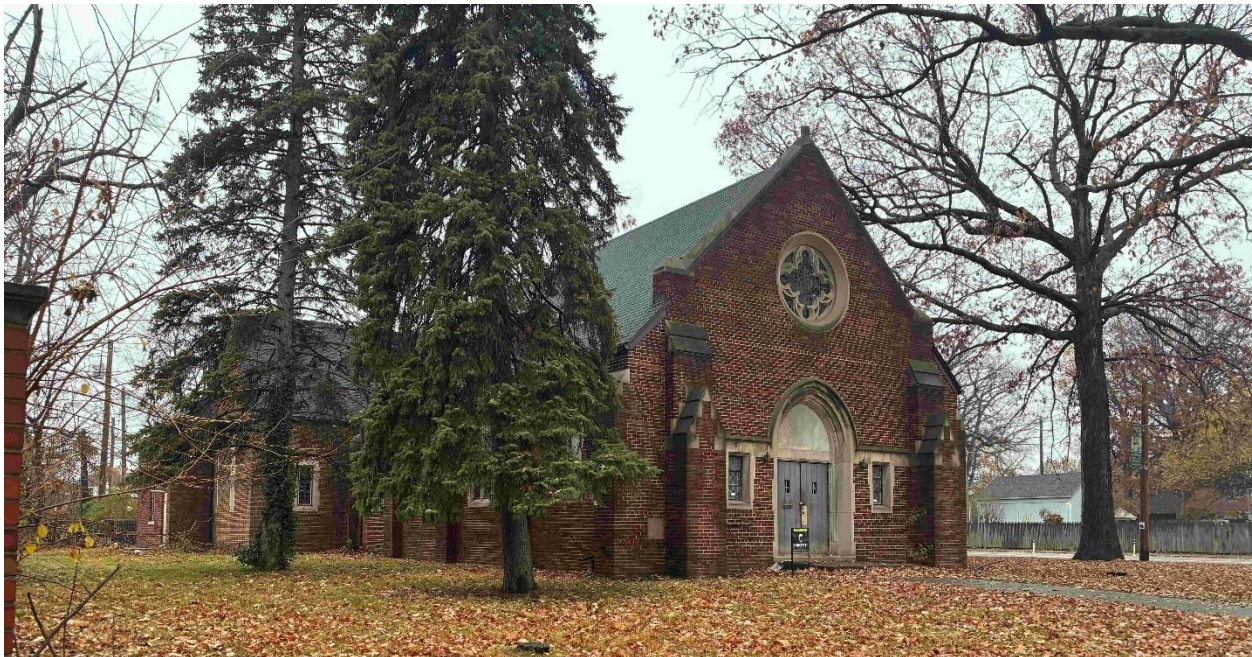
1815 Seminole, current conditions. Photo by staff, 11/20/2025

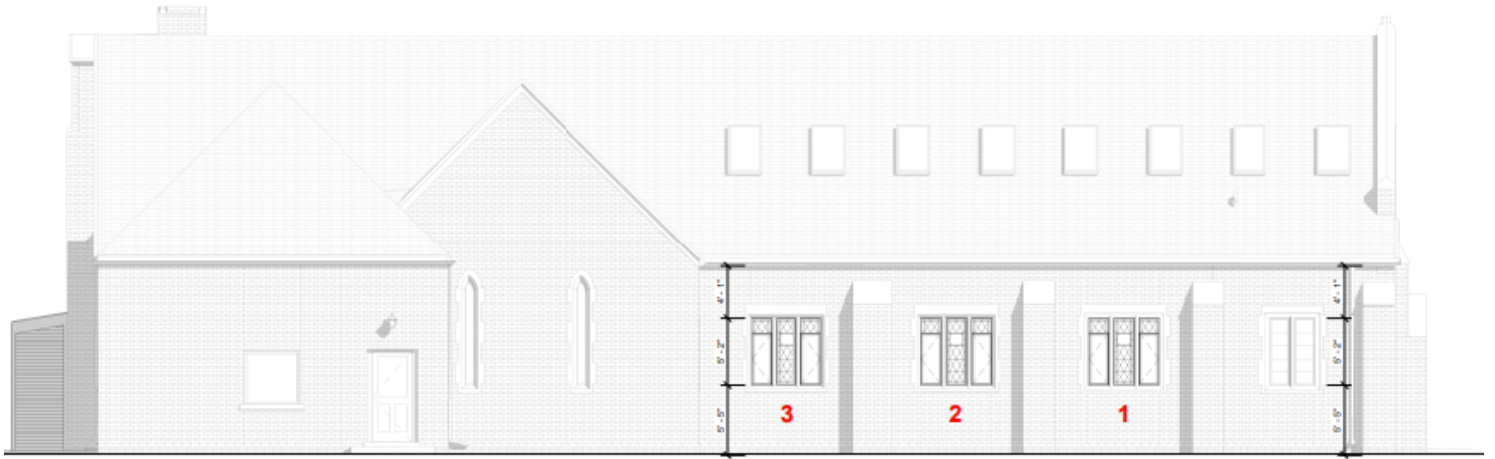
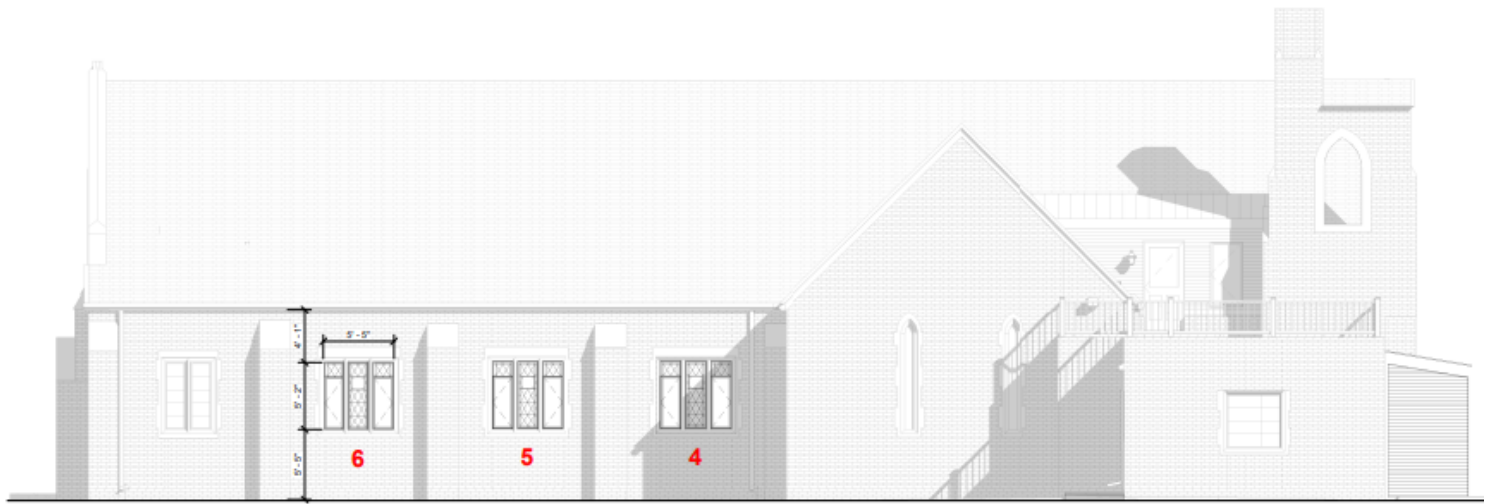
2 SOUTH ELEVATION
SCALE: 3/16" = 1'-0"

Windows proposed for replacement at north and south side. Elevation drawing by applicant

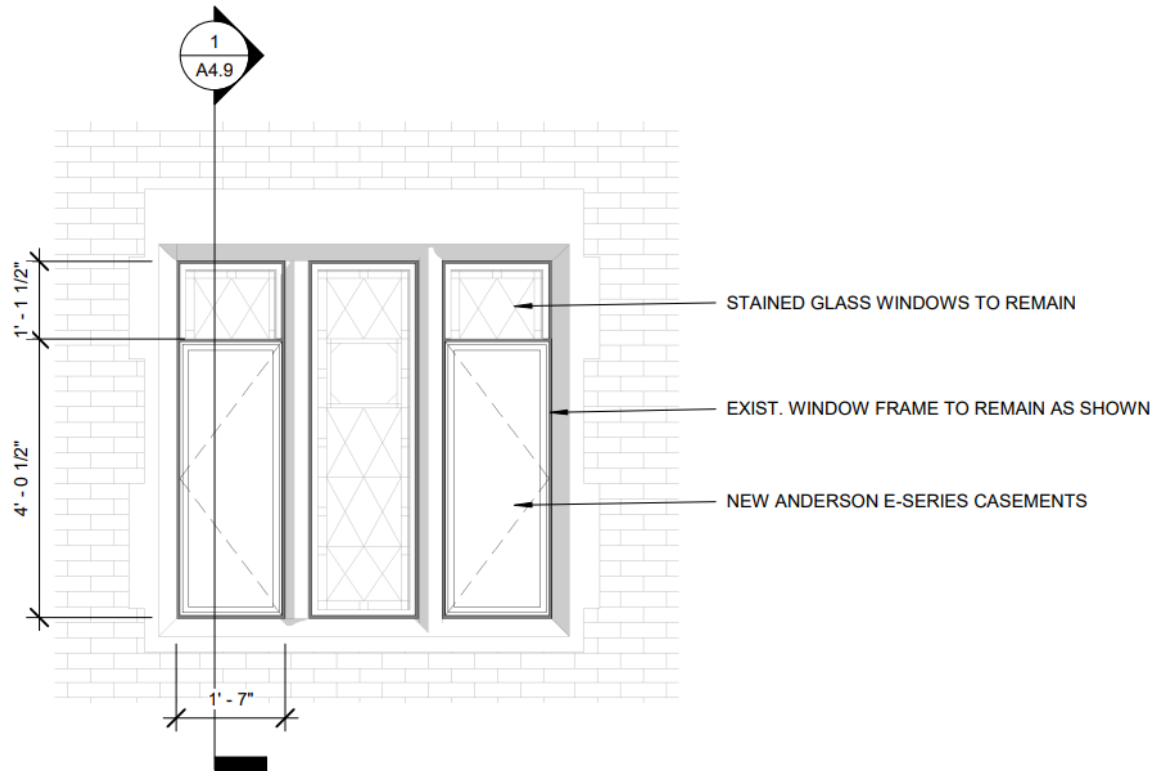
Typical proposed condition. Note that the existing central fixed window and the two existing transom panes will be retained. Drawing by applicant.

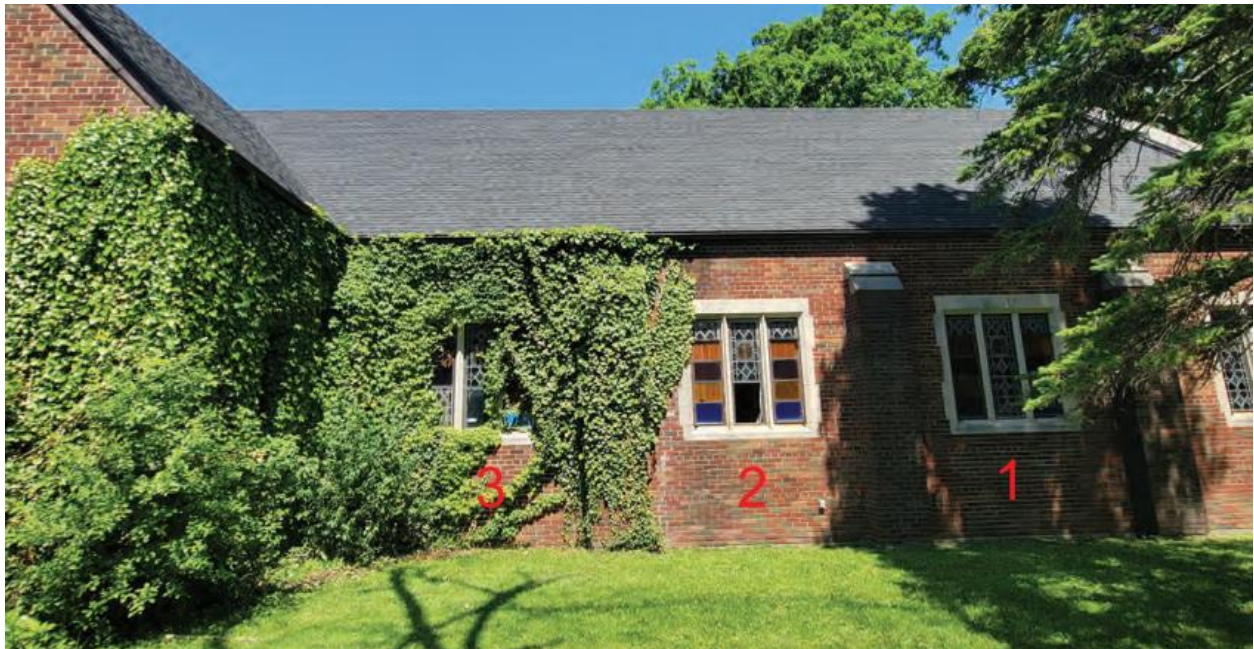
South wall, casement windows at openings 1-3 proposed for replacement. Annotated photo by applicant

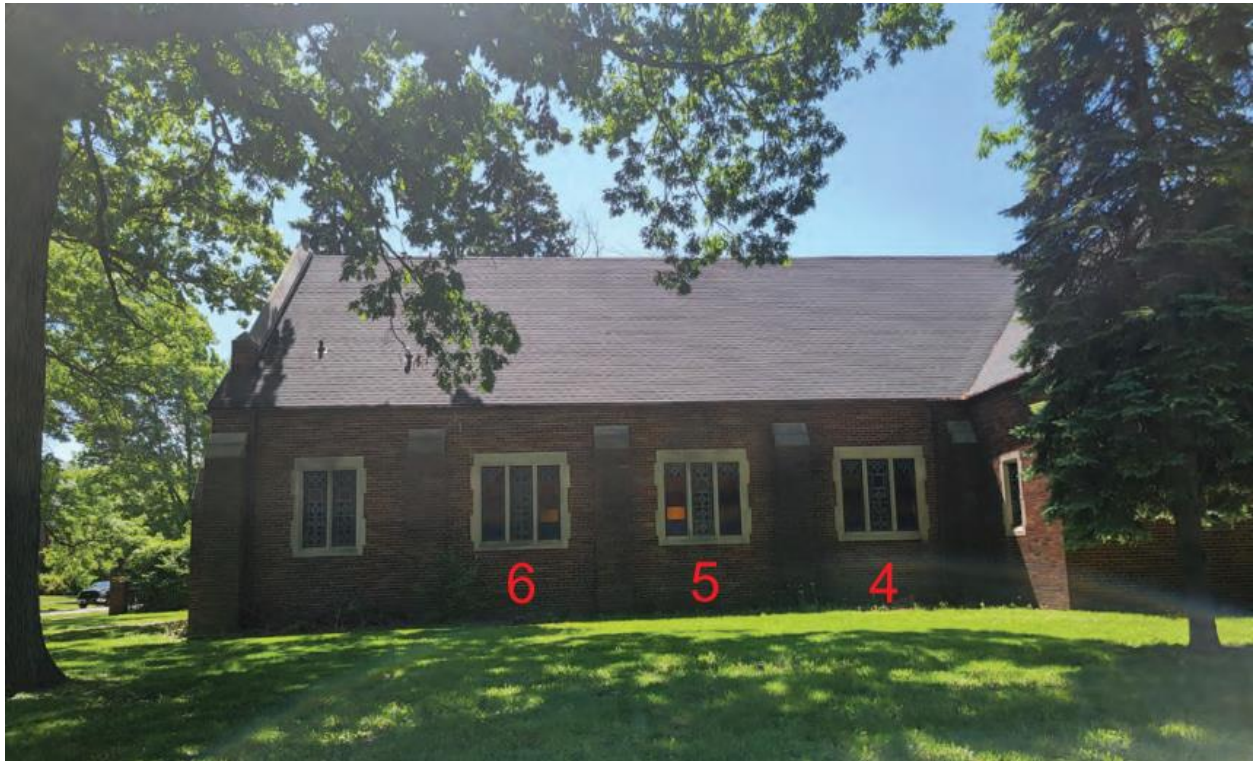
North wall, windows casement windows at openings 1-3 proposed for replacement. Annotated photo by applicant

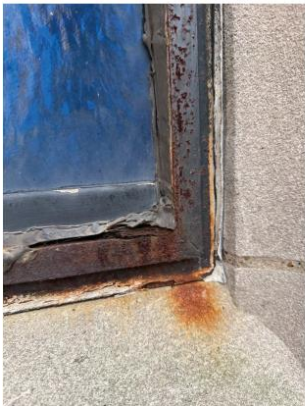
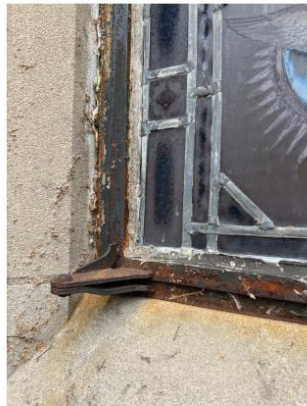
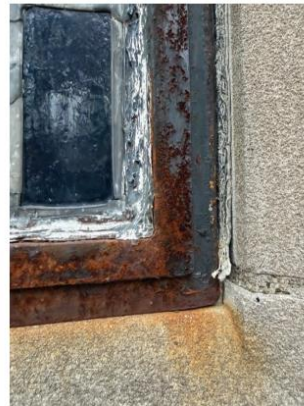
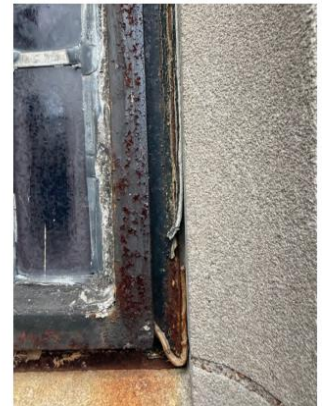
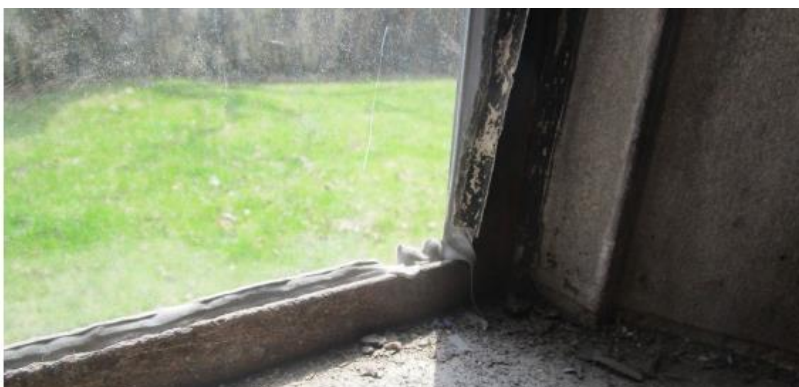
Photos by applicant. Showing typical conditions. Specific window locations not provided

- While the application materials do indicate the presence of asbestos at the subject steel casement windows, they do not adequately demonstrate that it is not technically and/or financially feasible to abate the hazardous materials while retaining the existing historic casement units. Also, the submitted photo documentation and narrative analysis does not adequately support the above statement that the windows are deteriorated to an extent that merits their replacement. Staff therefore recommends denial of the project because the removal of the original/historic steel casement does not meet the Standards.

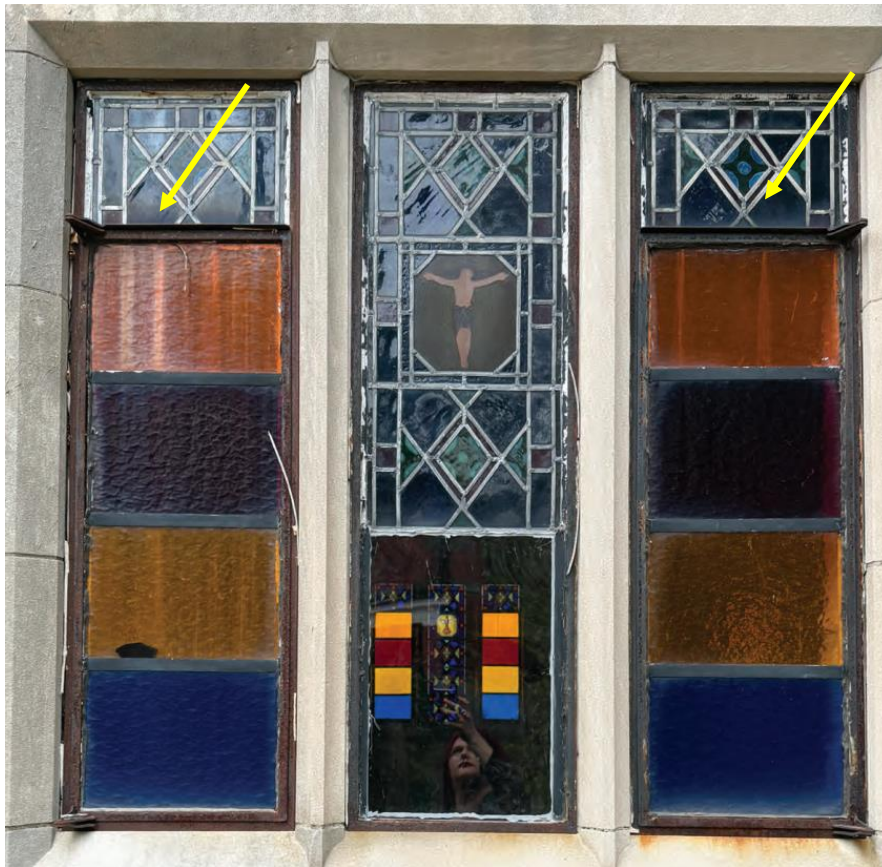
Photo provided by applicant. Note that the transoms panes appear to be slightly more inset within the opening than the operable sash. Staff notes that the submitted drawings do not provide dimensions of the top portion of the existing casement window frame (see yellow arrows).

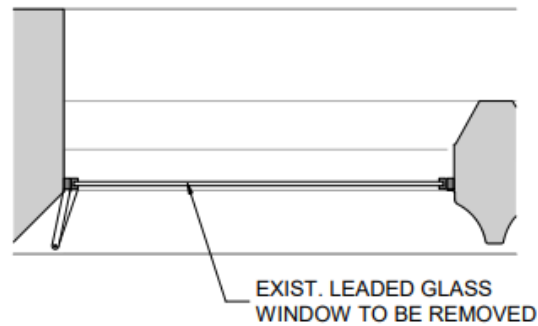
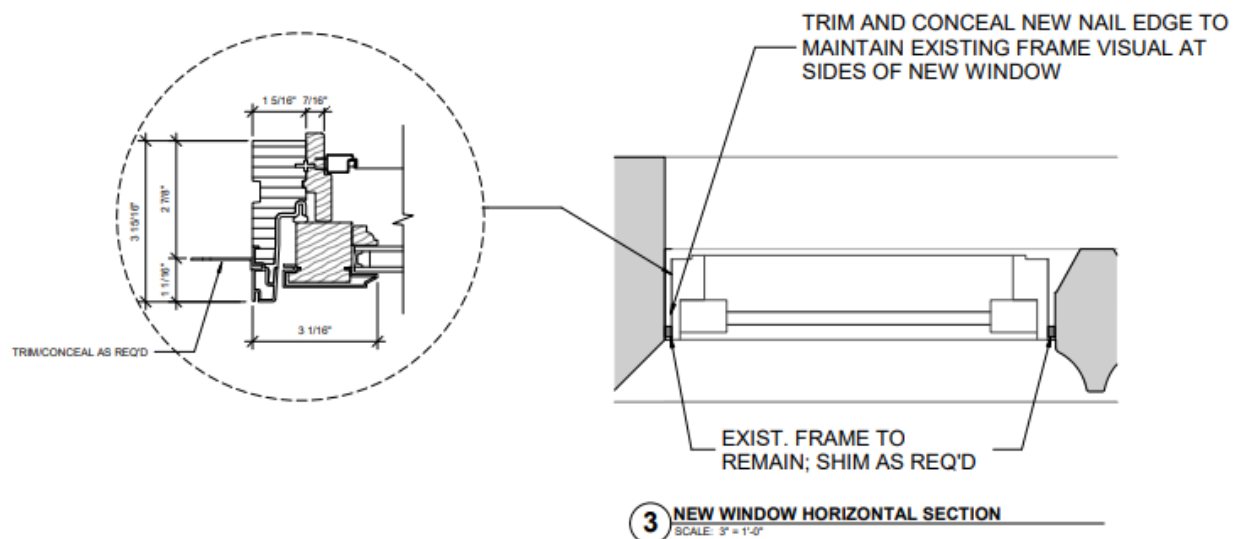
2 EXISTING WINDOW HORIZONTAL SECTION
SCALE: 3" = 1'-0"

- See the below photos drawings which the applicant submitted in response to the above request. Staff notes that the submitted drawings do not adequately document the existing conditions/dimensions at the top and bottom portion of the frame to compare to the proposed. However, a review the below horizontal sections (drawings #2 and #3) revealed that the side portions of the frame for the proposed new windows will be significantly wider than the existing. Also, each of the proposed new casement windows will include a single, undivided panel of glass while the existing casement units are divided to include four panes of glass each. Staff therefore concludes the proposed casement windows are not an adequate match to the existing historic steel units

Horizontal section showing existing and proposed condition
