**STAFF REPORT: DECEMBER 10, 2025 MEETING**

**APPLICATION NUMBER: HDC2025-00495**

**ADDRESS: 899 EDISON STREET**

**SCOPE: DEMOLISH TWO-STORY REAR WING, ERECT TWO-STORY REAR WING**

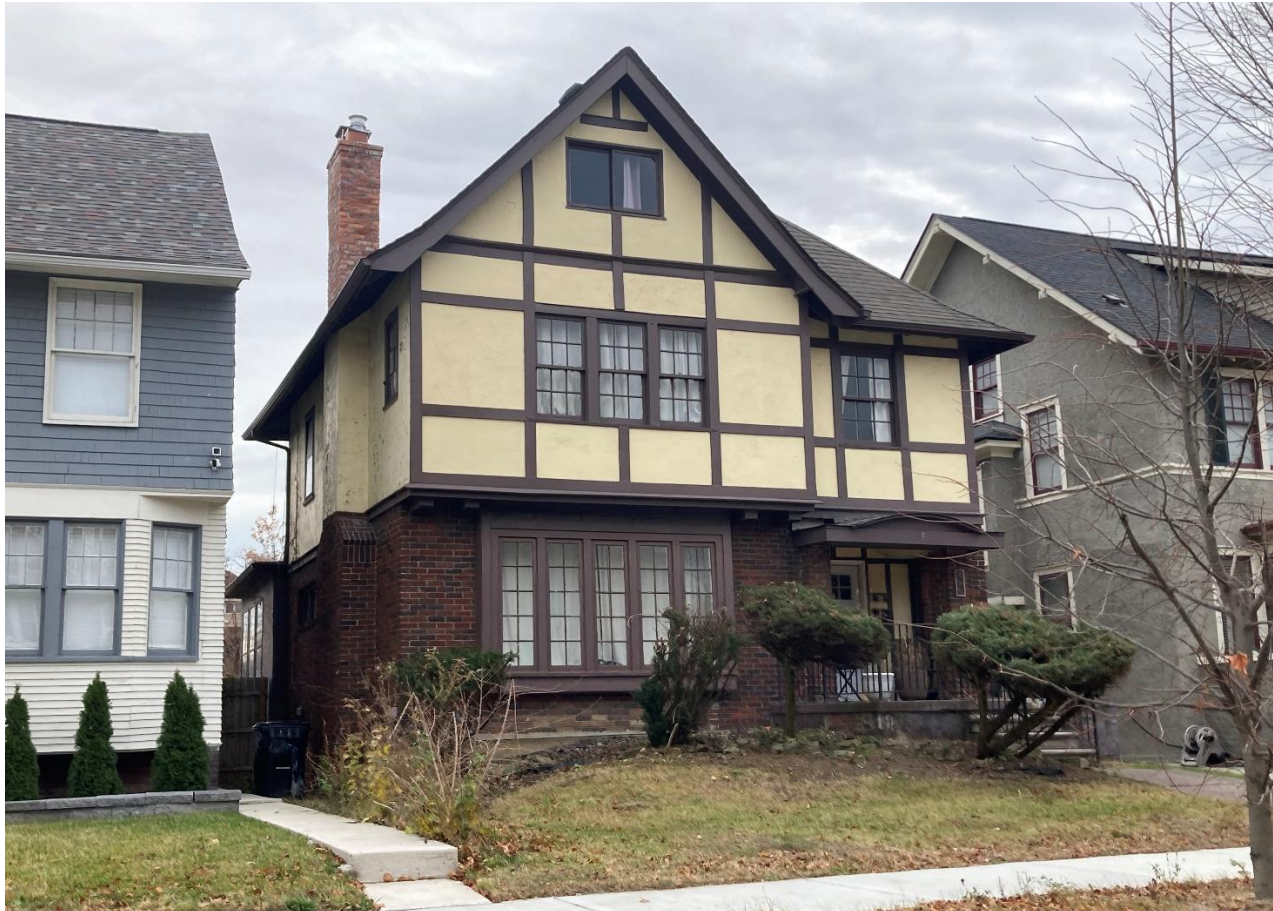
*Current condition, staff photo taken 11/24/25.*

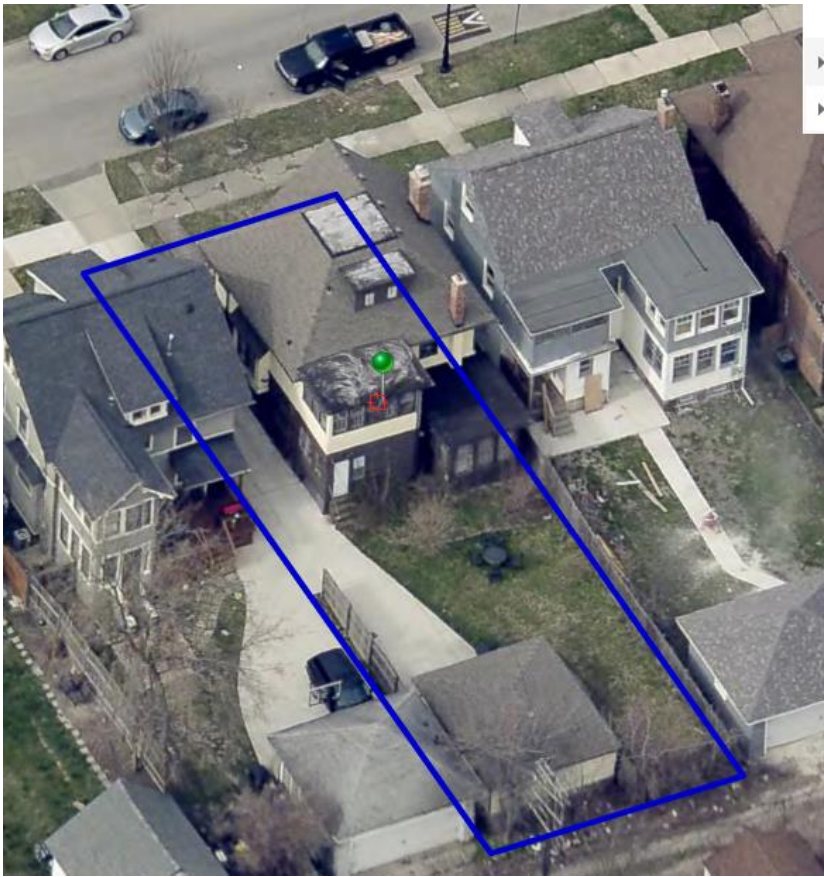
*899 Edison, two-story rear wing at the southwest corner and the one-story rear wing at the southeast corner, ConnectExplorer, March-April 2024.*

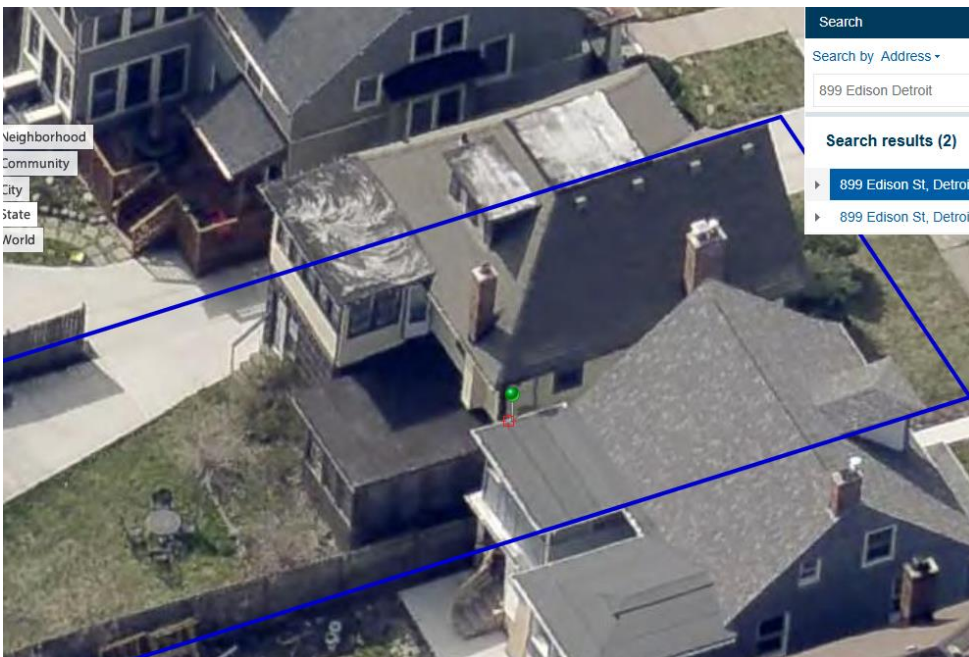
*899 Edison, two-story rear wing at the southwest corner and the one-story rear wing at the southeast corner, ConnectExplorer, March-April 2024.*

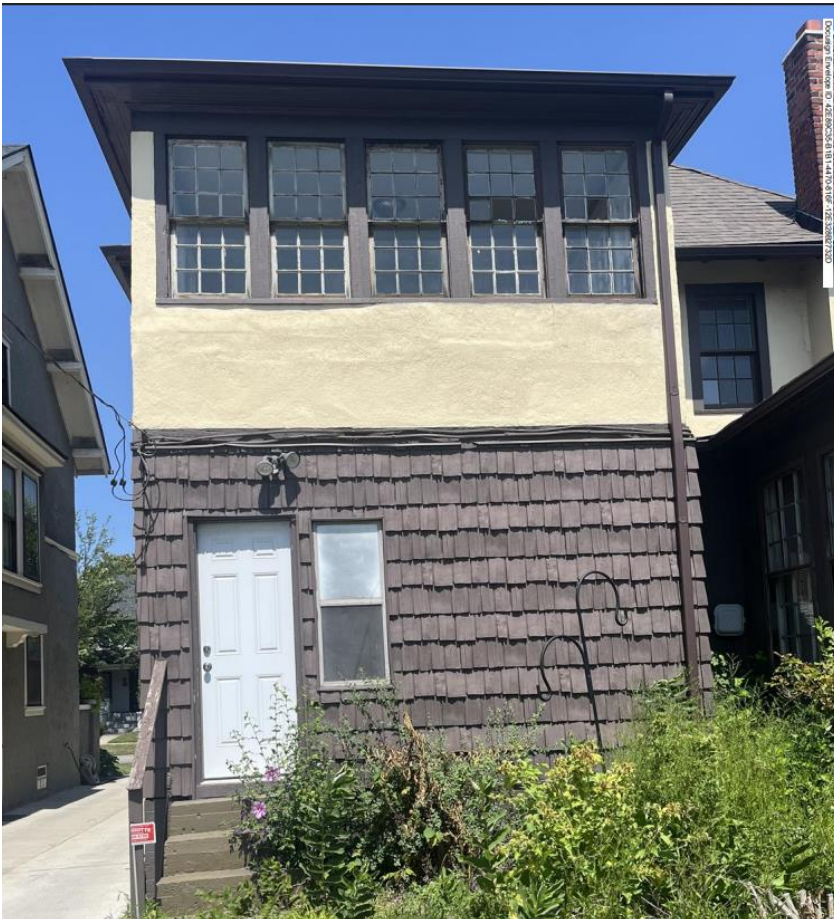
*899 Edison, rear two-story wing to be demolished and rebuilt. Historic windows are to be preserved and reused. A new steel door is proposed to replace the existing steel door. The adjacent one-story rear wing to the east (sun parlor) is just visible to the right. (Photo from applicant's materials.)*

- In looking at the rear wing's current level of deterioration, Mr. Mosley's letter states:
  - the "six-inch by eight-inch timbers holding the structure up on the piers (8) have seriously rotted away and are no longer affected.

- Without exception, all the floor and ceiling joists have warped from front to rear.
  - The outer rear wall has sagged more than eight inches as indicated by the shape of the side window."

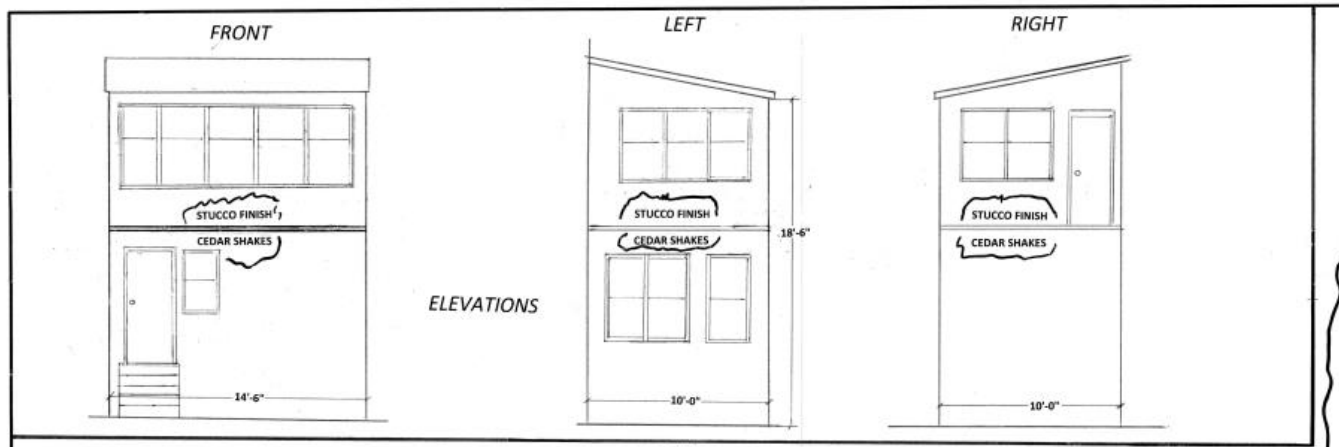
*Proposed elevations for the new construction, from applicant's materials.*

- However, it is staff’s opinion that the submitted elevation drawings are not sufficiently detailed to fully understand complete construction details. They also don’t show how windows will sit within the wall planes and how window trim will look when finished. Staff shared an example with the applicant of more detailed architectural drawings, but more detailed drawings for this proposal were not provided.

- The character-defining deep eave of the historic addition is proposed to be eliminated in the new construction.
  - Roof product specifications were not provided.

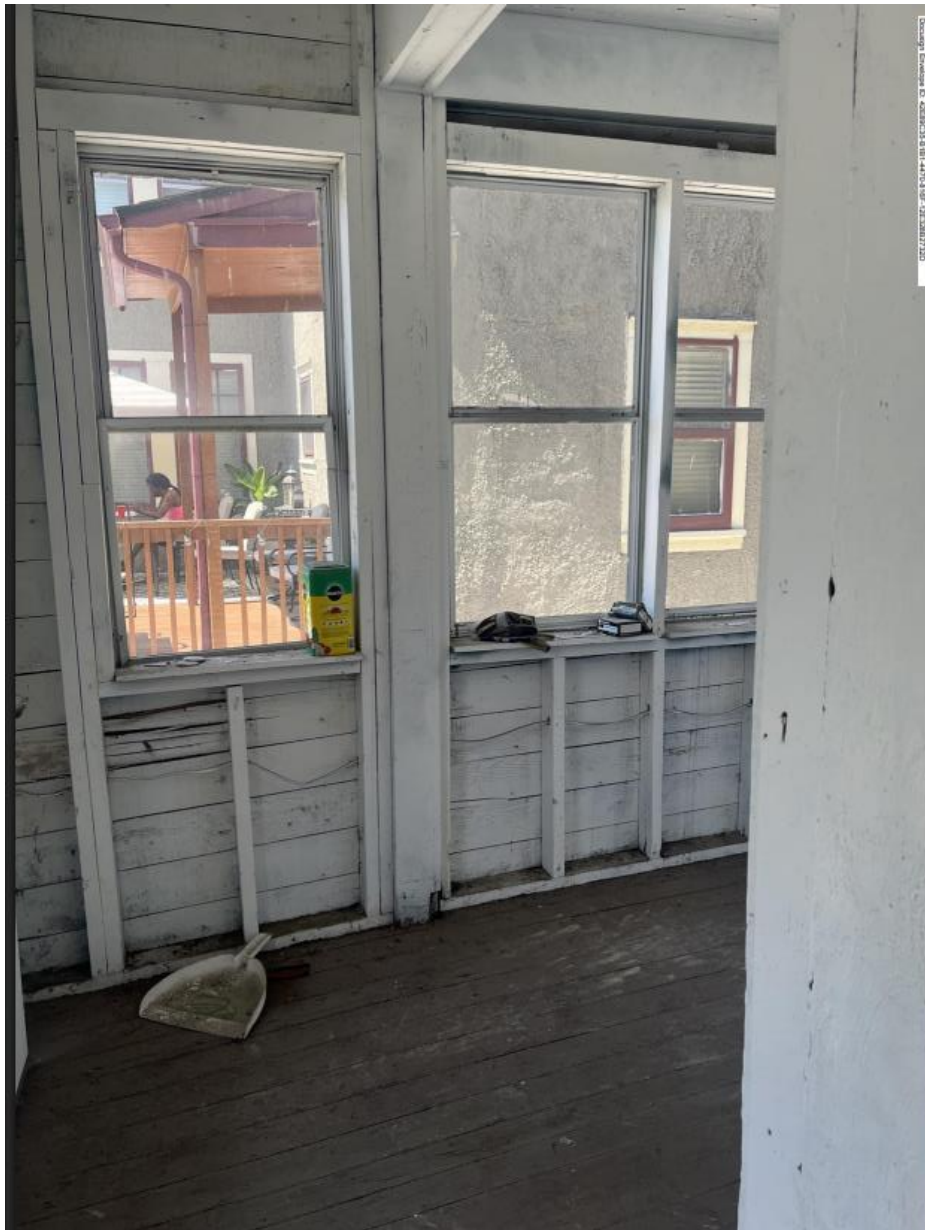
- Staff was unable to find historic photos of the rear of the house or records to document when the first-floor rear porch was enclosed. The first floor has been sided in non-historic shingle-style siding.

*First floor of the rear enclosed porch at 899 Edison. Shown is the west wall. From applicant's materials.*
