**STAFF REPORT: DECEMBER 10, 2025 REGULAR MEETING**

**APPLICATION NUMBER: HDC2025-00725**

**ADDRESS: 4785 STURTEVANT**

**SCOPE: REMOVE HISTORIC WOOD WINDOWS & INSTALL VINYL WINDOWS, REPLACE HISTORIC WOOD DOORS, AND DORMER SIDING**

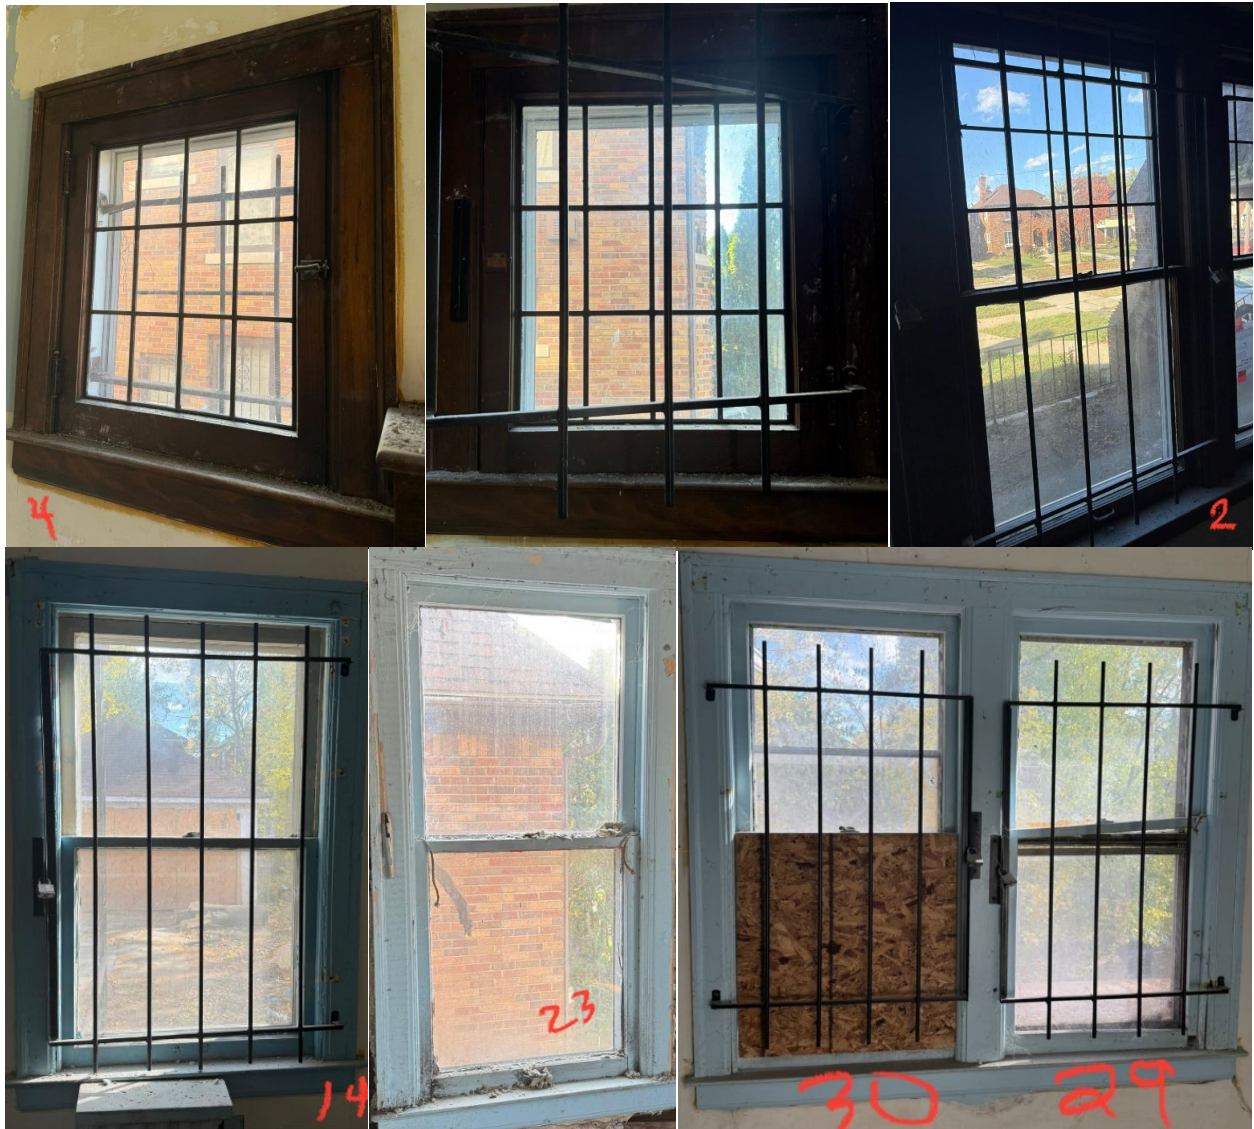
*Photos provided by applicant, Historic aged windows to remain*

- The front facade predominantly features historic wood, leaded glass casements, and multi-lite windows in the dormer. The other elevations are comprised of mostly single-lite, double-hung wood windows with some additional leaded glass casements with aluminum storm windows.
- Although the double hung single pane wood windows do not have leaded glass, they are indeed historic. The wood windows are a distinctive, character-defining feature for this property.

- However, it is staff's opinion that the historic-age wood windows are not beyond feasible repair.
- Additionally, should any windows be proven to be beyond repair, vinyl would not be an appropriate replacement window type for historic buildings, for the following reasons:

- It is staff's opinion that the historic wood windows are not beyond feasible repair and should therefore be retained and repaired where possible.
- If proven to be beyond repair, vinyl windows are not an adequate match for historic prototypes, for the following reasons:

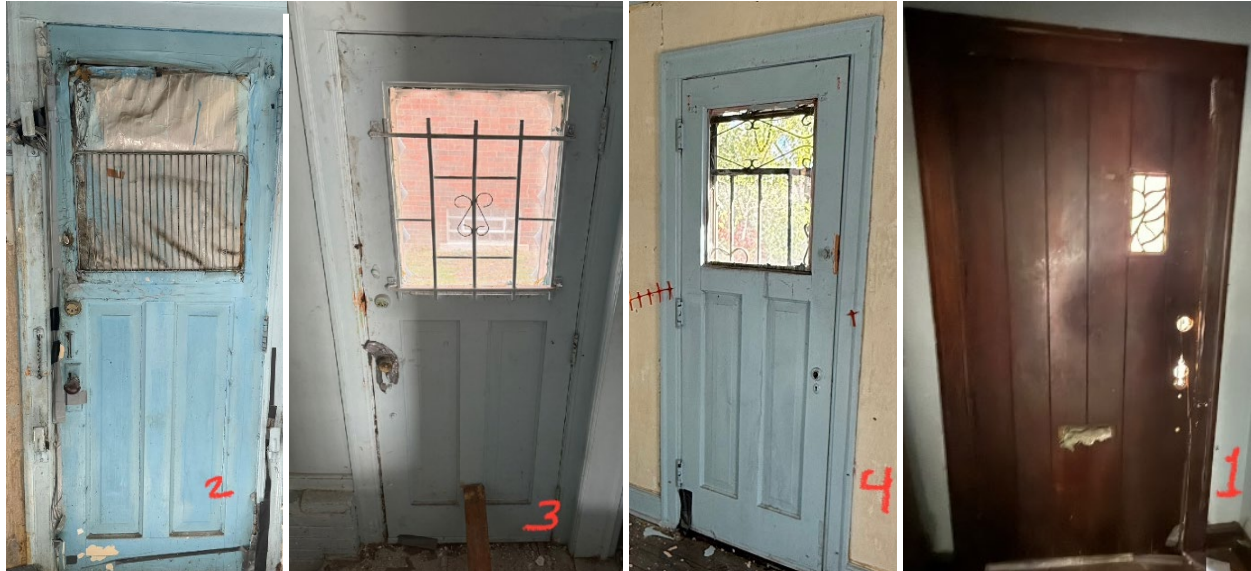
*Interior of doors, photos provided by applicant*

- Similar to the historic wood windows, the photos provided by the applicant show the historic aged doors have undergone relatively minor deterioration, such as chipped wood, peeling paint, faulty or missing knobs, and cracked glazing, which appear to have impaired their operation.
- It is Staff's opinion that these historic-age doors are not beyond feasible repair, as these conditions can similarly be remedied with reasonable cost and effort.
- It is especially important to retain and repair the original front door, since it is most commonly visible to public right of way and should maintain the historical integrity of the house.

- The historic wood doors are a character-defining feature of the house and should be retained where possible.
- Aluminum trim coil is typically not an appropriate material type within the historic district. Wood siding is commonly found at dormers within the historic district.

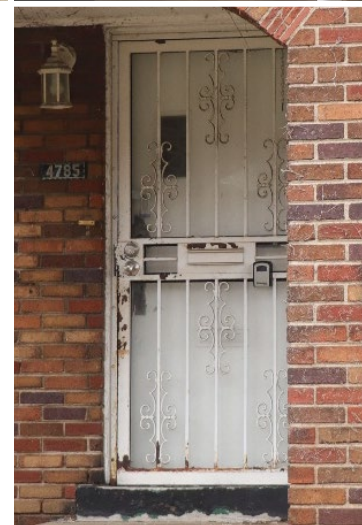
*Front door, photo taken by staff*

- The proposed storm doors, in Staff's opinion, may be installed over the wood doors and may be compatible except for the color, as the bright white will not be appropriate. A color closer to beige or brown, to match the house, will be more appropriate for a house within the historic district.
- Should the Commission elect to approve the removal of the historic aged doors, the proposed steel doors will be a more appropriate door replacement type. The fiberglass door proposed for the front of the house is typically not an appropriate material within the historic district.

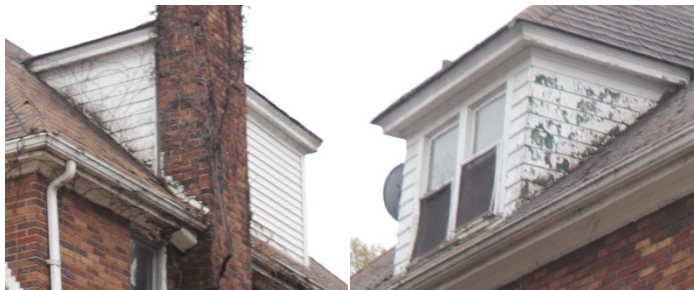
- Wood siding is commonly found at dormers within the historic district. Since the dormers retain their historic wood siding, the proposed aluminum trim coil will not be an appropriate replacement material. Per SOI No. 6, in the instance that the wood siding has deteriorated beyond feasible repair, it must be replaced like for like (i.e wood siding for wood siding).
