STAFF REPORT: FEBRUARY 11, 2026 MEETING

APPLICATION NUMBER: HDC2026-00003

ADDRESS: 1731 LONGFELLOW

SCOPE: REPLACE HISTORIC WOOD WINDOWS, OTHER ALTERATIONS (WORK COMPLETED WITHOUT APPROVAL)

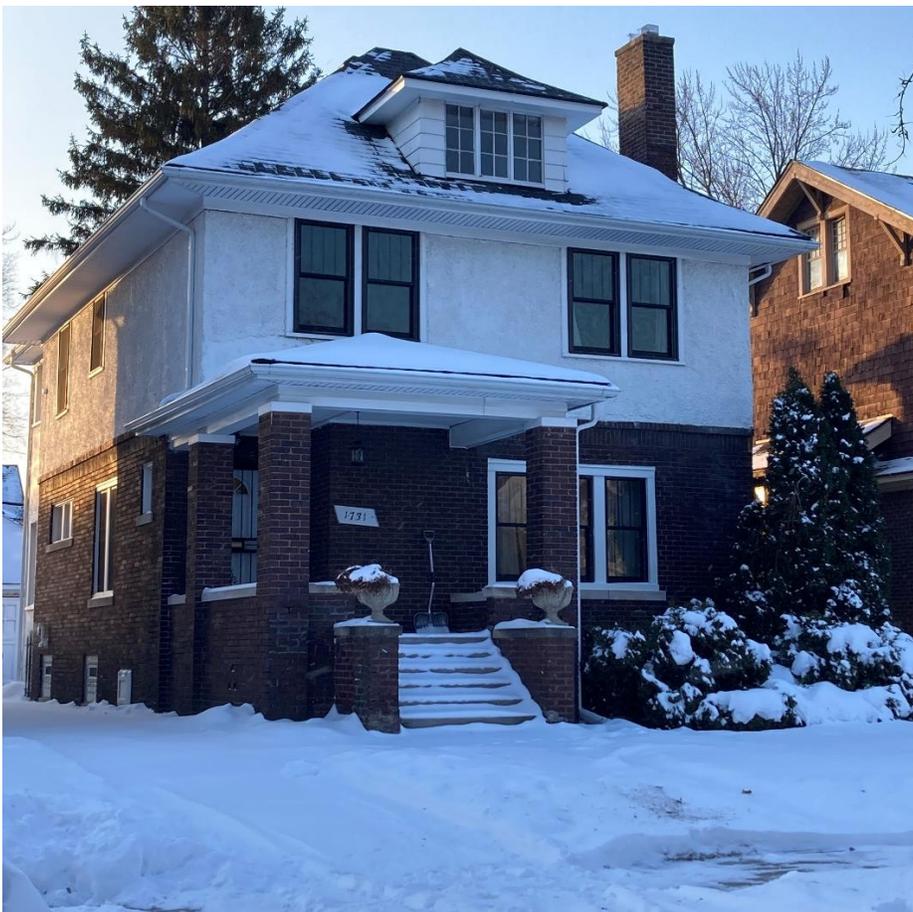
1731 Longfellow, January 2026. (Staff photo)

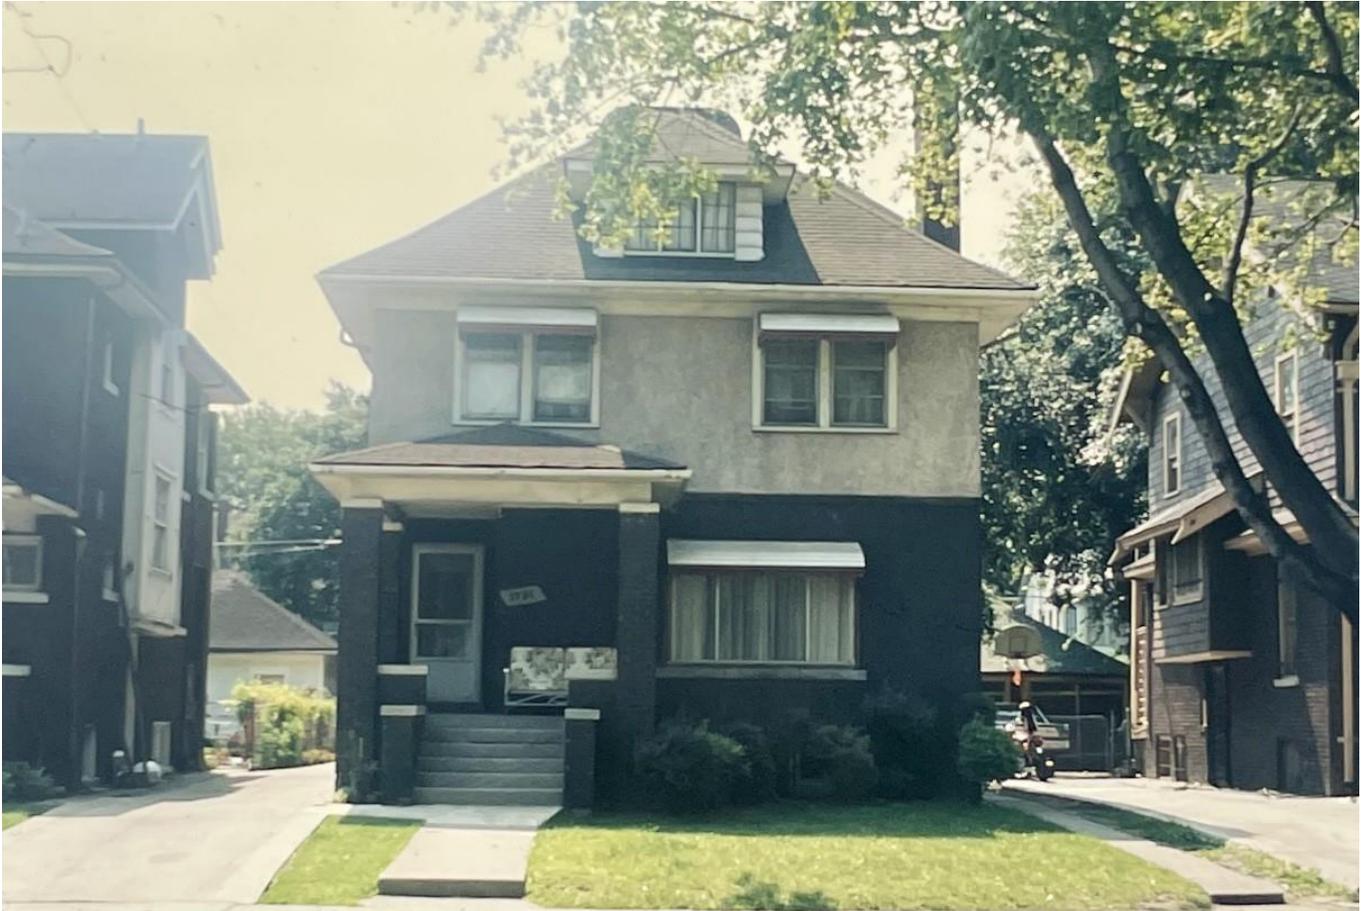
1731 Longfellow, designation slide, 1974, HDAB. The historic wood Craftsman-style windows are in the second-floor window openings, the stucco appears to be a pale gray, and the first-floor window at the front of the house is altered.

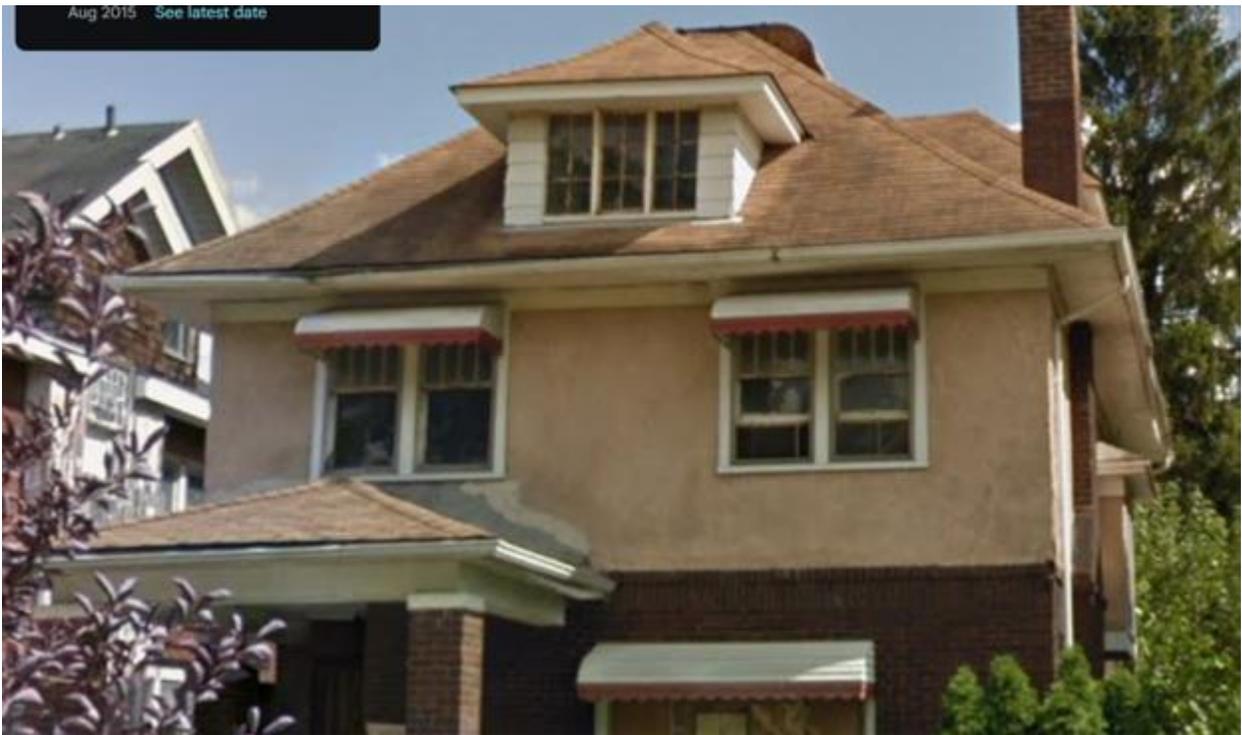
Google Street View, August 2015. Peach-beige stucco shown, and wood soffits, trim, and historic windows are shown in place. White gutters and downspouts are in place.

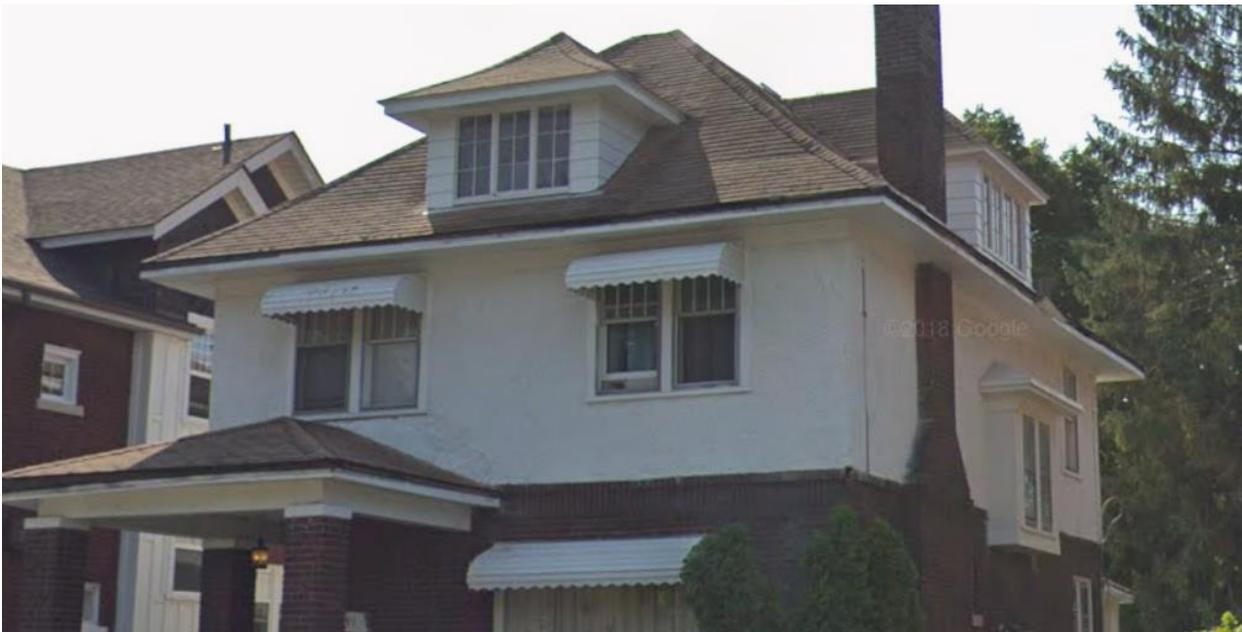
Google Street View, August 2018. Gutters and downspouts have been removed and the stucco has been painted white. Historic windows are still in place.

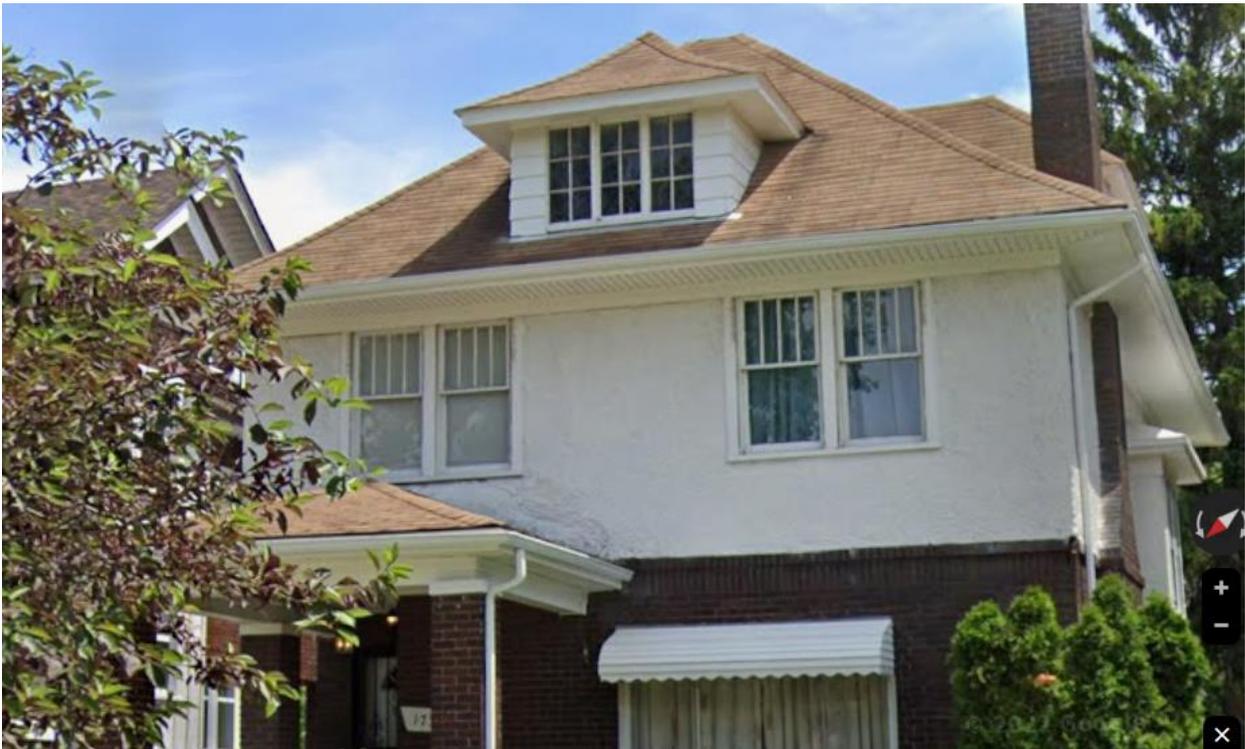
Google Street View, June 2019. Historic windows remain in place, new gutters and downspouts have been installed, and new aluminum soffits and aluminum trim over frieze boards have been installed.

- Wrap all frieze boards, soffits, and fascia with white aluminum (completed):
 - Painted historic wood trim, including frieze boards and soffits, are character-defining features of a historic house. The dimensional profile that helps to define historic wood frieze boards is lost when the features are covered (or replaced) with aluminum. Additionally, the pattern of the aluminum replacement soffits draws attention to the soffits whereas they were simple and understated before the replacement. The replacement of these materials is in violation of **Standards 2, 5, and 6** and it conflicts with the *Elements of Design 7 and 8* as quoted above. As a result, staff cannot recommend the installation of aluminum covering or replacing historic wood trim at the house’s fascia, soffits, or frieze boards.

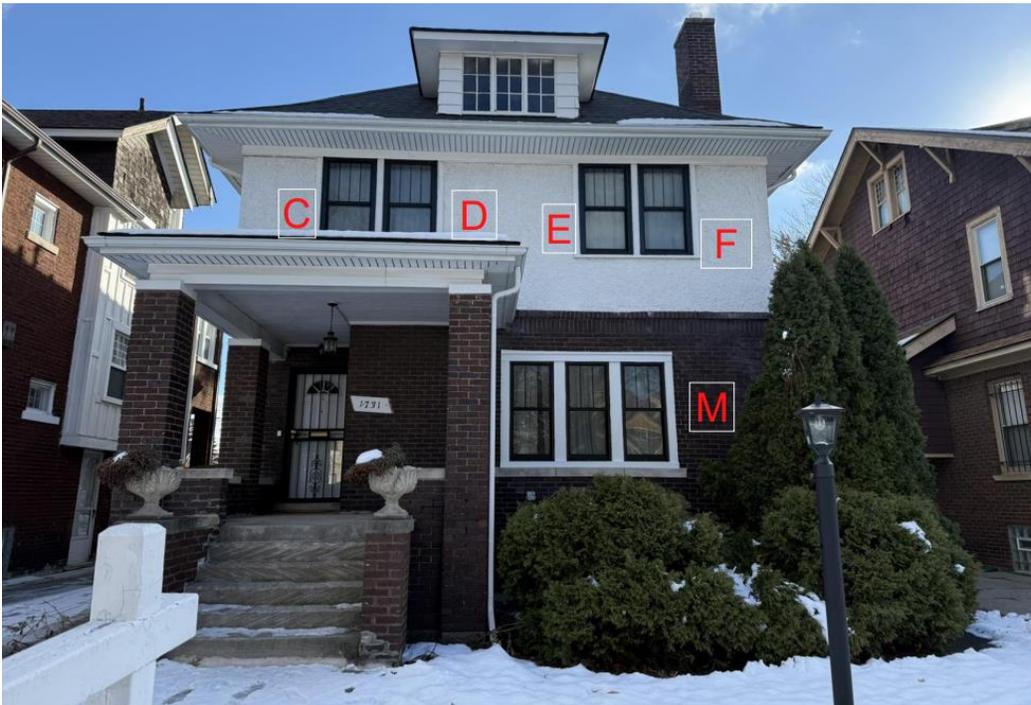
Applicant-provided image labeling windows that were replaced at the front (north) of the house. (Email, January 2026)

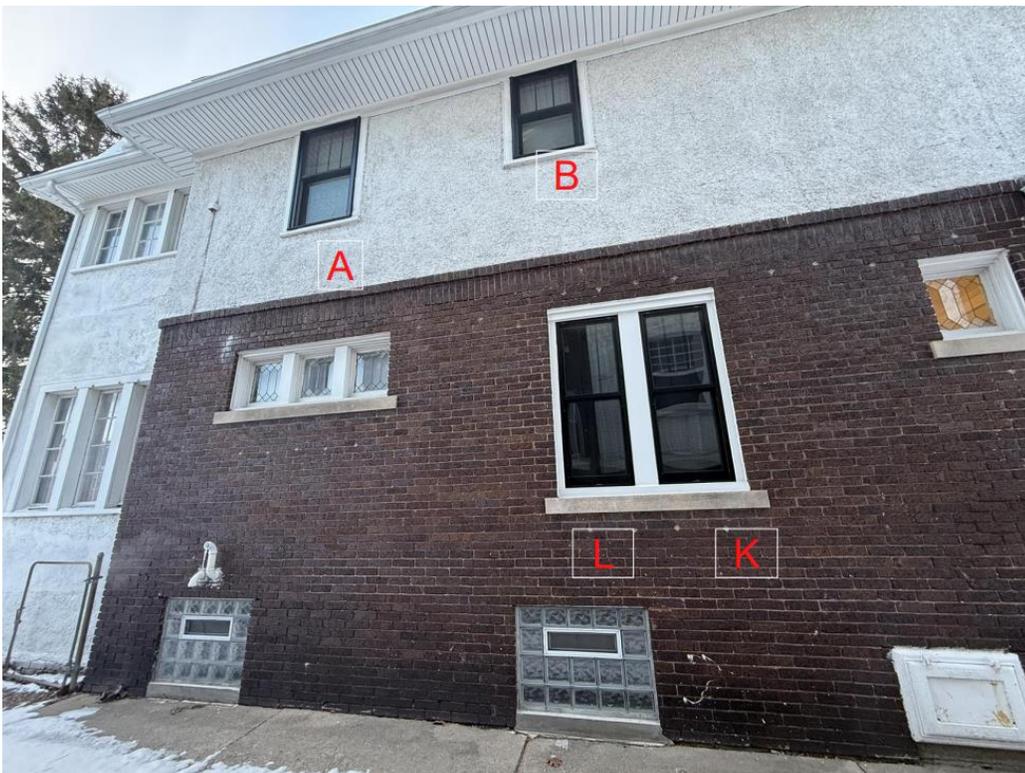
Applicant-provided image labeling windows that were replaced on the east side of the house. (Email, January 2026)

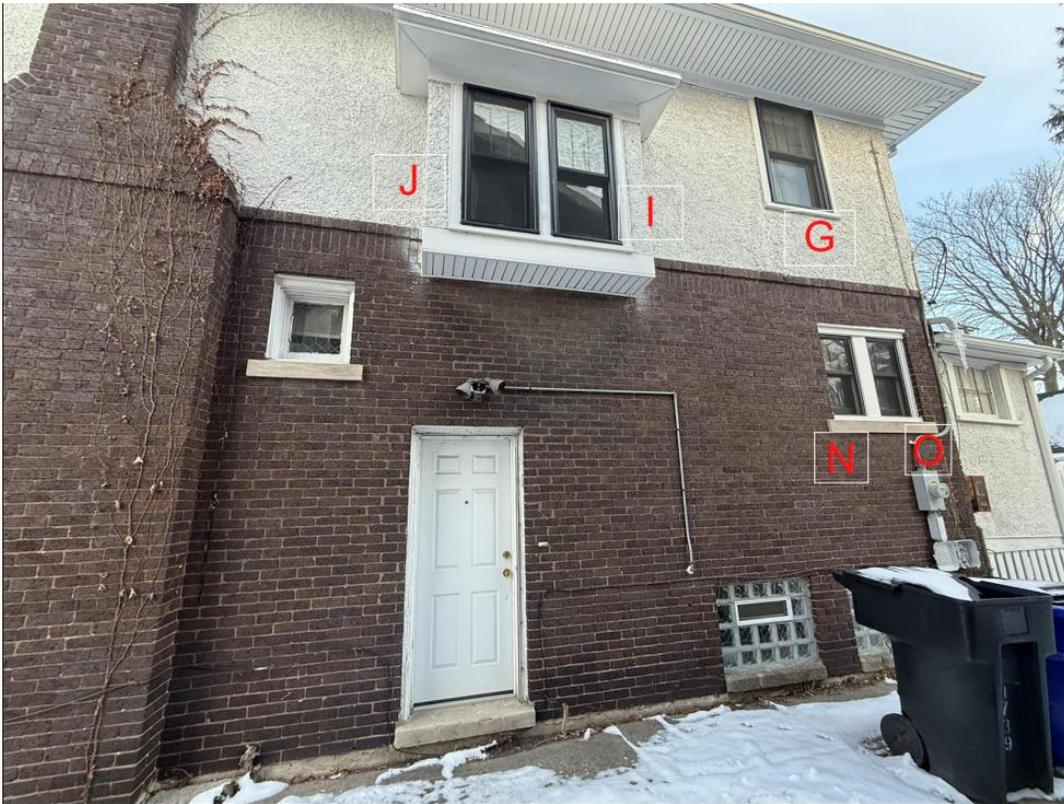
Applicant-provided image labeling windows that were replaced on the west side of the house. (Email, January 2026) The house's door replacements were reviewed and approved.

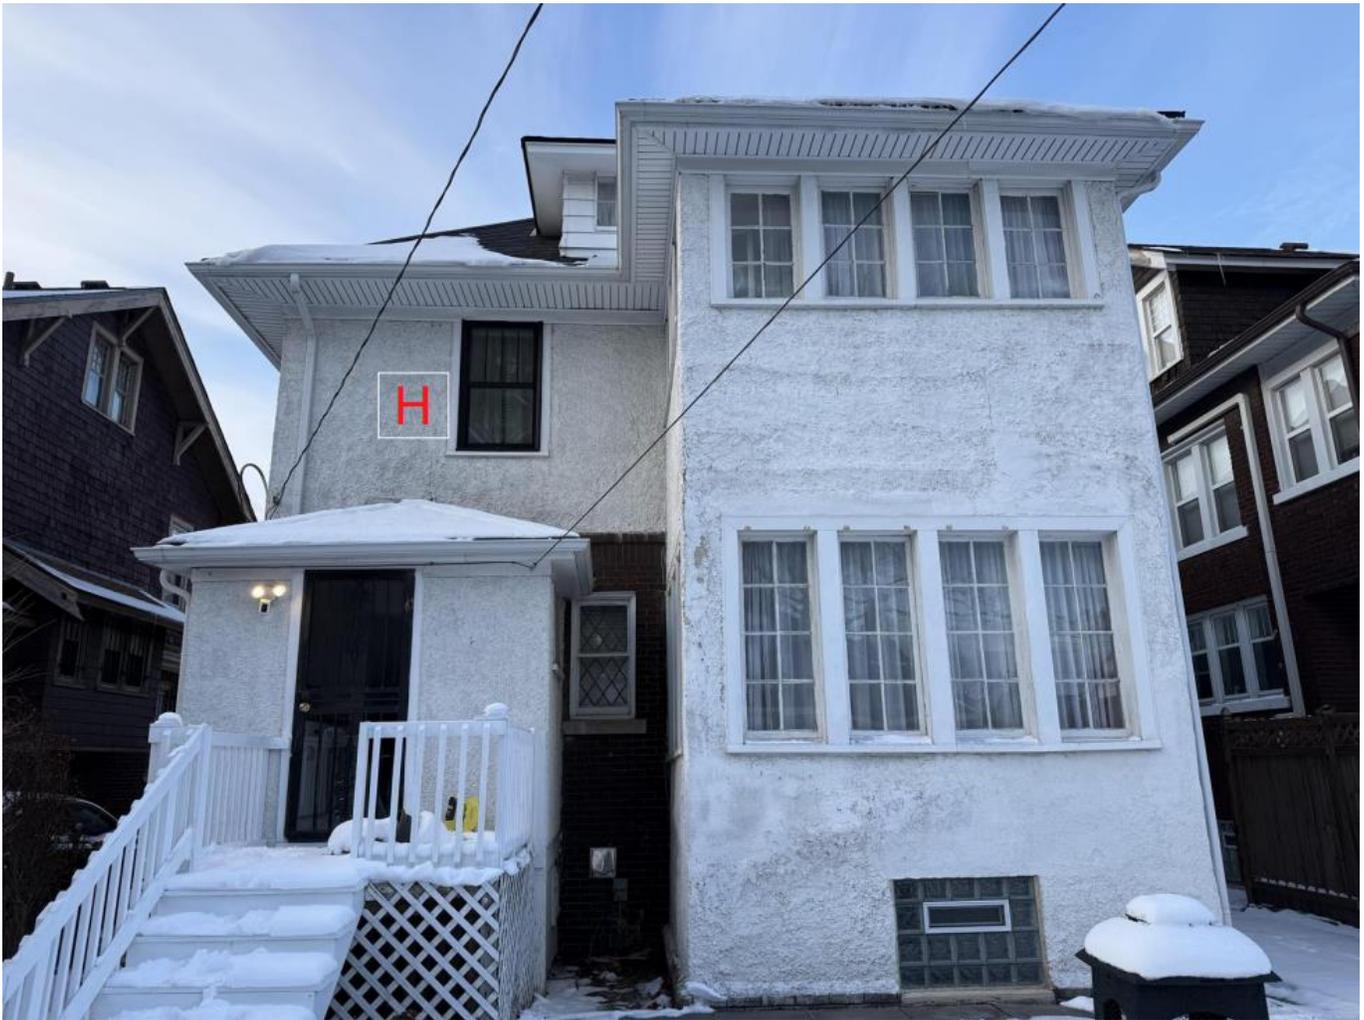
Applicant-provided image labeling window that was replaced on the rear of the house (south). (Email, January 2026)

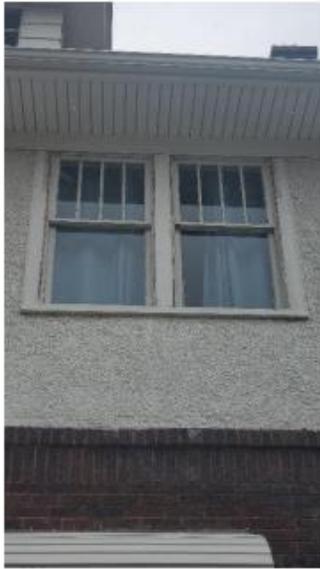
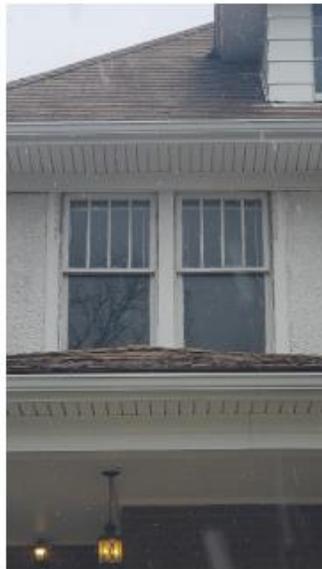
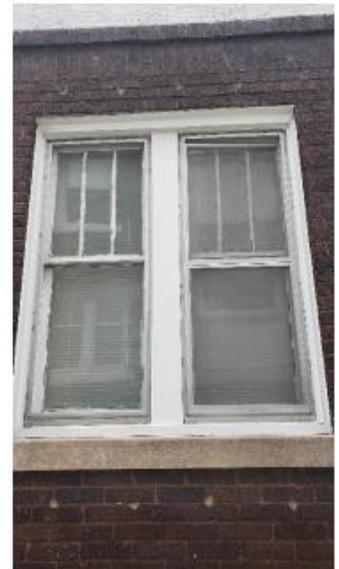
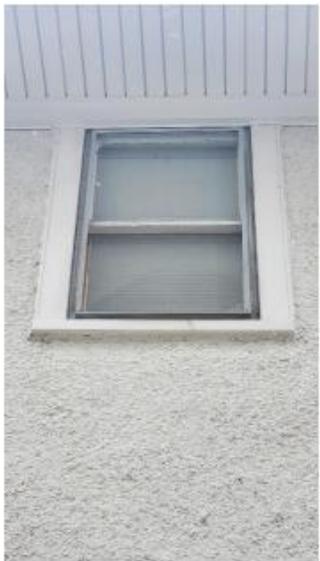
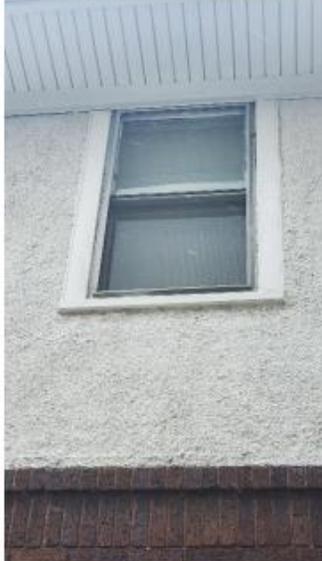
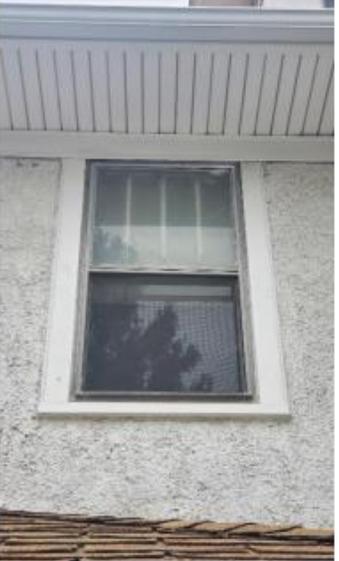
5. Detailed Photographs of Windows

- Proposed (completed) wood window replacement:
 - Historic windows are almost always a character-defining feature of a historic house, and these windows were no exception. The historic, character-defining windows were removed and replaced, so staff cannot opine on the feasibility of their repair or restoration. Photos of some of the windows proposed for replacement were included in the 2020 submitted application that was never completed, and those photos have been included below.

First (of two) sets of images from the 2020 application for window replacement showing existing window conditions.

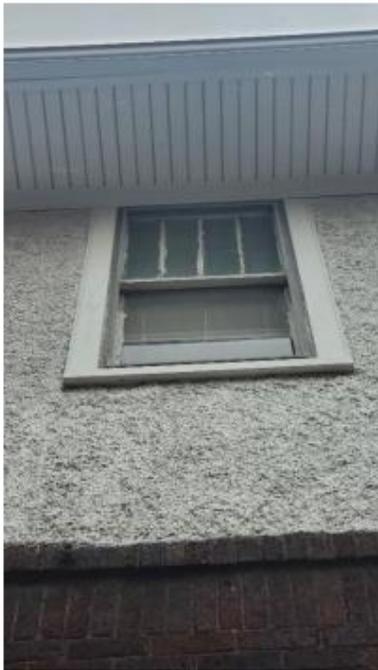
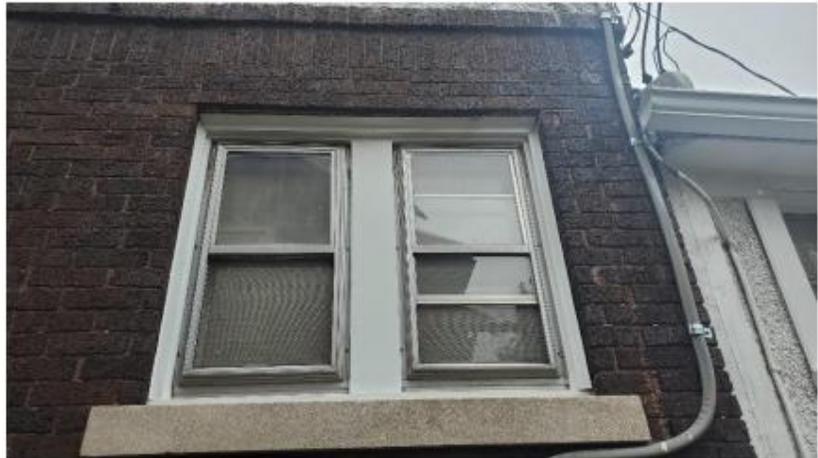
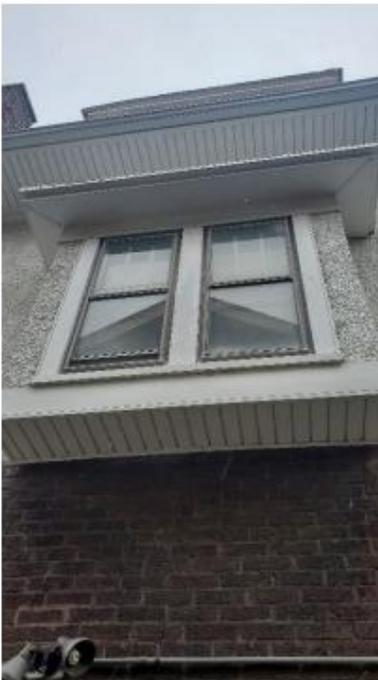
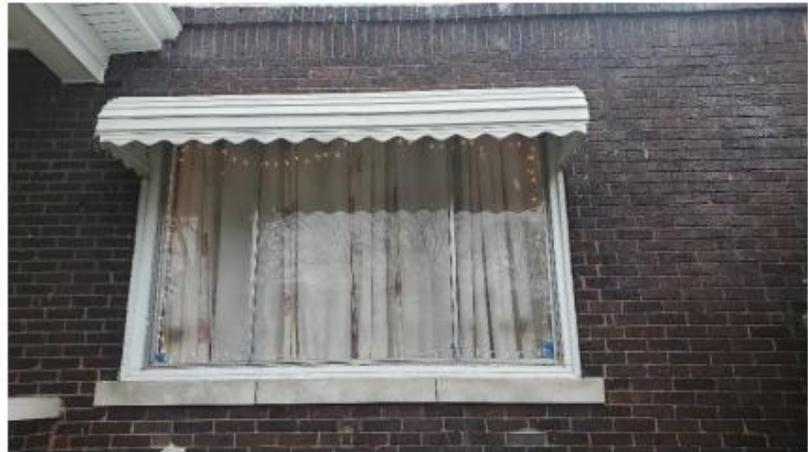
1731 Longfellow st – Window Replacement
12/15/2020

Second (of two) sets of images applicant submitted with the 2020 application for window replacement showing conditions of existing windows.

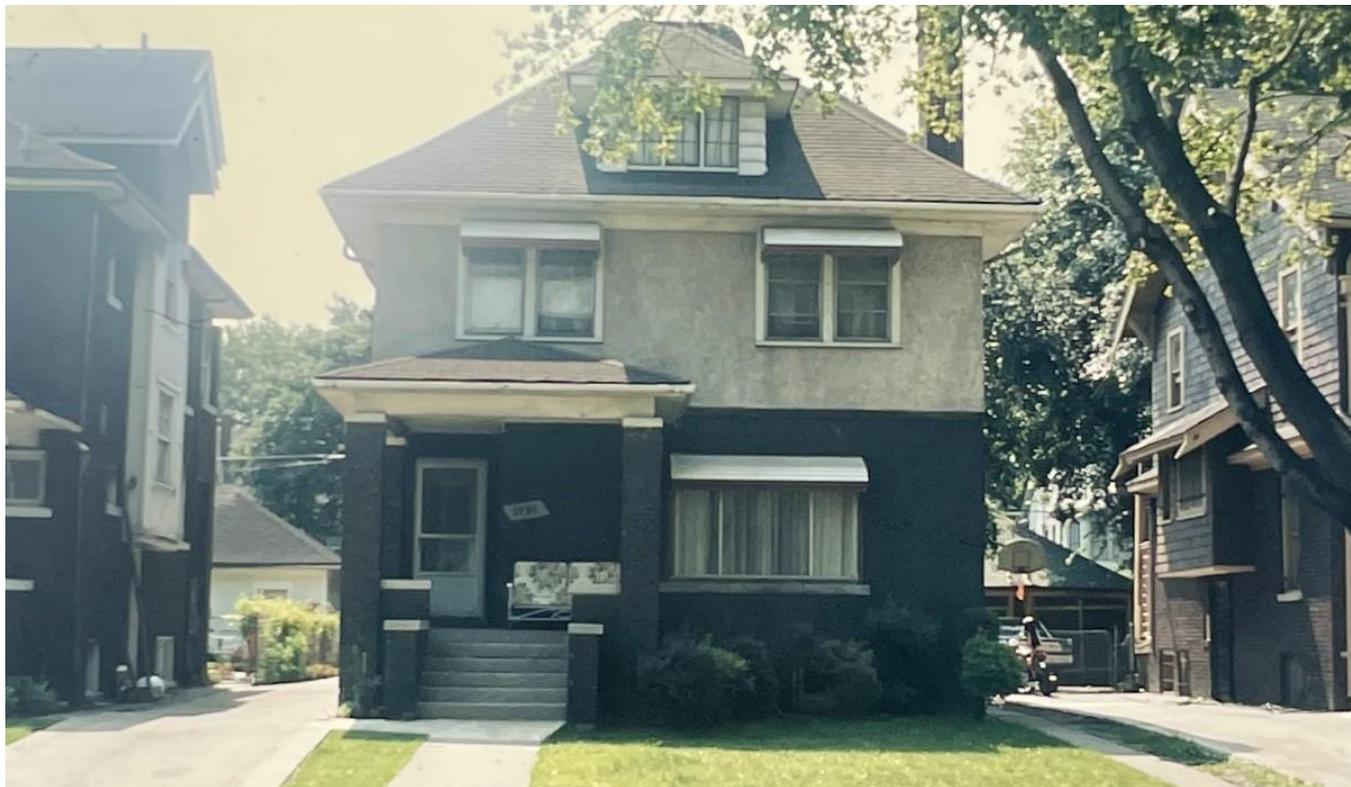
1974 designation slide (HDAB) when eave details were wood, compared with the image below.

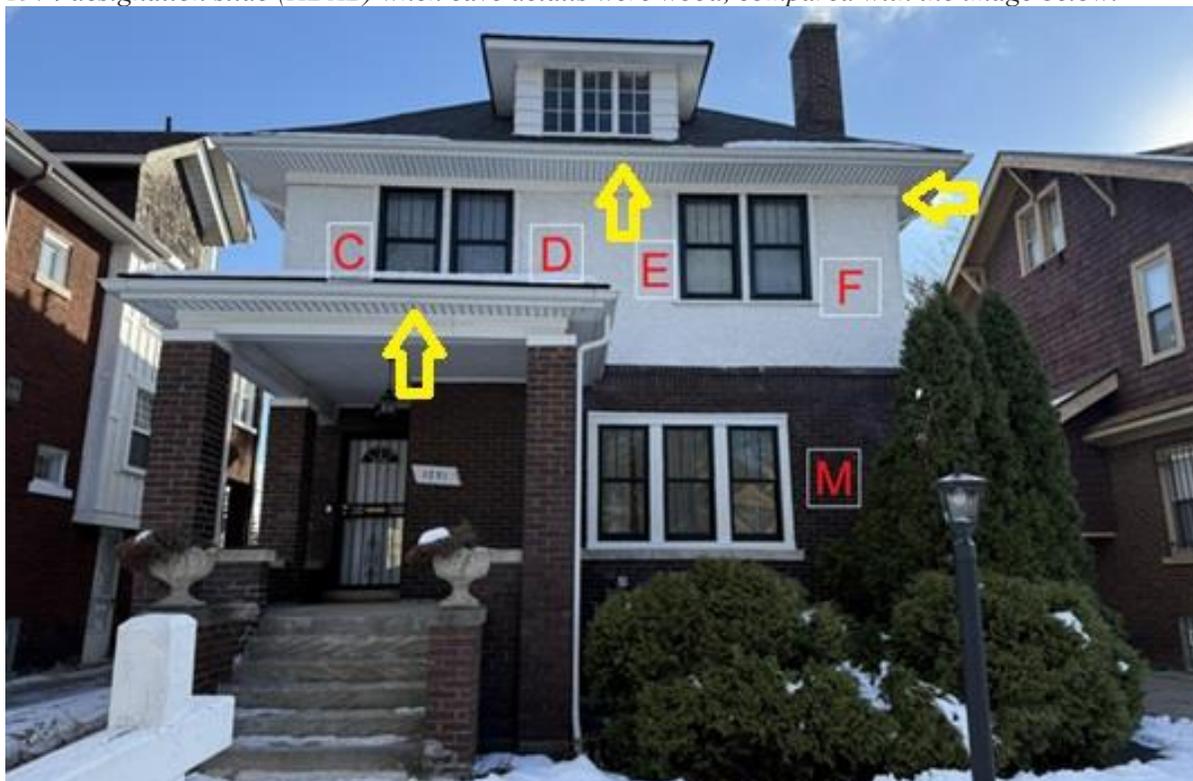
Applicant-provided image (email, January 2026). Note the flattening of the frieze board and the pattern created by the aluminum soffits. (Staff added arrows.)

- Regarding the covering or replacement of trim around the house's eaves, the dimensional profile that helps to define historic, character-defining wood frieze boards is lost when the features are covered (or replaced) with aluminum. The pattern of the aluminum replacement soffits draws attention to the soffits whereas they were simple and understated before the replacement. The replacement or covering of the frieze boards, fascia, and soffits is in violation of Standards 2, 5, and 6, and is in conflict with the District's *Elements of Design 7* and *8*.

- Regarding the covering or replacement of trim around the house's eaves, the dimensional profile that helps to define historic wood frieze boards is lost when the features are covered (or replaced) with aluminum. The pattern of the aluminum replacement soffits draws attention to the soffits whereas they were simple and understated before the replacement. The completed replacement or covering of the frieze boards, fascia, and soffits diminishes the house's historic character.
- Regarding the painting of the stucco and dormers a bright white, bright white is not an included color in Color System E.
