**STAFF REPORT:** 02/11/2026 MEETING  
**APPLICATION NUMBER:** HDC2026-00002  
**ADDRESS:** 2310 EDISON

**HISTORIC DISTRICT:** BOSTON-EDISON  
**APPLICANT:** ALEXANDER BELILOVSKY, ALEXANDRIA HOME SOLUTIONS  
**PROPERTY OWNER:** JONATHAN TAYLOR  
**DATE OF PROVISIONALLY COMPLETE APPLICATION:** 01/20/2026  
**DATE OF STAFF SITE VISIT:** 01/28/2026

**SCOPE:** INSTALL NEW WOOD WINDOWS AT FRONT (FAÇADE)

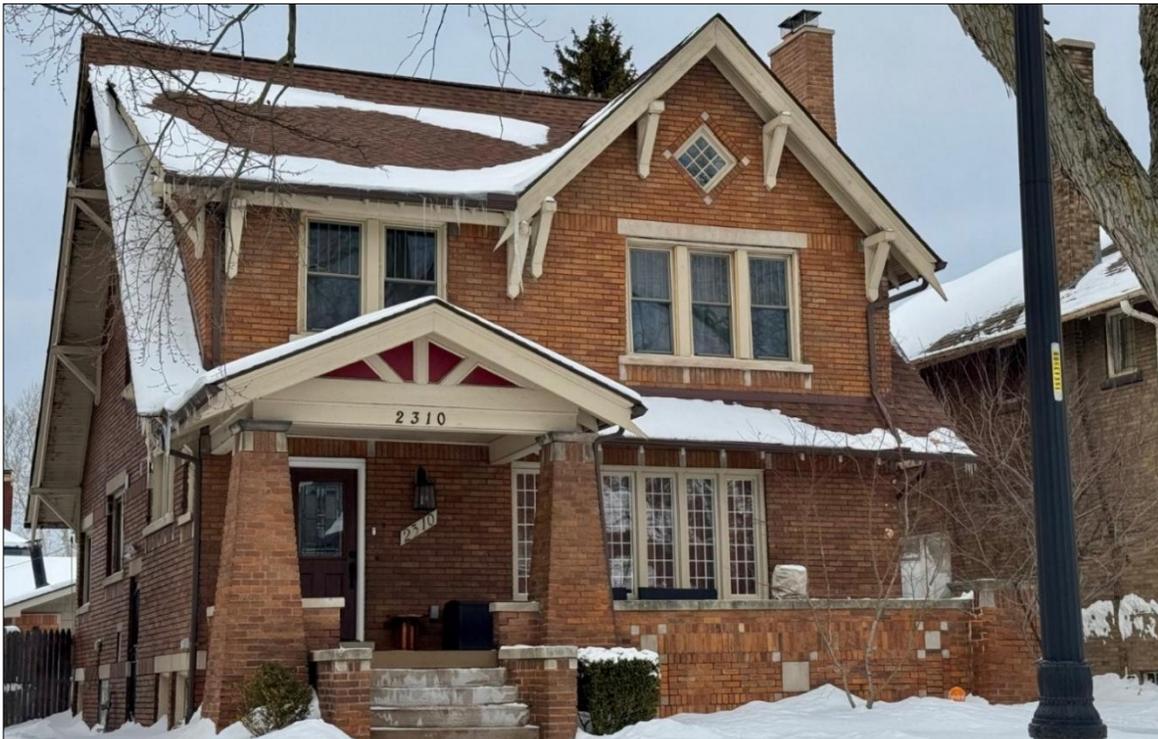
On the façade, grouped windows are at the first and second floors and a diamond-shaped window fits within the crest of the gable. The current window composition at the front wall is wood replacement windows at the first floor with wood brickmold exposed; vinyl windows at the second floor with wood brickmold and mullions wrapped in aluminum; and the original wood window at third floor/attic with wood brickmold exposed.

*Façade, looking northeast. Staff photo, January 28, 2026.*

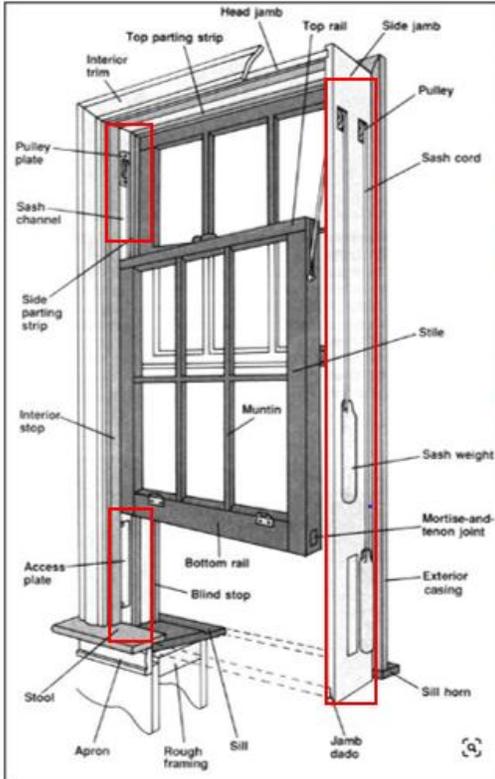
- Both estimates outline the damage that was done to the historic window openings when the windows were removed, namely the interior components of the window frames in which the window sash sit and control the operation were removed and discarded. The only parts of the window openings that remain are the outer parts of the window openings, brickmould and the window sash. All interior components need to be specially fabricated and installed within the window frames and sashes, therefore this estimate is likely higher than a repair estimate would have been for the “before” condition of the historic windows (i.e., all components intact prior to the April 2024 removal).

Left: All the interior components (boxed in red) that held and operated the window sash were removed and discarded. The window replacement contractor then sprayed foam in the open spaces left behind.  
Above: The wood window sash remain at the property and are being stored on a shelf in the owner's garage. Staff photo, November 4, 2024.

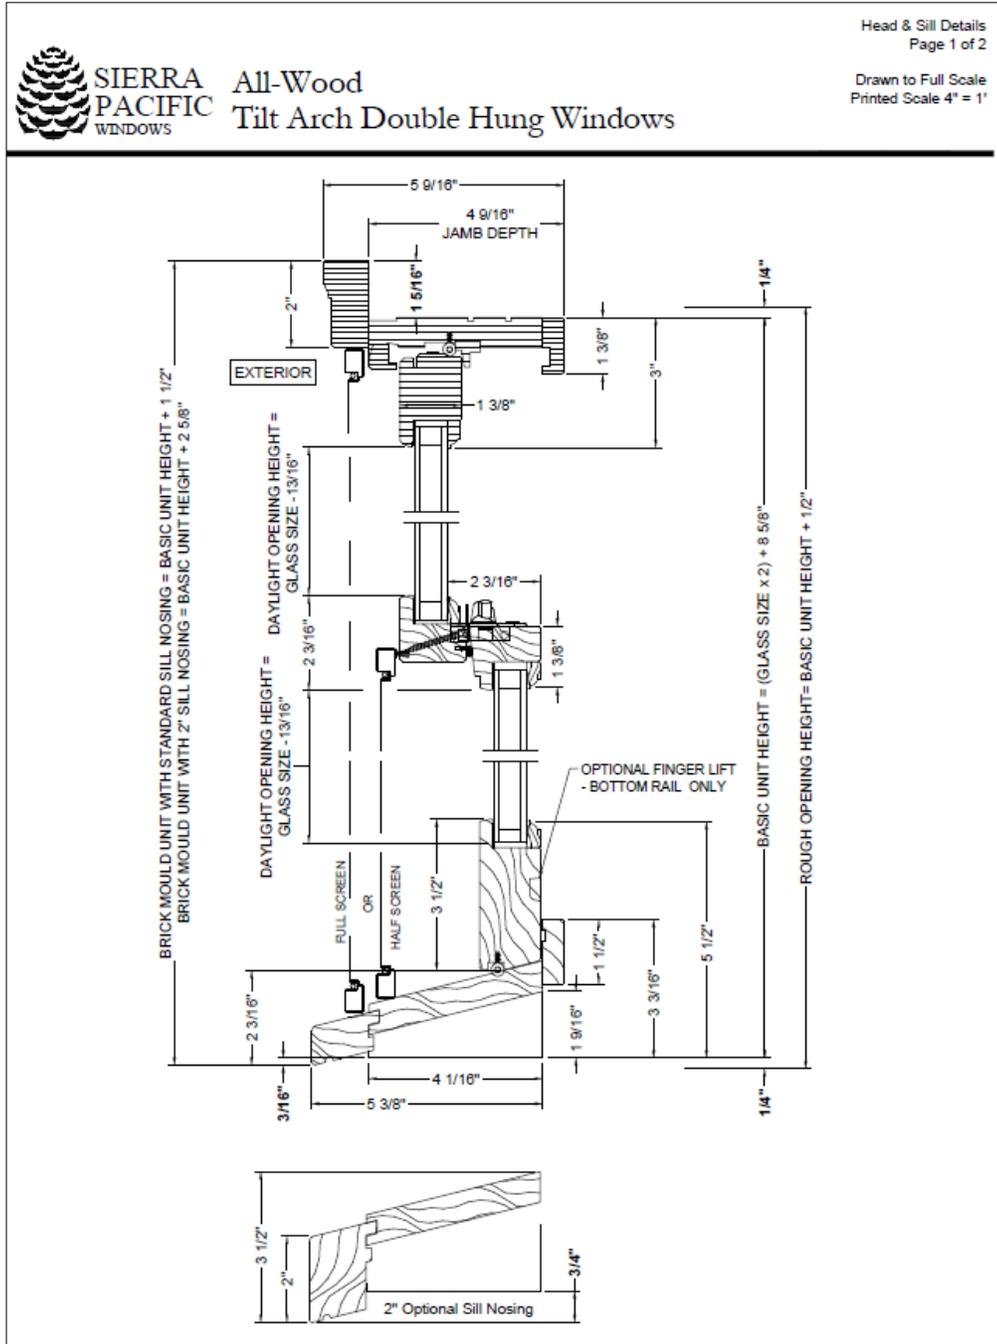
*Sierra Pacific cut sheet from applicant materials.*

- The applicant confirmed the optional sill nosing would not be ordered. The combined dimension of the Sierra Pacific standard sill nosing and bottom rail equals 5-1/2". For context, staff compared the Sierra Pacific dimensions against Marvin's Ultimate Wood double-hung window which has a combined sill/bottom rail height of 5-7/8".
- The applicant confirmed the existing wood brickmould will be retained and the aluminum wrap, installed at the time the vinyl windows were installed, will be removed.
- The property owners continue to retain the original sash at the property (for possible future reuse).
