STAFF REPORT: 02/11/2026 REGULAR MEETING

APPLICATION NUMBER: HDC2025-00740

ADDRESS: 19597 SHREWSBURY

SCOPE: REPLACE WOOD WINDOWS WITH ALUMINUM-CLAD WOOD WINDOWS

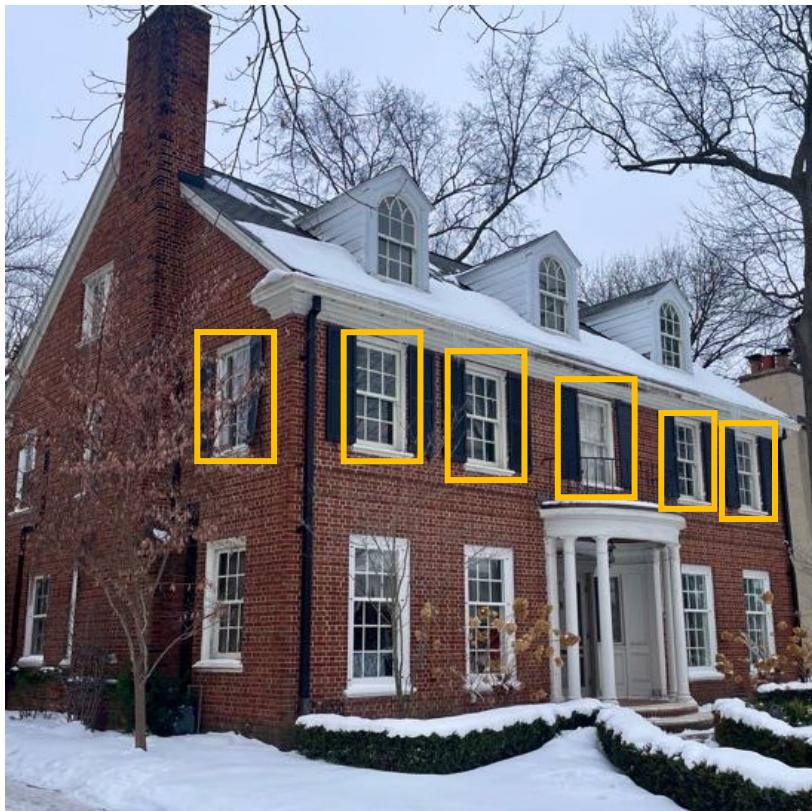
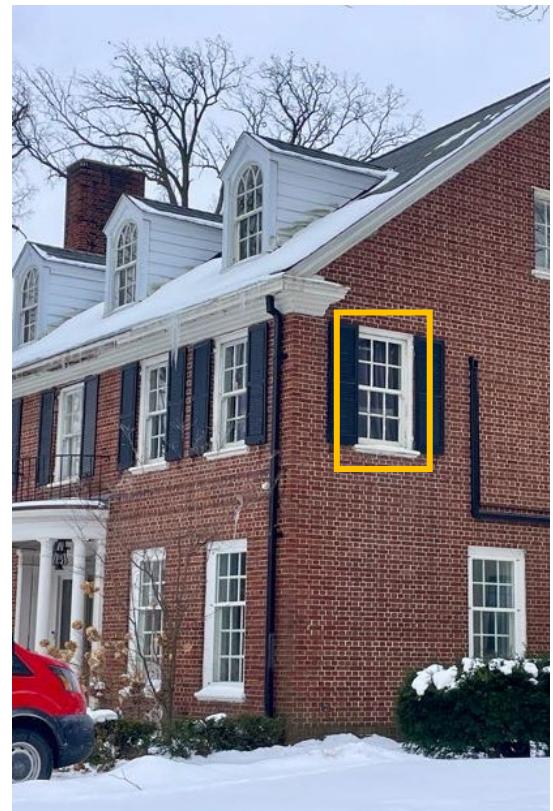
Staff photos, 02/05/2026

- Highlighted below are the seven (7) historic wood windows proposed to be replaced.

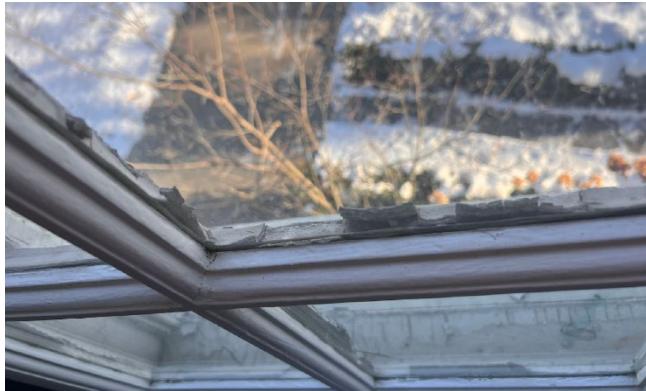
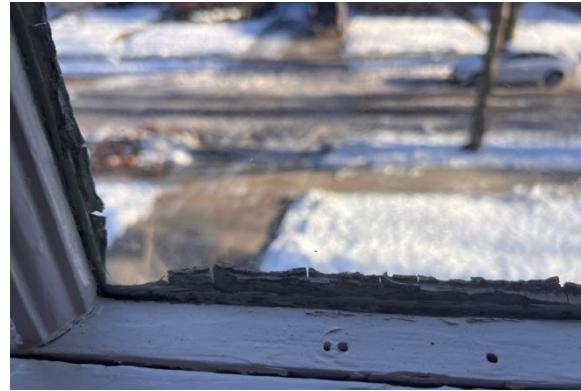
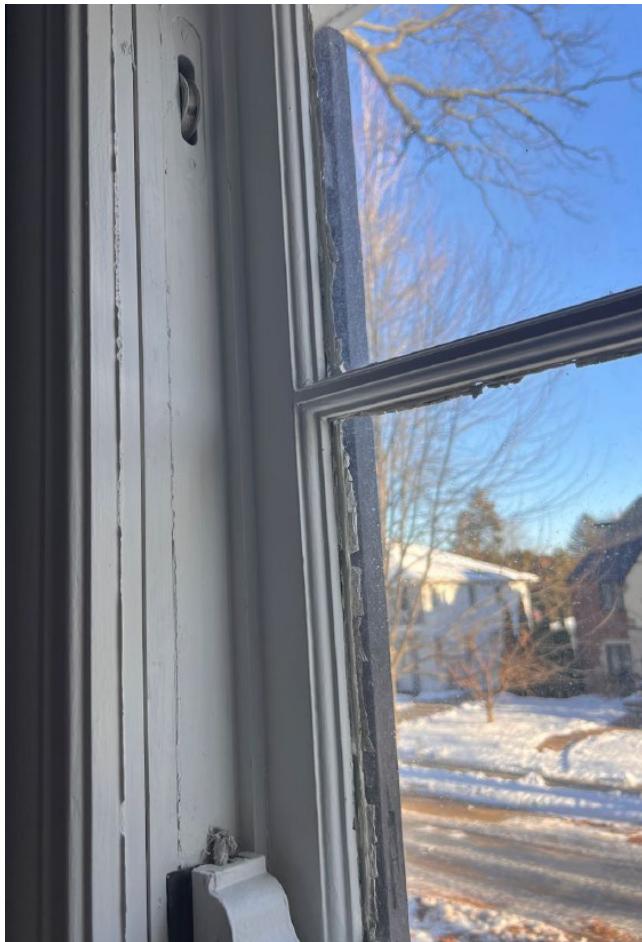
Photos from application

- Photos provided with the application show relatively minor deterioration, such as peeling paint and cracked glazing. Photos also show that some of the windows seem to have been painted-over multiple times and are missing the sash ropes and hardware, conditions that will impair their operation.

- Regarding the concerns of energy efficiency and air leakage of the existing historic windows, the National Park Service's [Preservation Briefs: 9 “The Repair of Historic Wooden Windows”](#) suggests treatments like reglazing, replacement of worn-out weatherstripping (or addition of if the weatherstripping is not present), and installation of storm windows as routes to “improve the thermal performance of existing windows.” It also goes on to state that “following the relatively simple repairs, the window is weathertight, like new in appearance, and serviceable for many years to come.”

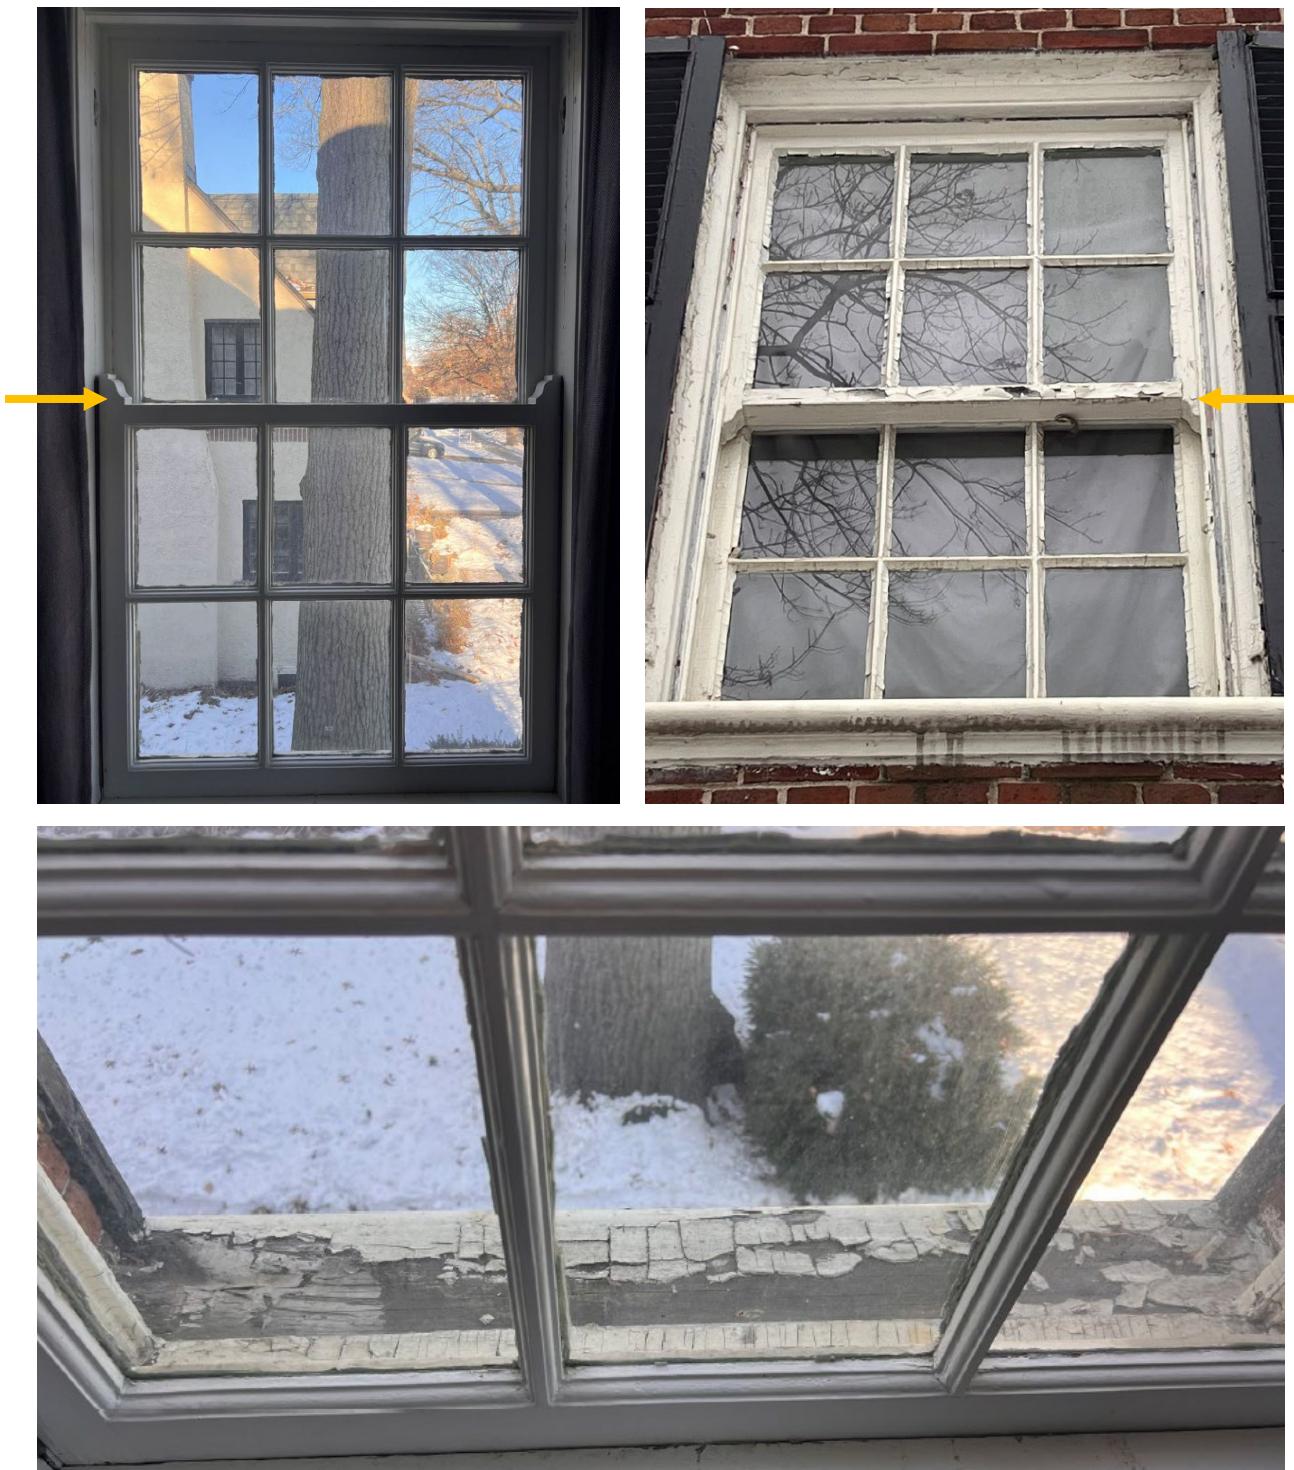
Photos from application

- Note the rich textural detail visible in muntins, rails, and brickmould/trim. The sash horns, marked by orange arrows, are particularly rare and distinctive, and not included in the replacement proposal.
