SR-2 – ADVISORY STAFF REPORT (03-06-2026)

ADDRESS: 19170 WARRINGTON

APPLICATION NUMBER: HDC2025-00648

SCOPE: REMOVE FAÇADE BALCONY (WORK COMPLETED WITHOUT APPROVAL)

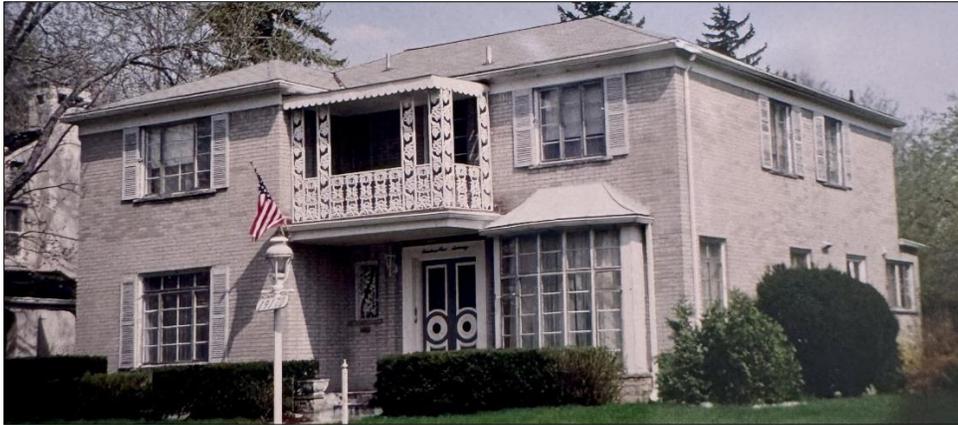
Designation photo, 2002. HDAB

1. The front balcony was a distinctive, character-defining historic feature that dates to the resource’s time of construction and the district’s Period of Significance.

2. The distinctive feature demonstrated a mid-century approach for a balcony structure on a modern-designed dwelling and was materially and proportionally compatible with the dwelling’s metal framed windows.

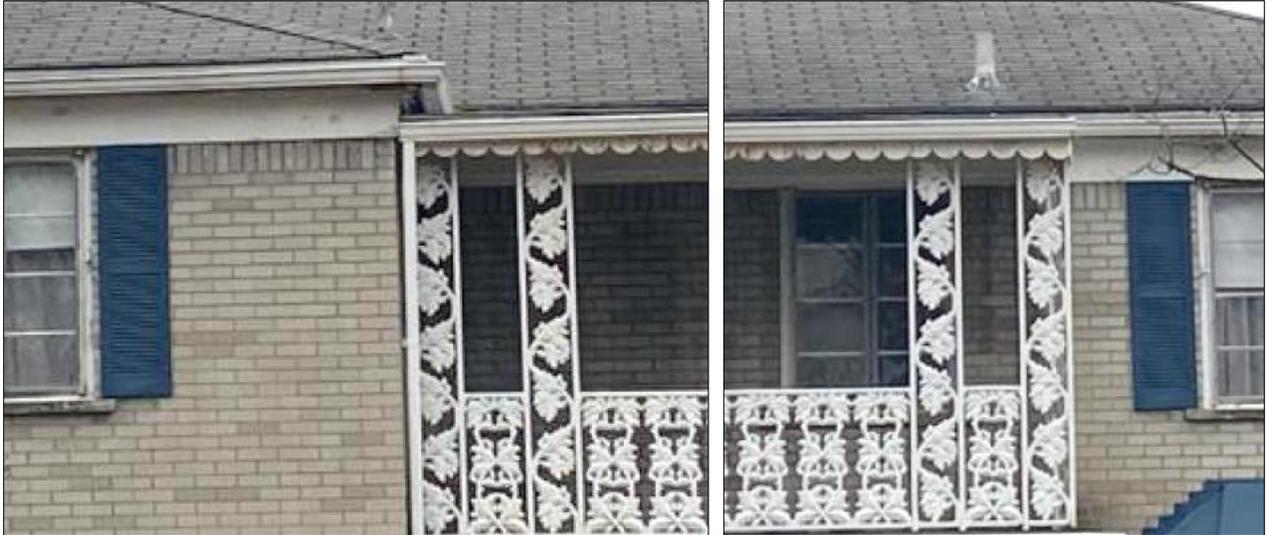
Photos from page 21 of the CNM Inspection Services Inspection Report. Inspection date: 12/20/2020.

- The photos below were taken by a home inspector in December 2020 in preparation of a report created for the applicant. The photos shows a fully intact balcony structure, posts and railing. Surface deterioration is visible at one section of the scalloped trim that covers the post installations at the roof.
- The accompanying inspection report states on page 12, “*Spot decay/deterioration noted at upper porch support and rear window ledge repair and refinishing needed. These should be keep (sic) well sealed against the weather to prevent damage.*”

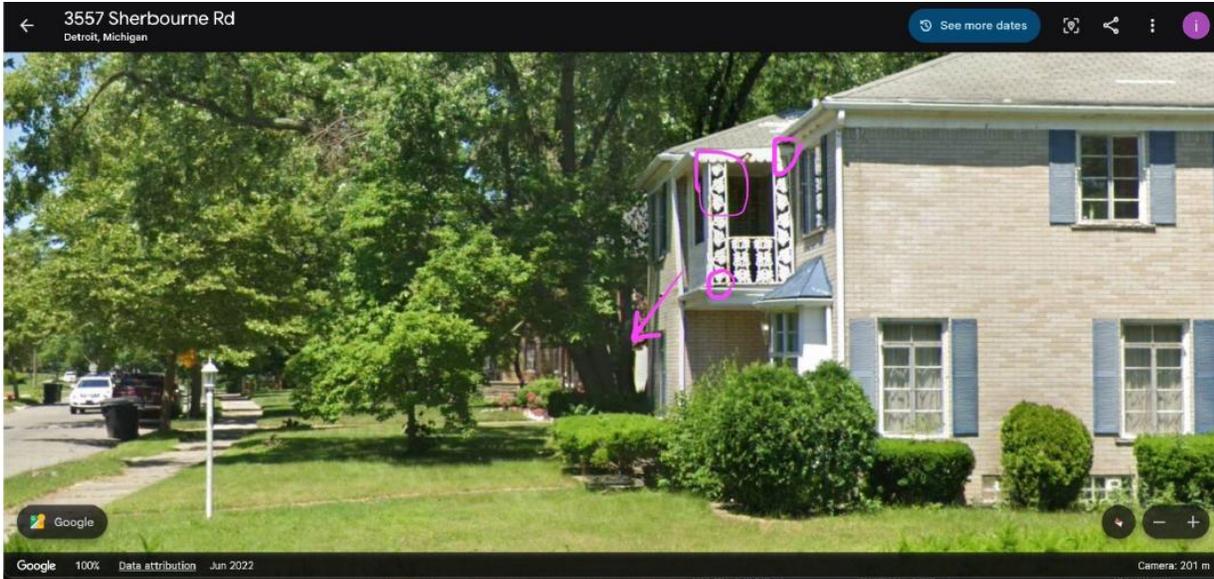
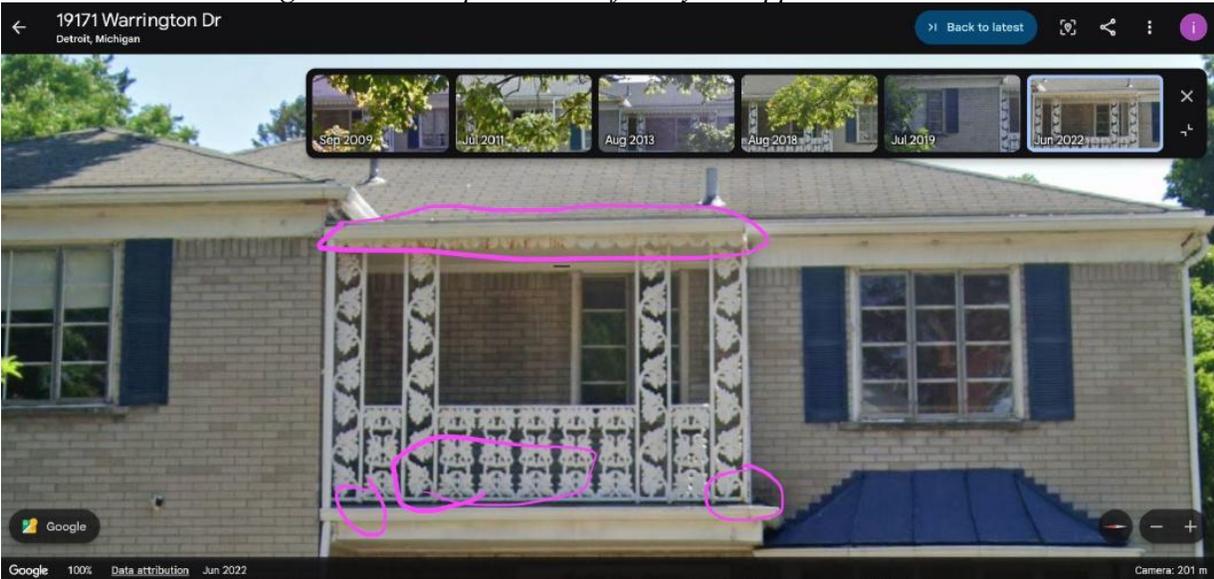
Above and below: Google street view photos modified by the applicant.

- During the review cycles for this application, staff made multiple requests for detailed photos of the balcony prior to its removal to substantiate the applicant’s claims that the components were unsafe and possibly deteriorated beyond repair. The only photos supplied by the applicant (outside of those within the inspection report) are shown on the following page.

- The original balcony, a distinctive-character defining historic feature, was removed without HDC approval; the scope of work that would meet the requirements of the historic ordinance (Section 21-2-59(e)) is the fabrication and installation of a new cast iron porch that matches the old.
