**SR-1 – OBJECTIVE STAFF REPORT (02-27-2026)**

**ADDRESS:** 1616 CHICAGO

**APPLICATION NUMBER:** HDC2025-00753

**SCOPE PHRASE FOR AGENDA:** – DEMOLISH GARAGE (WORK COMPLETE), DEMOLISH REAR WING (WORK COMPLETE), REHABILITATE HOUSE

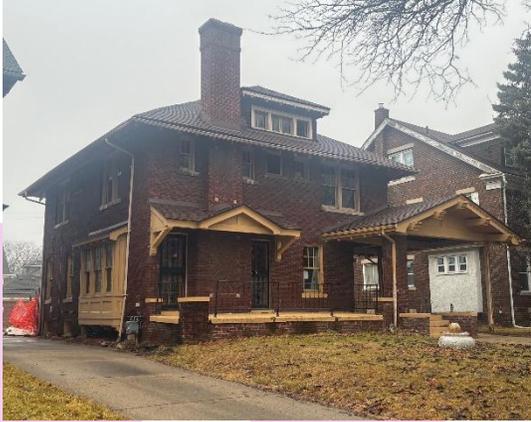
- Exterior walls are mostly clad with brick, although vinyl siding has recently been installed at the rear wall, at the location of the former two-story sleeping porch wing (which was removed without HDC approval). Also, the stucco cladding has been removed from the rear one-story, flat-roof wing, leaving only the wood underlayment exposed

- Windows are typically the historic wood units, although window openings at the rear have been boarded up. Also, two vinyl windows are located at the rear wall

- Extant doors appear to be of historic age, although some doors have been boarded up at the rear
- The front façade porch is brick and features a concrete cap/floor. The existing metal handrails and guard rails are not of historic age

1616 Chicago. 2/19/2026 staff photo, facing northeast
