**SR-1 – OBJECTIVE STAFF REPORT (03-06-2026)**

**ADDRESS:** 2050 ATKINSON

**APPLICATION NUMBER:** HDC2025-00741

**SCOPE PHRASE FOR AGENDA:** INSTALL VINYL WINDOWS, REHABILITATE HOUSE  
(WORK DONE WITHOUT APPROVAL)

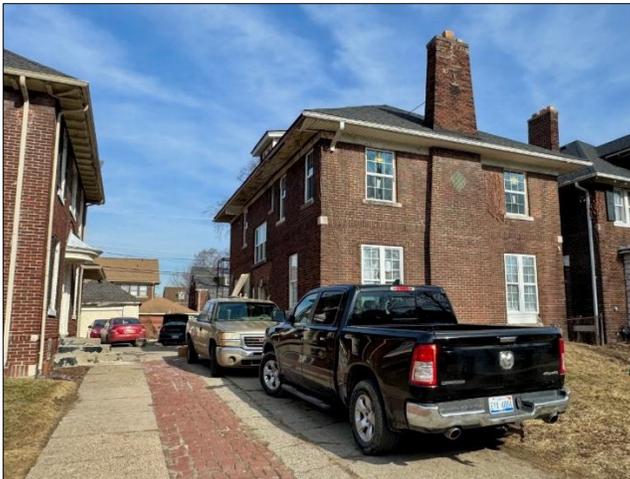
- First floor: Each tall opening is filled with two mulled narrow/very tall single-hung windows (6-over-6 pattern) above one EIFS panel.
  - Second floor: Taller than wide single openings each have one, 6-over-6 single-hung vinyl window.

- The window openings on the side and rear walls include single and mulled single-hung windows.
- Evidence of the previously removed front porch is visible surrounding the door opening.

*Façade/front and west/side walls looking north. Staff photo, 02/26/2026.*
