**SR-2 – ADVISORY STAFF REPORT (03-06-2026)**

**ADDRESS:** 1616 CHICAGO

**APPLICATION NUMBER:** HDC2025-00753

**SCOPE:** DEMOLISH GARAGE (WORK COMPLETED), DEMOLISH REAR WING (WORK COMPLETED), REHABILITATE HOUSE

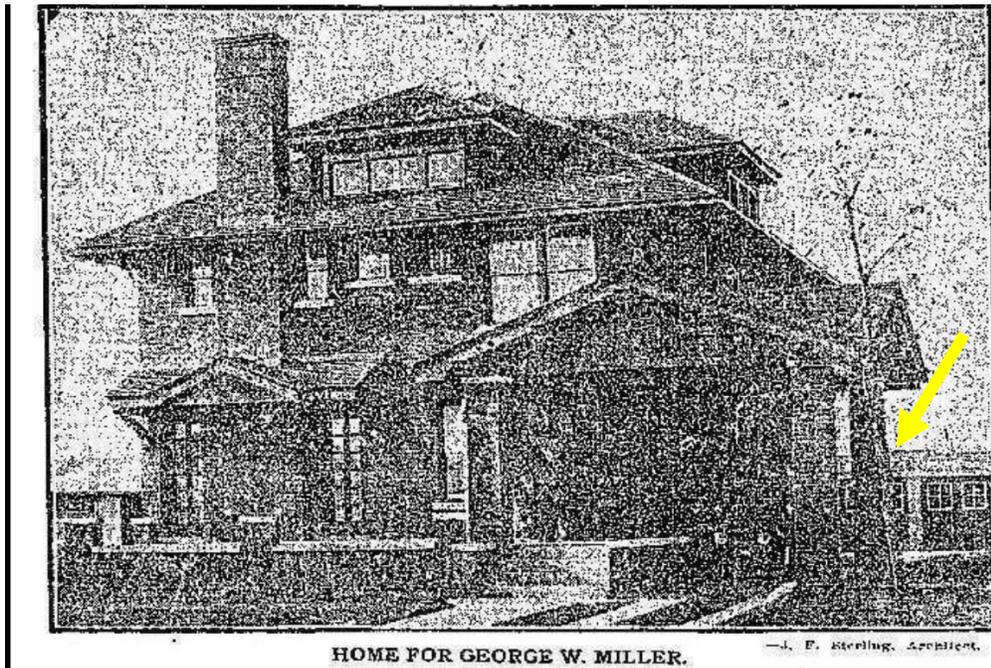
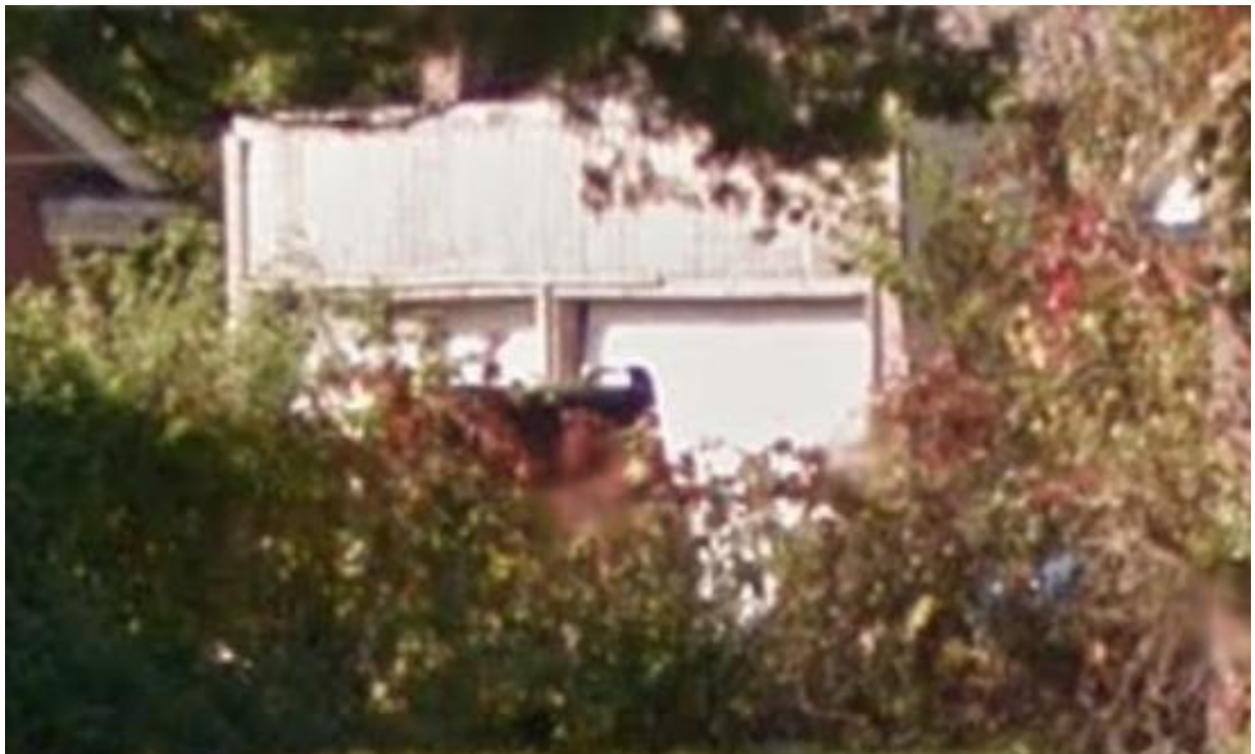
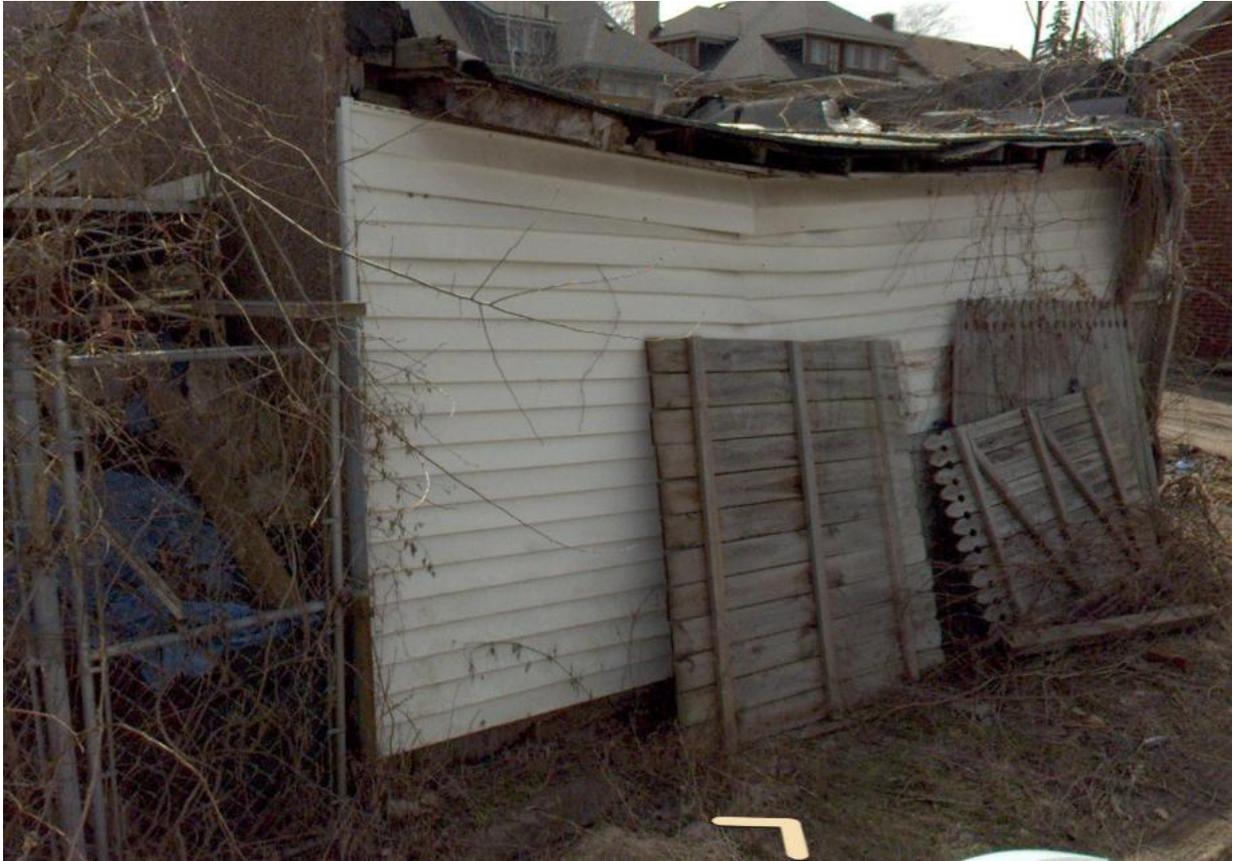
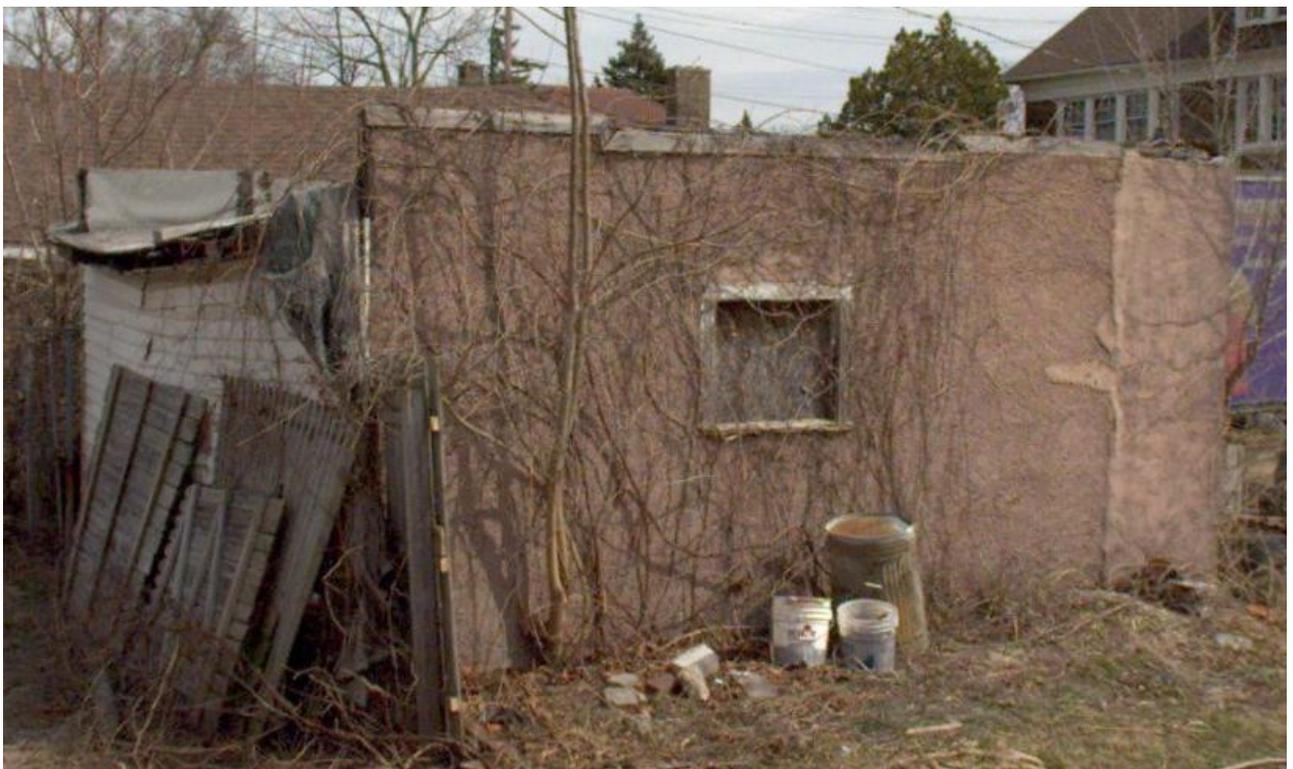
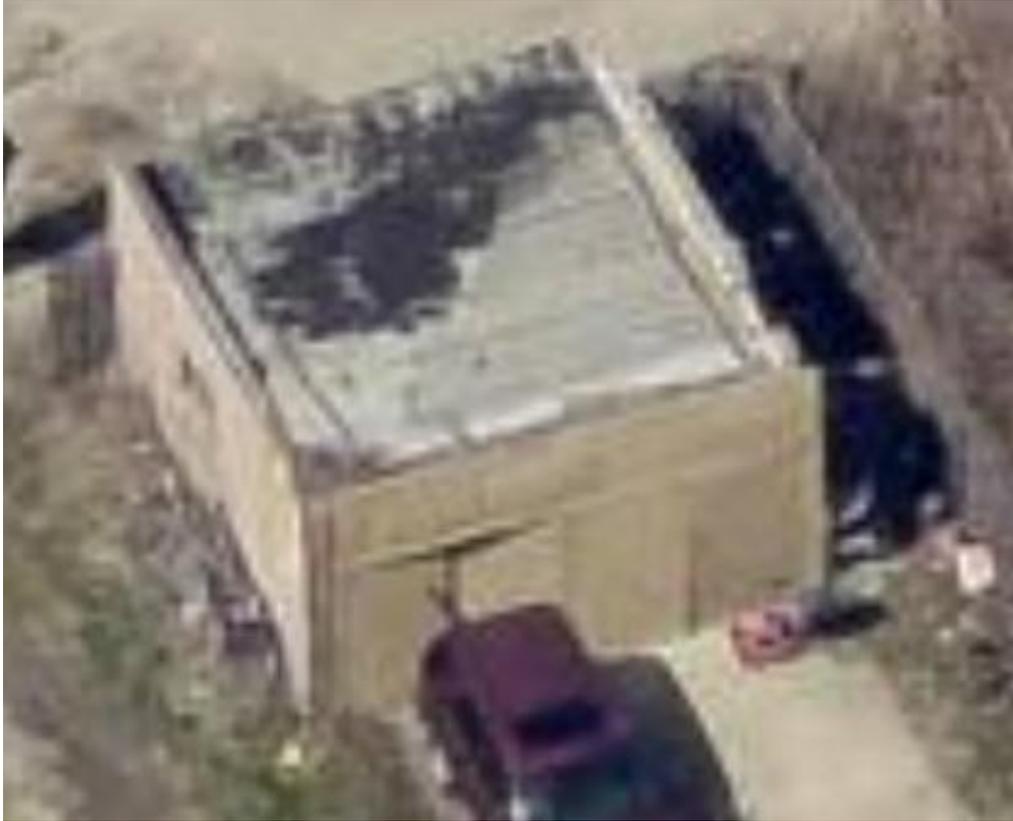
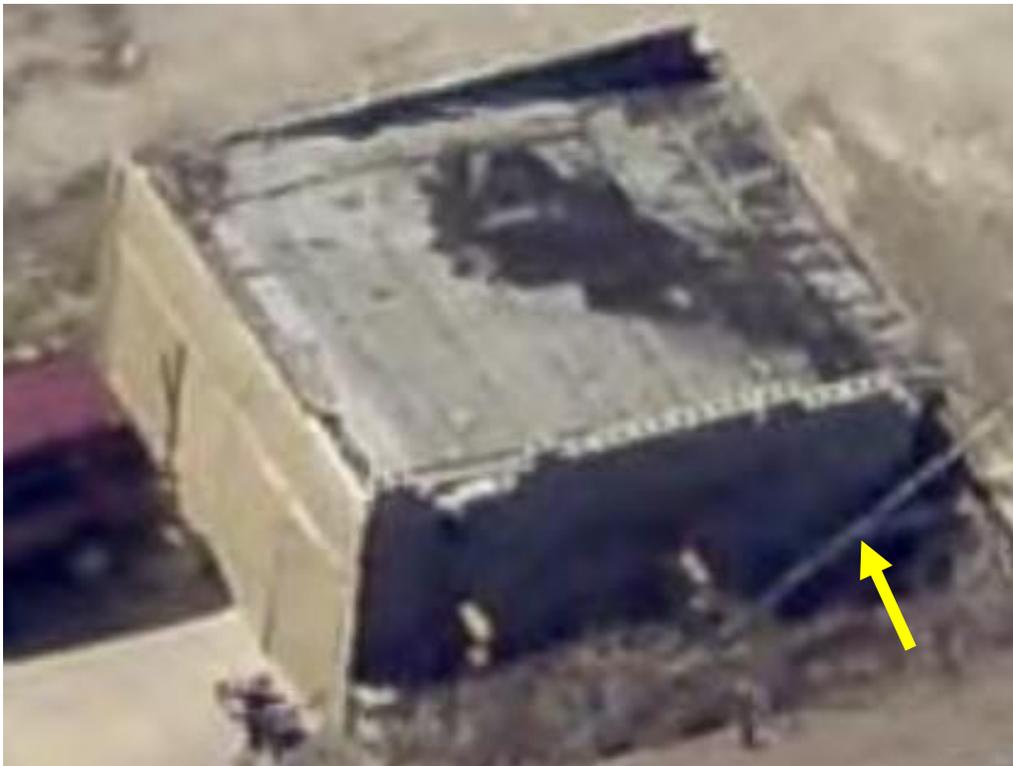
- The building was a two-car, masonry flat-roofed garage that was one story in height
  - At the time of the garage’s unapproved demolition, the exterior walls at the front and west side were clad with stucco and vinyl siding was located at the rear wall. The east wall appeared to have been recently constructed of concrete blocks and was unfinished.

- A comparison of the images of the garage indicates that the front wall had been greatly altered from its original appearance
  - Although the garage appeared to date from the property’s original construction, it had suffered from numerous unsympathetic alterations which had been undertaken after the district’s period of significance to include the recladding of the rear wall with vinyl, the altering of the front façade to include the removal of the historic garage doors, and the reconstruction of the east wall. For those reasons, the garage had lost

its historic integrity and was not a contributing element to the district at the time of its unapproved demolition, in staff's opinion. Staff therefore supports its demolition.

Detroit Free Press, 1915. Original appearance. Yellow arrow indicates the garage

Google Streetview, 2012. Facing northwest towards the garage's front façade

**Detroit Mapillary, 2019. Facing southwest towards the garage's vinyl clad rear wall**

**Detroit Mapillary, 2019. Facing southeast towards the garage's west/side and rear walls**

**Connect Explorer, 2022 birdseye image of the garage. Facing northeast**

**Connect Explorer, 2022 birdseye image of the garage. Facing northwest. Note that the east wall has been constructed from concrete blocks (see yellow arrow)**

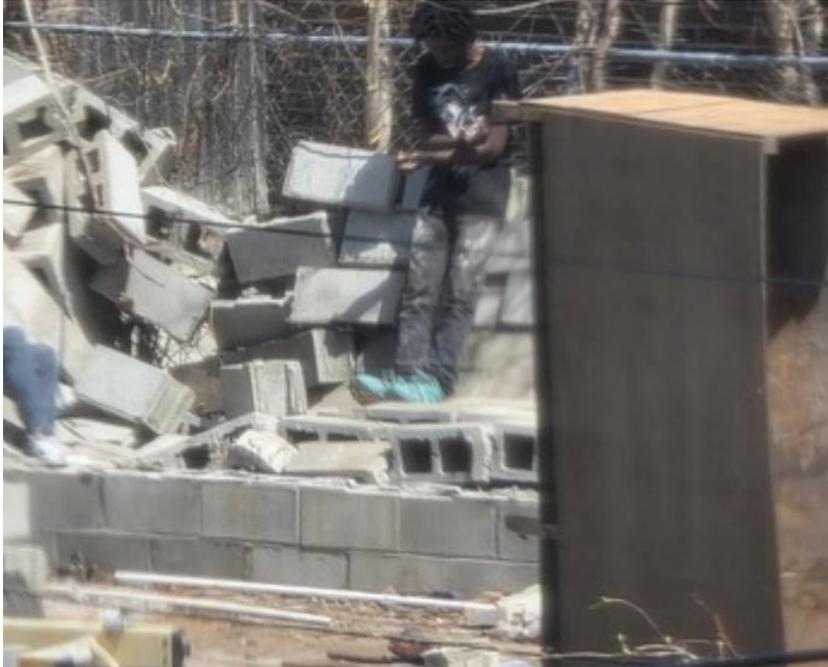
**Photo of garage rubble after its unapproved demolition. Photo from See Click Fix/Improve Detroit**

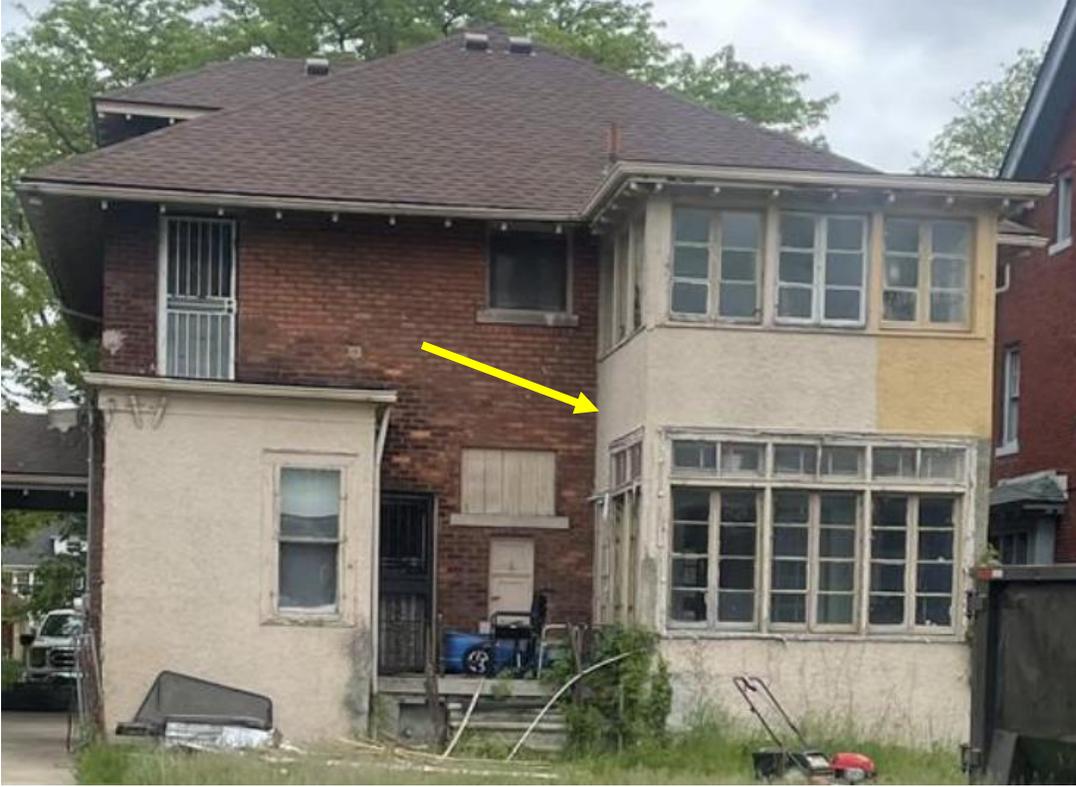
1. The rear, two-story sunroom wing that was demolished without HDC approval was an historic distinctive character-defining feature of the building. The proposed permanent removal of this character-defining feature alters the historic character of the property.

- The wing that was removed without HDC approval was two-stories in height and was clad with stucco. Windows at the first story were historic wood casement units with wood transoms while the second story windows were wood casement units. Consistent with the house's main roof, the eaves at the wing's flat roof displayed decorative rafter tails. The doors were the historic wood French doors. Also, the projection and massing of the original wing is lost in the truncated replacement. It is staff's opinion that this wing was a distinctive, historic character-defining feature of the building.

**Rear wall prior to unapproved work. Yellow arrow indicates that former, two-story sunporch which was recently removed without HDC approval. Note wood windows and decorative rafter tails at roof eaves, the massing and form of the wing, and the overall building footprint. Photo by applicant**

- Therefore, per the Standards, the wing should have been retained and repaired using in-kind materials. If repair was not possible, then the wing should have been rebuilt to match the original. The current application does not meet the Standards because it proposes not to rebuild the wing which was demolished without HDC approval.

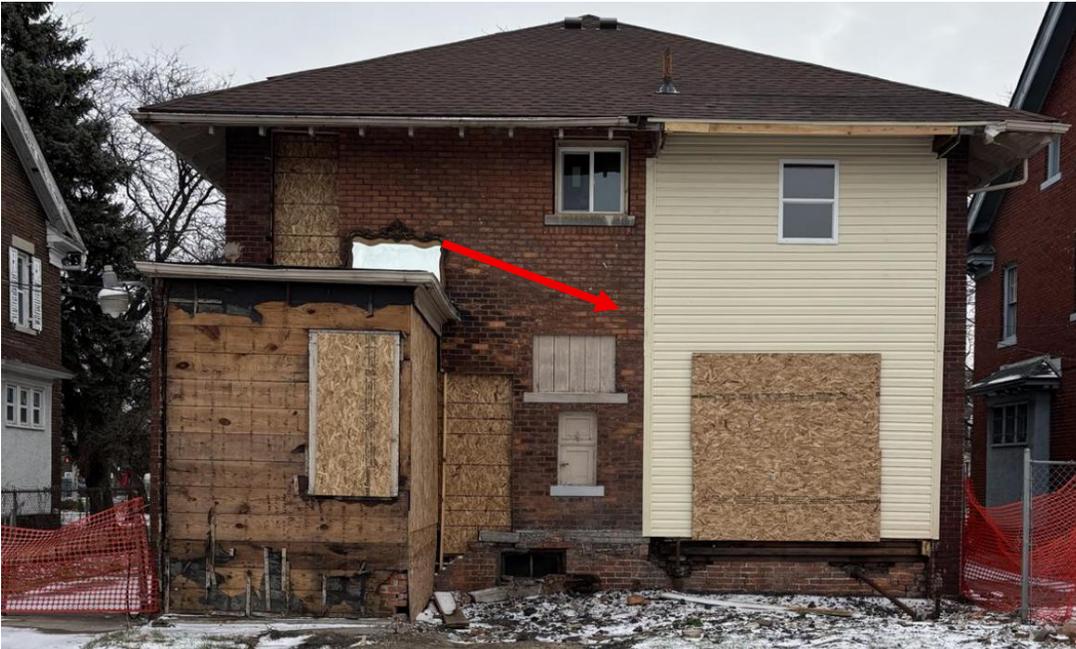
3. The vinyl siding and window proposed for installation at the location of the former two-story rear sunroom wing are incompatible with the building's historic character

- Furthermore, the application is seeking to retain the vinyl siding and vinyl window that was installed at the rear wall/the location of the former wing without HDC approval. These work items do not conform to the Elements of Design for the district because, as noted above, most houses are clad with brick and/or stucco and windows are typically made of wood. Also, vinyl siding does not adequately reproduce a historic wall surface and the proposed/extant vinyl window at this location does not mimic the dimensionality, texture, and finish of historic window sash.

**Current Appearance of the rear wall after the unapproved work. Note that vinyl siding and a vinyl window has been installed at the wall surface/the location of the former two-story sunroom wing (red arrow). Also, the building footprint has been significantly reduced and the former substantial massing and projection of the wing has been lost. Photo by applicant**

1. The rear, two-story sunroom wing was an historic distinctive character-defining feature of the building. The proposal to demolish it, not rebuild the feature to match, and clad the area where it was formerly located with vinyl and install a vinyl window has resulted in the removal of historic materials and the alteration of features and spaces that characterize the property. Specifically, the work incompatibly alters the historic footprint and massing of the building, destroys important historic finishes and architectural elements, and introduces new materials that are incompatible with the building's historic character.

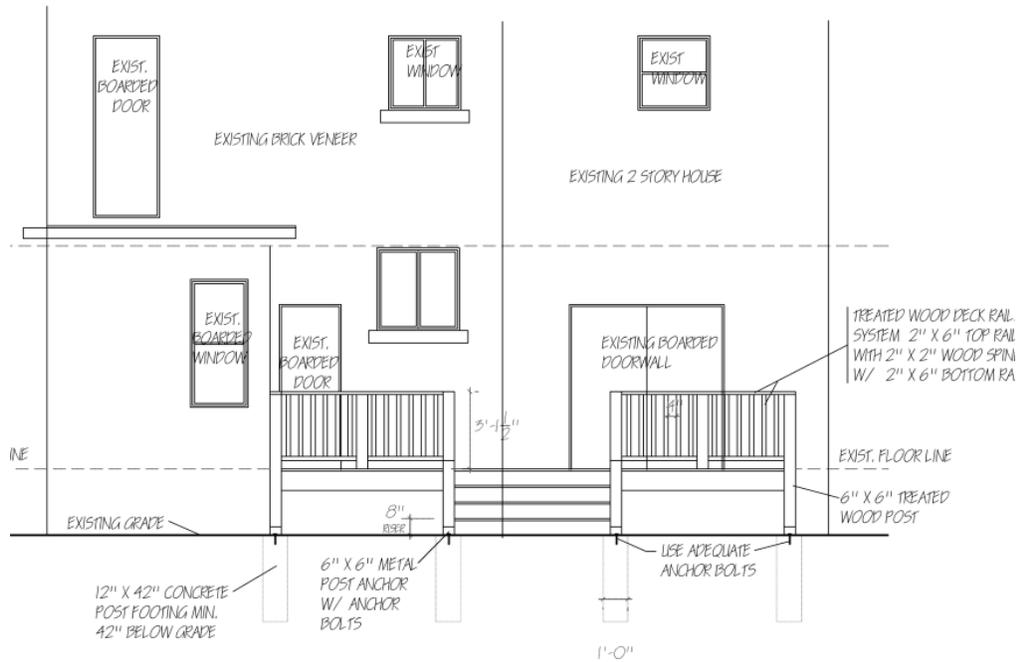
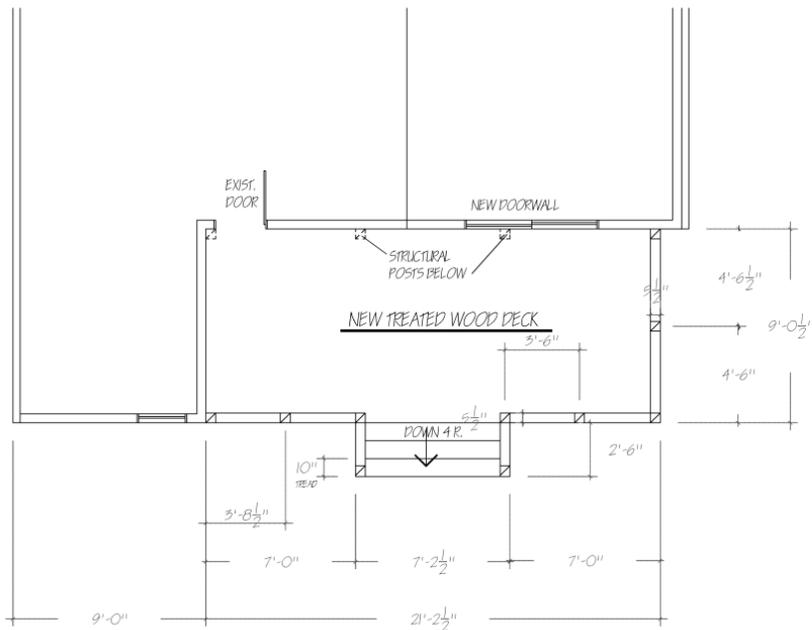
2. While the design of the new rear deck appears to be compatible with the building's historic character, its location is not appropriate because it is proposed to be erected within the footprint of the former two-story sunroom wing that was demolished without HDC approval.

- Finally, while the design of the new rear yard deck would not detract from the building's historic appearance, staff does not recommend approval of this scope item as proposed because it will be erected within the footprint of the former rear two-story sunroom wing that was removed without HDC approval.

**Proposed rear wall and deck (elevation), by applicant**

**Proposed rear wall and deck (in plan), by applicant**

1. The proposed rear deck shall not extend into the footprint of the former two-story rear sunroom wing. The new design shall be submitted to staff prior to the issuance of the permit for review and approval.

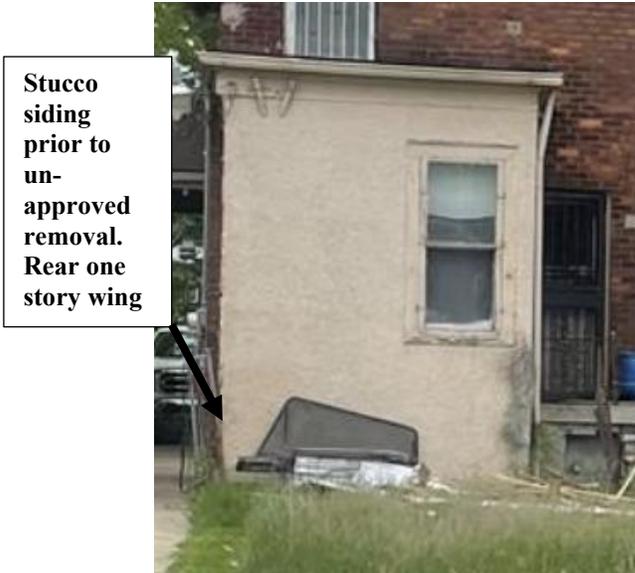
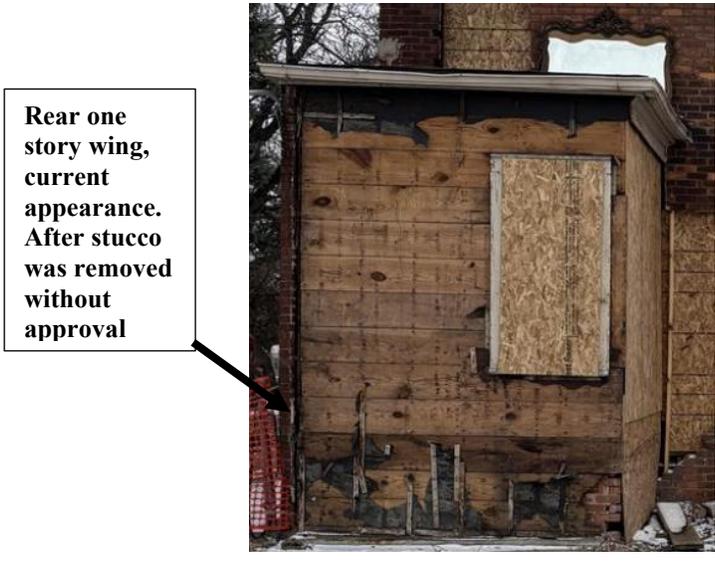
4. The stucco at the rear, one-story wing which was removed without HDC approval was a distinctive finish that characterized the property. Its proposed replacement with lapped wood siding/siding that does not match the original.

- The stucco cladding that was at the rear, one-story wing’s side and rear walls was historic and was consistent with the stucco cladding that was at the former rear, two-story wing (see the below images). The siding was a distinctive finish that characterized the property and conformed to above-listed Element of Design #7, which notes that stucco is commonly found within the district. The proposed replacement of the siding with lapped wood siding does not conform to the

Standards, which require that the replacement siding match the original. Also, Element of Design #7 states that wood "...clapboard is rare" within the district. Staff therefore recommends against the approval of this work item.

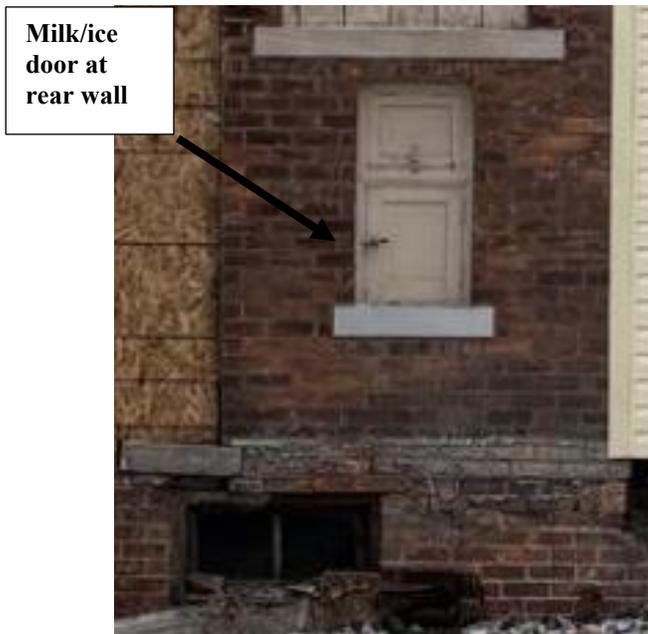
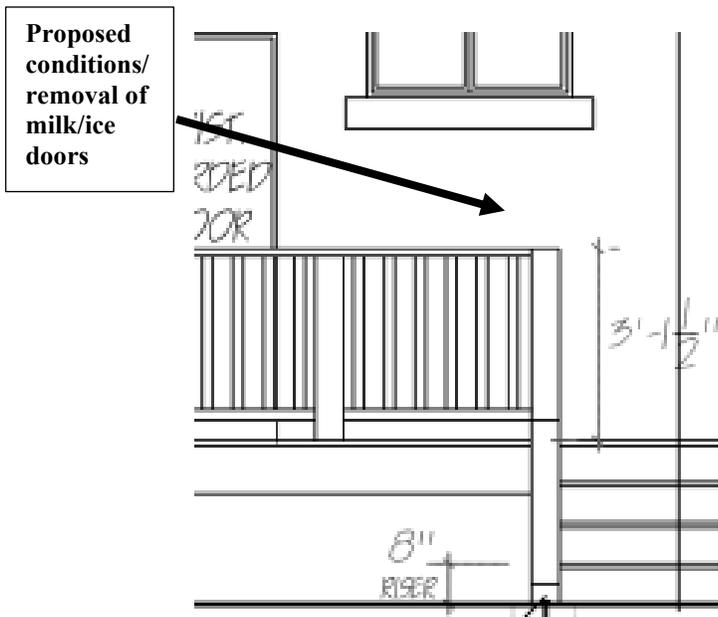
5. The milk/ice doors at the rear wall are historic distinctive character-defining features of the building. The proposed permanent removal of these character-defining features alters the historic character of the property.

- See the below images. The rear elevation drawing which was submitted with the application indicates that the existing milk/ice doors and the stone sill beneath at the rear wall, first story will be removed and the opening infilled (material not specified). These elements date from the period of significance and speak to the house's appearance prior to the development of widespread/modern refrigeration. The proposed removal of such a feature that characterizes the property does not meet the Standards. Staff therefore recommends against its removal.

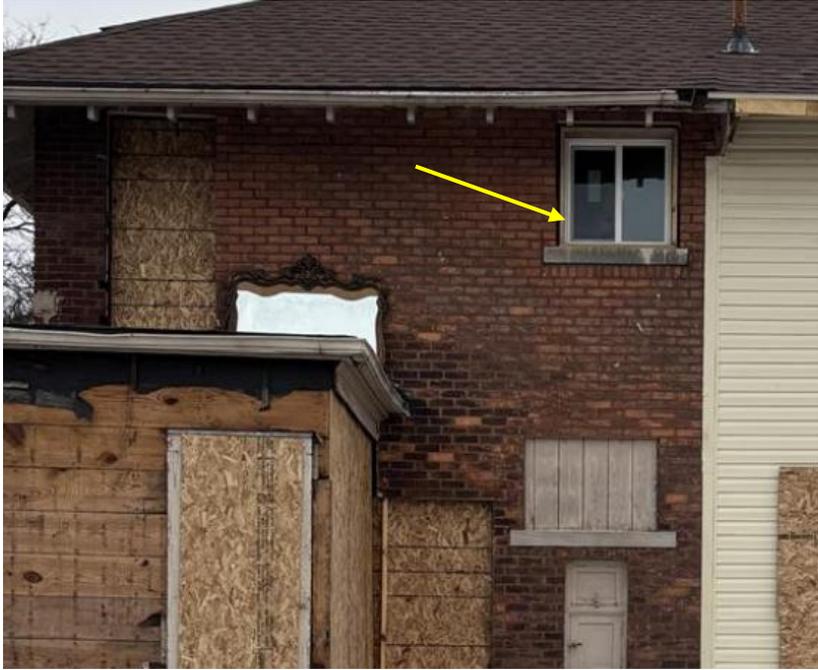
6. The vinyl slider window which was installed at the building rear wall, second story without HDC approval are not compatible with the building's historic character

- The existing vinyl sliding window at the rear façade, second story was recently installed

without HDC approval. Per the above proposed elevation drawing, the applicant is seeking to retain these windows. It is staff's opinion that these windows are not appropriate/incompatible with the building's historic character because the Elements of Design for the district note that windows are typically made of wood. Also, the vinyl siding windows do not adequately reproduce the dimensionality, operation, texture, and finish of historic window sash.

**Rear wall, vinyl sliding window installed without HDC approval (yellow arrow). Photo by applicant**

2. The Elements of Design for the district note that windows are typically made of wood. Also, the proposed vinyl windows/vinyl windows installed without HDC approval do not adequately reproduce the dimensionality, operation, texture, and finish of historic window sash. The

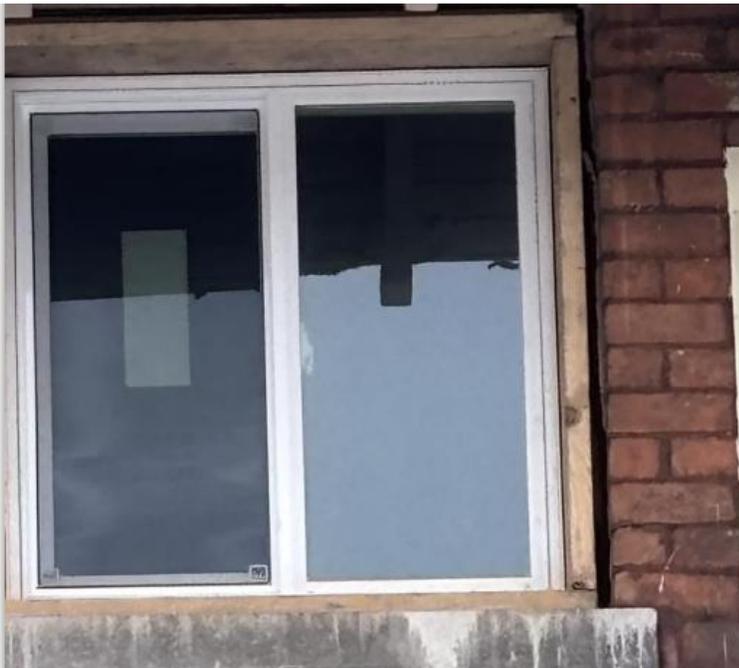
**Rear wall, vinyl sliding window installed without HDC approval. Also, note that the window opening has been improperly "stepped down" with dimensional lumber to accommodate the manufactured window. Detail. Photo by applicant**
