SR-2 – ADVISORY STAFF REPORT (03-06-2026)

ADDRESS: 1806 LEVERETTE

APPLICATION NUMBER: HDC2026-00001

SCOPE: REPLACE WOOD WINDOWS WITH VINYL WINDOWS

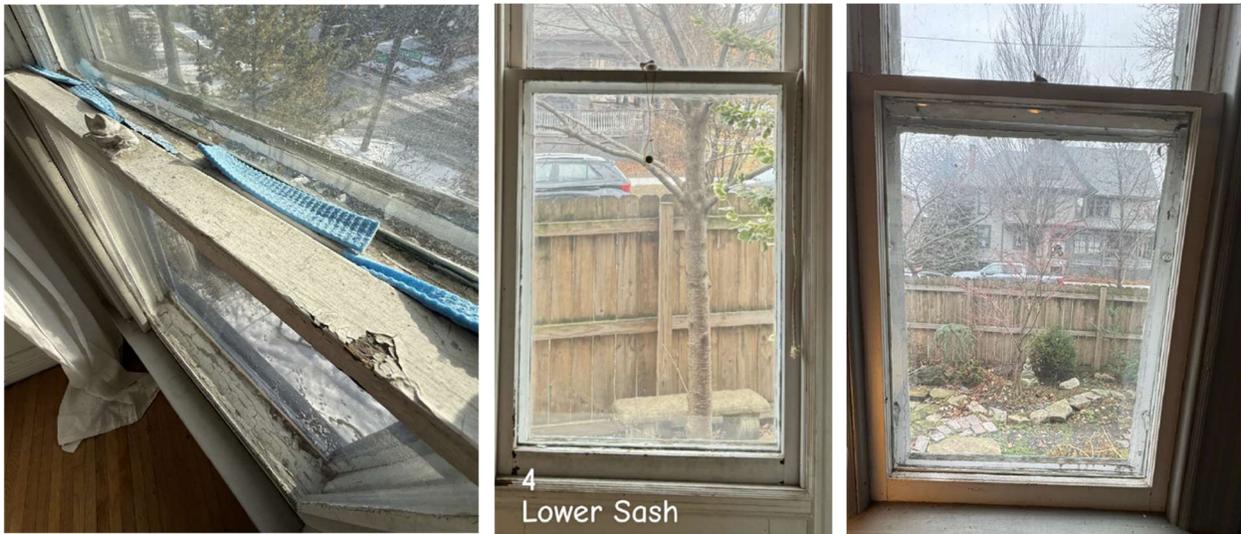
- The applicant states that the current wood windows “are significantly deteriorated, allow substantial air infiltration, and are not energy efficient. In addition, many of the windows no longer operate properly, with several unable to open or remain open, and most lacking functional locking mechanisms” and “restoration would not restore functionality or energy performance to an acceptable level.”
- Photos provided with the application show relatively minor deterioration, such as peeling paint and cracked glazing. Photos also show that some of the windows seem to have been painted-over multiple times and are missing the sash ropes and hardware, conditions that will impair their operation, but are ultimately repairable.

Photos from application to show existing conditions

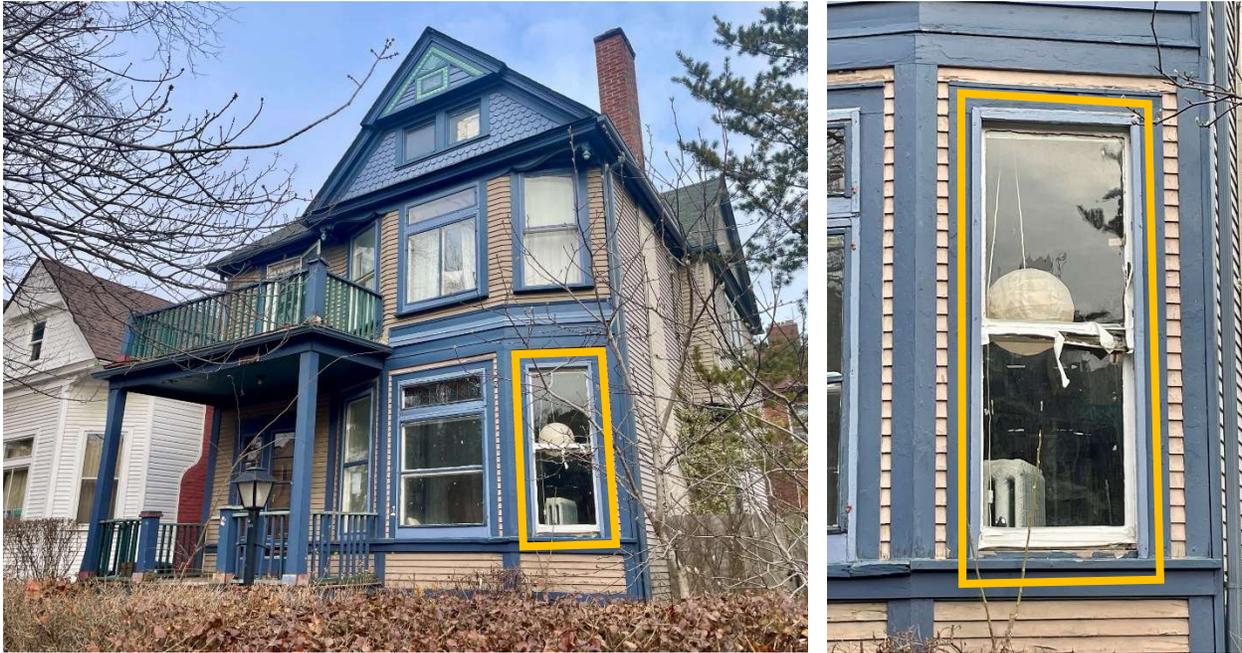
- It is staff’s opinion that the upper sash of **window #5** is beyond repair. To preserve the visual and architectural continuity of the property and if the sash is determined to be beyond repair, it is recommended that the upper wood sash be replicated in-kind* and the bottom sash be restored.

Staff photos, 02-24-2026

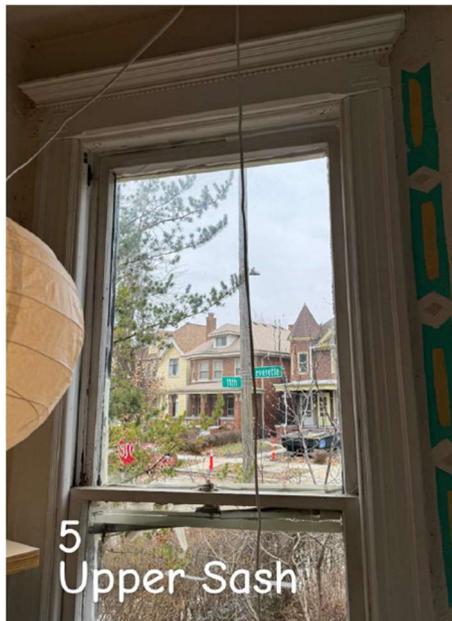
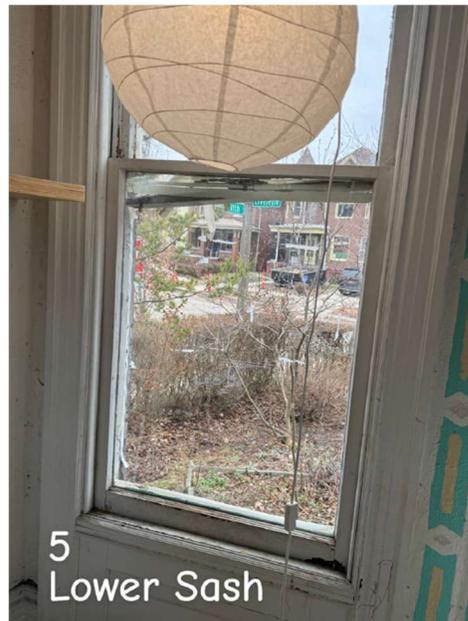
Photos from application
