SR-2 – ADVISORY STAFF REPORT (03-06-2026)

ADDRESS: 2105 BURNS

HISTORIC DISTRICT: INDIAN VILLAGE

SCOPE: DEMOLISH CONTEMPORARY SUN ROOM, CONSTRUCT REAR DECK,
REHABILITATE HOUSE AND GARAGE

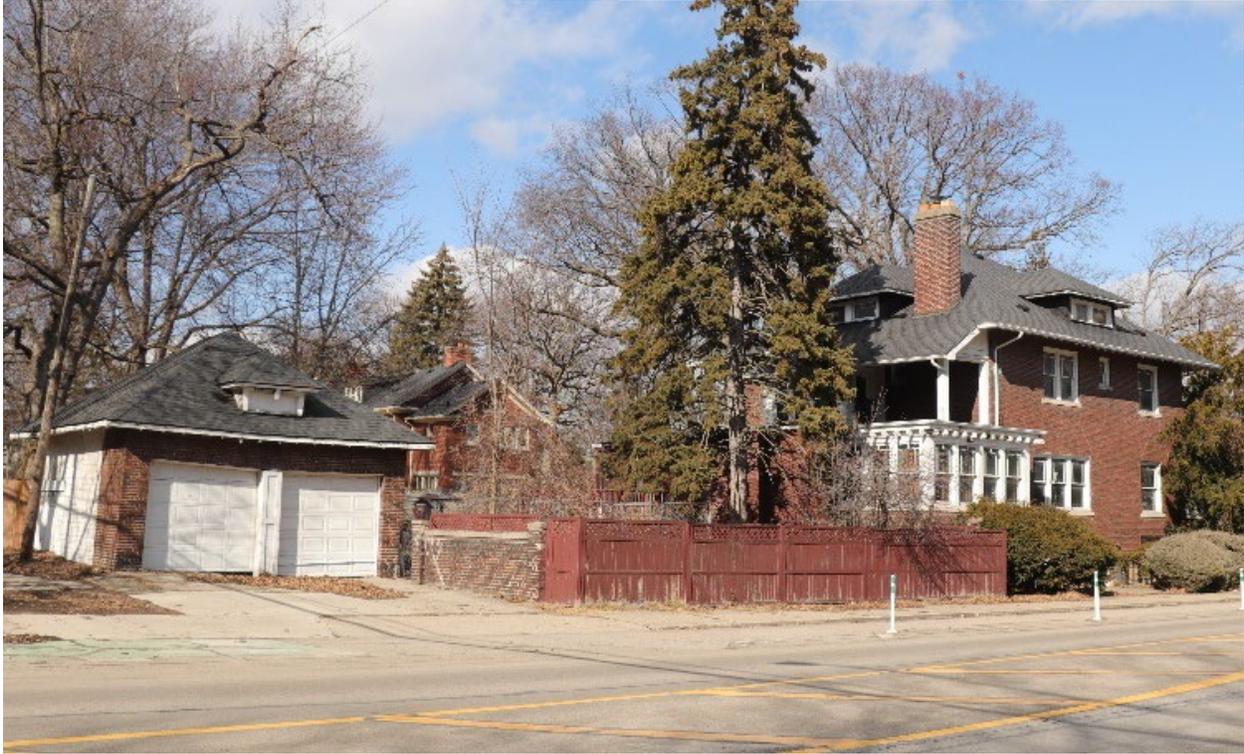
Photo taken by staff on 02/25/2026, Kercheval Street view

- The house is situated on the corner of Kercheval St. and Burns St., which is partially visible to the public-right-of-way. Any changes to the rear will impact on the historic character of the neighborhood.

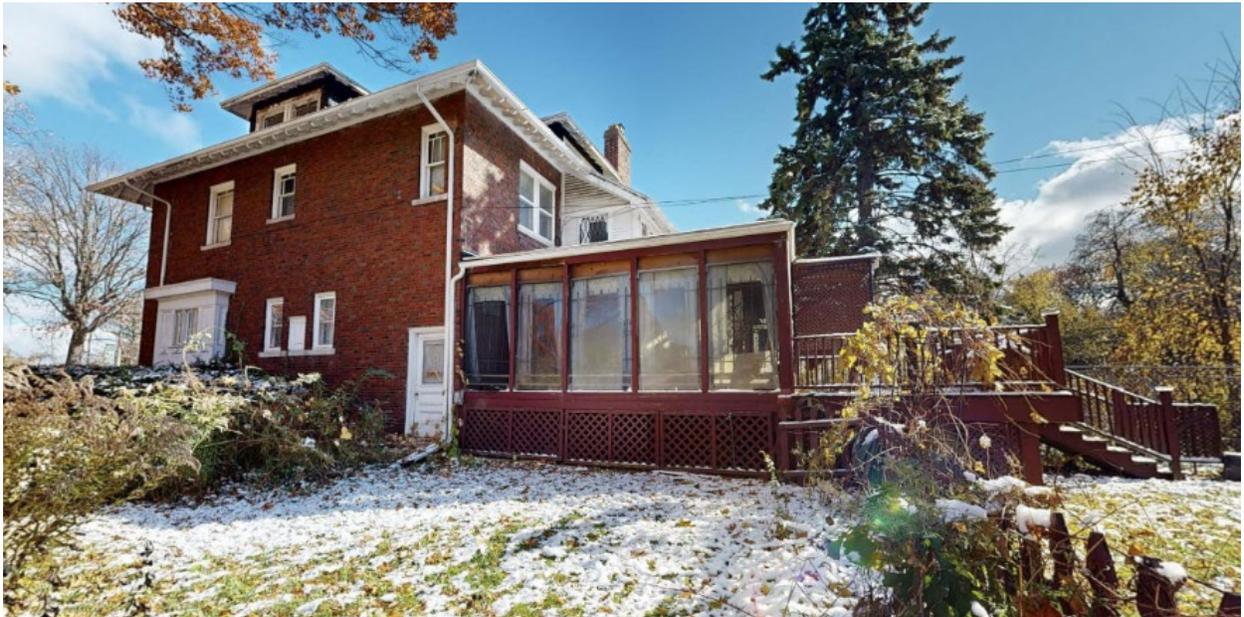
ABOVE: Photo provided by the applicant, show the house in relation to the historic sun porch addition and the non-historic wood deck addition

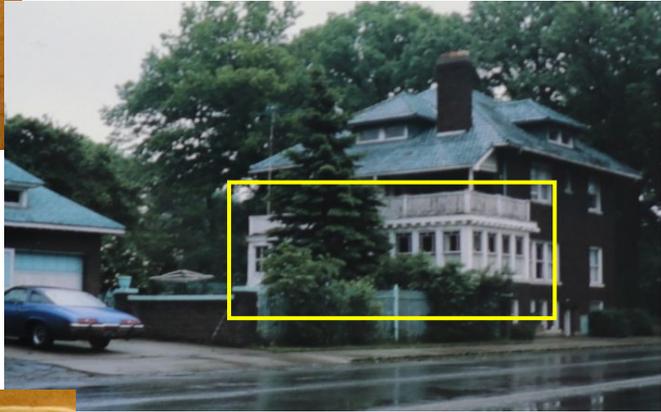
Image from HDC files circa May 1981

- Photo slides found in the HDC records (shown above) dated May 1981, show the original 1926 sun porch (painted white) with a balcony railing.

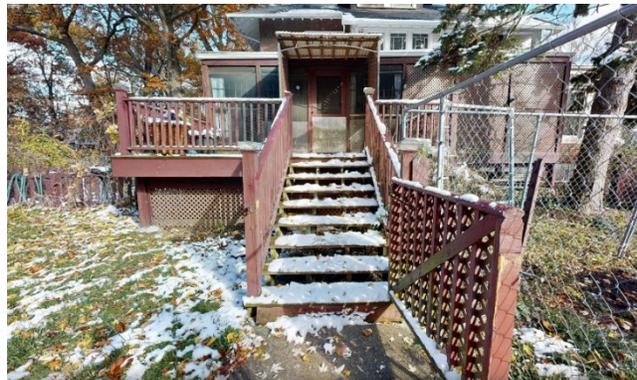
- Staff could not find a record of review or approval for the construction of the contemporary sun room and deck, which appears to have occurred subsequent to 1981. *Photo provided by applicant of the rear wood deck*

- It is therefore staff’s opinion that the removal of the wood deck will be an appropriate demolition within the context of the historic house and will have no impact on the historic character of the building.
- It is Staff’s opinion that the proposed design for the wood deck generally appears to be compatible within the existing context and will serve as an appropriate addition to the rear of the house.
 - The contemporary design proposes a recessed lower level with larger gaps between the wooden panels which will limit visual interference with the historic house.
 - It is staffs opinion that this will improve the historic integrity of the house as it will re-expose the original brick, the character-defining door (maintaining its operability) and adjacent historic wood window, and the original sun porch.

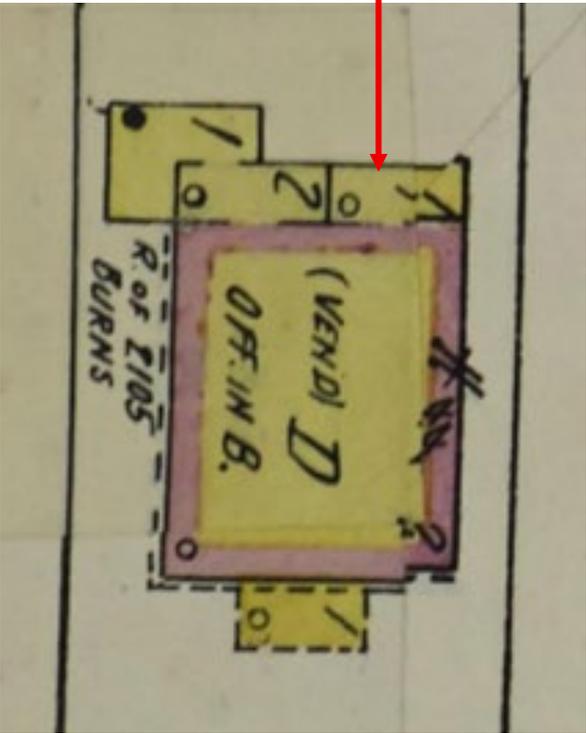
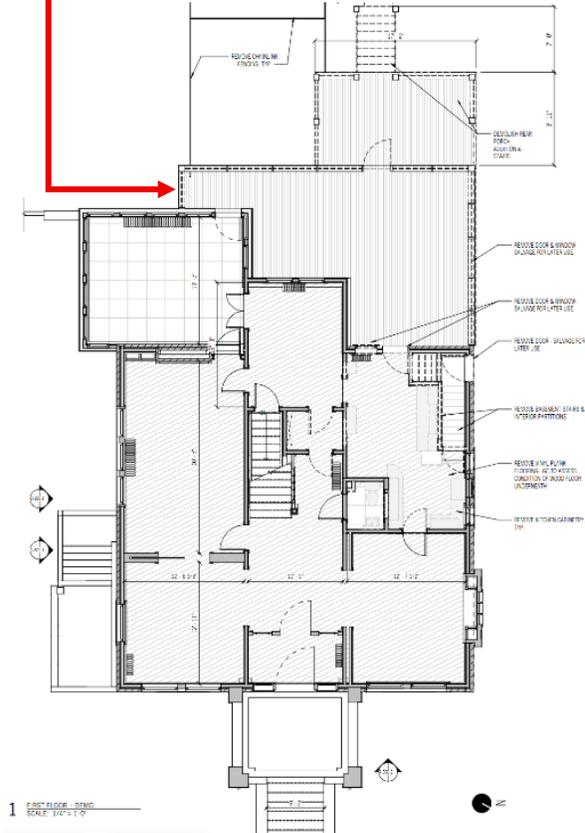
- Since the contemporary sunroom required the removal of the 1-story porch, no record of approval for the removal of that porch exists.
- Based on a comparison of the Sanborn Map (see below) and a demolition floor plan provided by the applicant, the contemporary sunroom addition was not part of the original house and was not added within the districts estimated period of significance.

Contemporary sun room – added after 1981

1-story sun porch that has since been removed

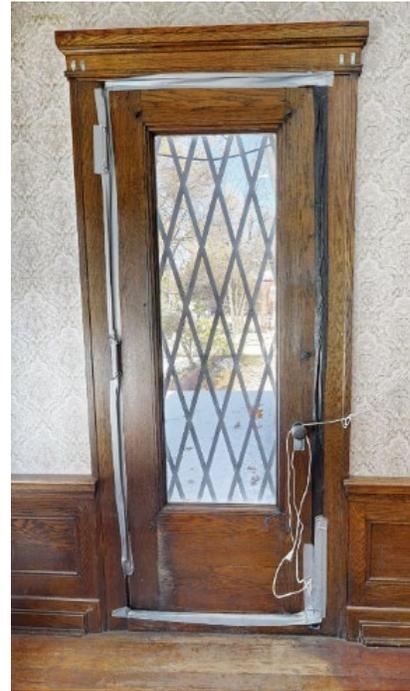
- The house retains many of its original wood doors. The historic wood door located on the second-floor rear balcony (see photo) maintains its condition and can easily be remedied. The removal of this historic wood door will not be appropriate for the context.

- Based on the demolition elevation plans provided by the applicant, it appears as though this door was originally a window opening, that was made a door opening in 1926 when the addition of the 1926 sun porch required access to the occupiable and railing enclosed roof.

- The partial removal of the historic-age sun porch consequently removed the intended use for this door as access to the balcony. Should the Commission elect to approve the demolition of the contemporary sun porch, this door will become inoperable.

- The brick infill should match as closely as possible in color and texture. The mortar should also match as closely as possible in color, texture, and hardness and the brick should be laid behind the existing opening, recessed a couple inches from the face of the building in order to maintain the existing door opening.
 - Should future homeowners wish to reestablish the door opening, the integrity will not have been compromised.
- However, it is staff opinion that the wood doors are distinct, character defining features that should remain in place.
