SR-1 – SUMMARY STAFF REPORT (05/29/2026)

ADDRESS: 4038 FULLERTON

APPLICATION NUMBER: HDC2025-00562

SCOPE PHRASE FOR AGENDA: REPLACE VINYL WINDOW WITH NEW VINYL WINDOW

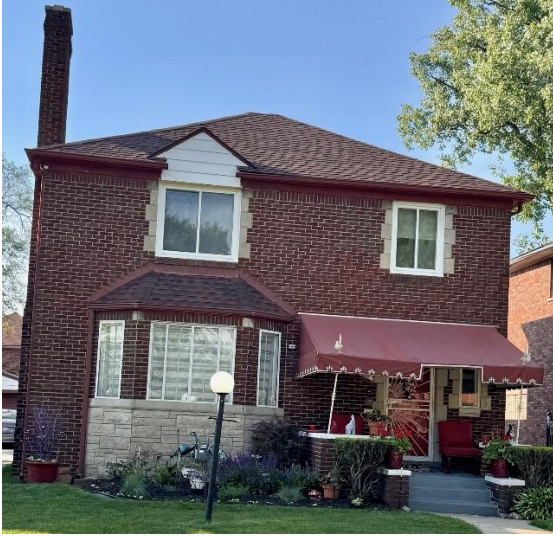
Staff photo, Façade looking north, 05/20/2026
