**SR-1 – SUMMARY STAFF REPORT (05/29/2026)**

**ADDRESS:** 470 MARTIN LUTHER KING JR. BOULEVARD

**APPLICATION NUMBER:** HDC2026-00162

**HISTORIC DISTRICT:** WILLIS-SELDEN

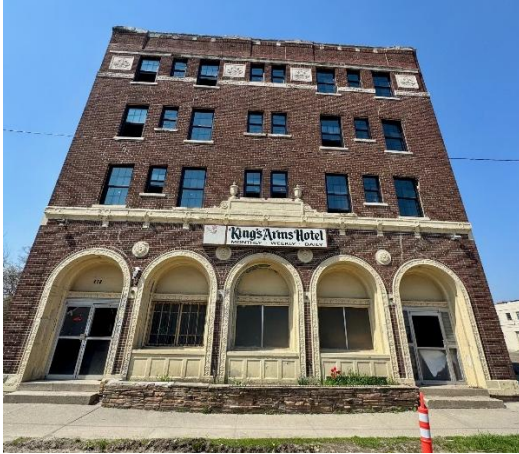
• Staff photo, looking north, 04/22/2026
