**SR-1 – SUMMARY STAFF REPORT (05-01-2026)**

**ADDRESS:** 2900 CASS (AKA 146-166 TEMPLE) T  
**MEETING DATE:** 05-13-2026  
**APPLICATION NUMBER:** HDC2025-00121  
**HISTORIC DISTRICT:** CASS PARK LOCAL  
**APPLICANT/ARCHITECT:** THOMAS ROBERTS/THOMAS ROBERTS ARCHITECT, LLC  
**OWNER:** TEMPLE COMMONS LLC  
**DATE OF PROVISIONALLY COMPLETE APPLICATION:** 04-17-2026  
**DATE(S) OF STAFF SITE VISIT:** 04-23-2026

**SCOPE PHRASE FOR AGENDA:** STABILIZE AND REHABILITATE BUILDING

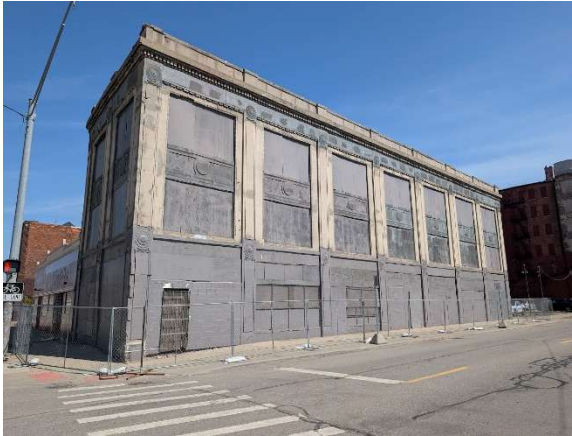
- Current condition of the property appears to be poor, with substantial deterioration of the exterior façade visible along with boarded windows and storefronts. A protective fence is erected on the sidewalk surrounding the public-facing facades.

Staff photo, view to northwest fronting Temple. 04-23-26
