**SR-1 – OBJECTIVE STAFF REPORT (05-29-2026)**

**ADDRESS:** 4252 CORTLAND

**APPLICATION NUMBER:** HDC2026-00169

**SCOPE PHRASE FOR AGENDA:** REPLACE 5 DOORS

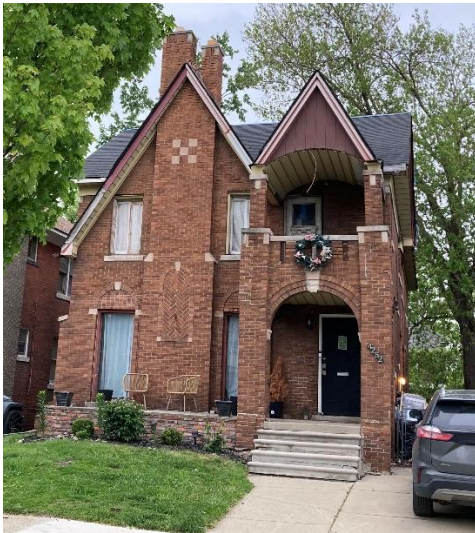
- Staff photo, front of house (south end), May 2026
