# LLCC Clarifications in Response to the HCD Staff Report

July 8, 2020

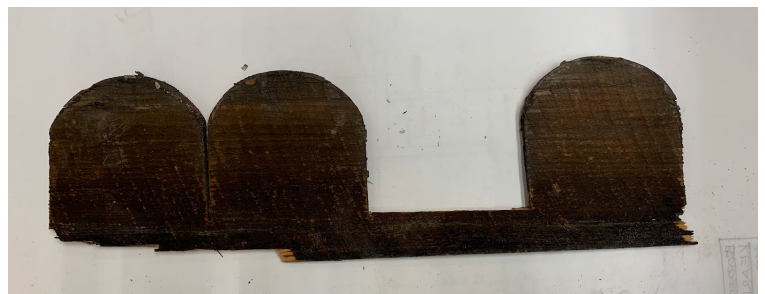
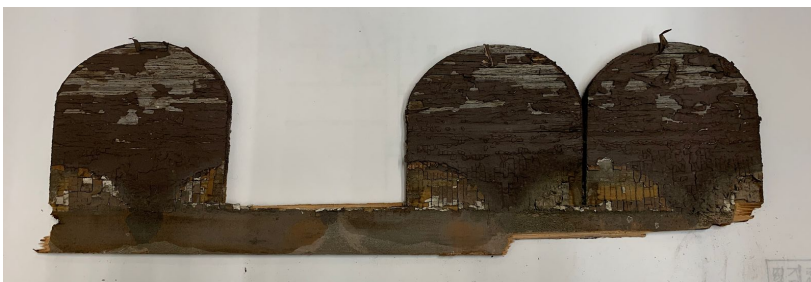
- 1) Existing Siding is Clapboard - We are unclear as to if the current scalloped wood siding is original; however, the material is **not** an individual shingle reminiscent of standard Queen Anne style materials used in other homes on the block. Rather, the current material is a clapboard/panel style, thus removing and replacing single shingles is not an option. Our first attempt at removing a single panel resulted in internal breakage of the panel. We expect significant challenges with not all material breaking and not coming free when removing individual panels.

- 2) Rot Behind Shingles - Another issue we anticipate is rot on the original pine tongue and groove underlayment that lays behind the current clapboard. Interior areas where the walls are open show water damage to underlayment that poses structural integrity issues.

- 3) Single Scallop Exposure - In general the existing panel siding has scallops that are 4" wide with a 5" exposure for individual shingles. We have done extensive research and are unable to find a product that matches these dimensions.

- 4) Different Exposures in Use - In some areas, a previous owner has patched them with a material that has 5" side scallop. We believe this is due to the difficulty of emulating a clapboard with 4" wide scallop. Generally, these patched areas show a poor design aesthetic that detract from the original intent that the siding have a cohesive exposure throughout.

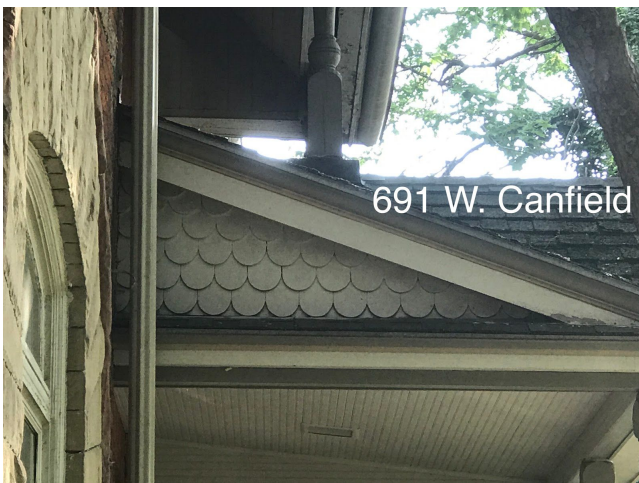
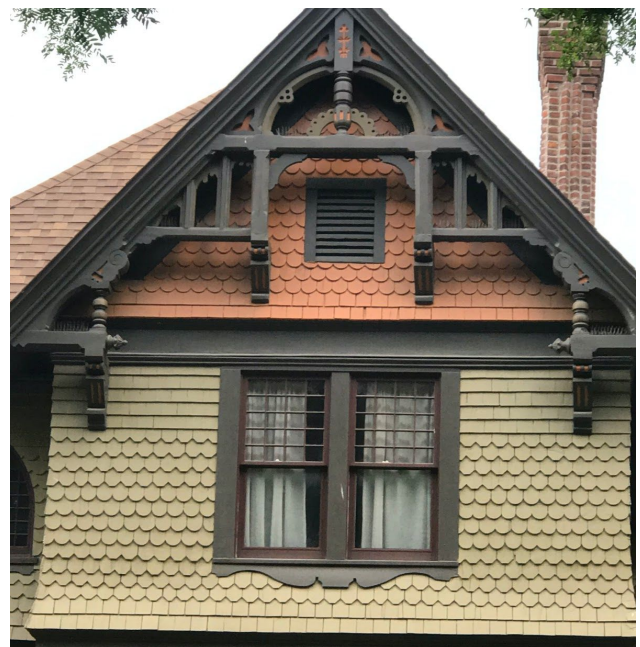
*Note - we believe that exposures of 5" and greater are still historically accurate and seen in other homes on the West Canfield block (see photos below)*

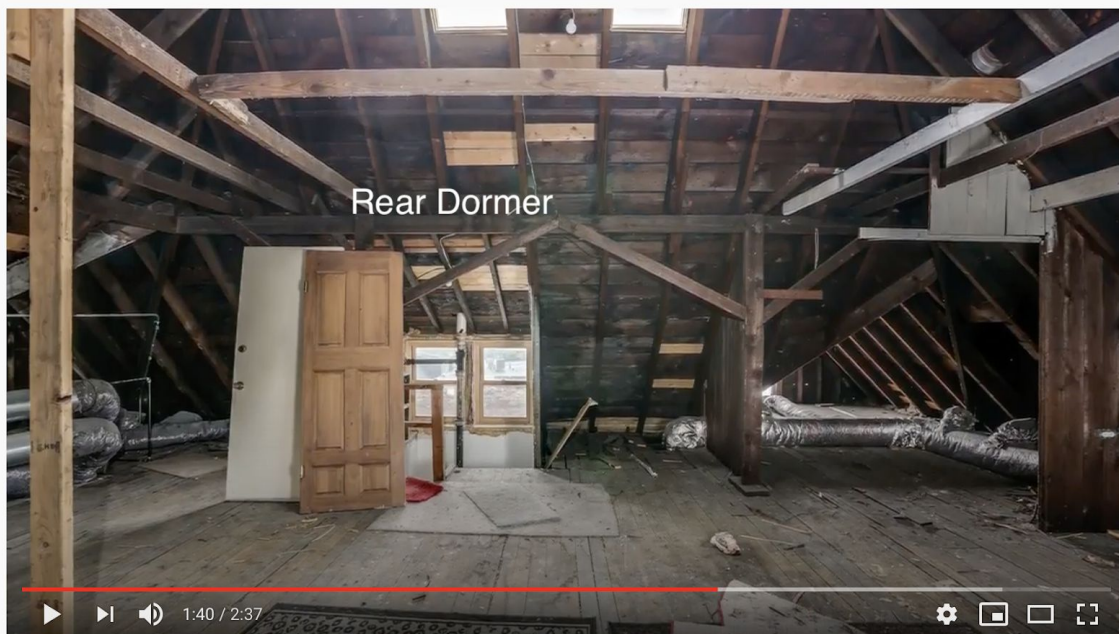
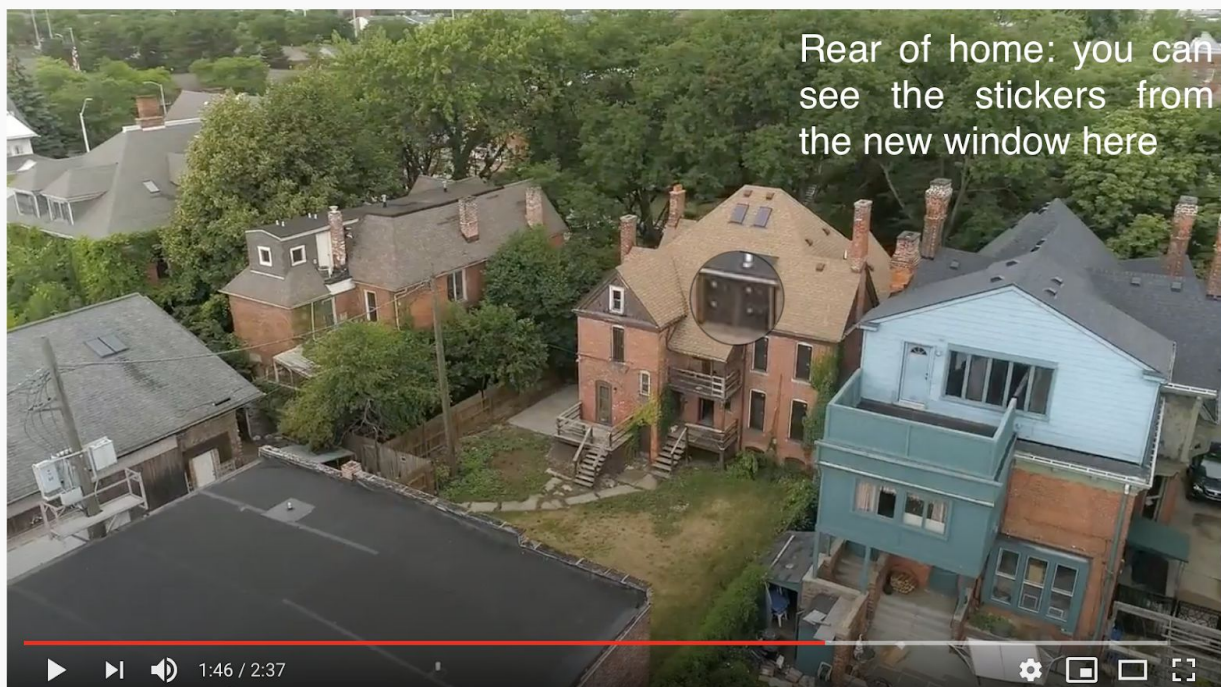
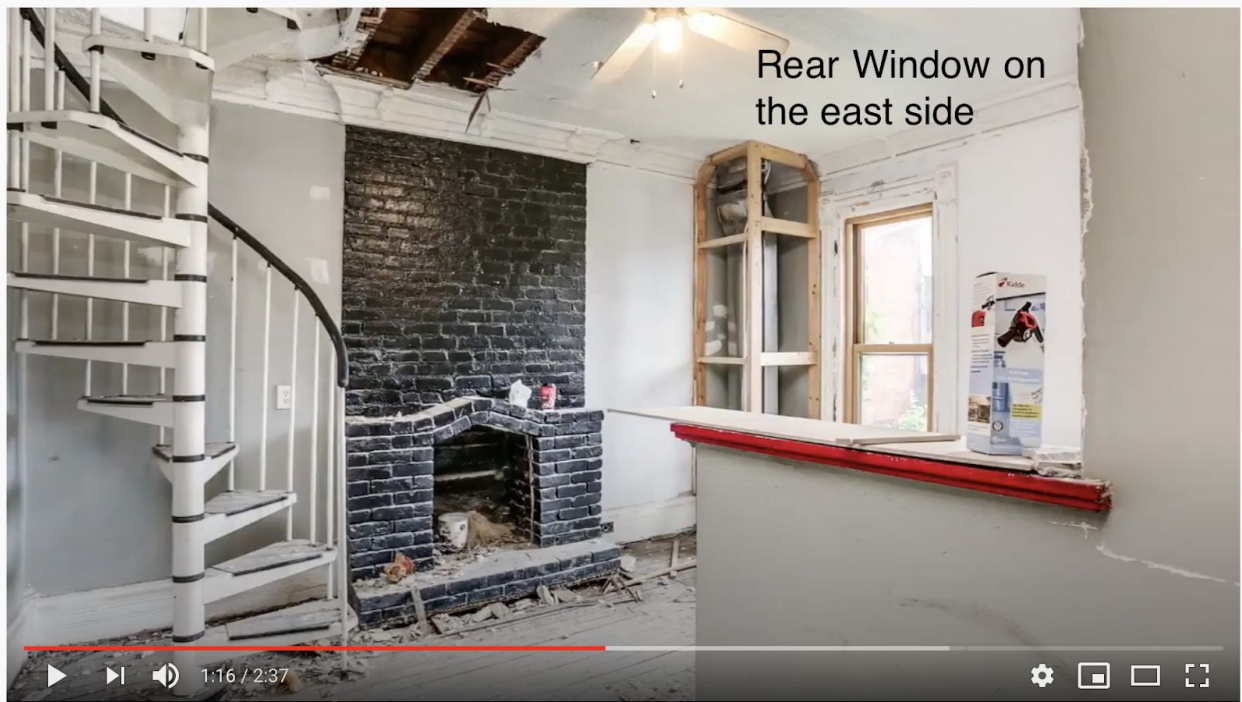
Rear Window on the east side

1. Rear windows were installed before the homeowners purchased the house.
2. Here is a video from Hawkins Reality, who sold the home last to Matt and Kelli.
  - a. <https://youtu.be/IATXLUBSHMI?t=70> see 1:15, 1:39, 1:48 for view of windows prior to purchase of the house
  - b. This video was posted on August 2, 2018 prior to when they purchased the home in September 2019. See photos below
