HISTORIC DISTRICT COMMISSION PROJECT REVIEW REQUEST

1991 West Chicago Blvd Detroit, MI

1991 West Chicago Boulevard

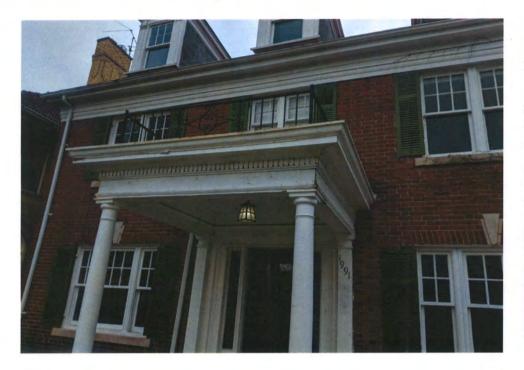
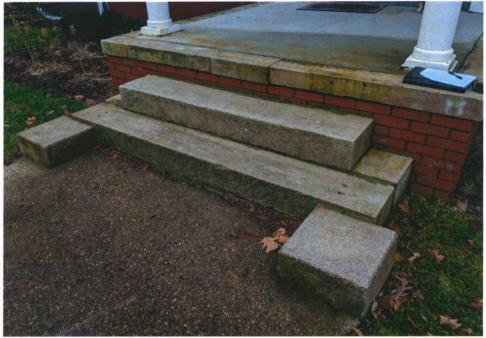
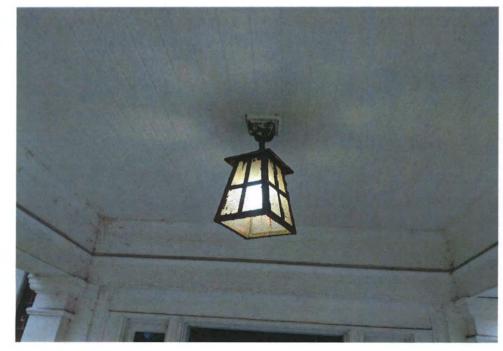
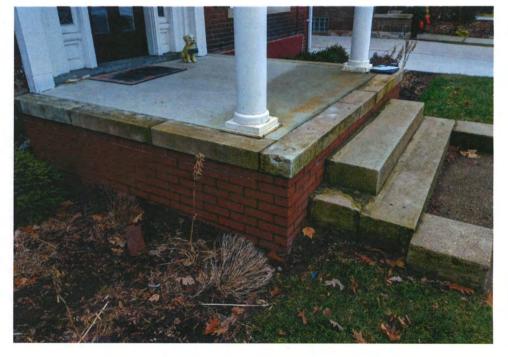
1991 CHICAGO BLVD NOW

- 1) Wings of porch removed. The wings were collapsing due to failing footings (See attached photo). The wings could not have been repaired. They would have had to be completely re-built. In order for us to do so we would have had to dig out the old footings and pour new ones and re-build from that point. Rebuilding the wings would have added \$20,000 to the cost of the porch rebuild. This would not have made financial sense considering the value of the home. The main porch's footings were in good shape so we were able to just rebuild the brick work etc. for the center porch. In respect to the old footings, we dug them out and removed to accommodate installation of the new landscaping and grading from the exterior walls of the house. We also used as much of the original porch materials as possible in the re-build which is evident in the photos.

- 2) Railings on wings of porch removed. The railing was corroded and damaged, but intact, on the left wing but none attached to the right. The vintage of the railing was undetermined.

- 3) Columns reduced from 4 to 2. The two interior columns were rotted out and could not be salvaged. The exterior columns were able to be salvaged and re-built/repaired.
