Project :
**RESIDENTIAL DUPLEX
 EXTERIOR REPAIR
 7949 E. LAFAYETTE ST.
 DETROIT, MI 48214**

Sheet Title :
**EXTERIOR REPAIR
 WORK**

Sheet No. :
A3.1

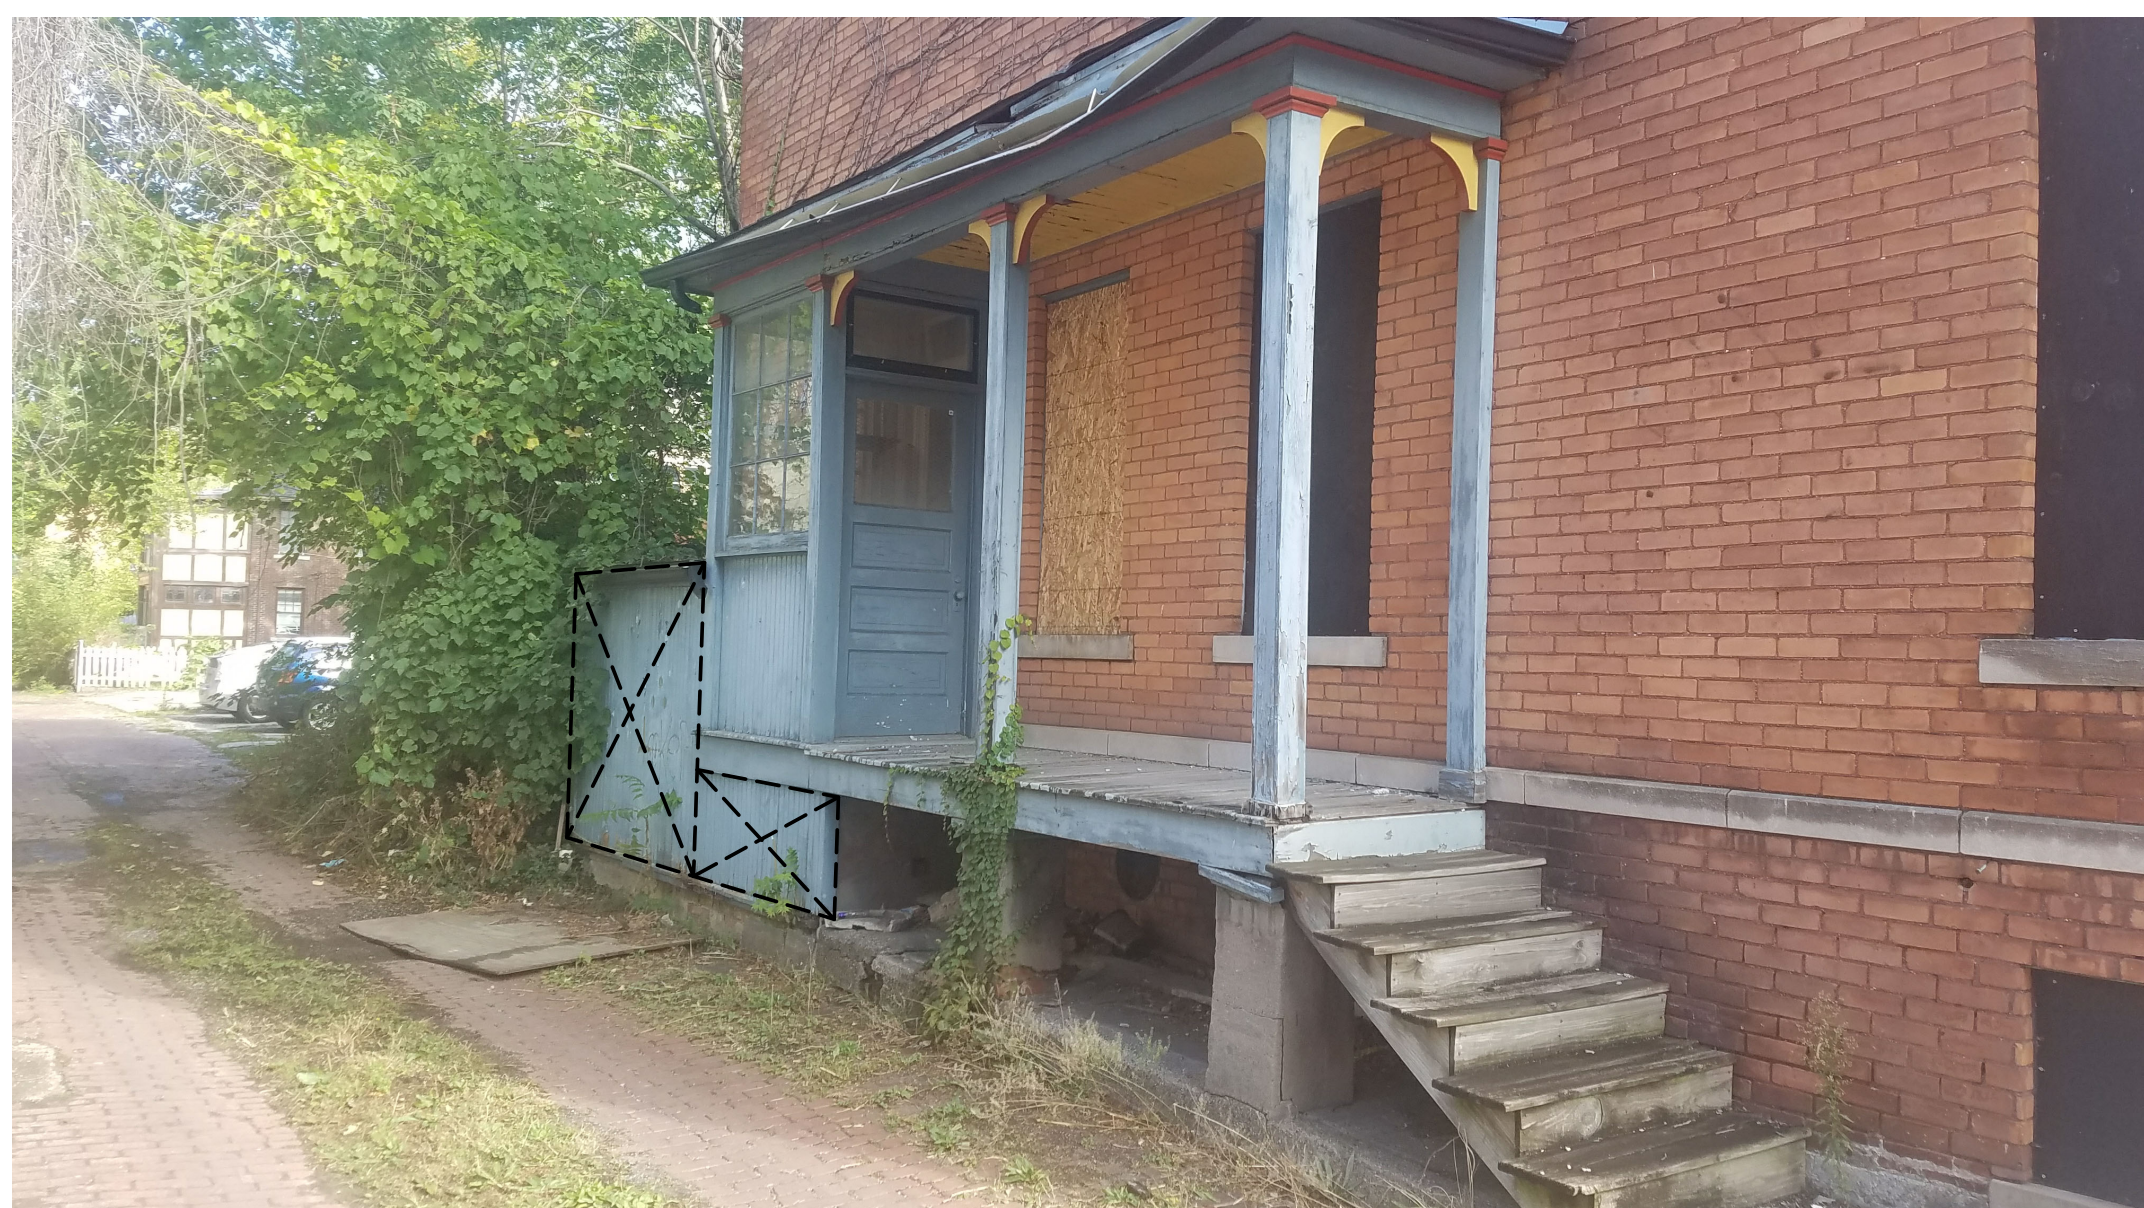
EXISTING PORCH AND BASEMENT STAIR ENCLOSURE (IDENTICAL ON BOTH SIDES OF THE BUILDING)

BASED ON OBSERVATIONS OF MORE MODERN FRAMING MEMBERS WITHIN THE BASEMENT STAIR ENCLOSURES, WE BELIEVE THESE WERE ADDED AFTER THE COMPLETION OF THE BUILDING.

THE PROPOSAL IS TO REMOVE THE REAR ENCLOSURES OF THE BASEMENT STAIRS AND INSTALL A LIMESTONE CAP ON TOP OF THE BRICK STAIR ENCLOSURE FOUNDATION.

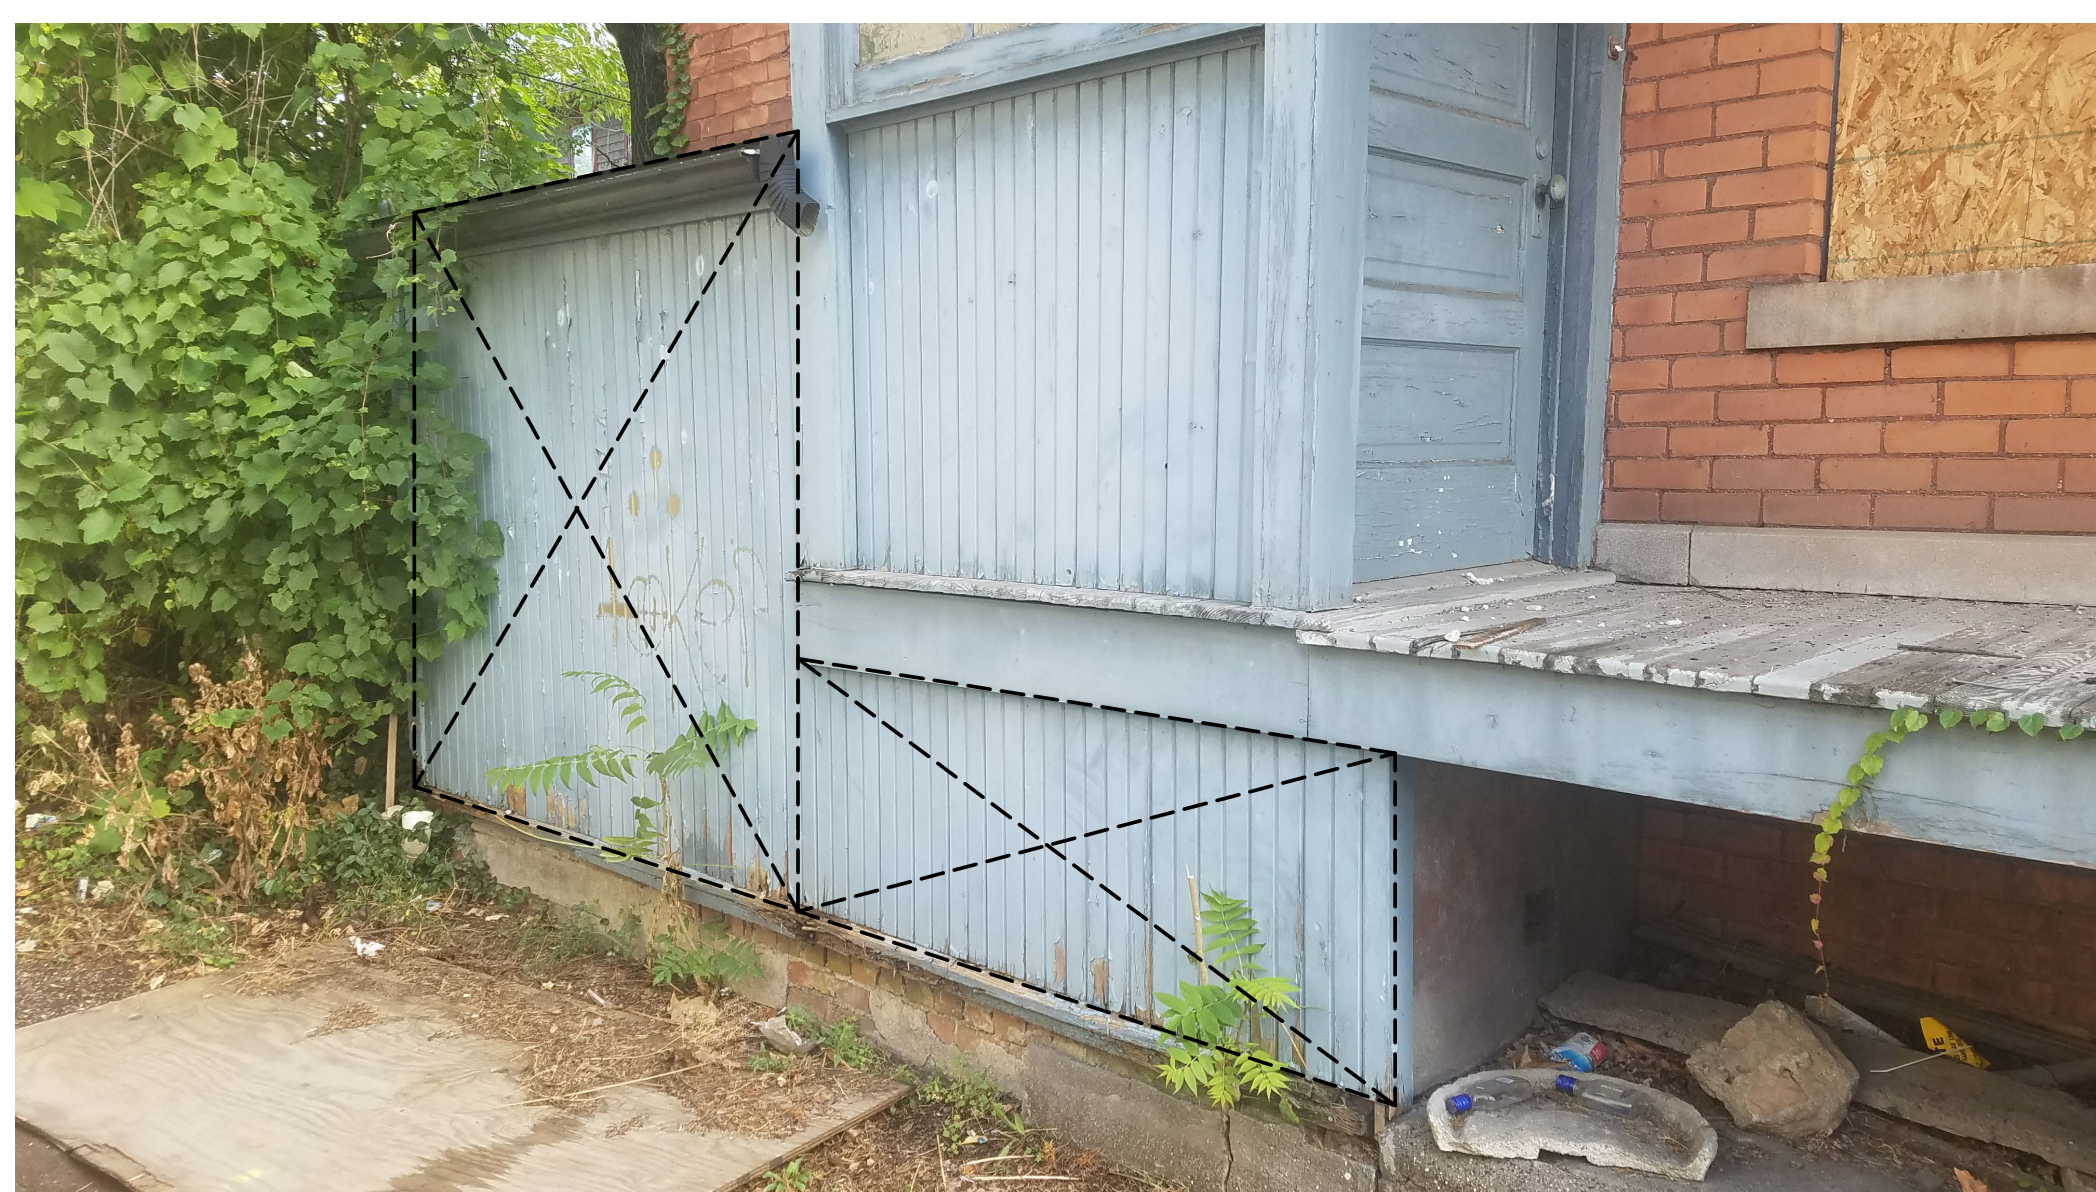
BASEMENT STAIR ENCLOSURE CLADDING TO BE REMOVED
