**Supporting Information for Application to Replace Historic Windows at**

**1437 Vinewood Street Detroit, MI 48216**

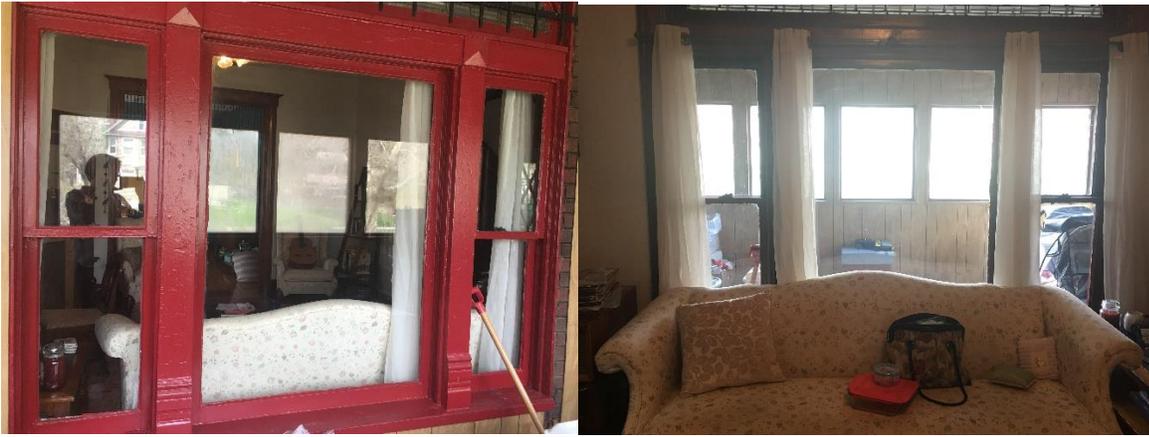
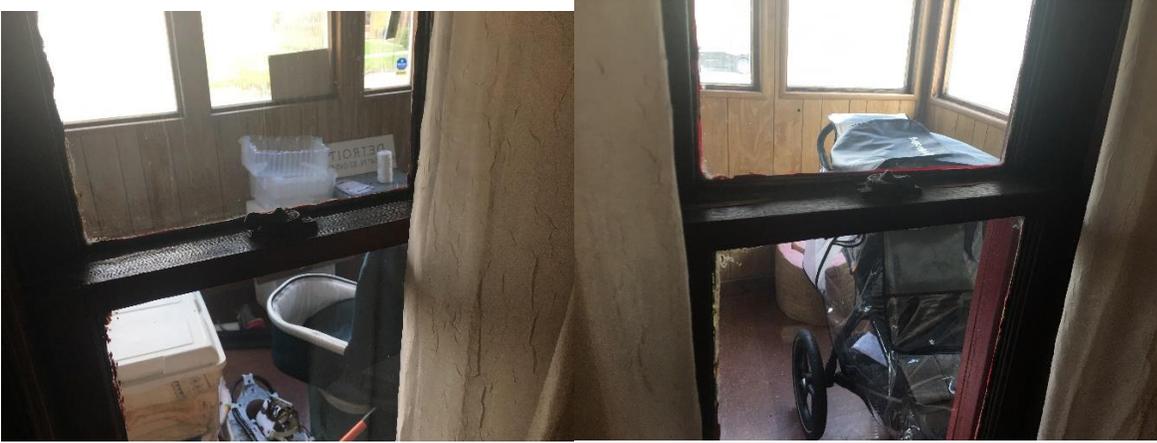
3 windows to be replaced inside covered porch on front of house (Northeast Side)

It should be noted that three of the windows that the Applicants are requesting to replace are not exterior windows. They are enclosed by the front porch mentioned before. The Applicants are not certain they should be including those windows in this application, but they wanted to just to be safe. None of the windows that Applicants are asking to replace can easily be viewed from the street.

- Replace 1 wood, picture window inside covered porch on front of house (Northeast Side) with 1 vinyl, picture window.
- Replace 2 wood, double-hung windows inside covered porch on front of house (Northeast Side) with 2 vinyl, double-hung windows.
- Replace 1 wood, double-hung window on southeast side of house facing front of house (Northeast Side) with 1 vinyl, double-hung window.
- Replace 2 wood, double-hung windows on southeast side of house facing southeast side with 2 vinyl, double-hung windows.
- Replace 1 wood, double-hung window on northwest side of house facing northwest side with 1 vinyl, double-hung window.

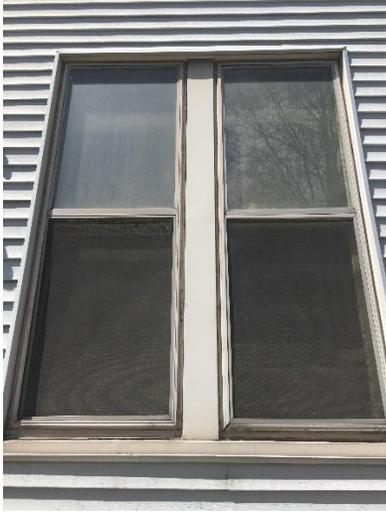
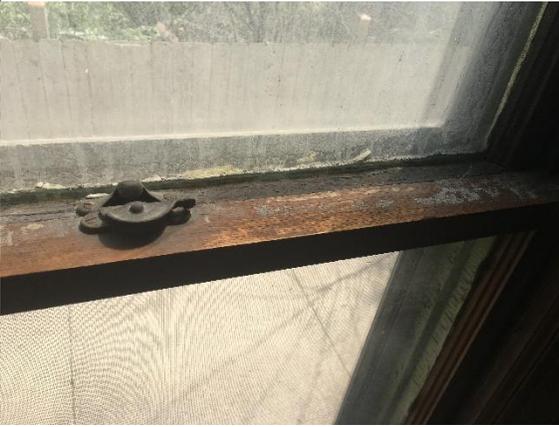
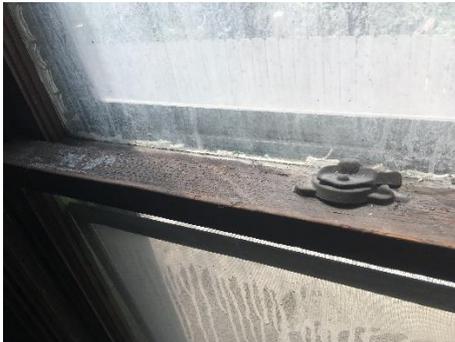
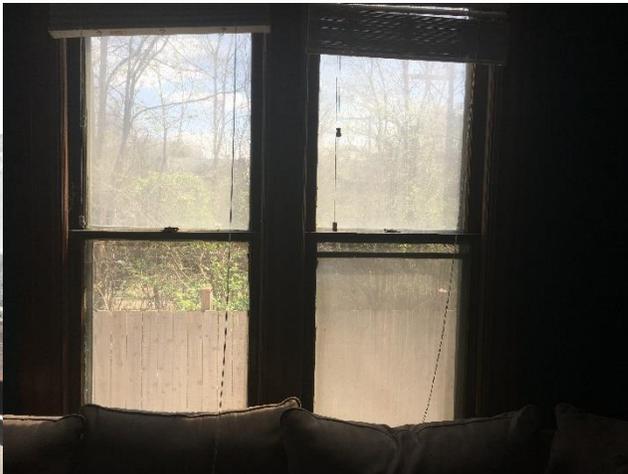
2 windows to be replaced on southeast side of house facing southeast

The remaining seven windows are wood, and the Applicants believe them to be historic. Those windows are deteriorating. The Applicants have made attempts to insulate the walls and areas around the windows, but there are still air leaks coming from the windows. The Applicants want to replace those seven wood windows with vinyl windows to match the character of the existing attributes of the home.
