691 W Canfield

691 W Canfield SCOPE OF WORK

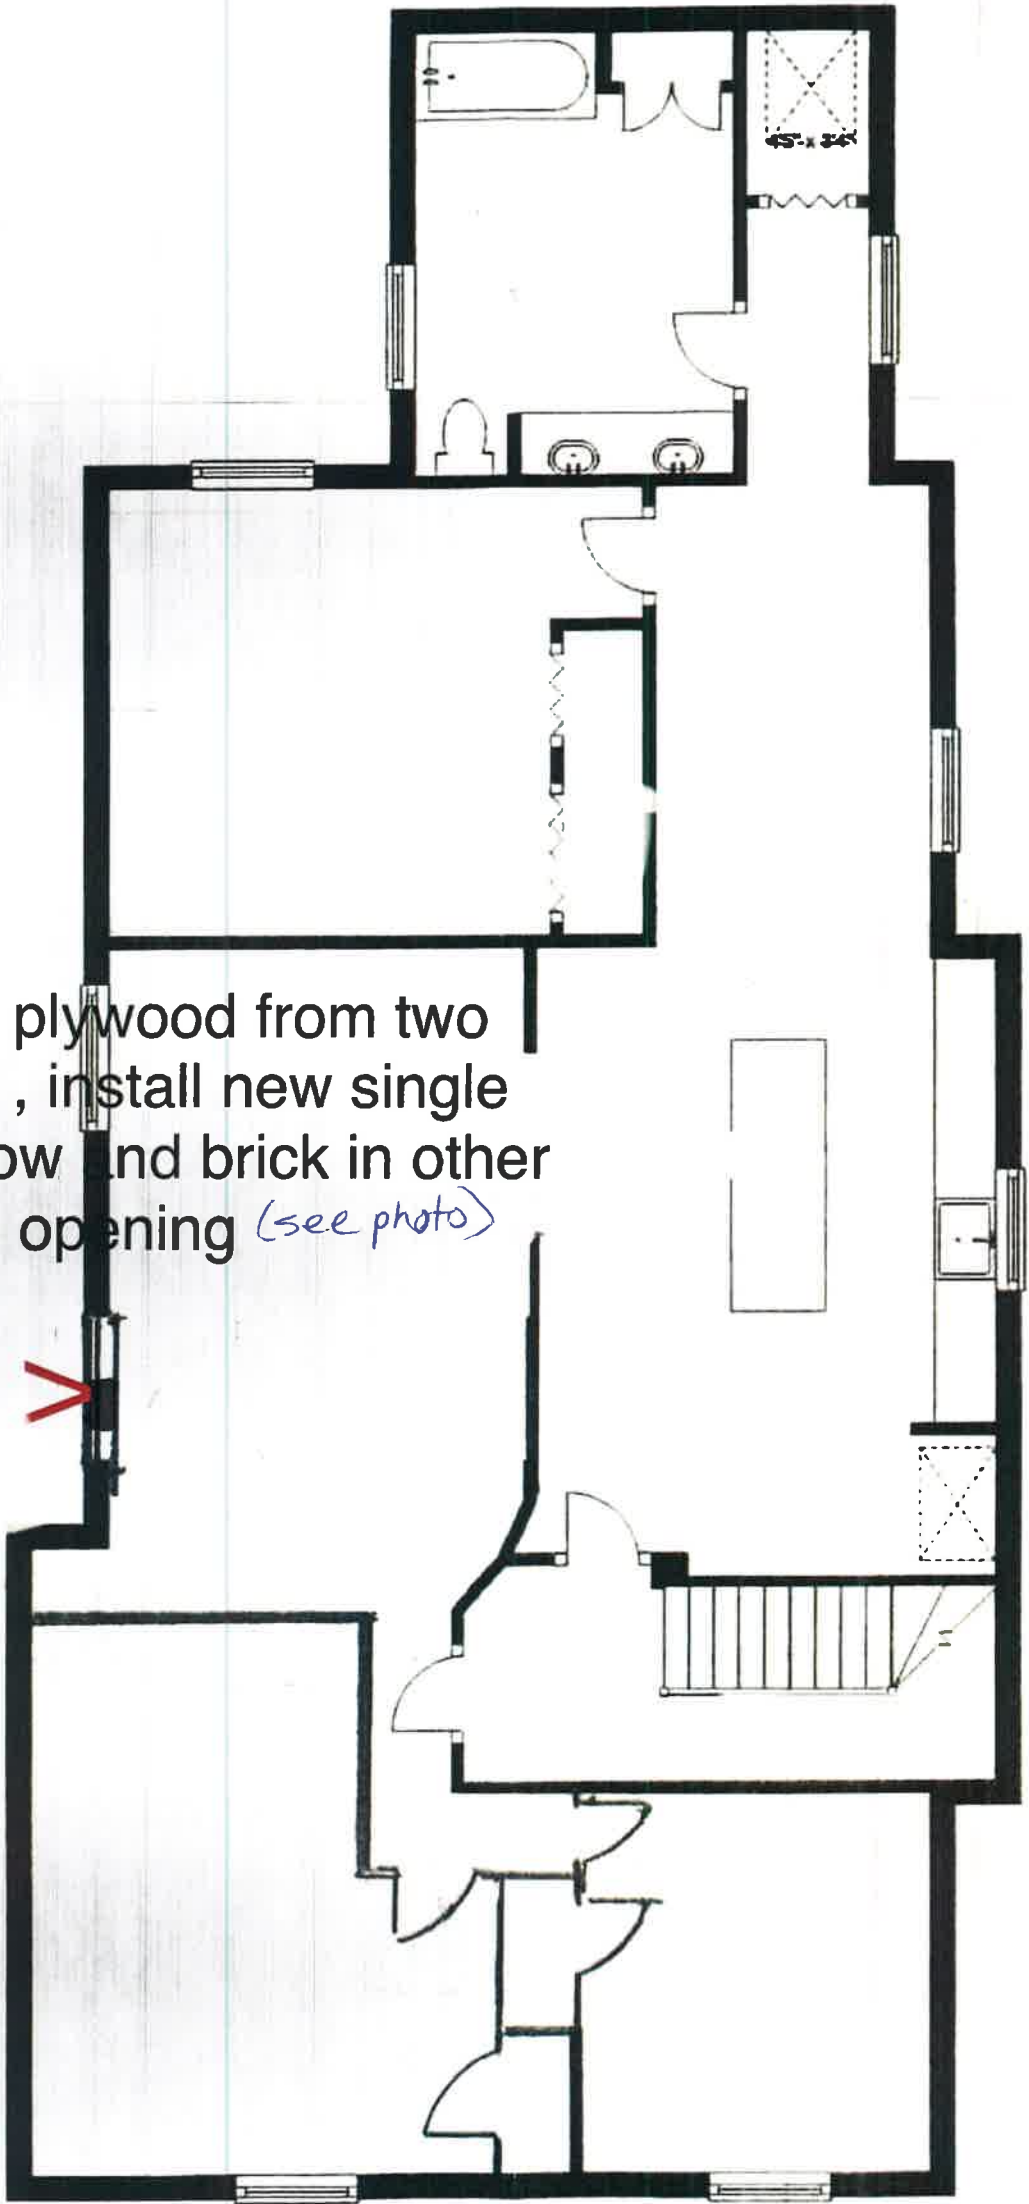
II.

Remove plywood from two openings , install new single hung window and brick in other opening (see photo)

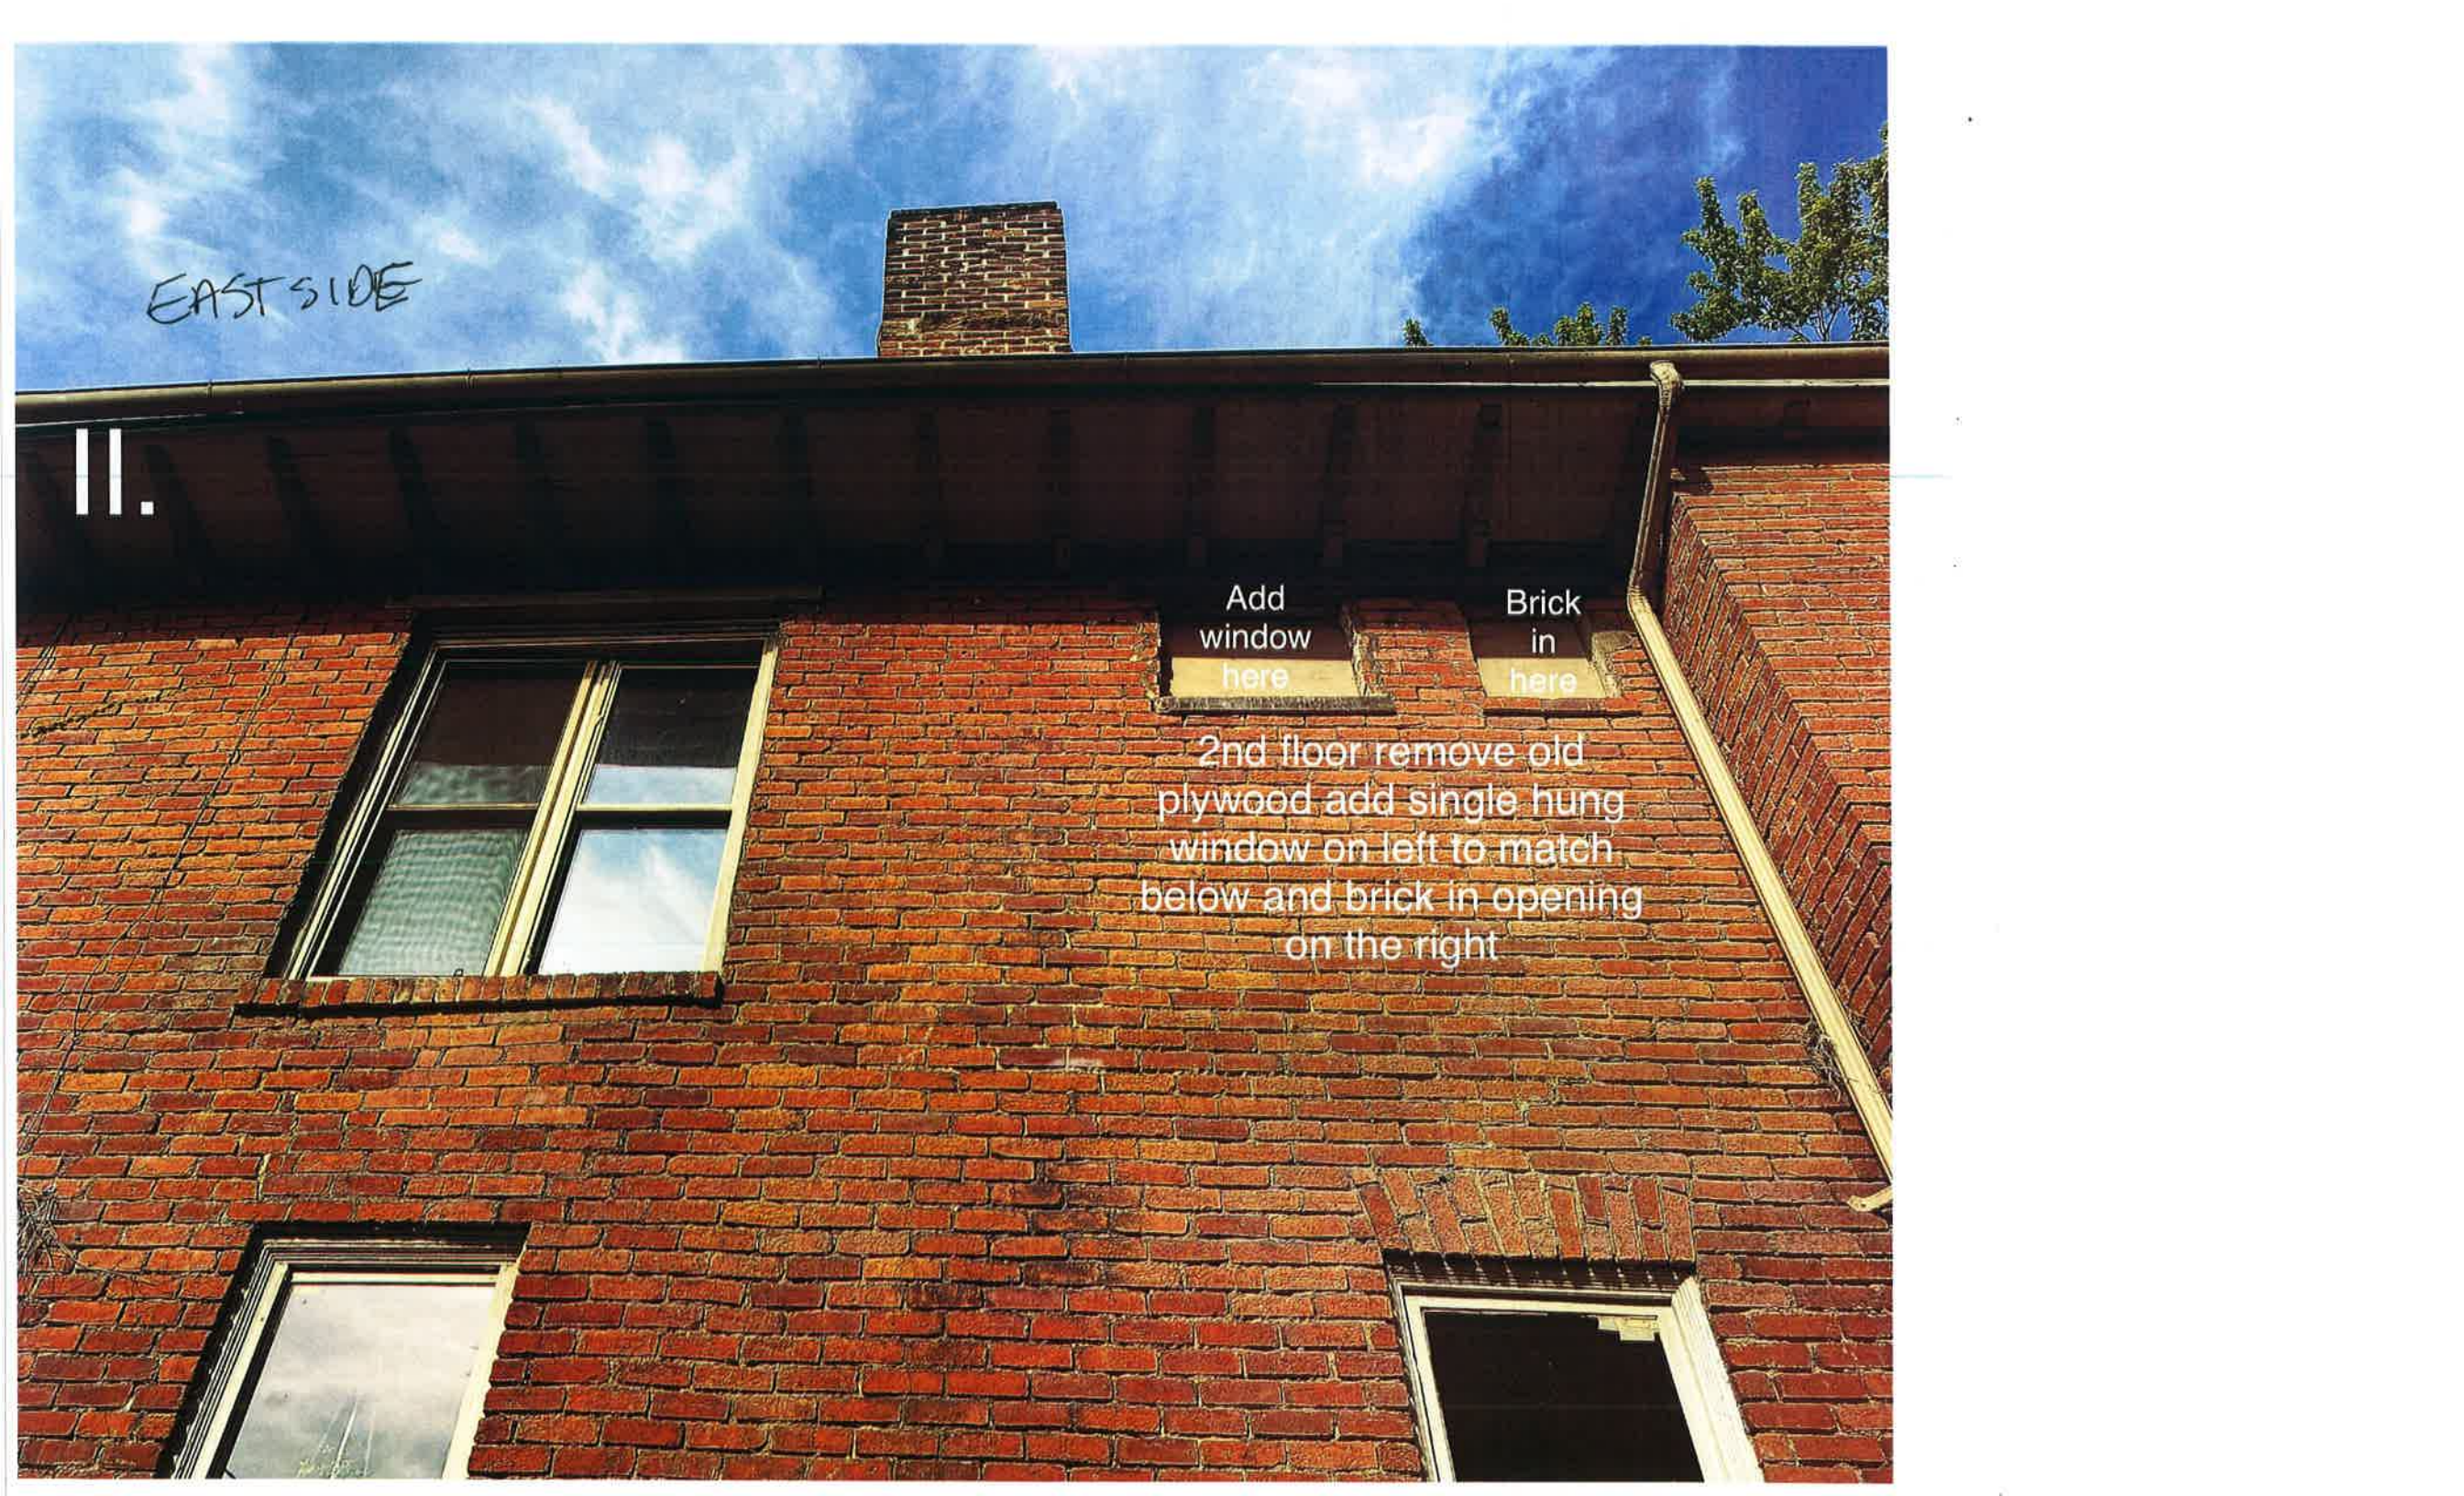
Add window here

Brick in here

2nd floor remove old plywood add single hung window on left to match below and brick in opening on the right

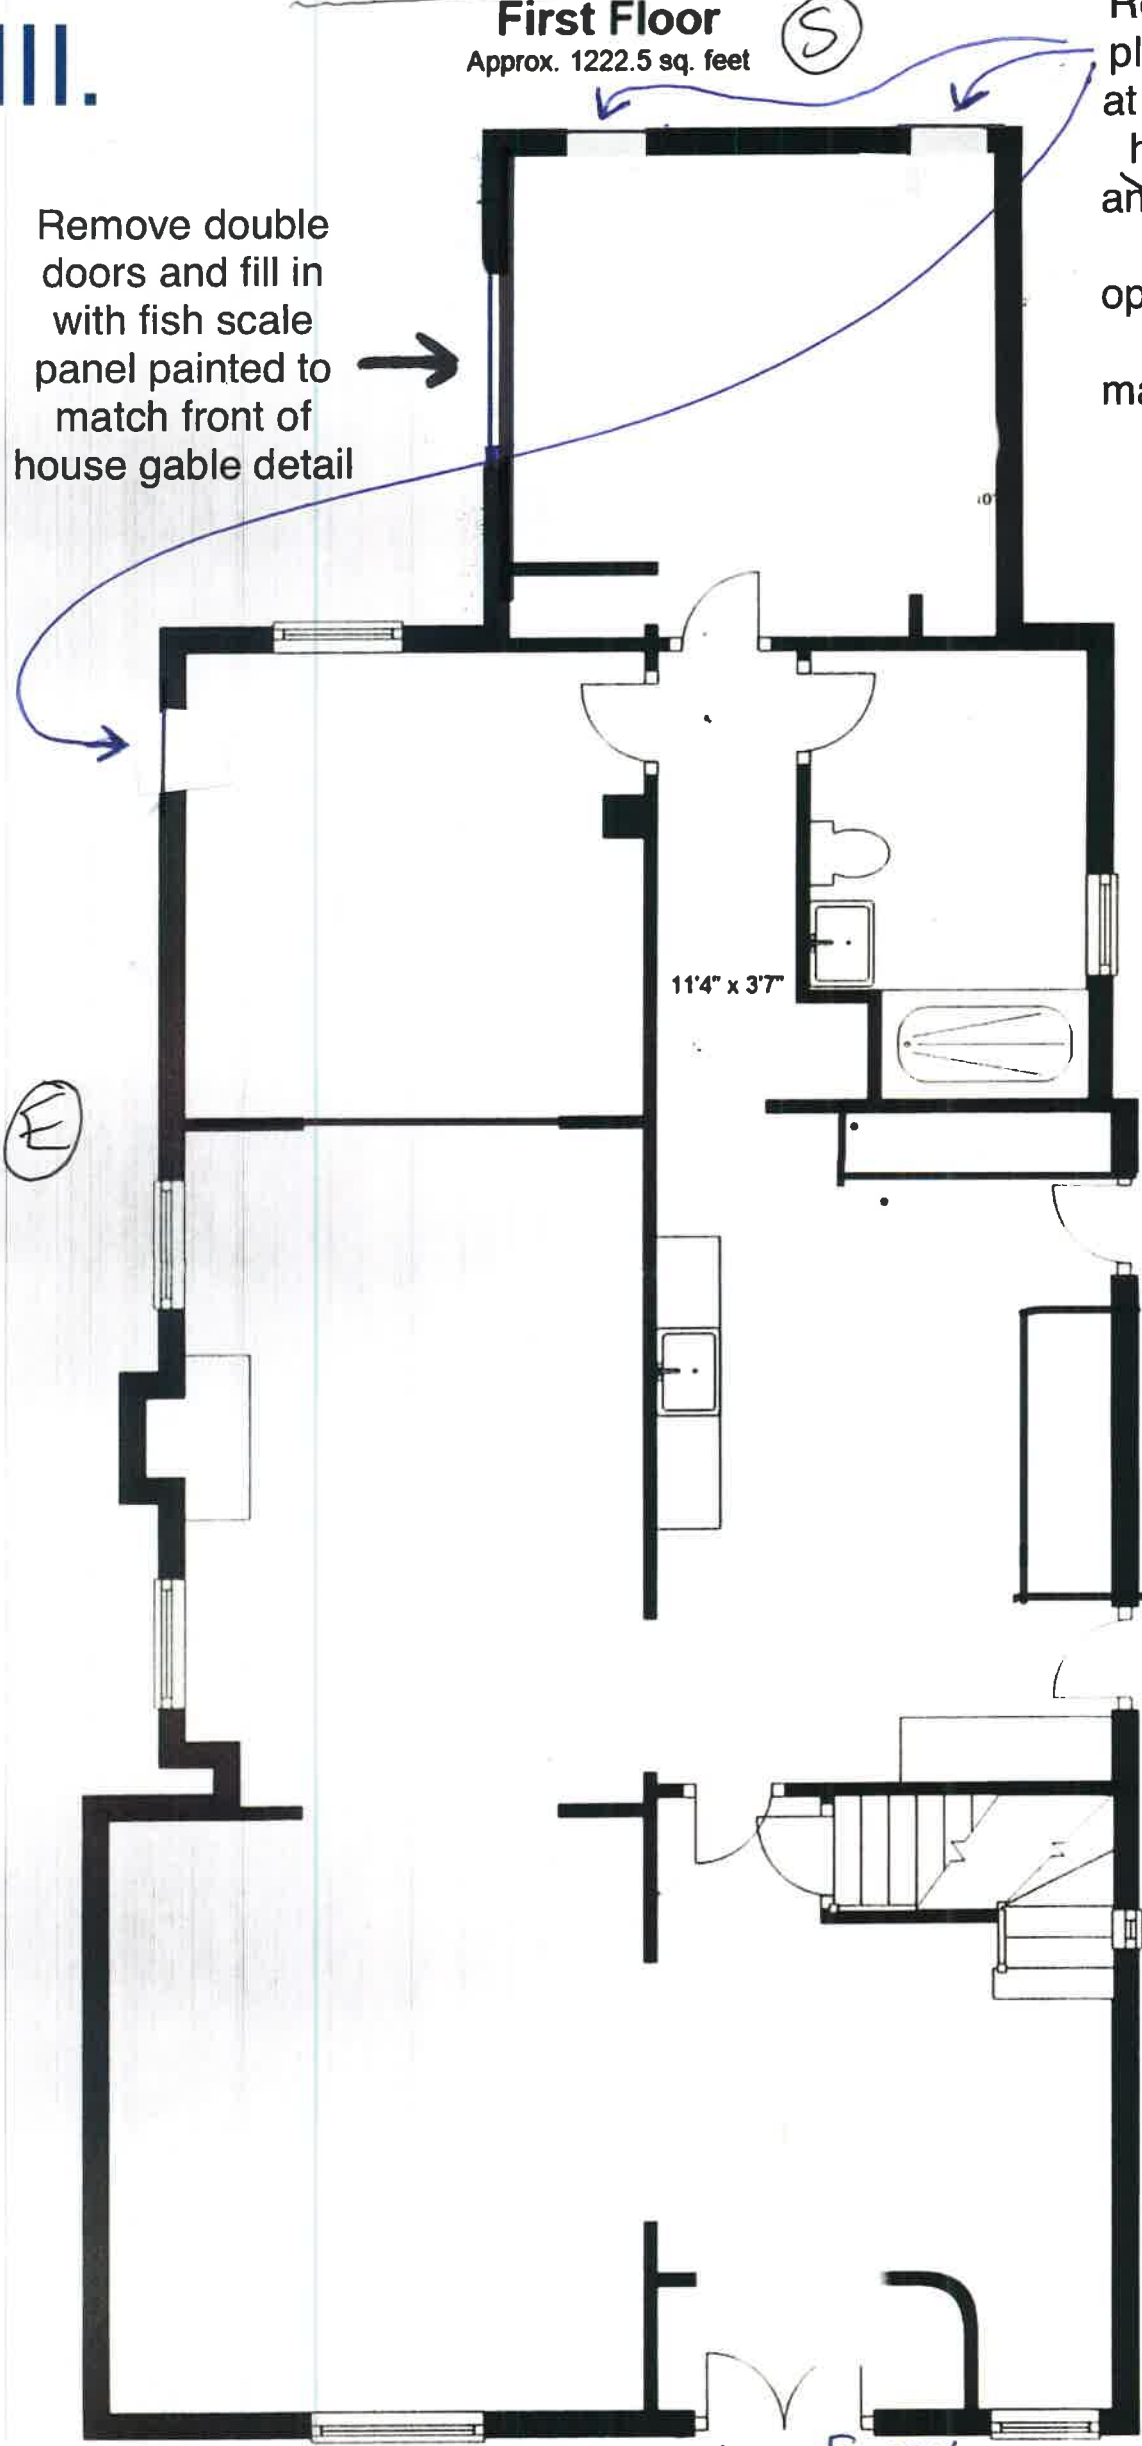
III.

Remove plywood at rear of house and brick in 3 openings with matching brick

Remove double doors and fill in with fish scale panel painted to match front of house gable detail

porch roof - new shingles

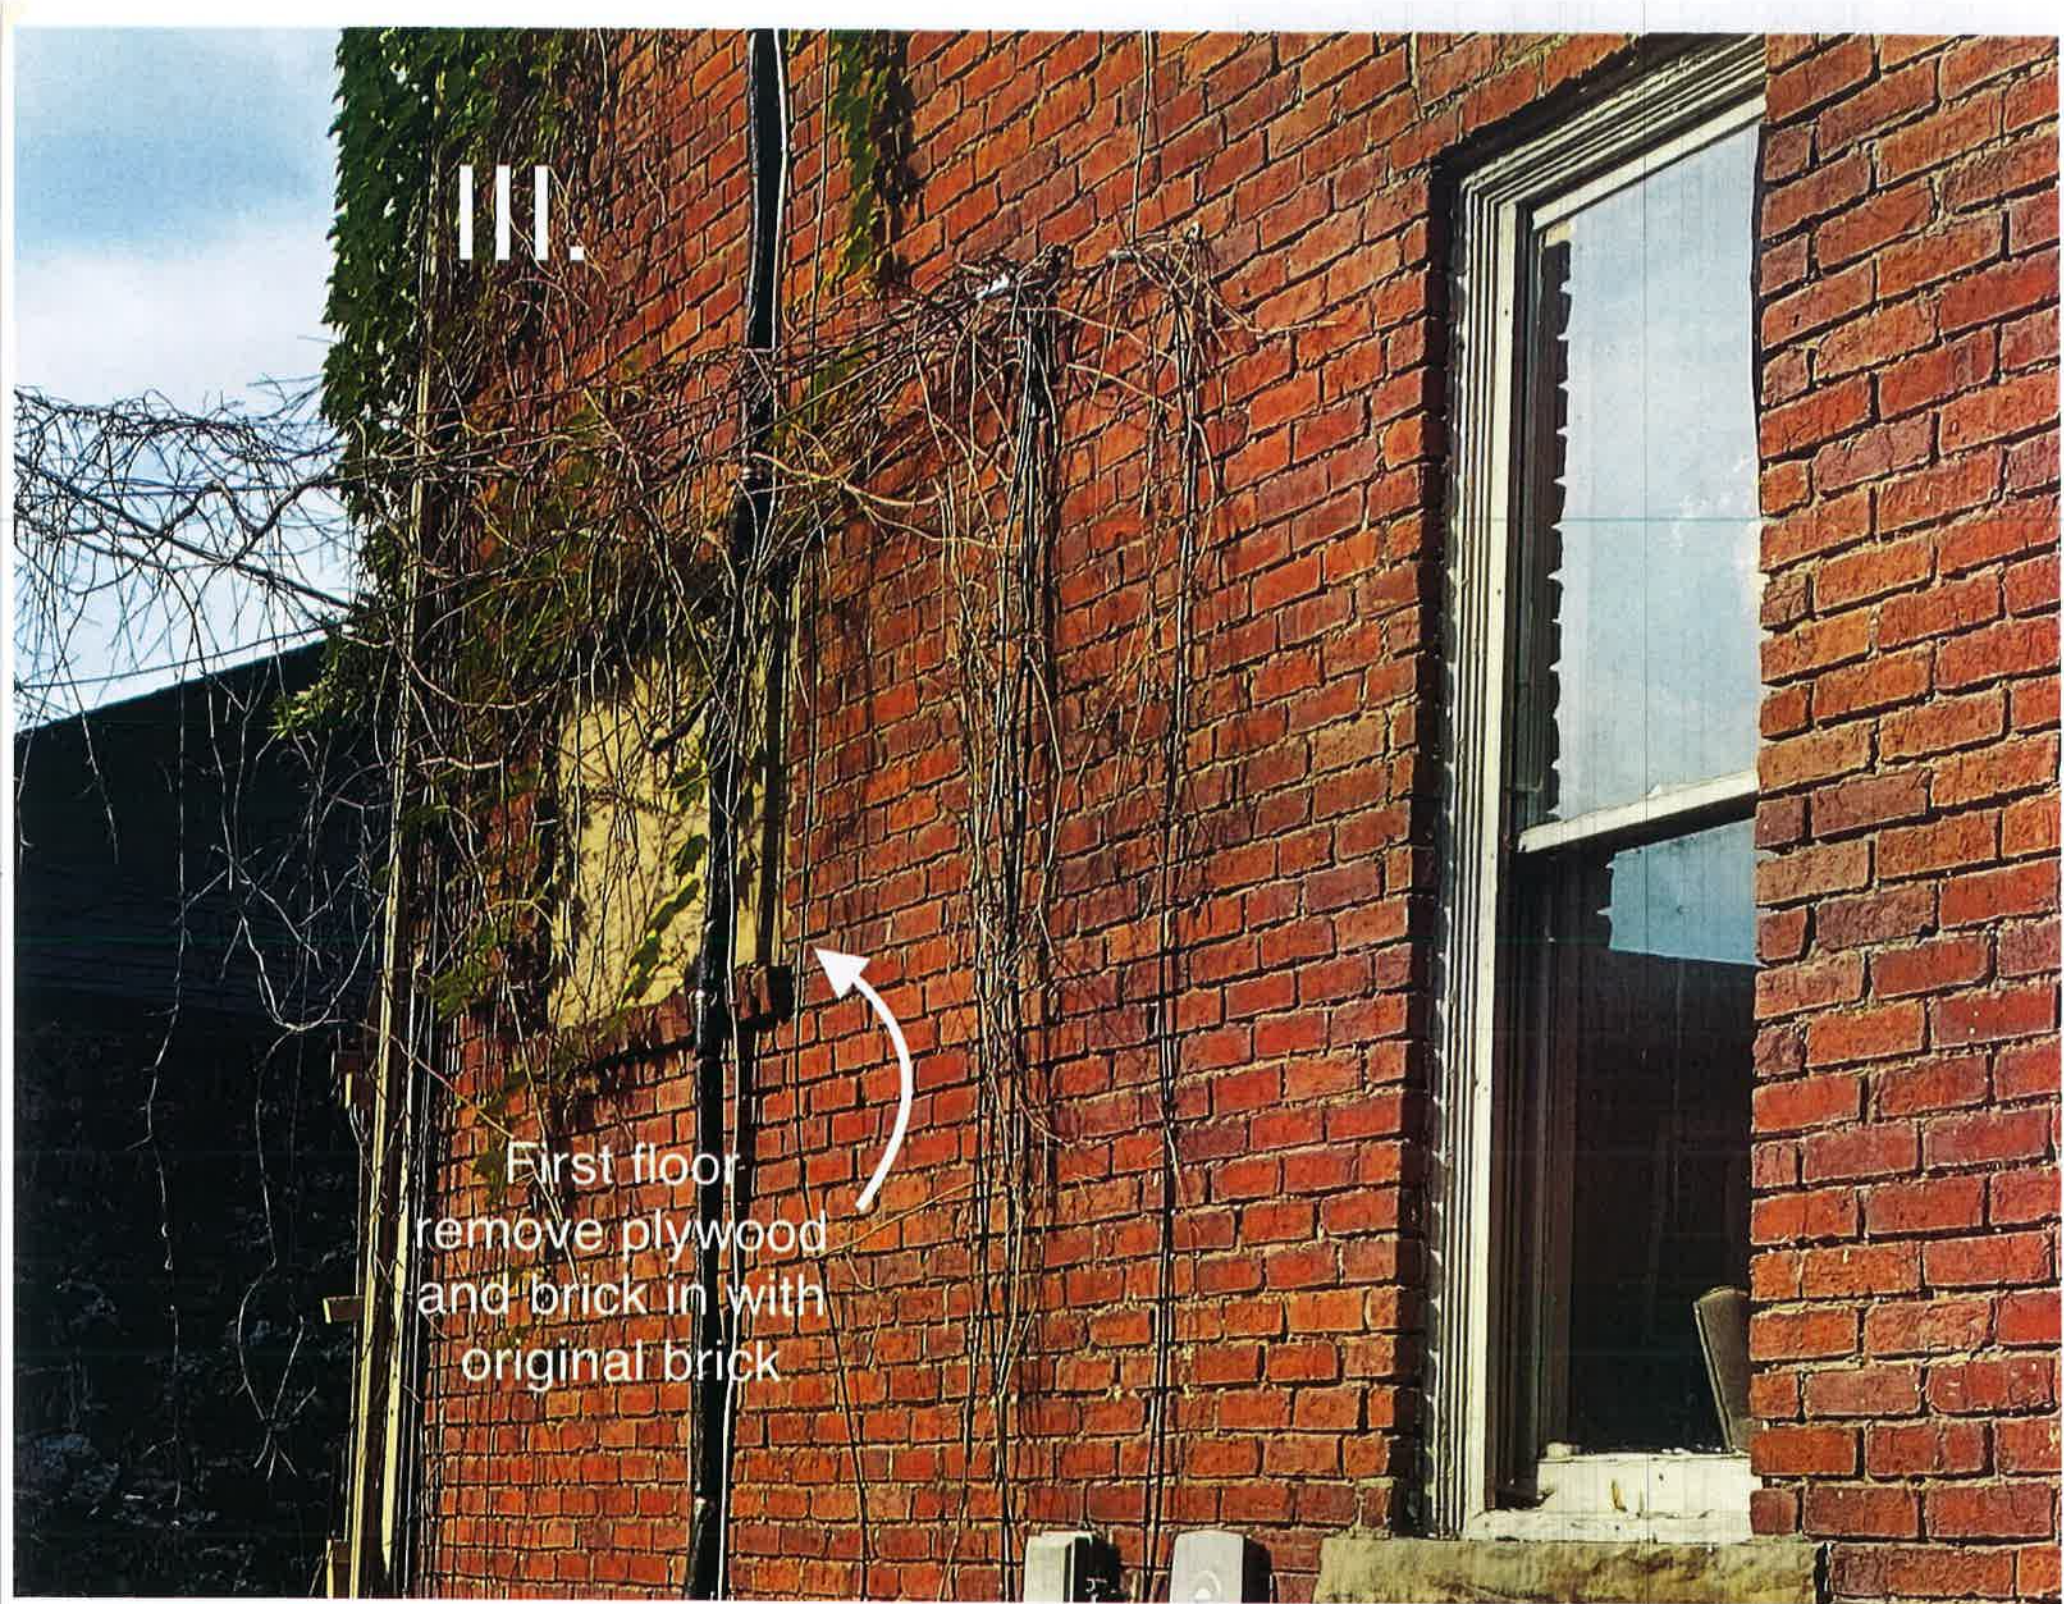
III.

First floor
remove plywood
and brick in with
original brick

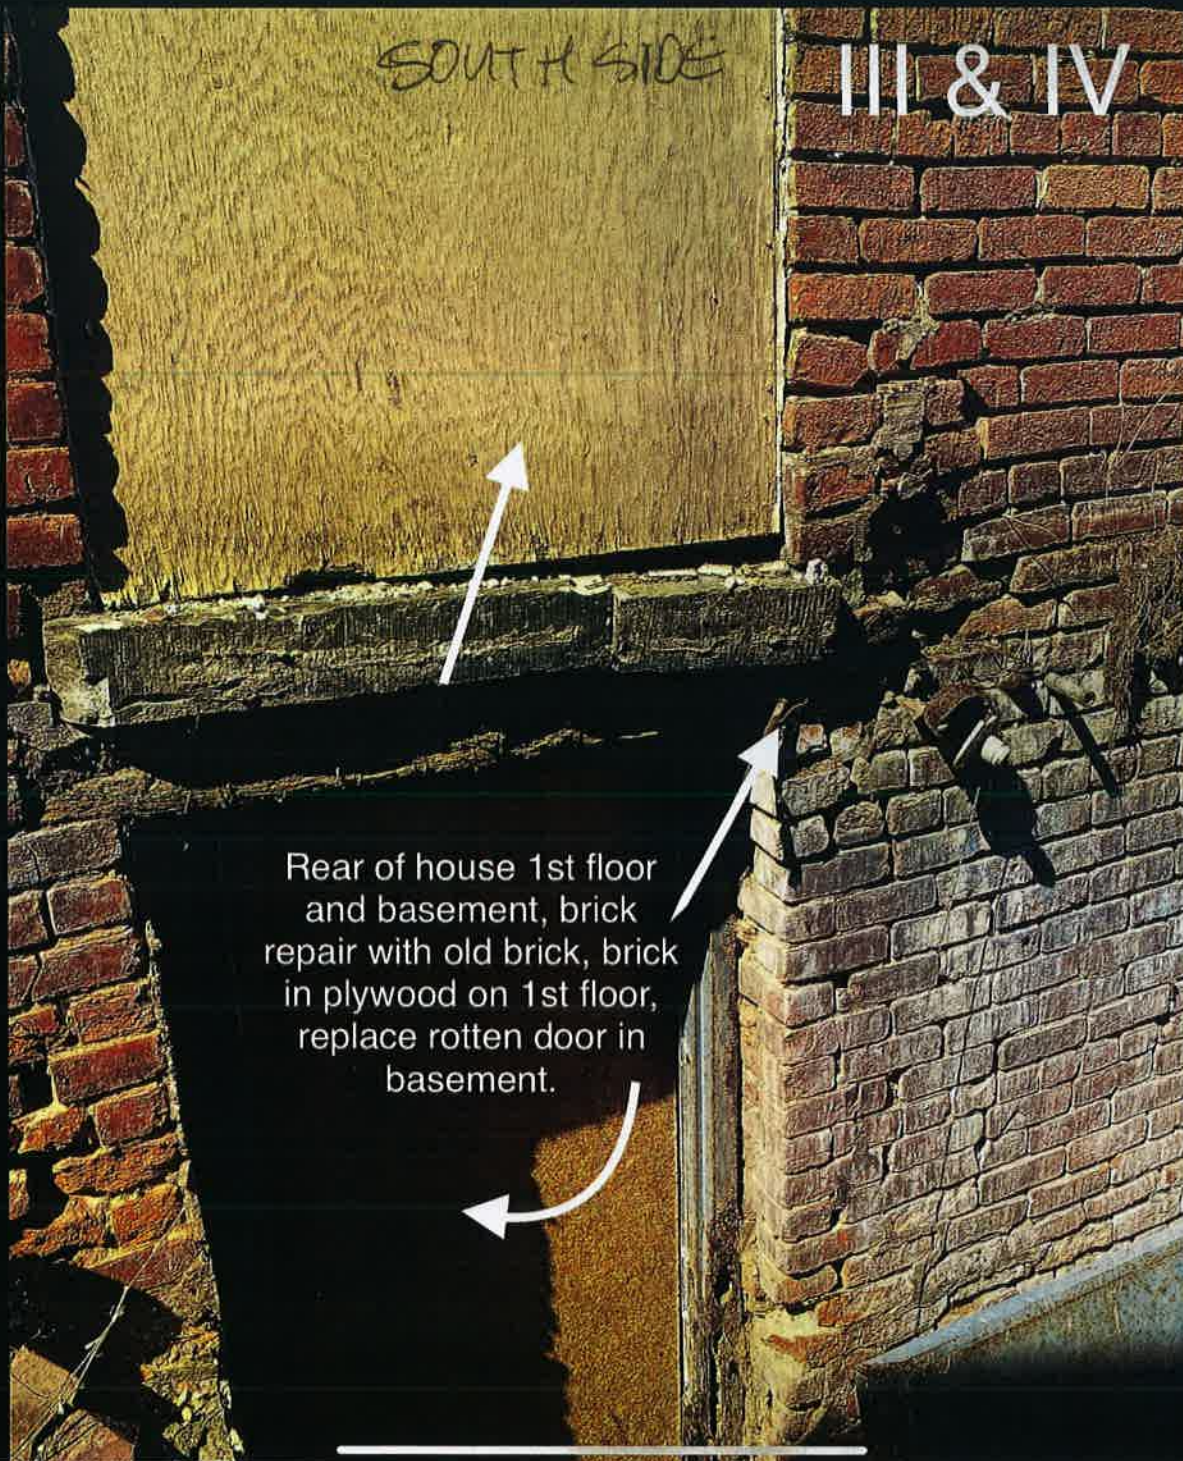
Rear of house 1st floor
and basement, brick
repair with old brick, brick
in plywood on 1st floor,
replace rotten door in
basement.

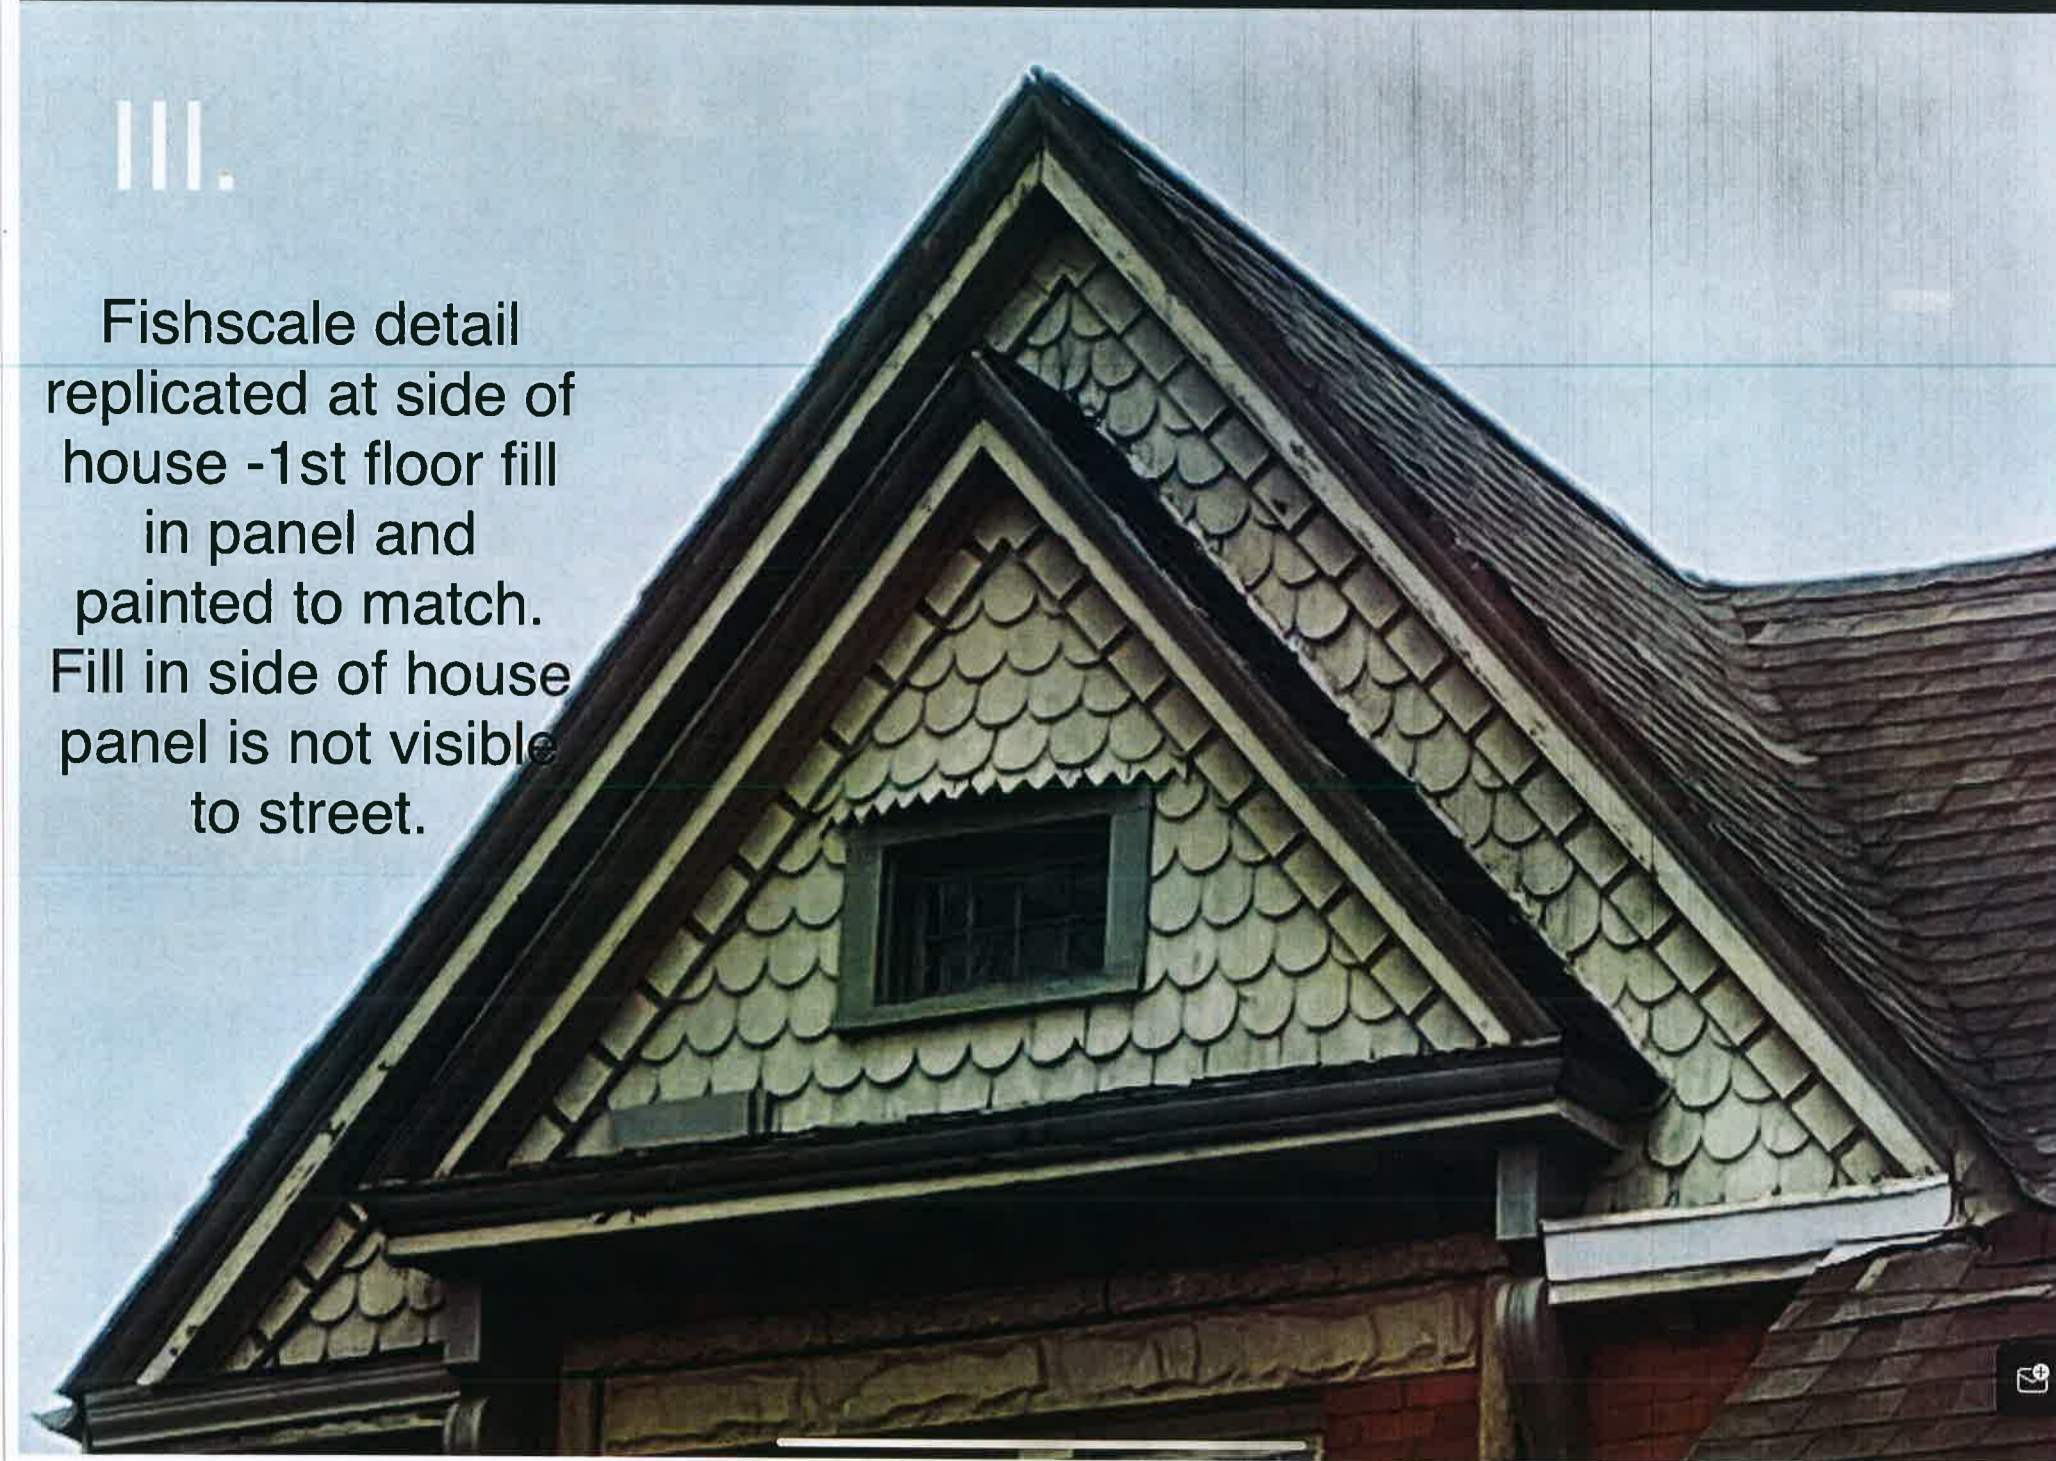
III.

Fishscale detail replicated at side of house - 1st floor fill in panel and painted to match. Fill in side of house panel is not visible to street.

1st floor, remove rotten doors, fill in with fish scale panel to match front of house and paint to match

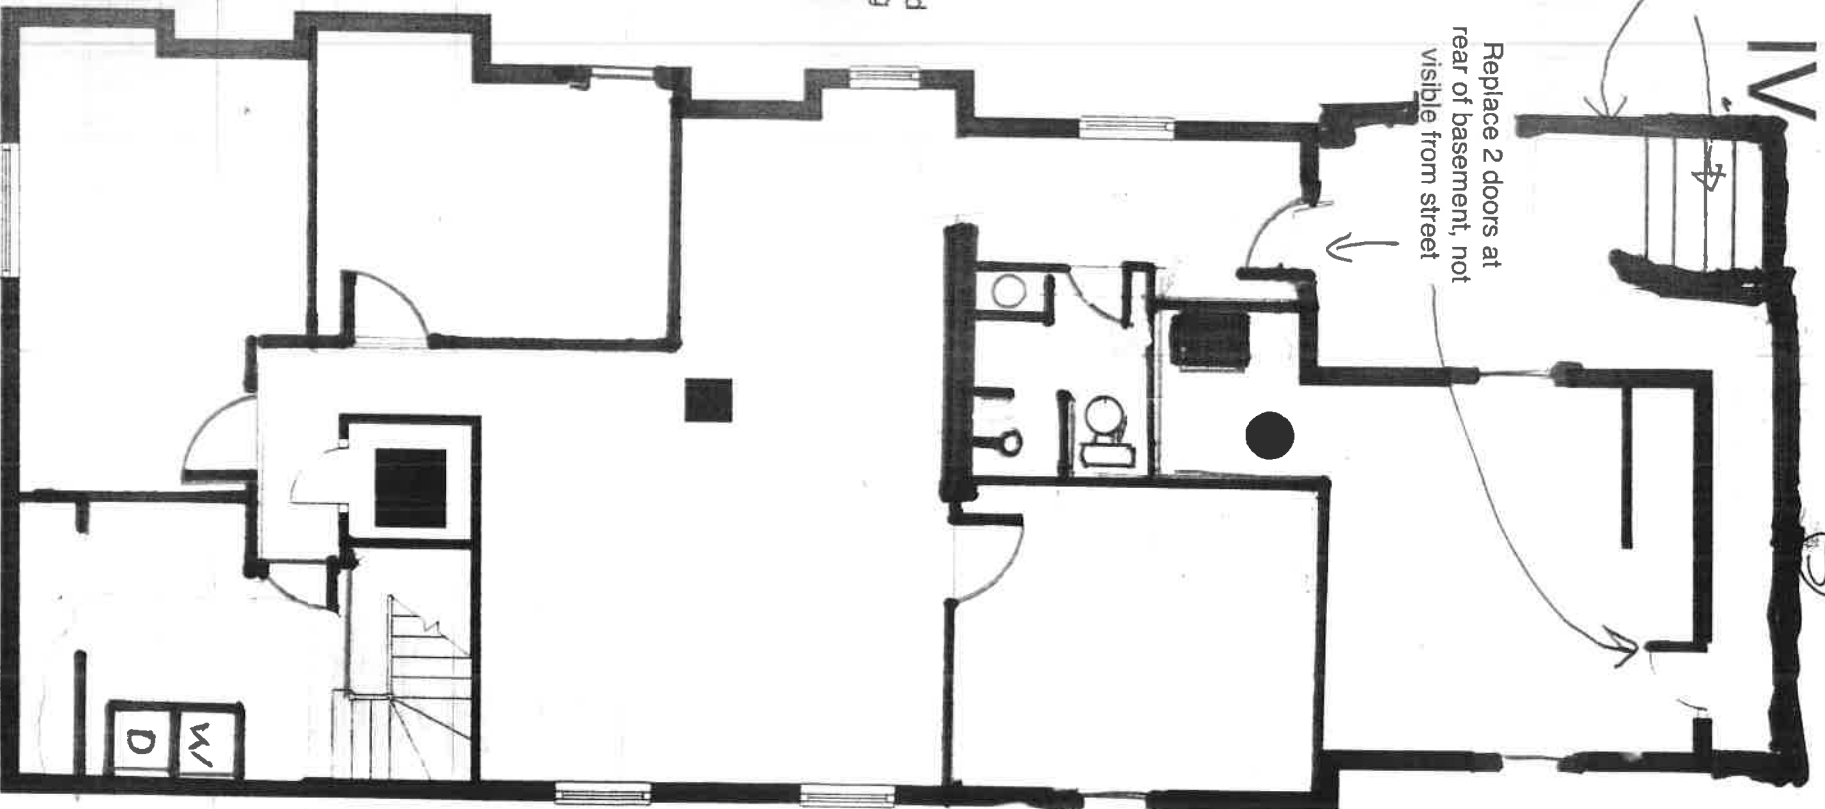
Existing concrete
Foundation. Add new
wooden exterior
stairs

Replace 2 doors at
rear of basement, not
visible from street

Uncover window and
replace with new
egress window.

Remove glass block and
replace with single hung
egress window

Cut in and install new
single hung egress
window to match

Remove small slider windows at
front and replace with single
hung egress window

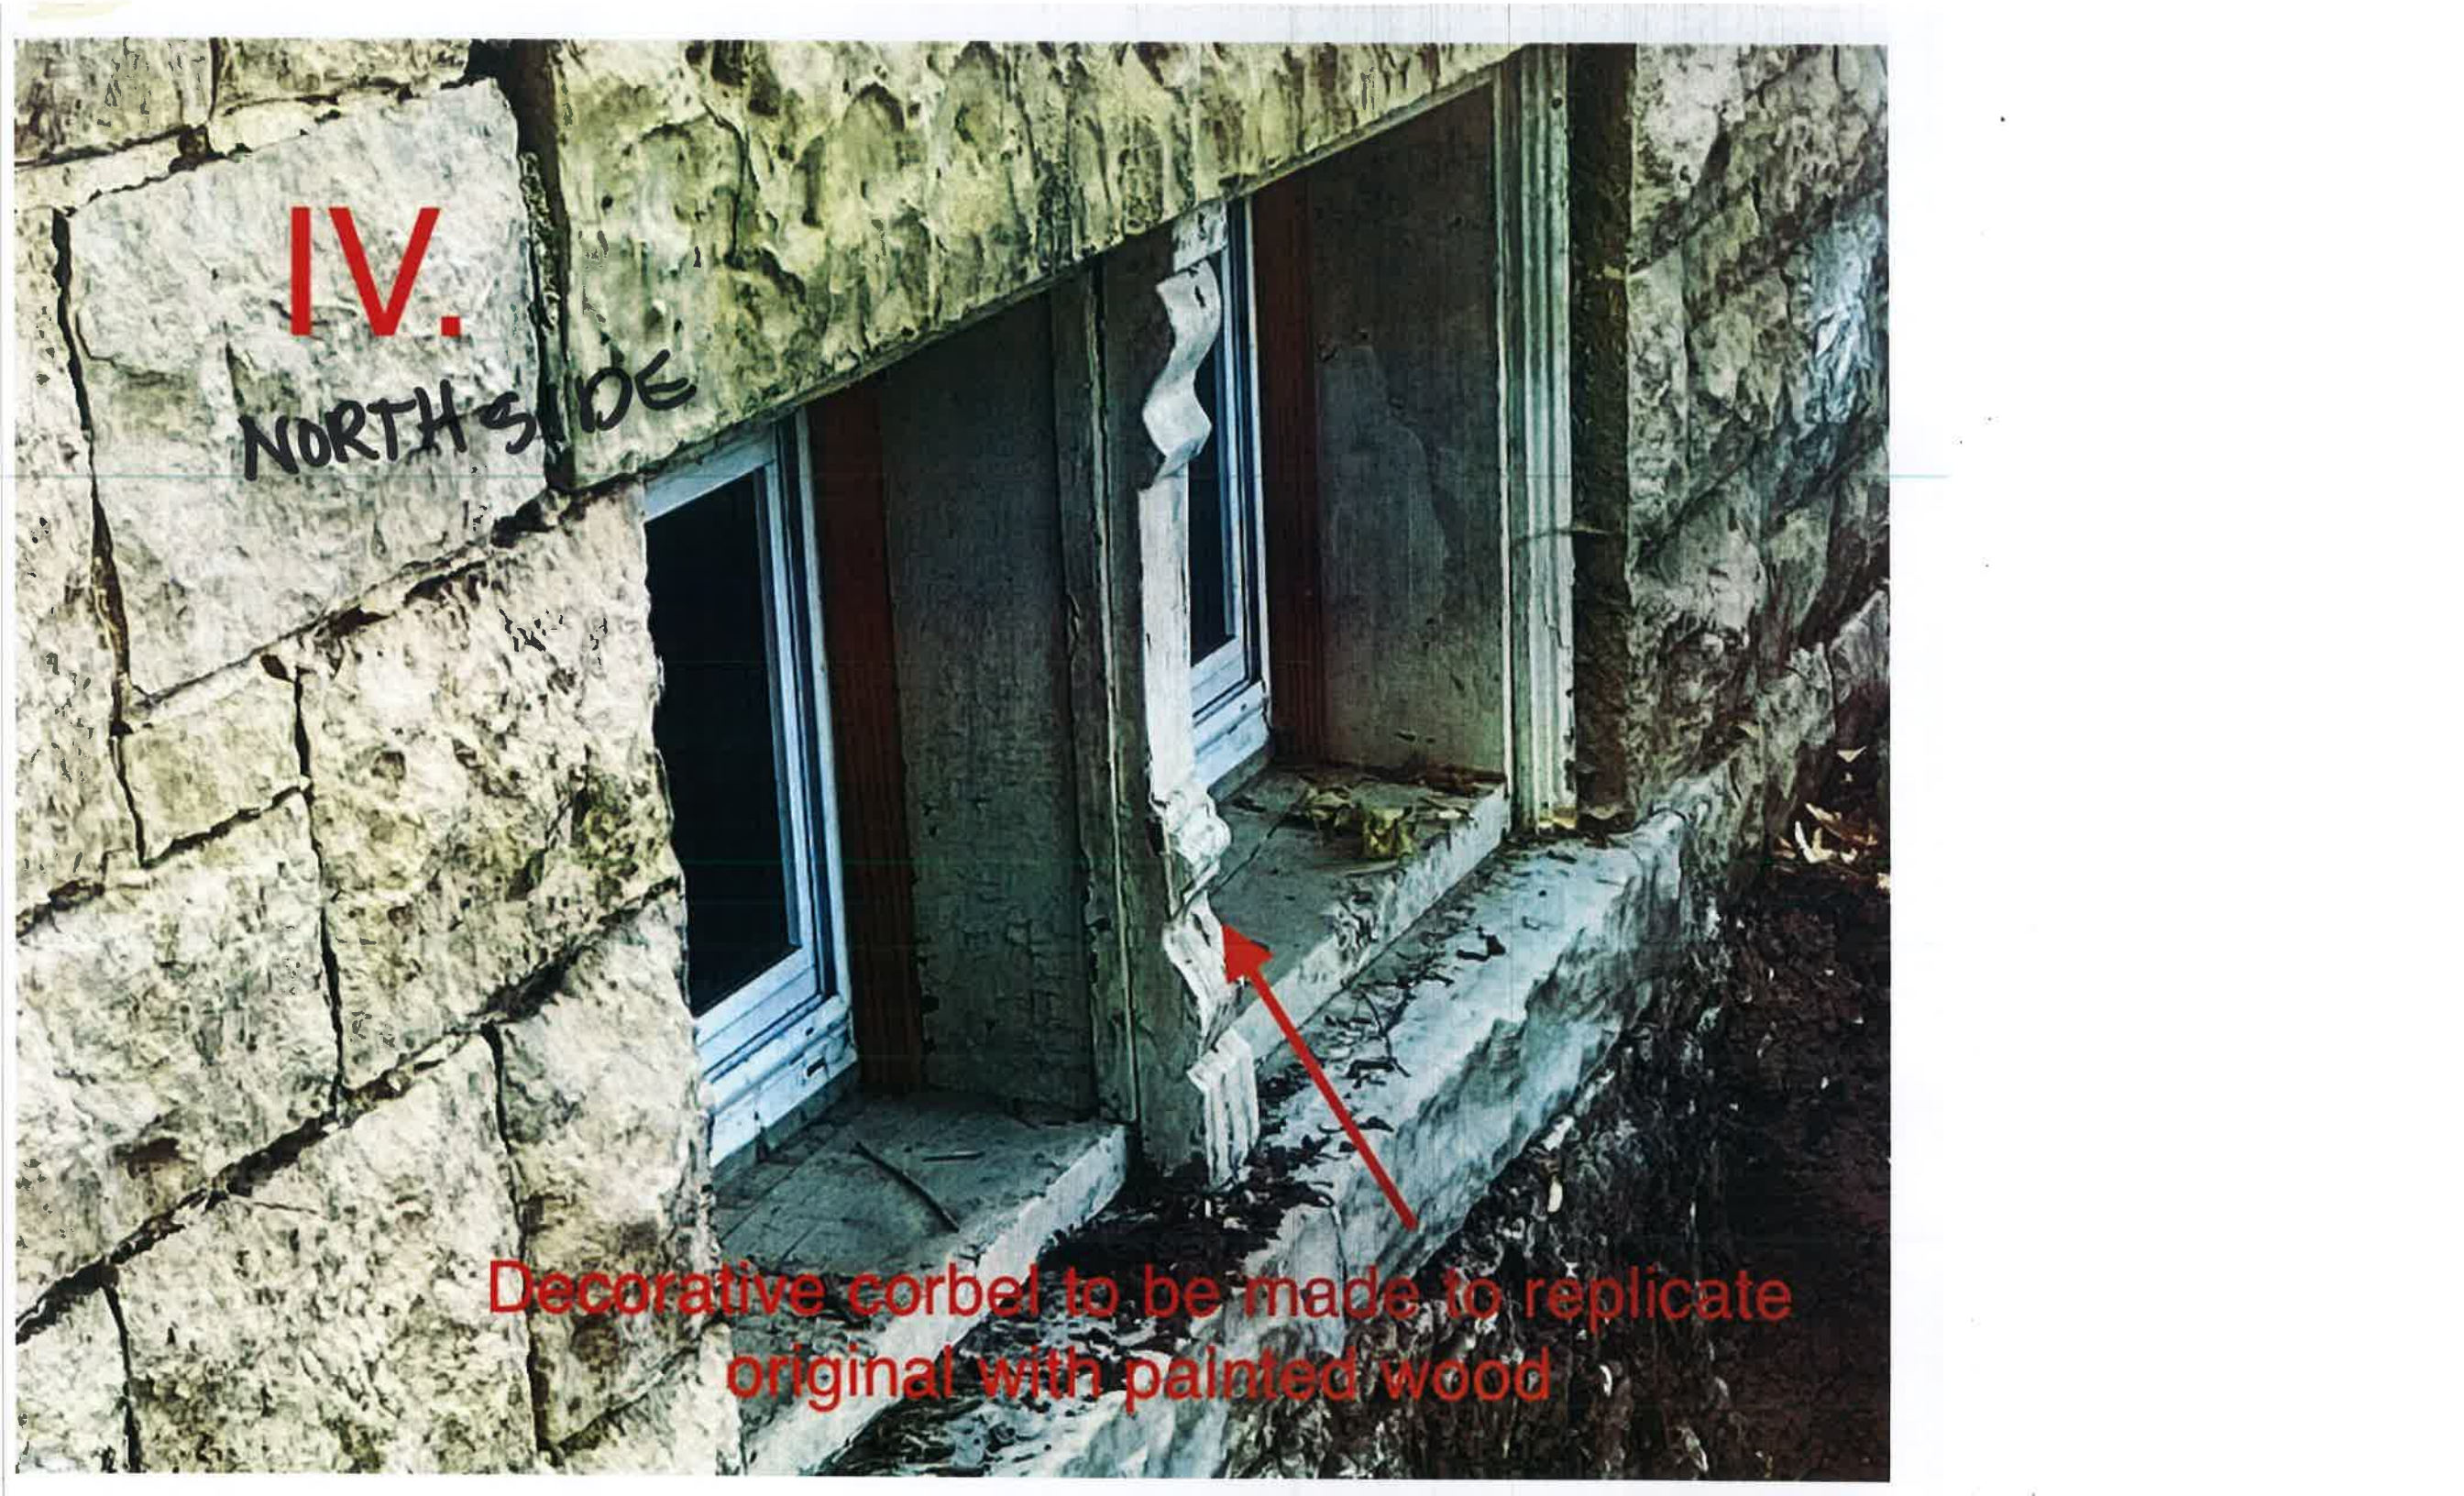
IV.

Decorative corbel to be made to replicate original with painted wood
