691 W Canfield

691 W Canfield SCOPE OF WORK

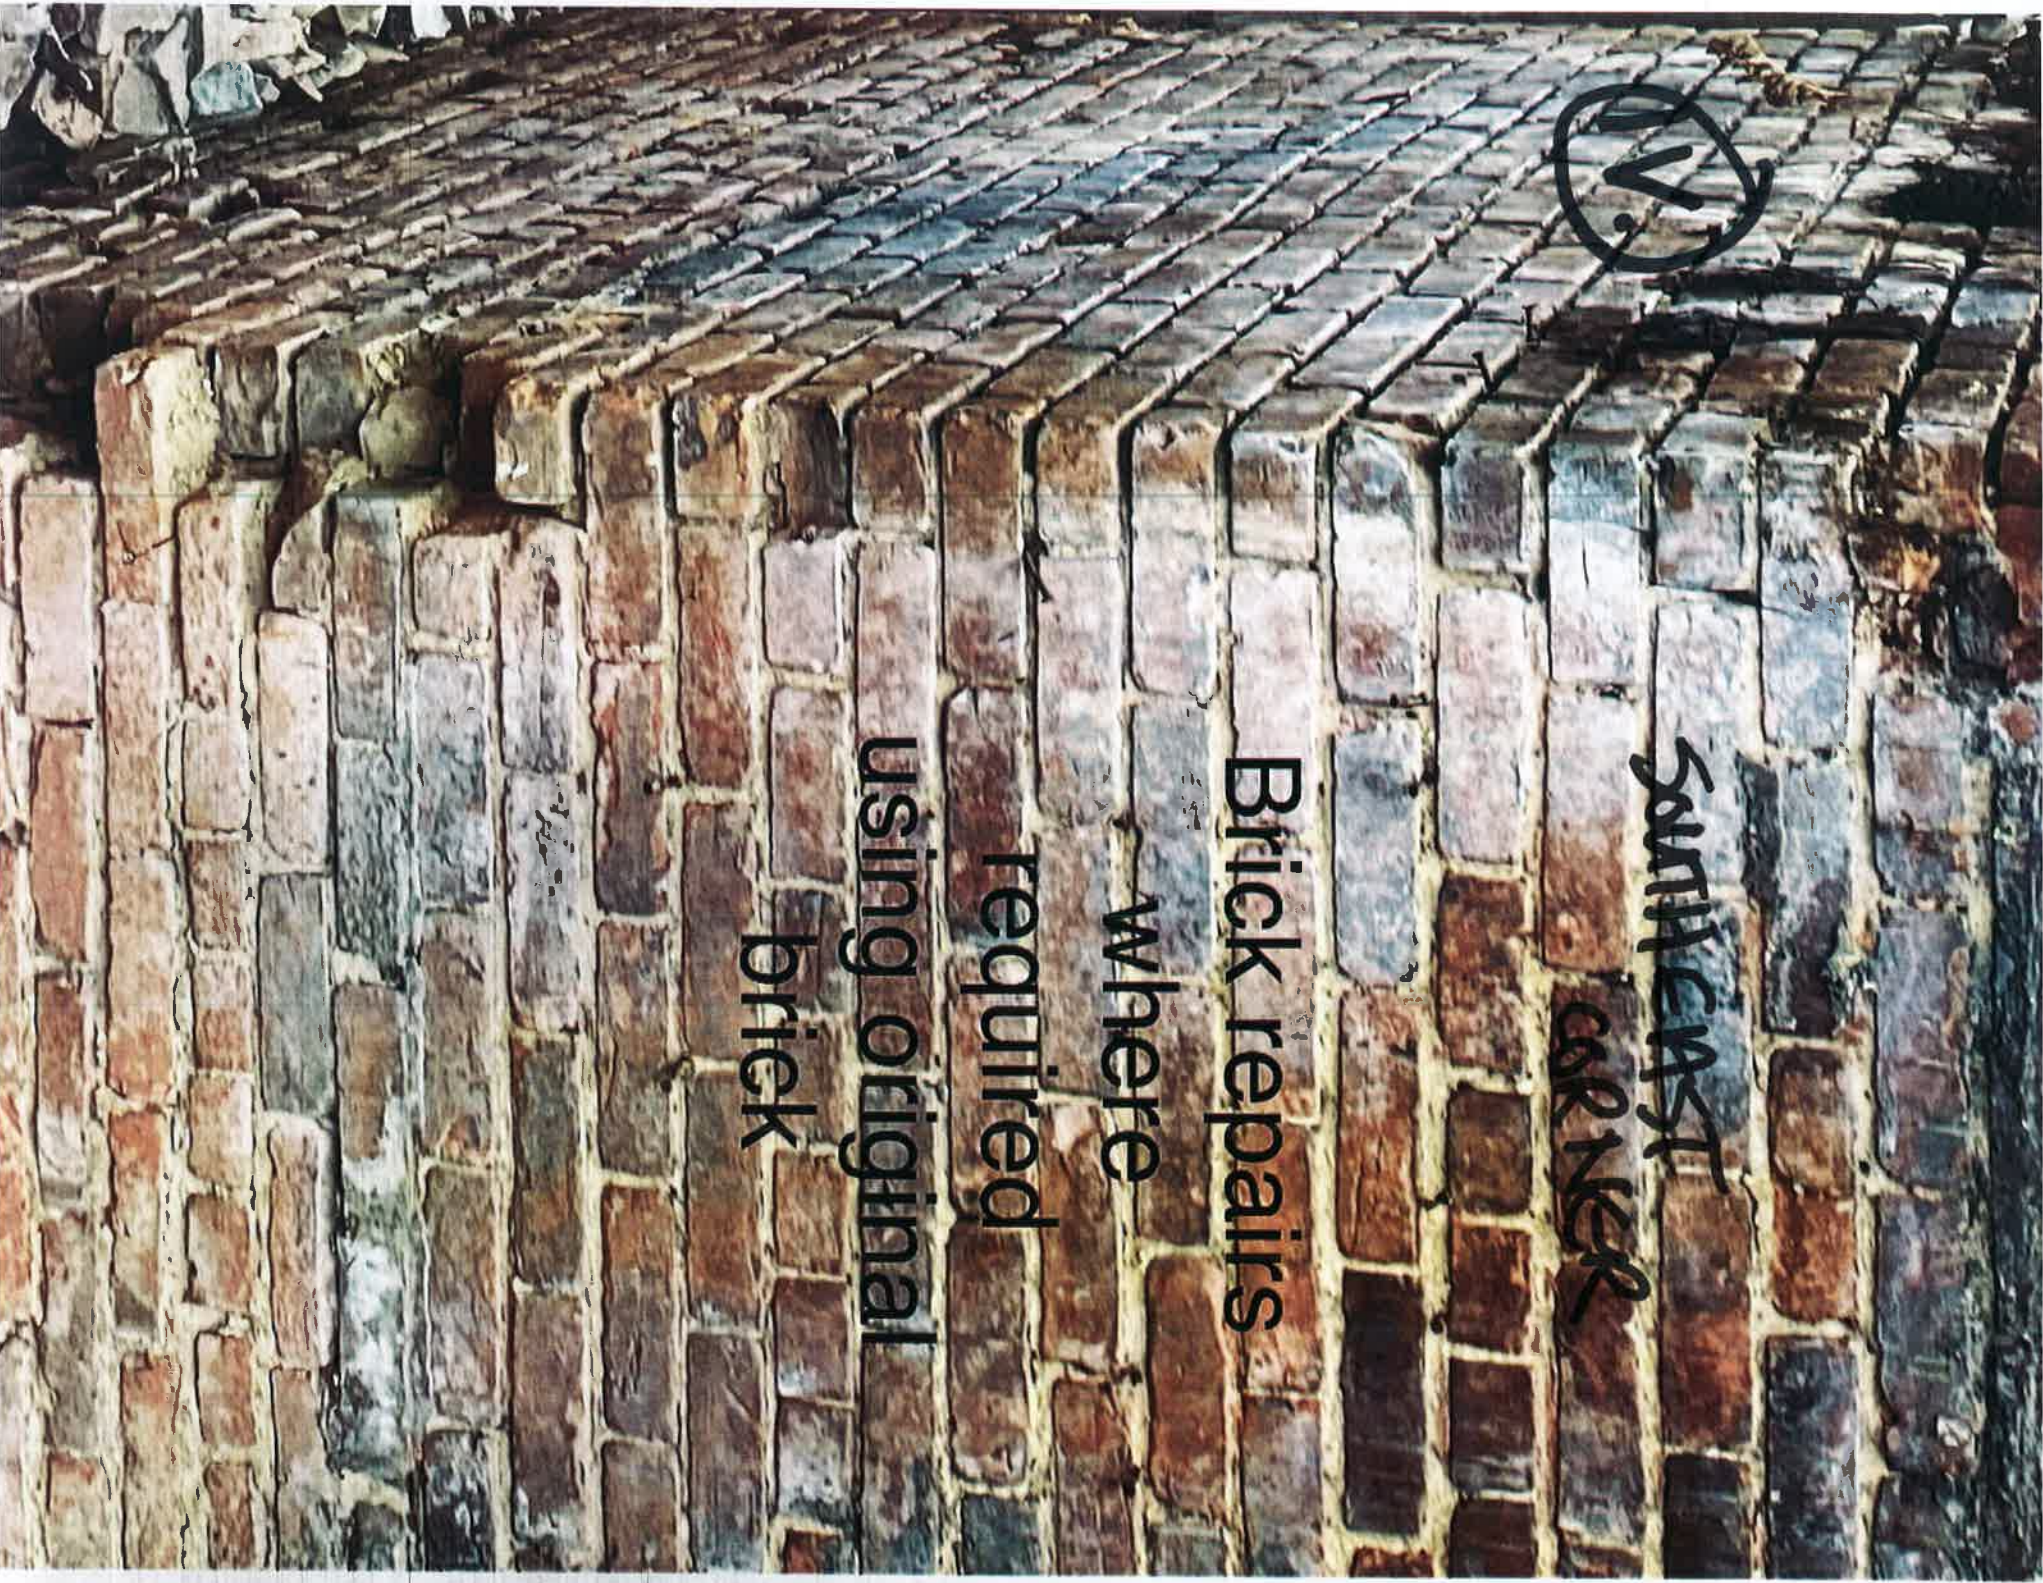
SOUTH EAST
CORNER

Brick repairs
where
required
using original
brick

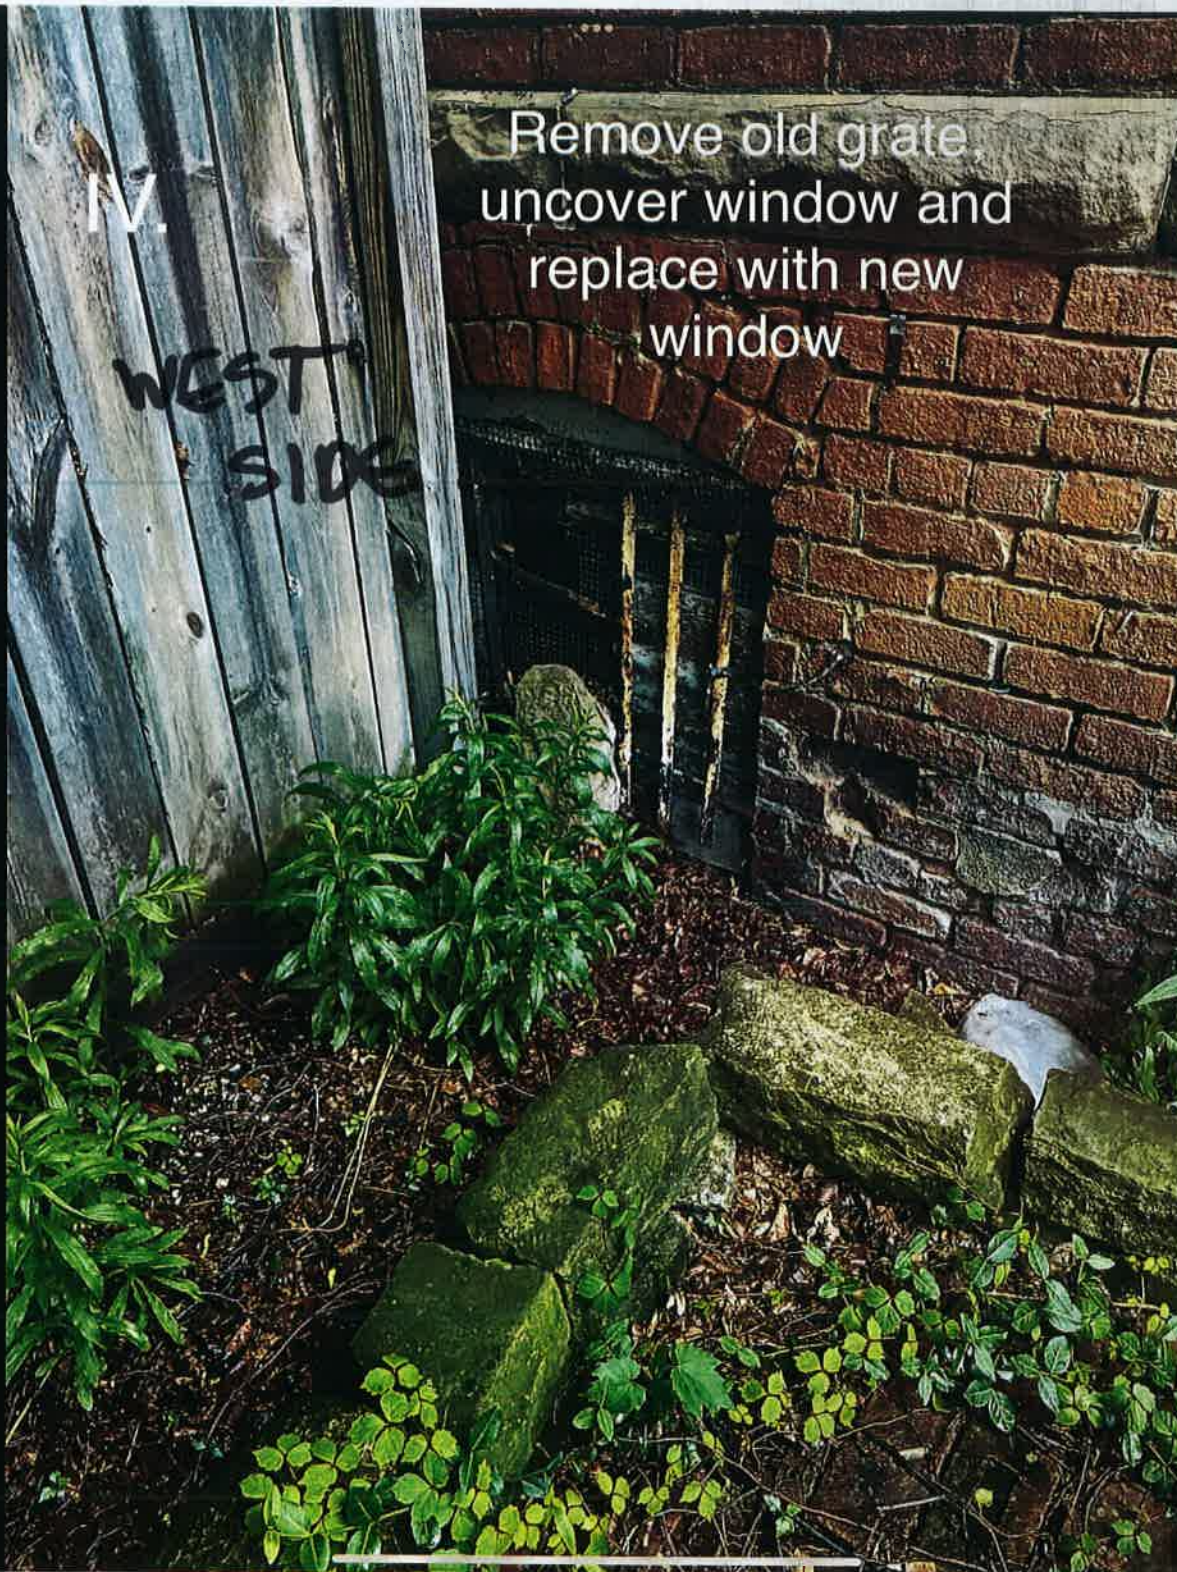
WEST
SIDE

Remove old grate,
uncover window and
replace with new
window

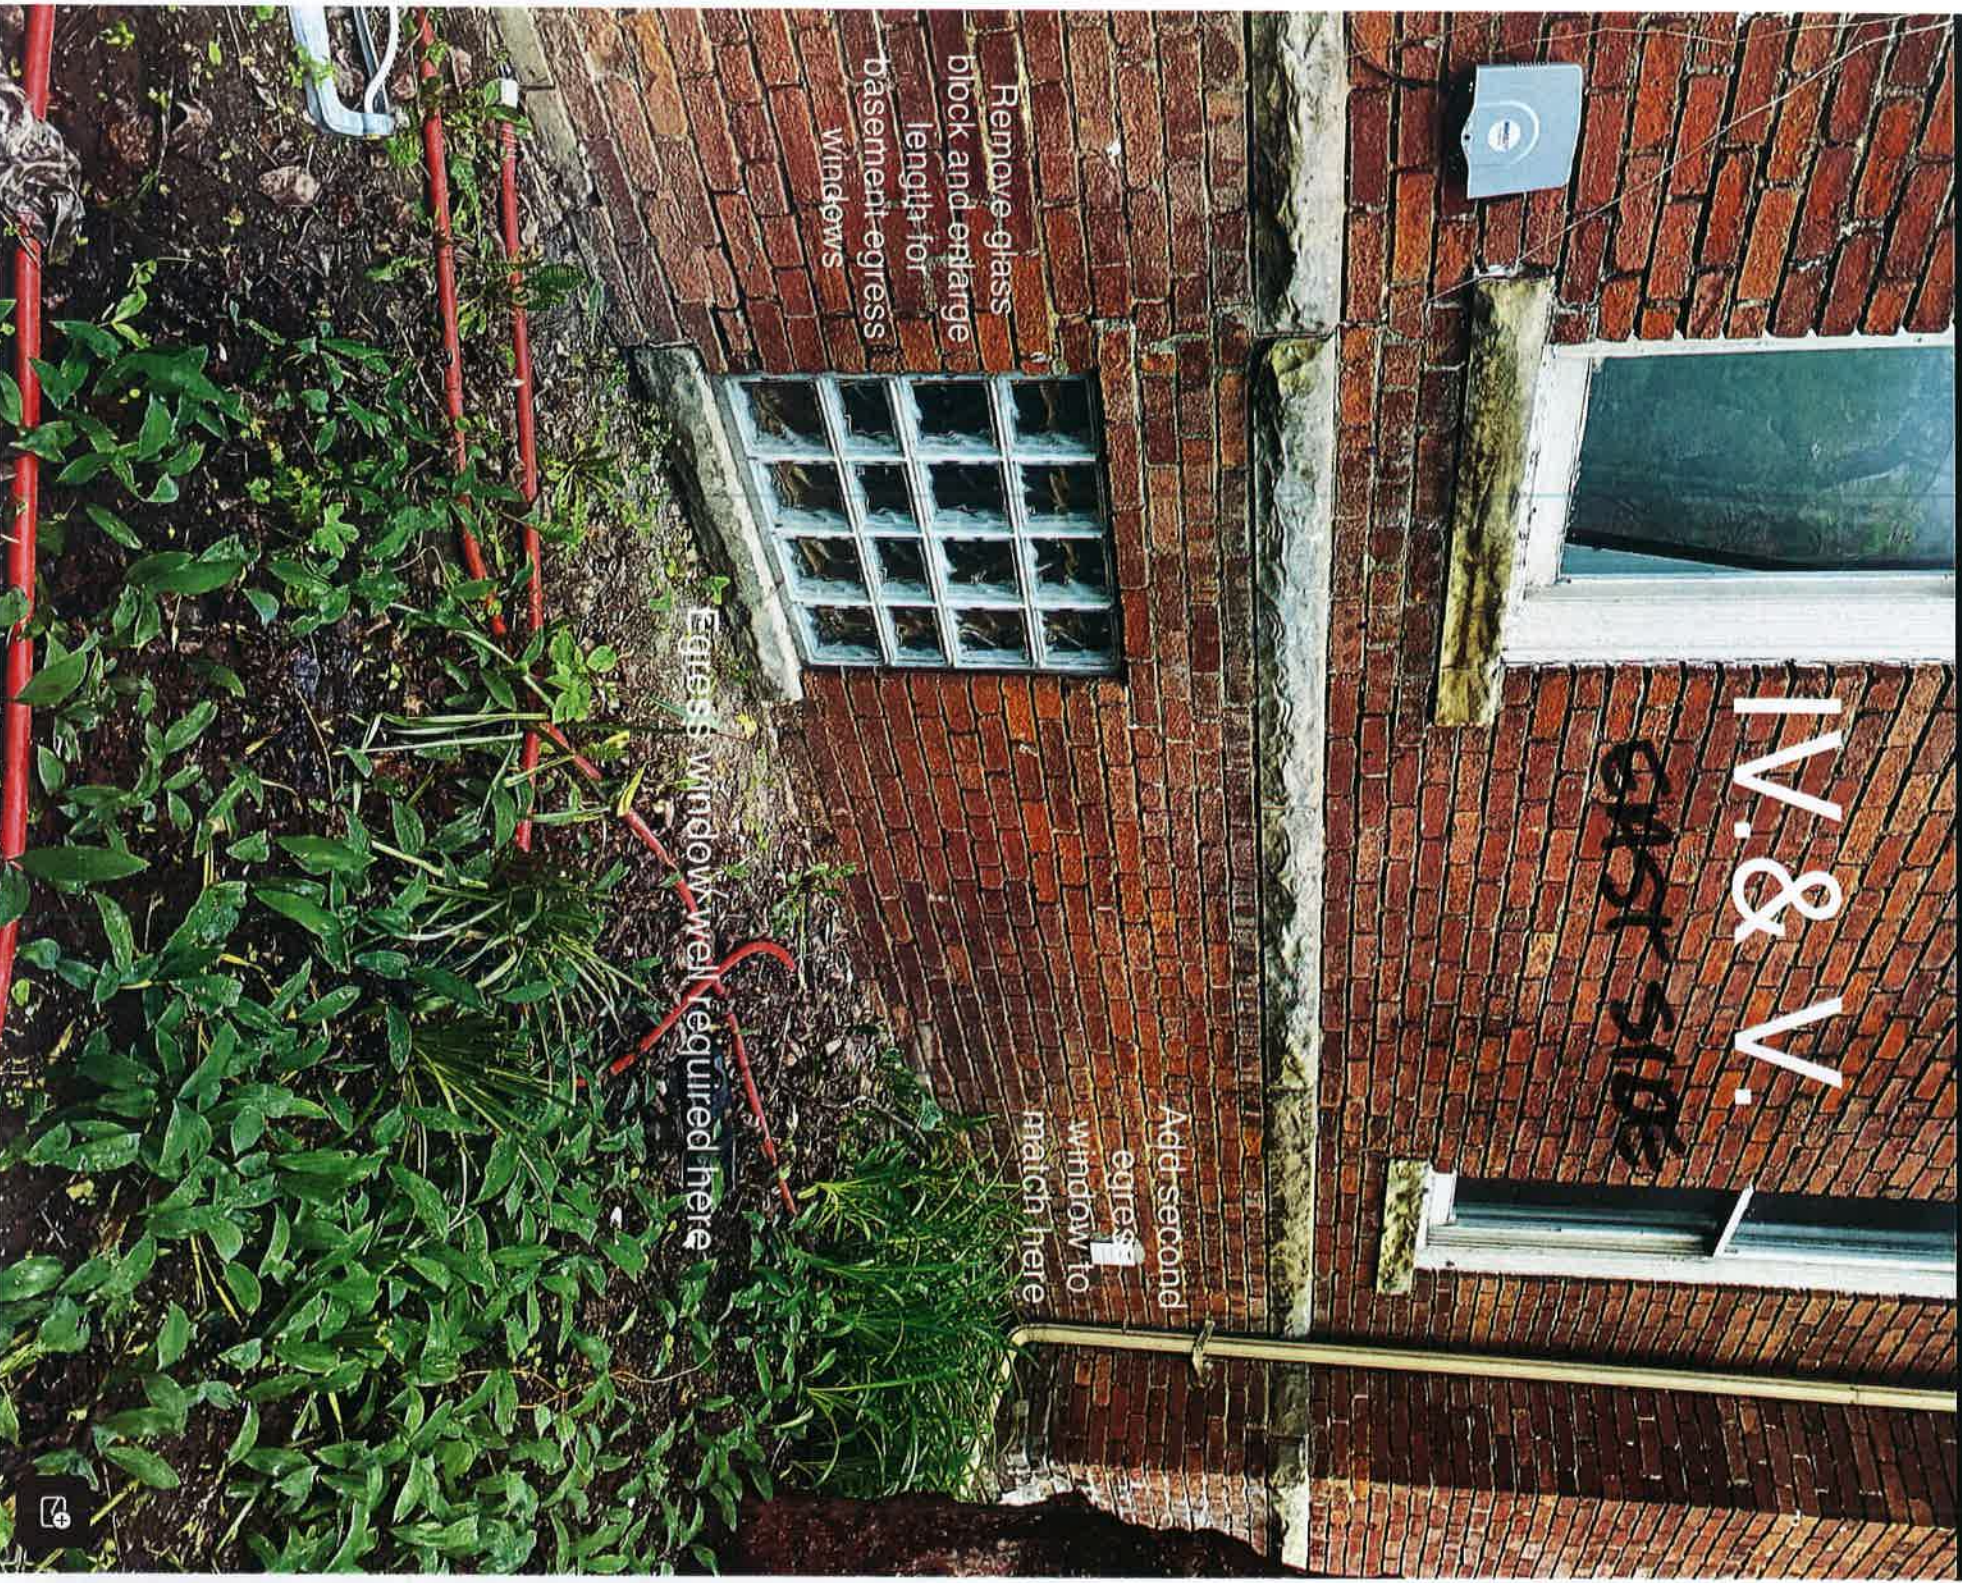
IV.&V.
FIRST STEP

Remove glass
block and enlarge
length for
basement-egress
Windows

Add second
egress
window to
match here

Egress window well required here

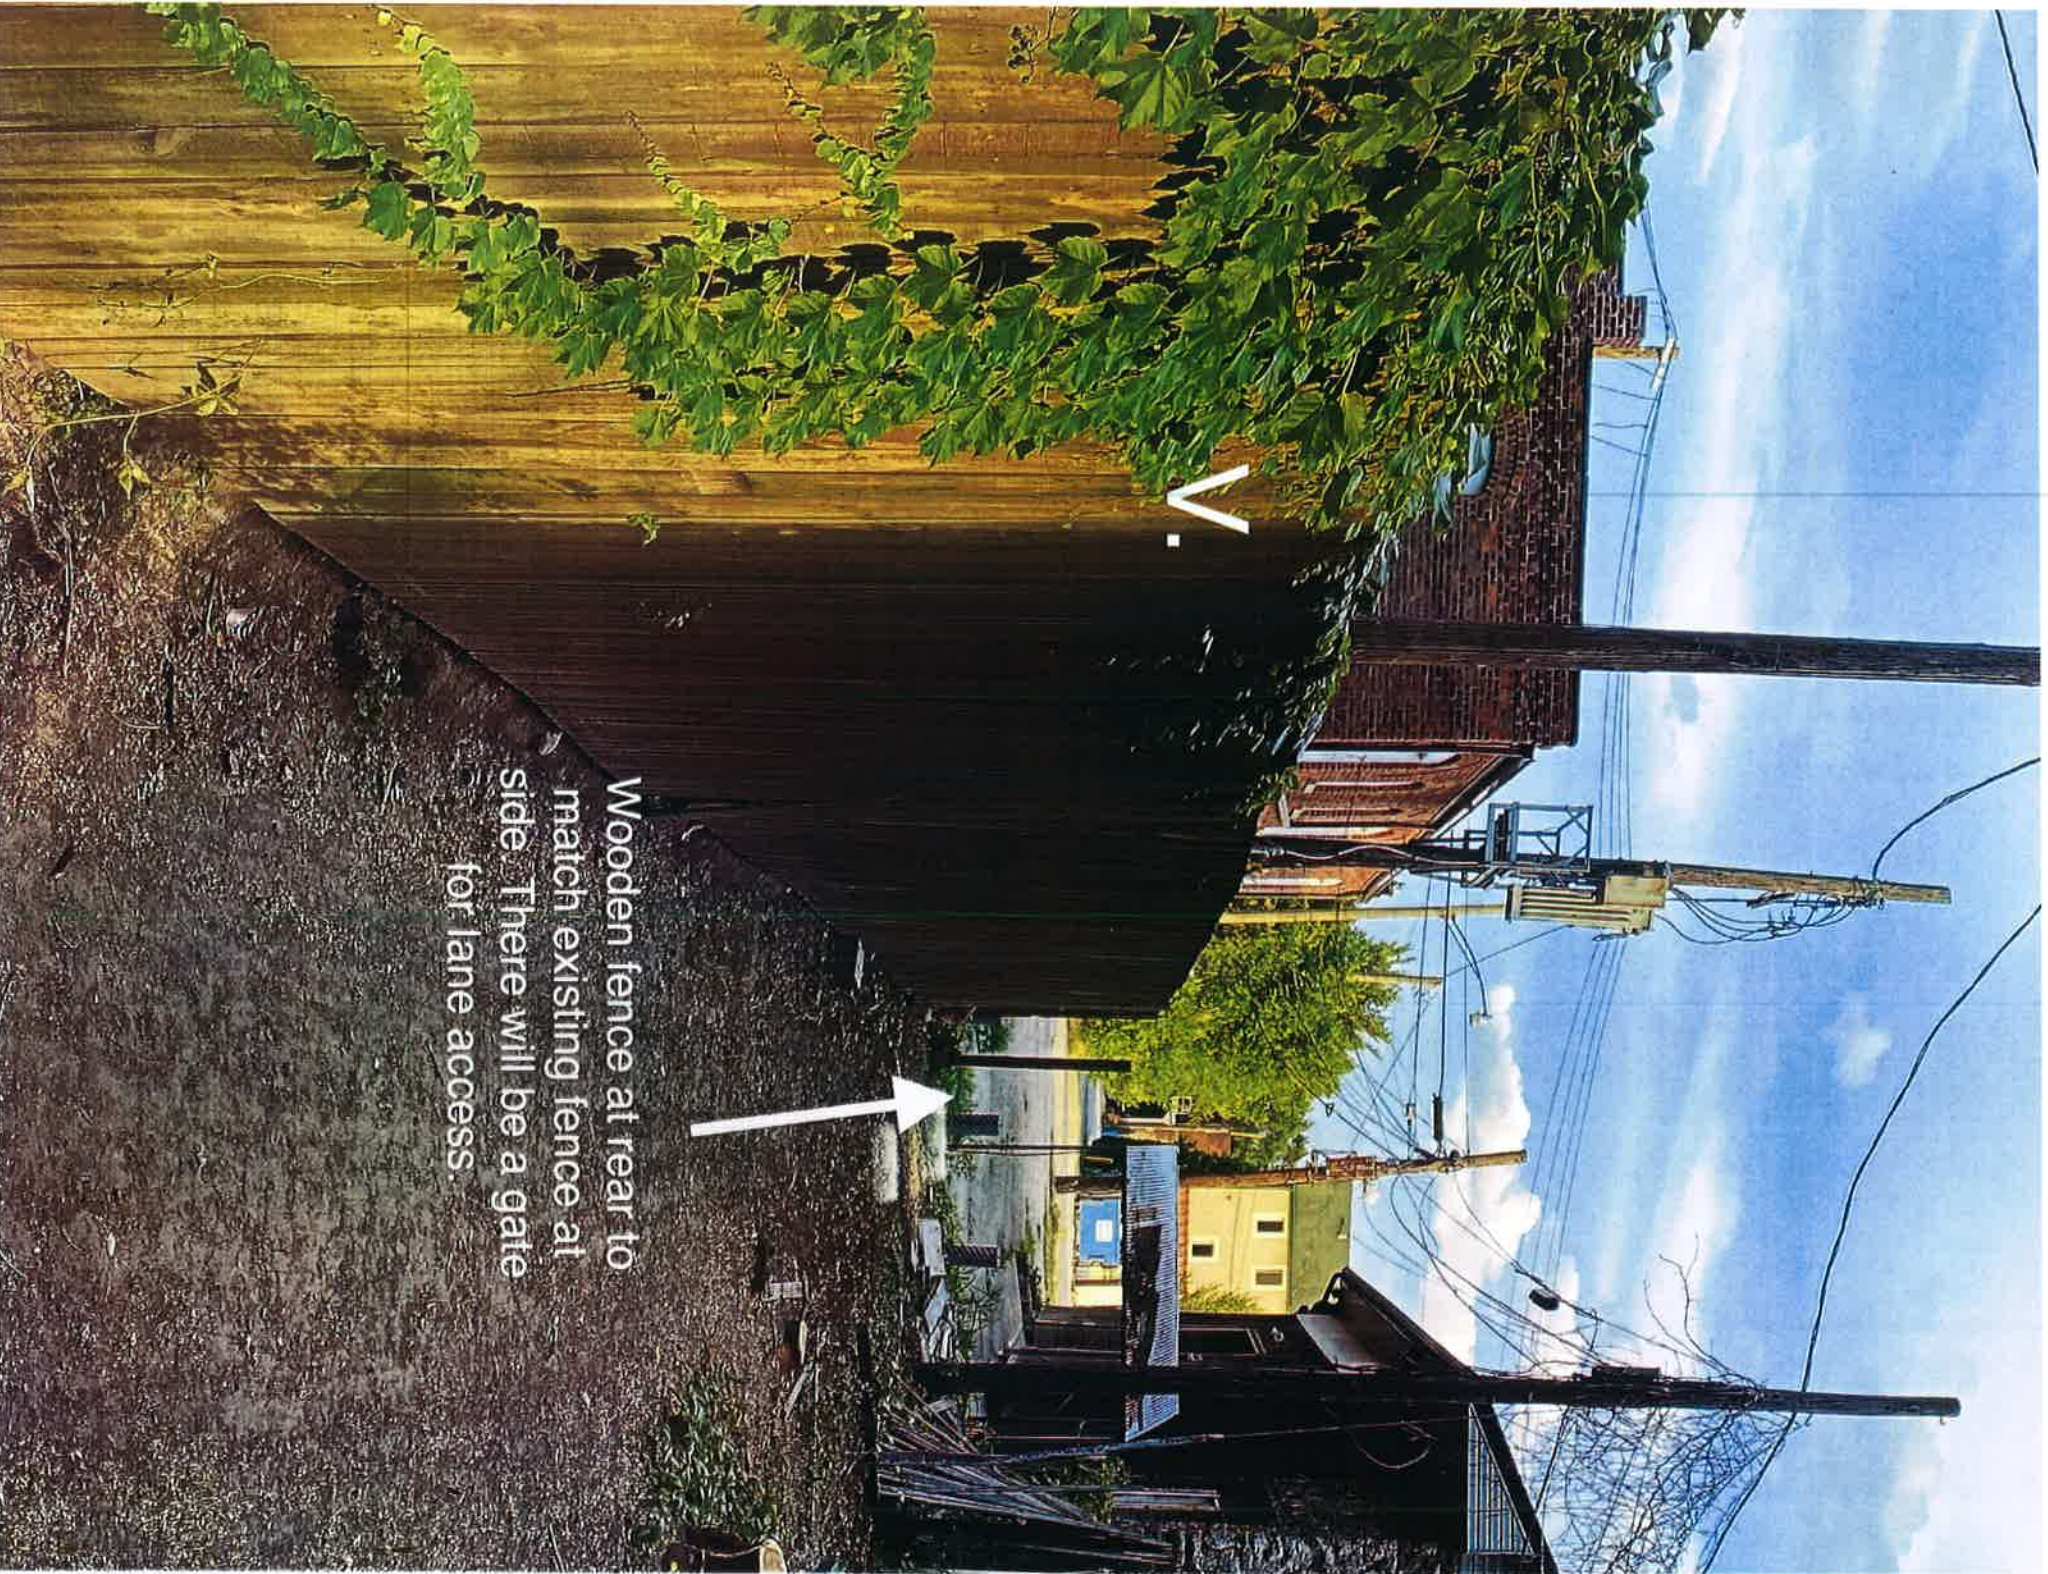
V. Old granite pavers to be used in pathways and landscaping to complement brick pavers

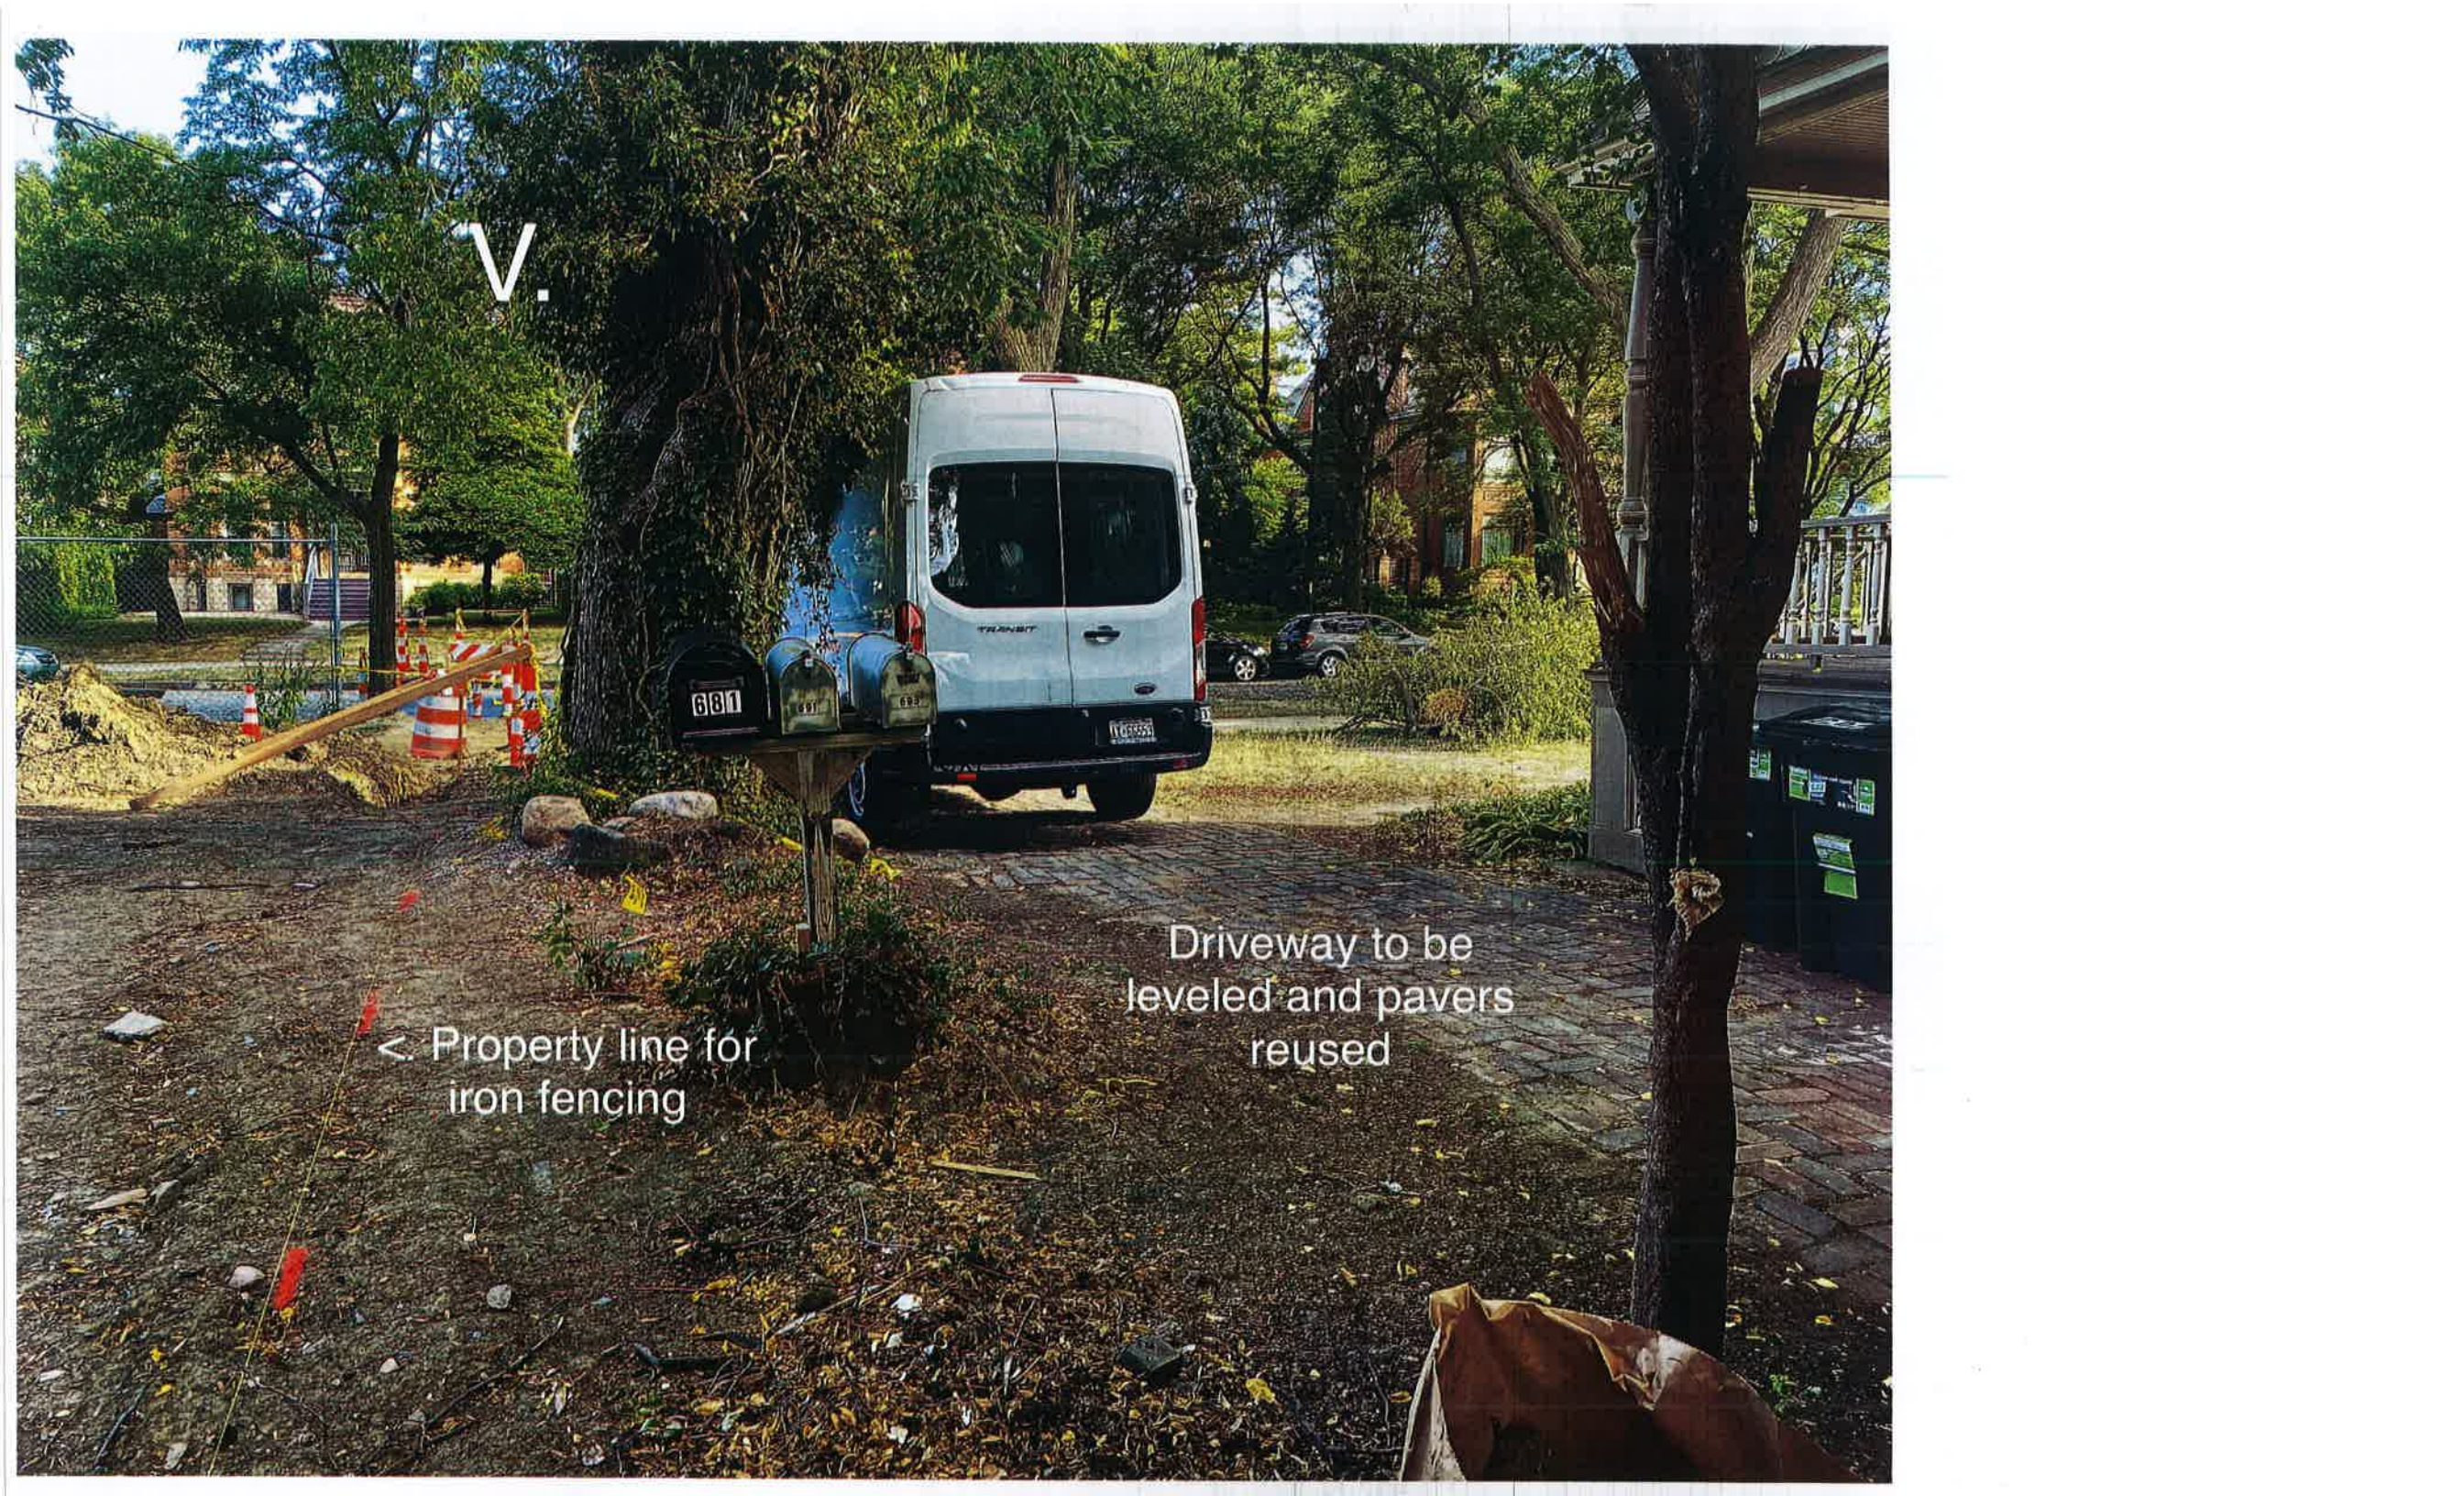
Wooden fence at rear to match existing fence at side. There will be a gate for lane access.

< Property line for iron fencing

Driveway to be leveled and pavers reused

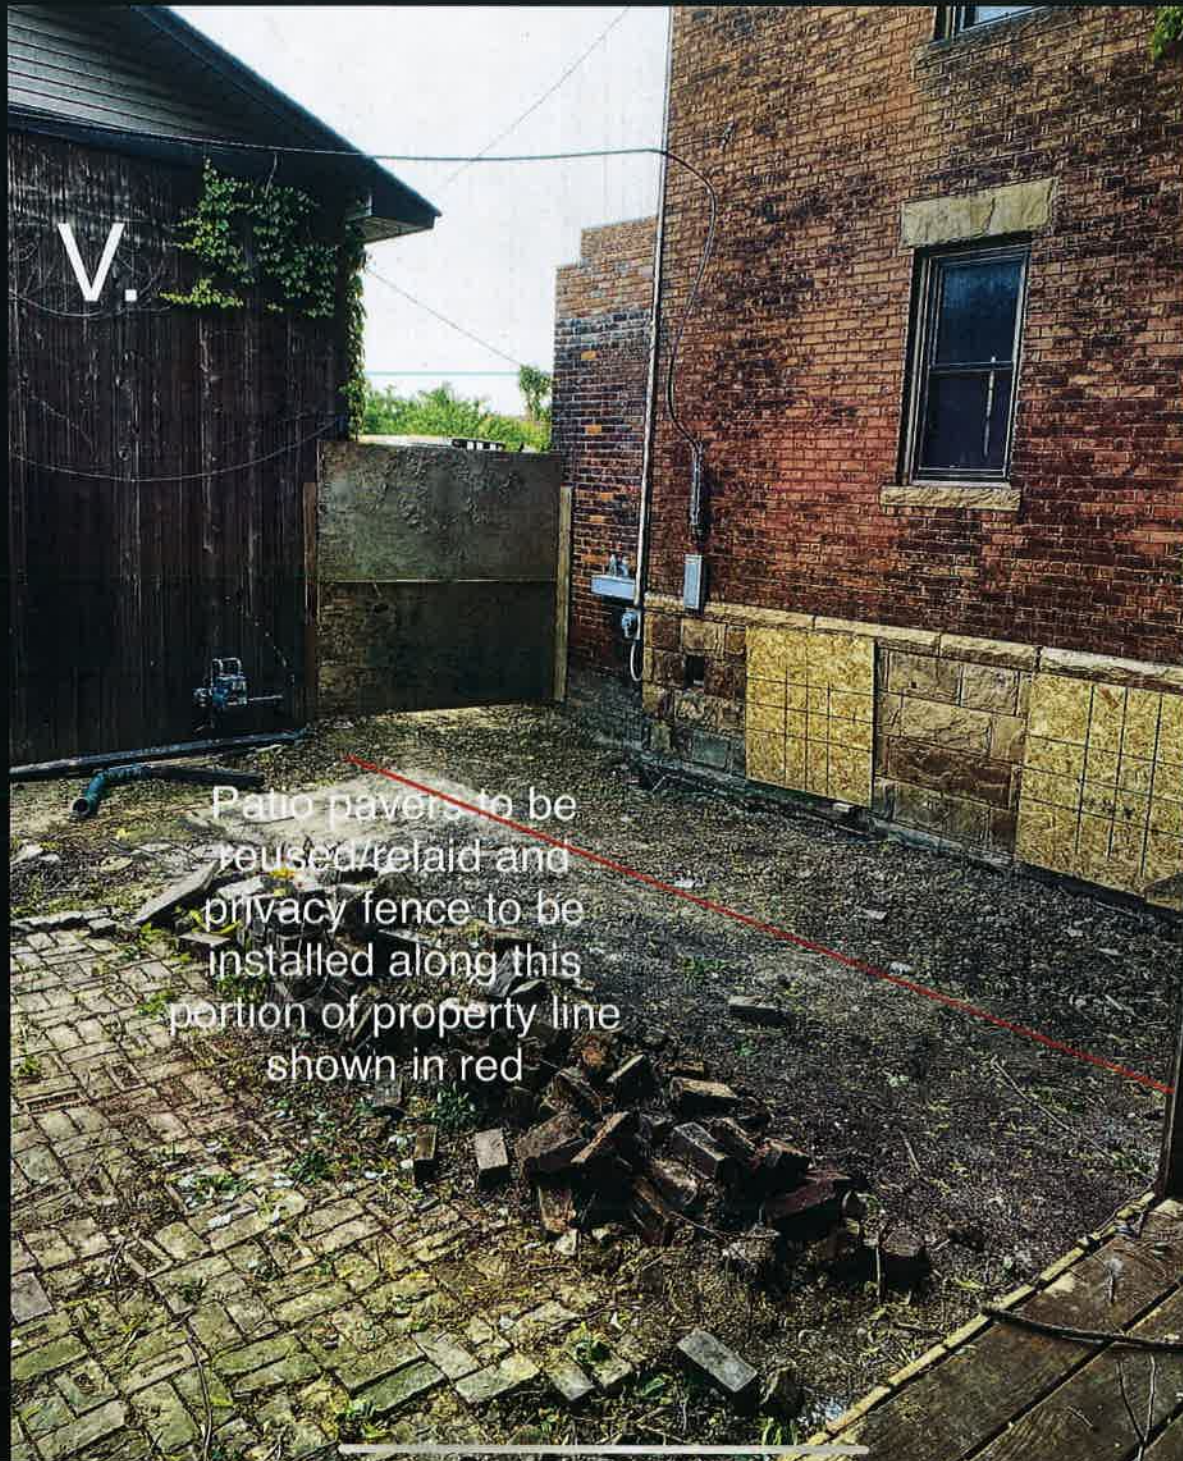
Patio pavers to be reused/relaid and privacy fence to be installed along this portion of property line shown in red

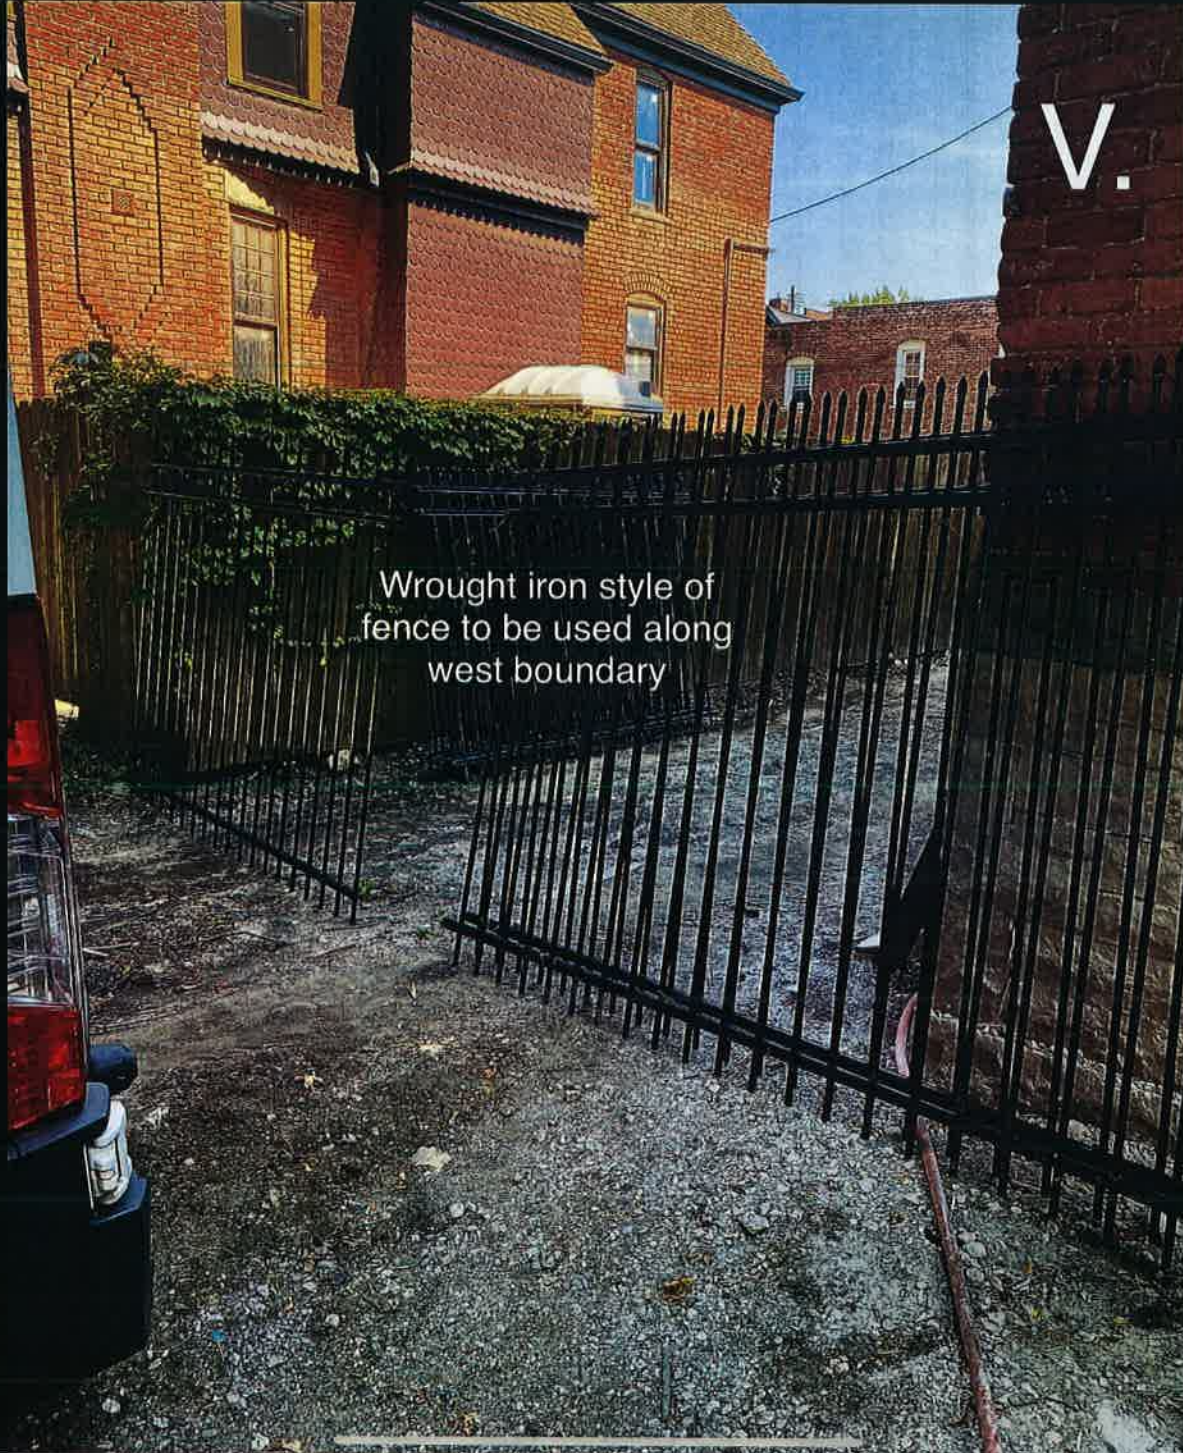
Wrought iron style of
fence to be used along
west boundary
