15015 Ashton Road Detroit, MI 48223 October 14, 2022

Please accept my application for having windows installed in my home in one of Detroit's Historic Districts.

DESCRIPTION OF EXISTING CONDITIONS INCLUDING DETERIORATION, MATERIALS AND DESIGN

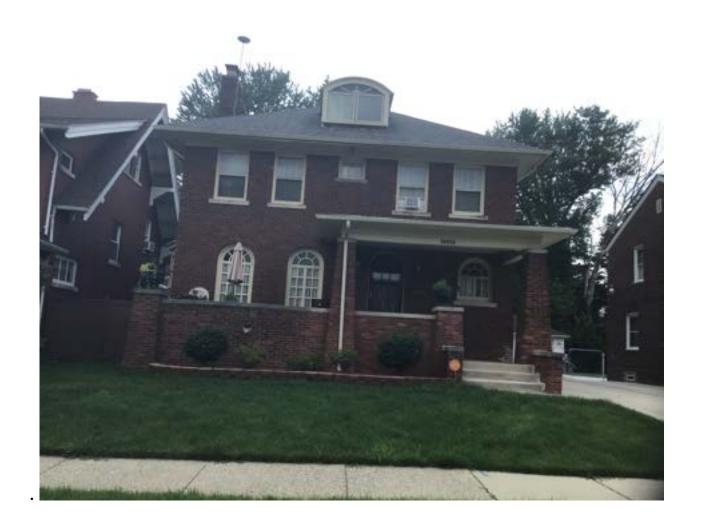
The East side of the house.

The front of the house is on the East side. The construction of the window are double-hung wooden frames. The ones to be replaced from this vantage point are windows #6, 5, 9, 4 and 3. There is an existing vinyl replacement window on the window in the attic.

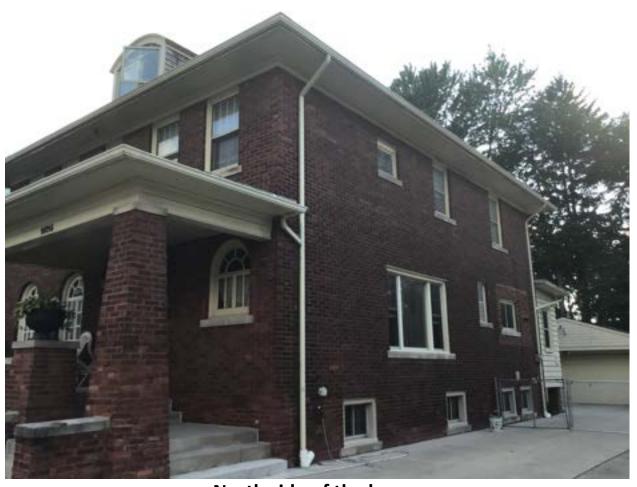
The North side of the house has replacement windows on the first floor and the four windows in the basement. From this vantage point, the upstairs windows that need to be replaced are windows #2; #8 and #1.

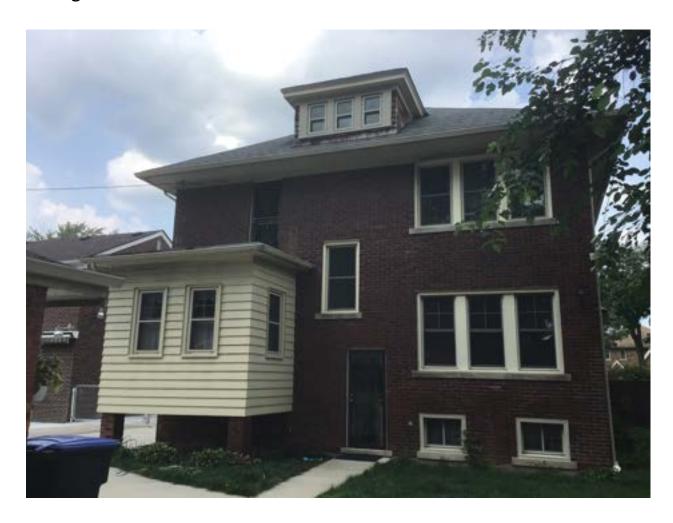
West side of the house.

The West side of the house has replacement windows on all three floors, Including the basement.

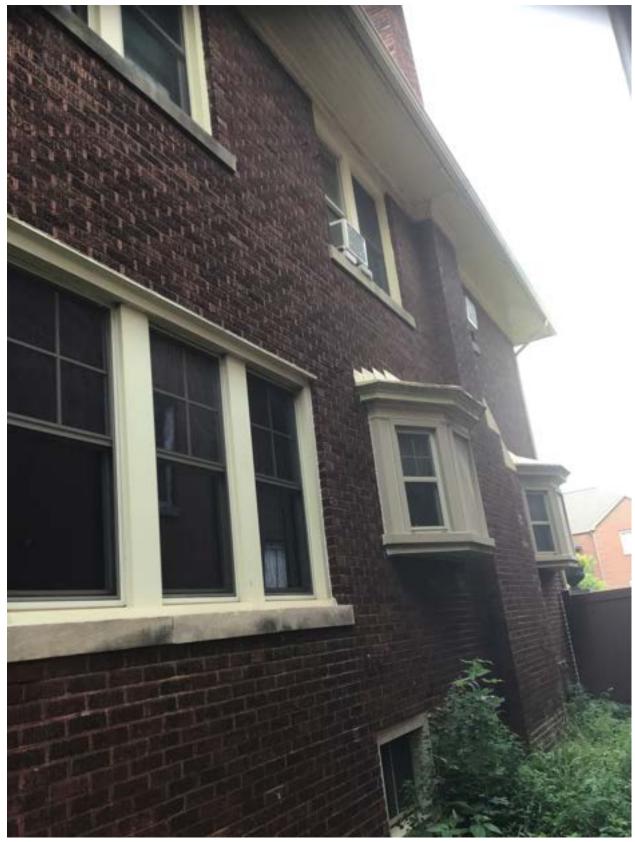
The South side of the house likewise has replacement windows on the first floor, the basement and the four windows on the 2nd floor of the southwest side.

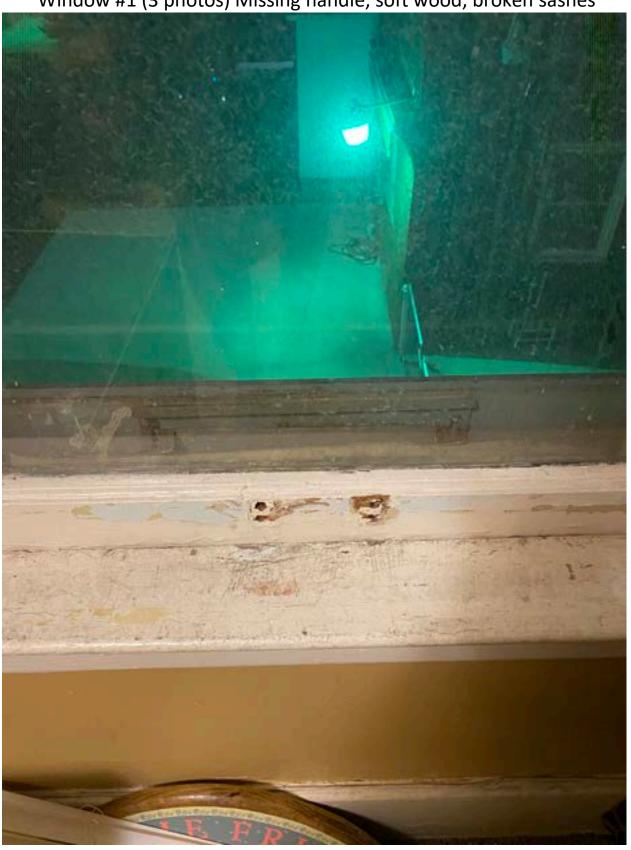
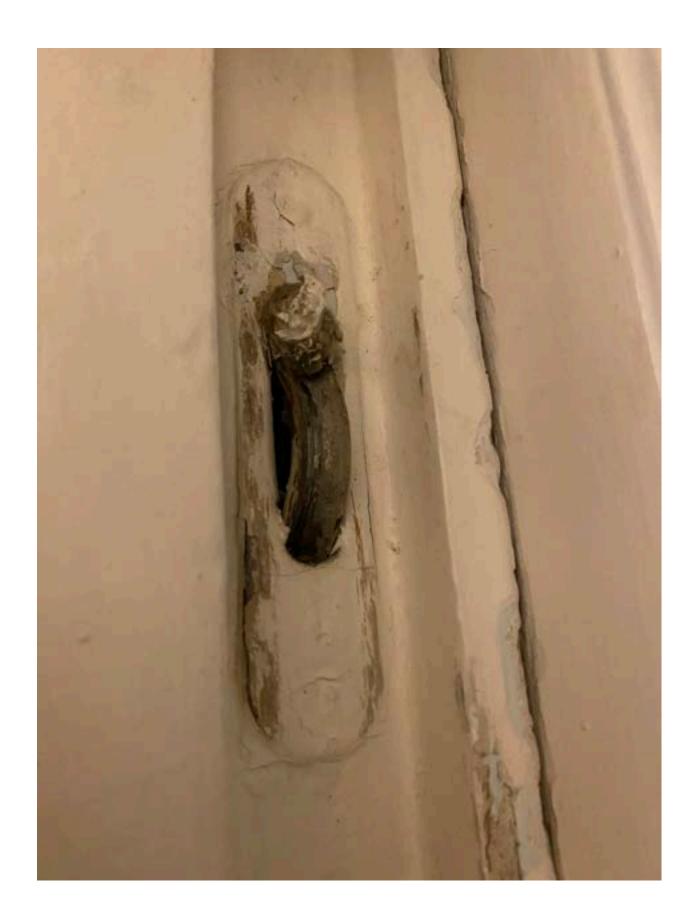
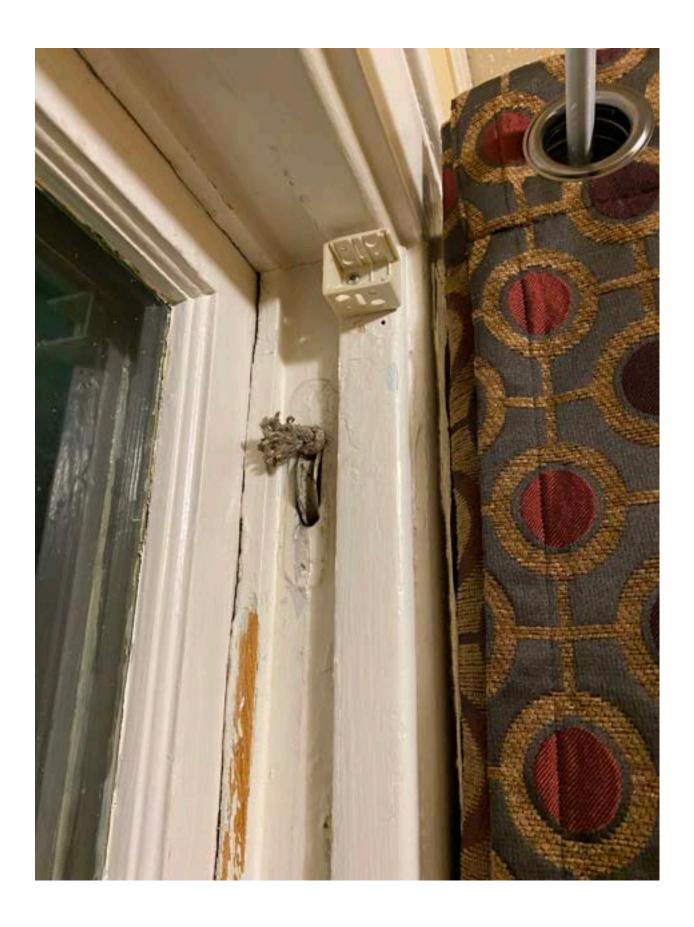
This wood window is on the second floor of the north west side of the house. It does not have a lock or handles. I am not able to attach handles because the wood is soft and rotting. I am not able to open the window.

Condition: Sash cords are not attached.

Why it cannot be repaired: The wood is badly damaged.

Window #1 (3 photos) Missing handle, soft wood, broken sashes

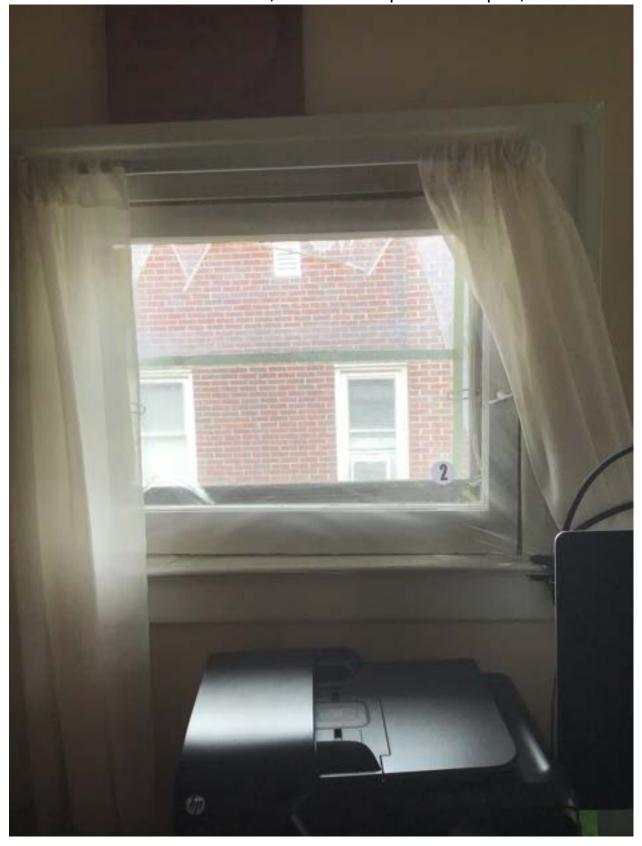
Condition: The storm window is missing and the window is covered with plastic. It does not close completely. The alignment is off. The storm window is damaged and has gaps that allows the wind to blow the window open, even when covered with plastic.

Why it cannot be repaired: My repairman was not able to find parts to replace the damaged parts.

Window #2- Latch won't close; no available parts for repair; no storm window

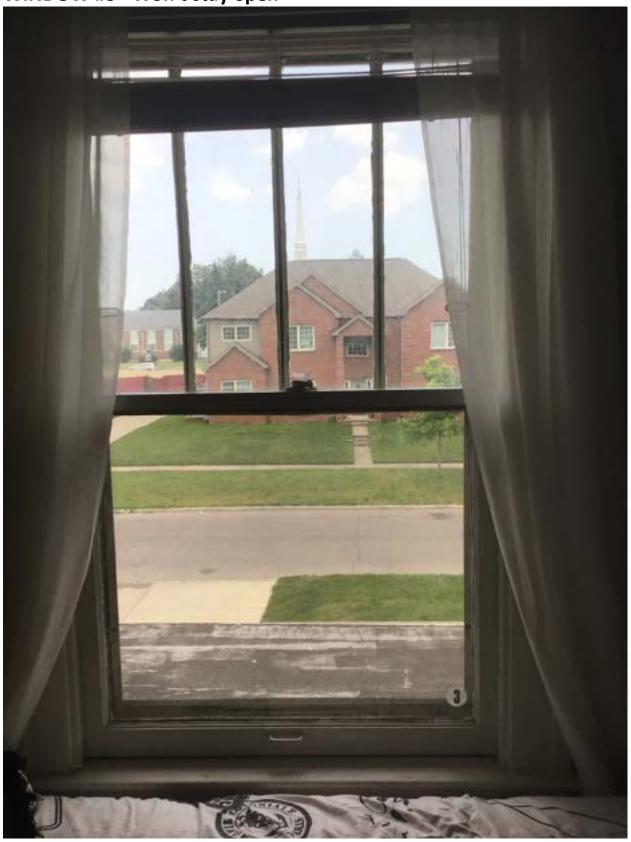
Condition: It does not have a lock. It does not have handles. It doesn't close all the way.

WINDOW #3 - Won't stay open

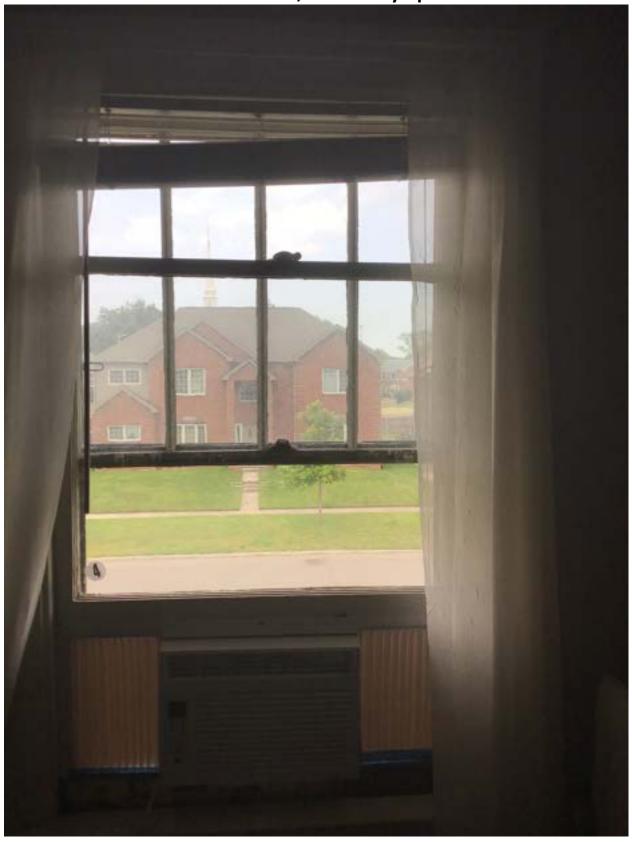
Condition: It does not have a storm window. It does not have a lock.

WINDOW #4 - No storm window, won't stay open on its own.

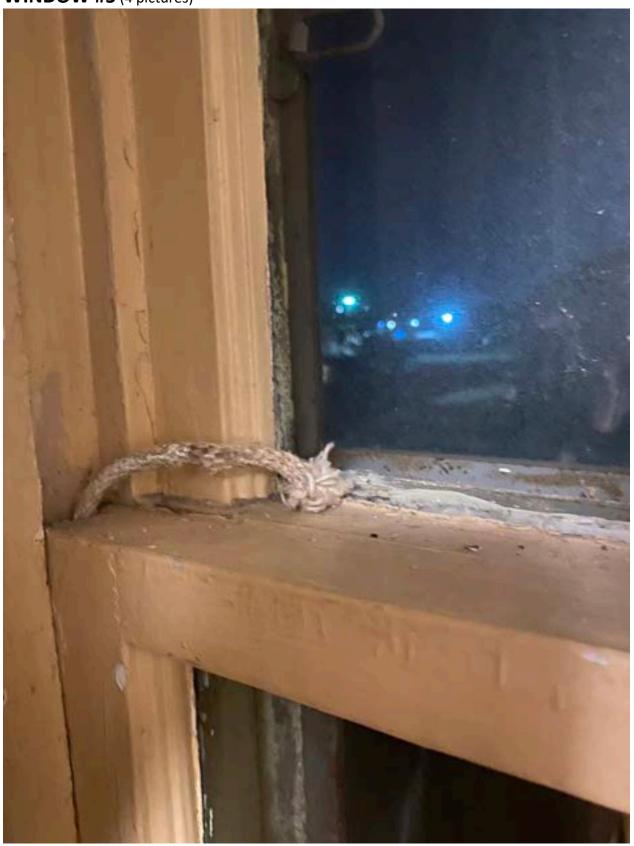
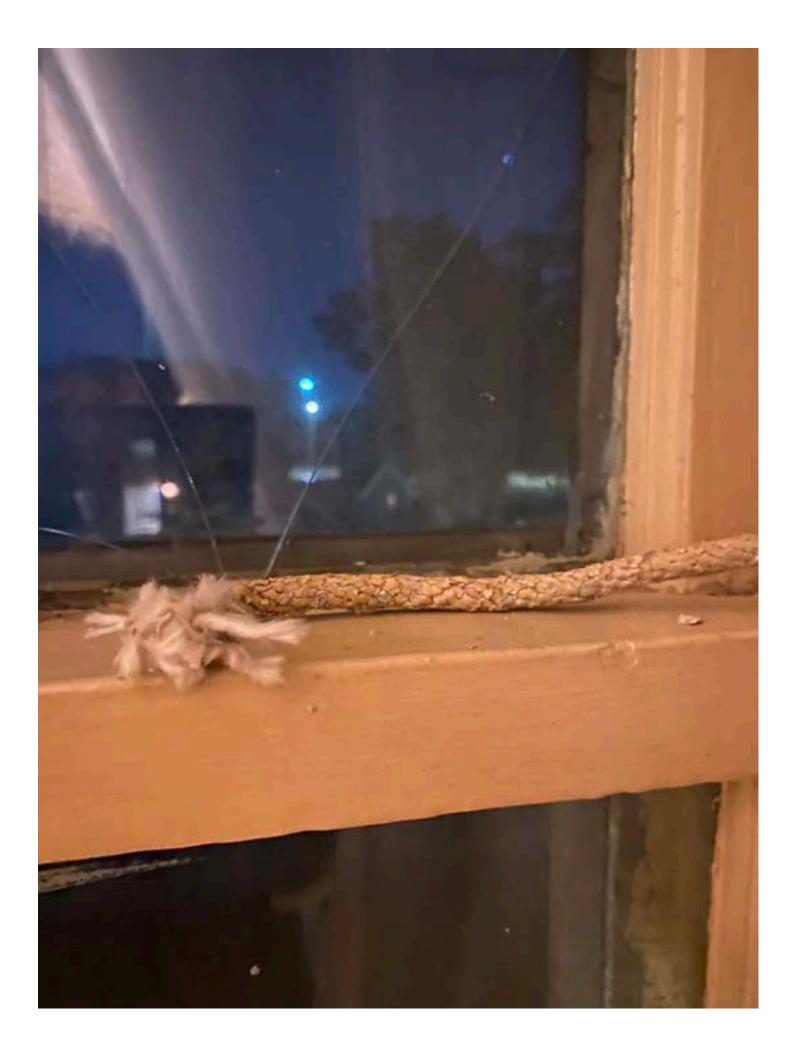
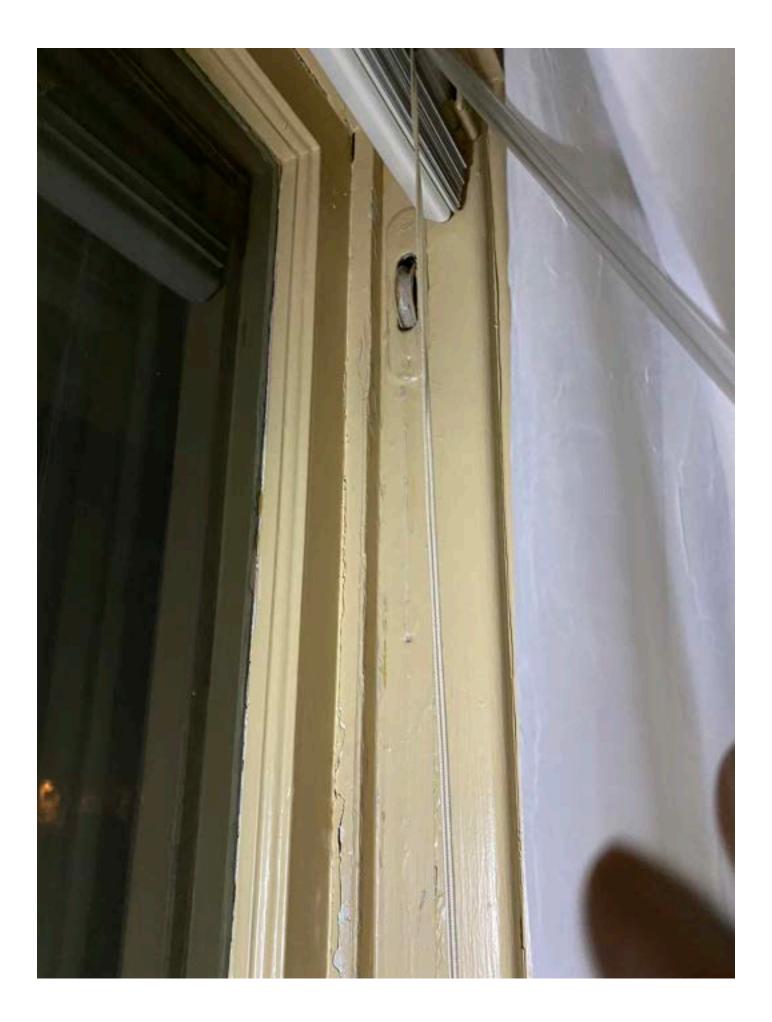
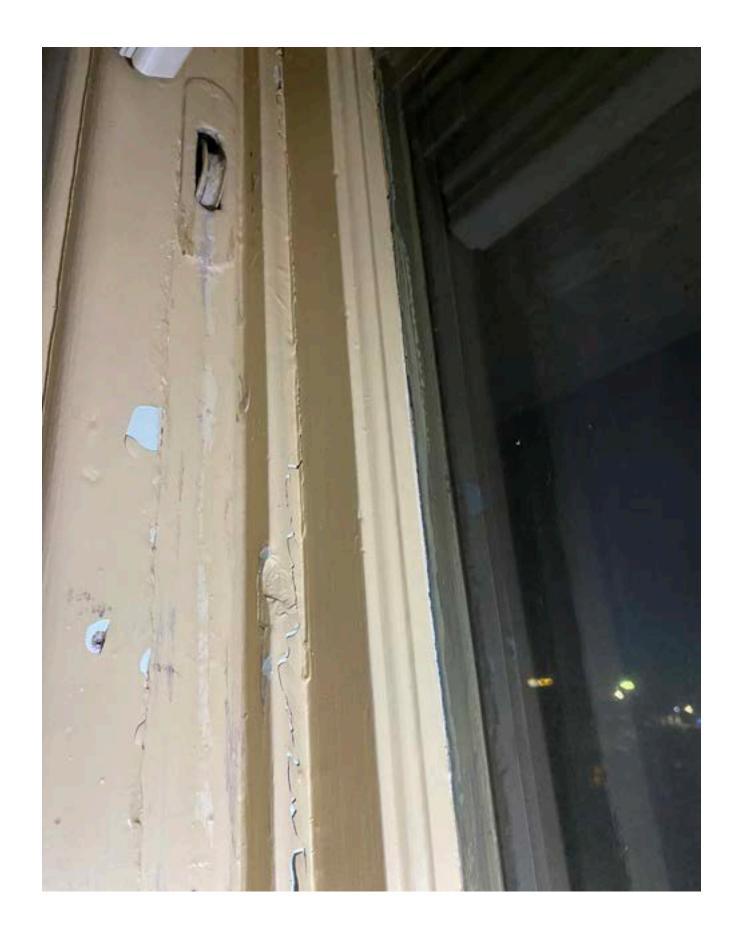
WINDOW #5 (4 pictures)

Condition: The cord is broken. It does not have a lock.

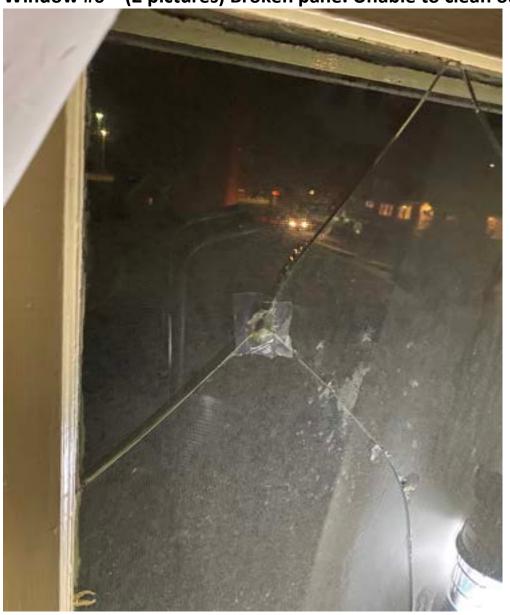
Condition: The rope is broken; the pane is broken and the window will not remain open on its own. It must be propped up

Window #6 – (2 pictures) Broken pane. Unable to clean outside.

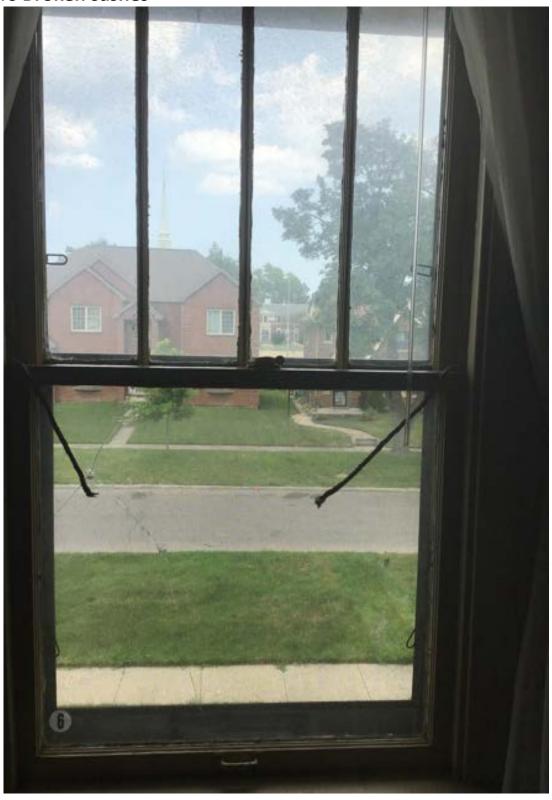
Window #6 Broken sashes

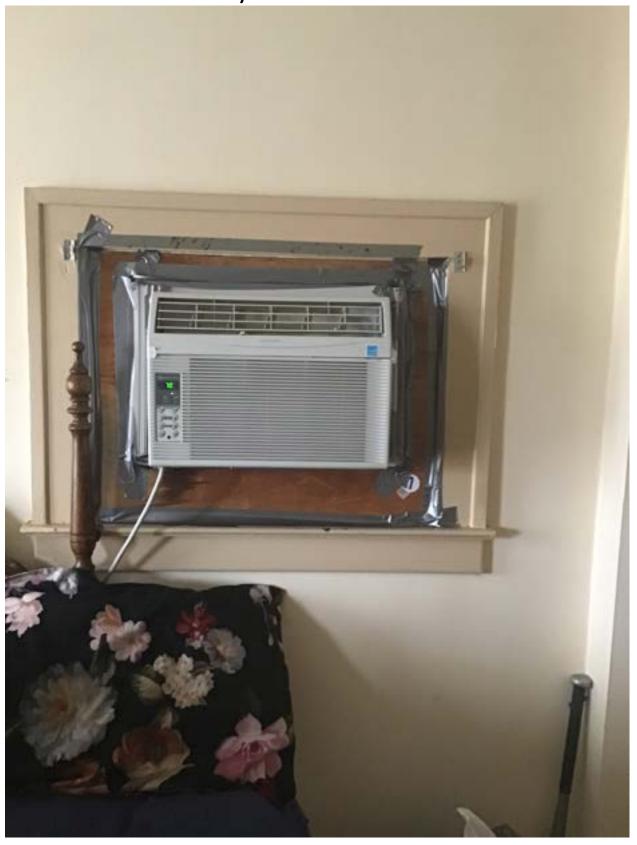
Condition: It is like window #2. It won't stay latched and it emits a

Window #7 (the window unit has to be completely removed in order for the air conditioner to be installed).

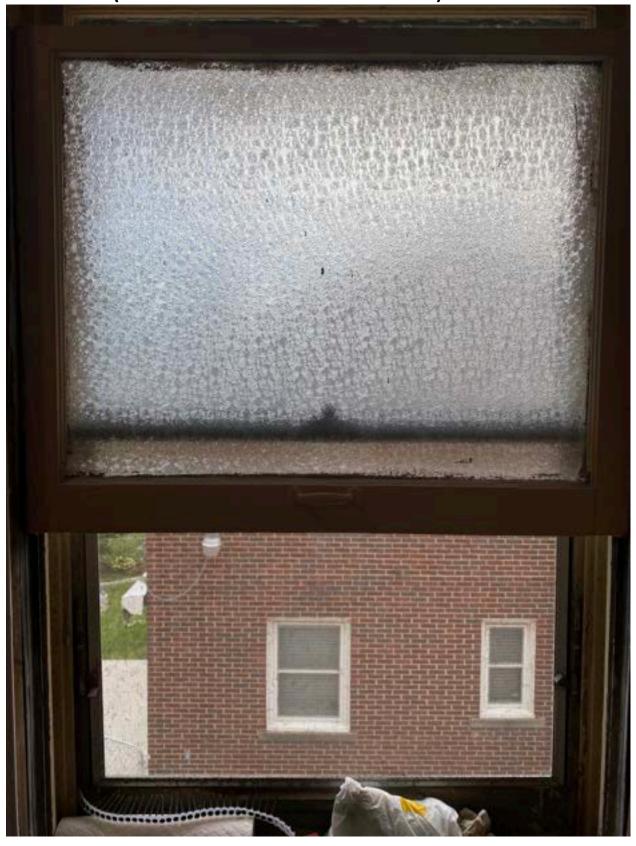
Condition: The window is difficult to open and has no storm window. **Why it cannot be repaired:** The repairman cannot find replacement

Window #8 (This window has no storm windows)

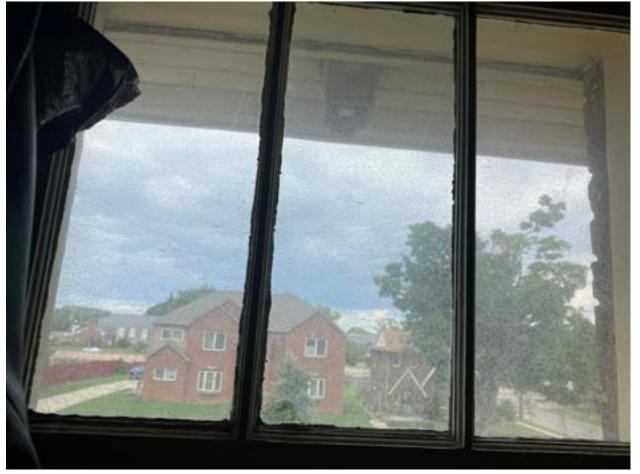
One of the panes is cracked.

Window #9 (the center pane is cracked in the lower left corner. The window is
