MERCHANTS BUILDING - 206 E. Grand River

HDC Review

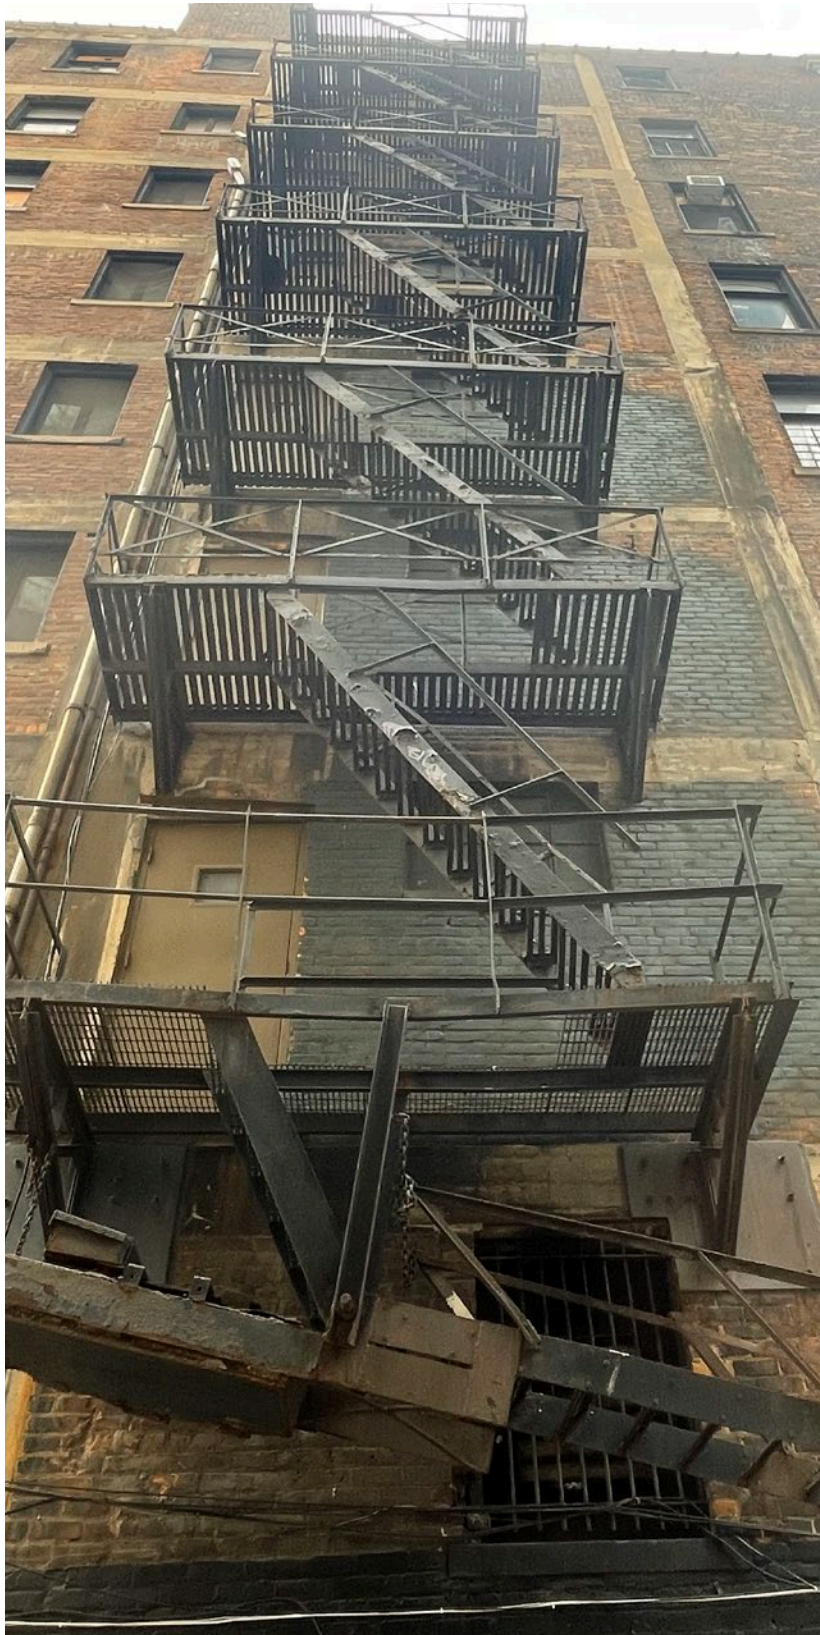
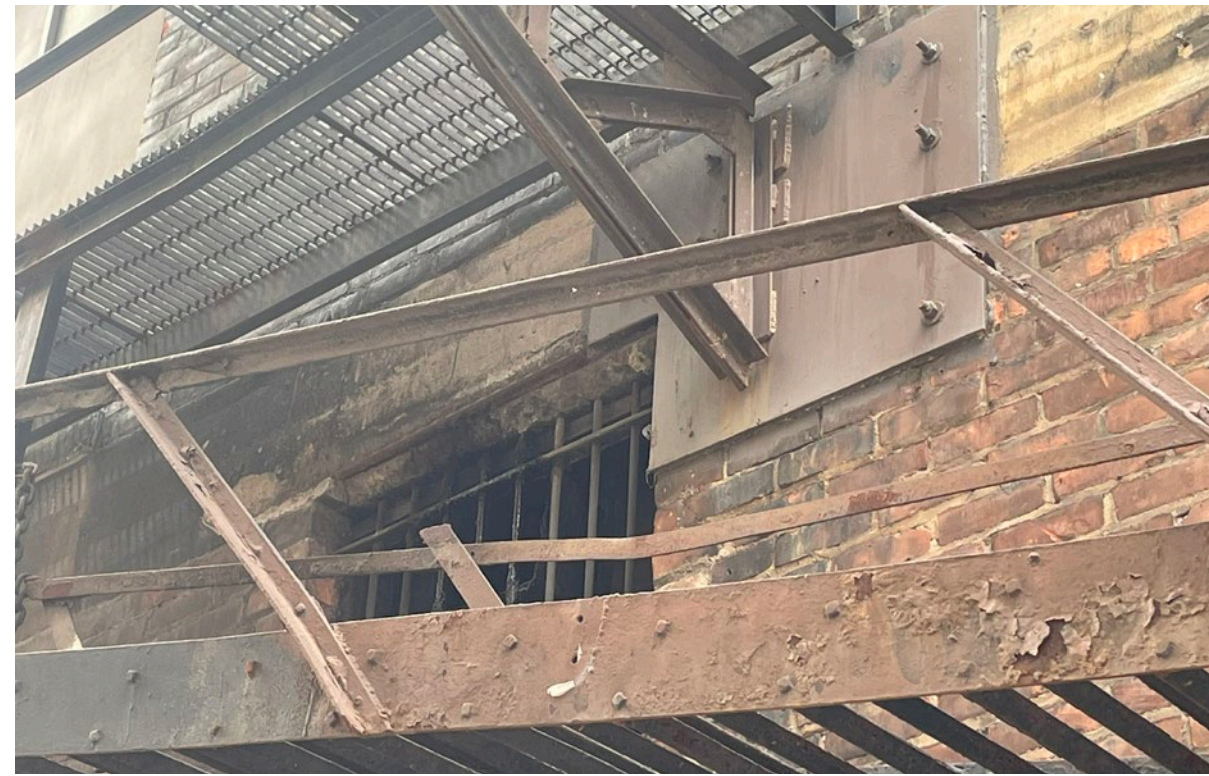
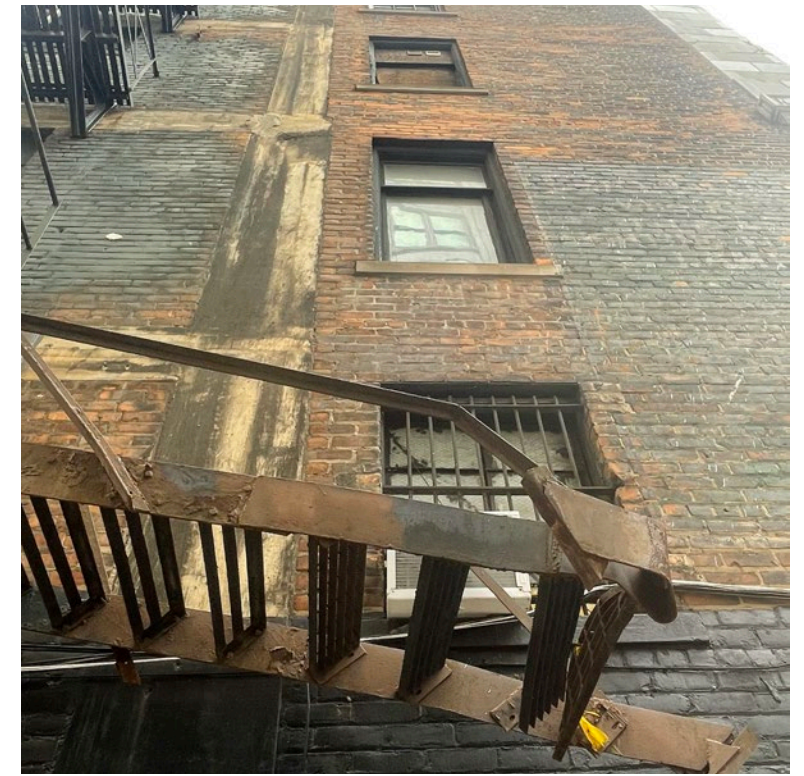
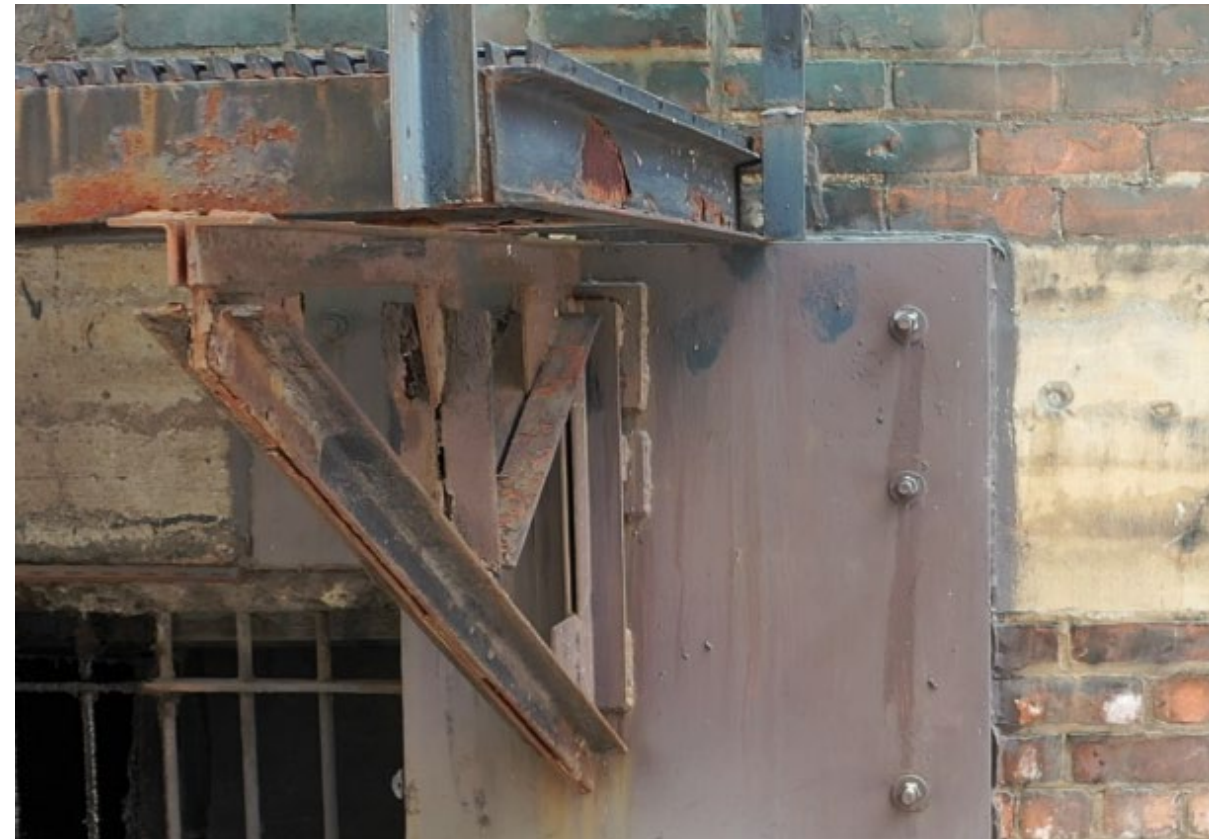
Typical fire escape condition photos, 4/17/23.

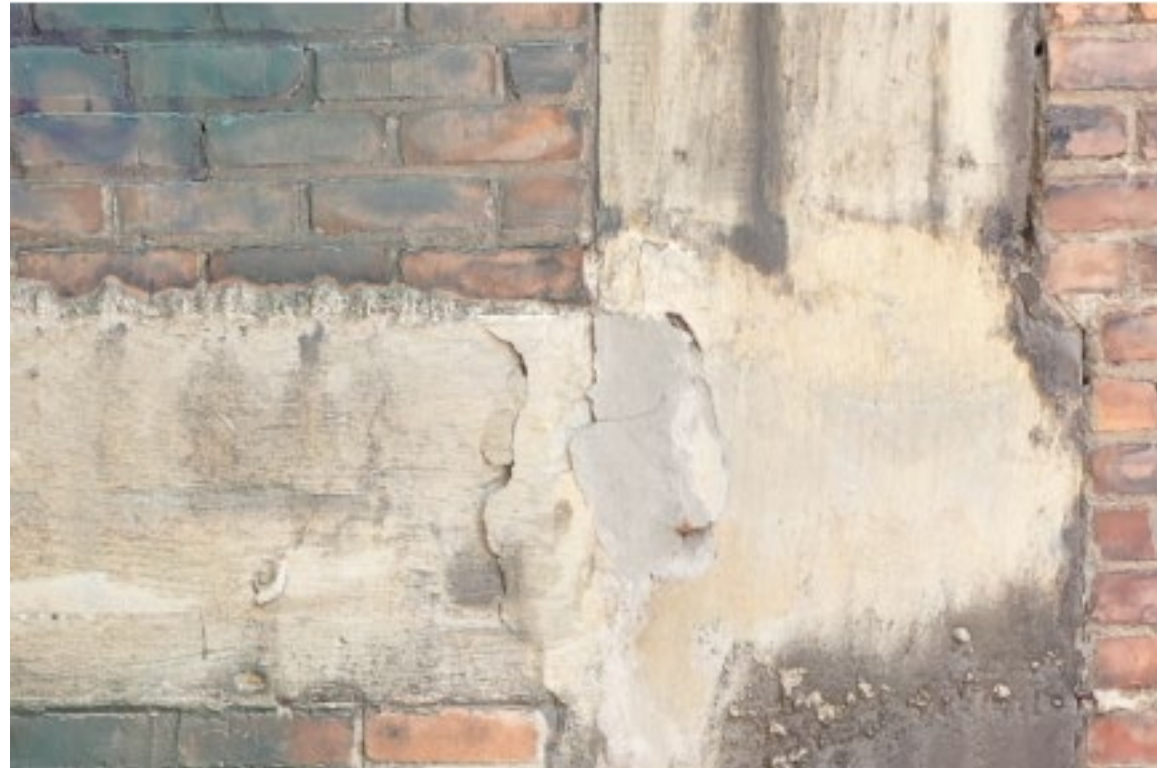
Example of exposed concrete structure spalling, April 2023

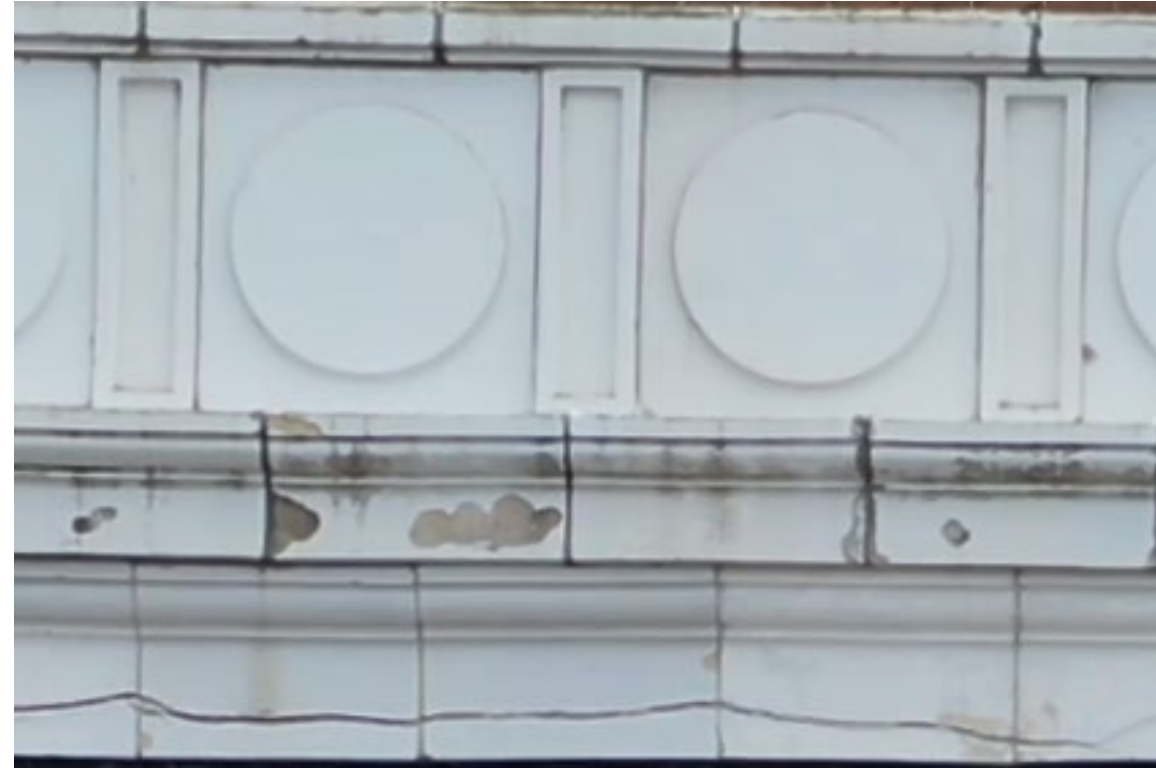
Example of terracotta cracking and delamination at water table, April 2023

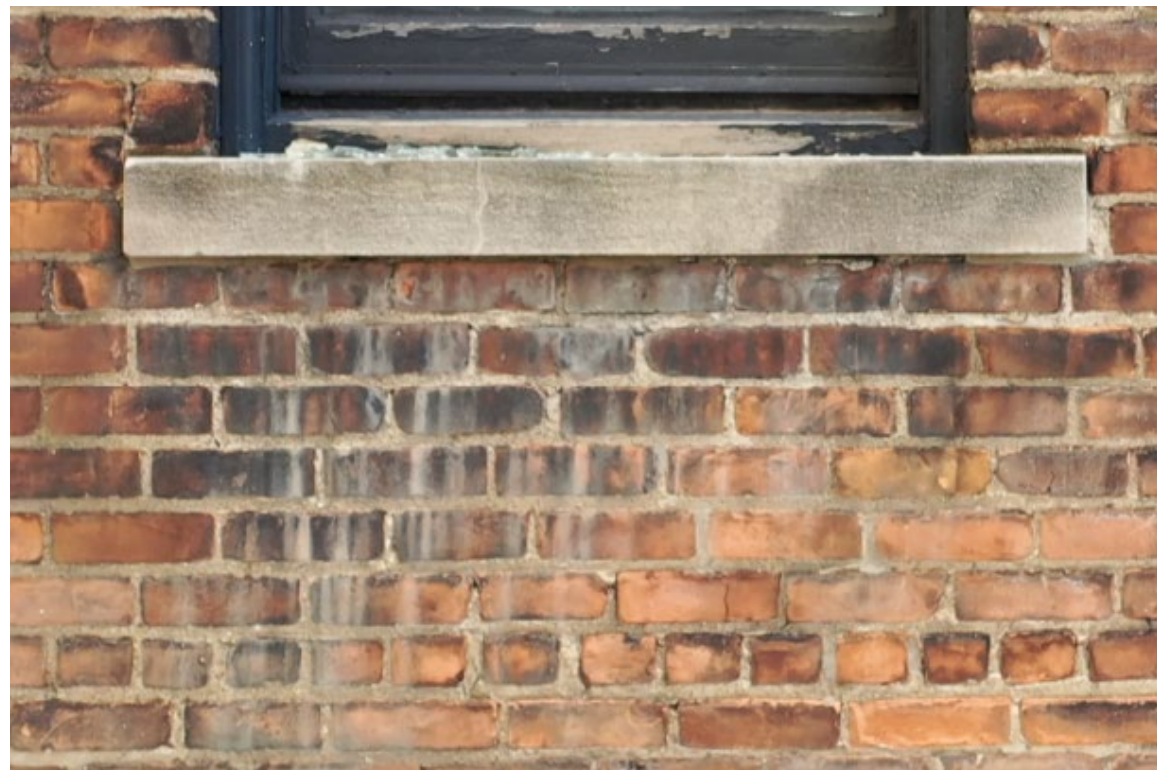
Example of typical brick efflorescence and deterioration, April 2023

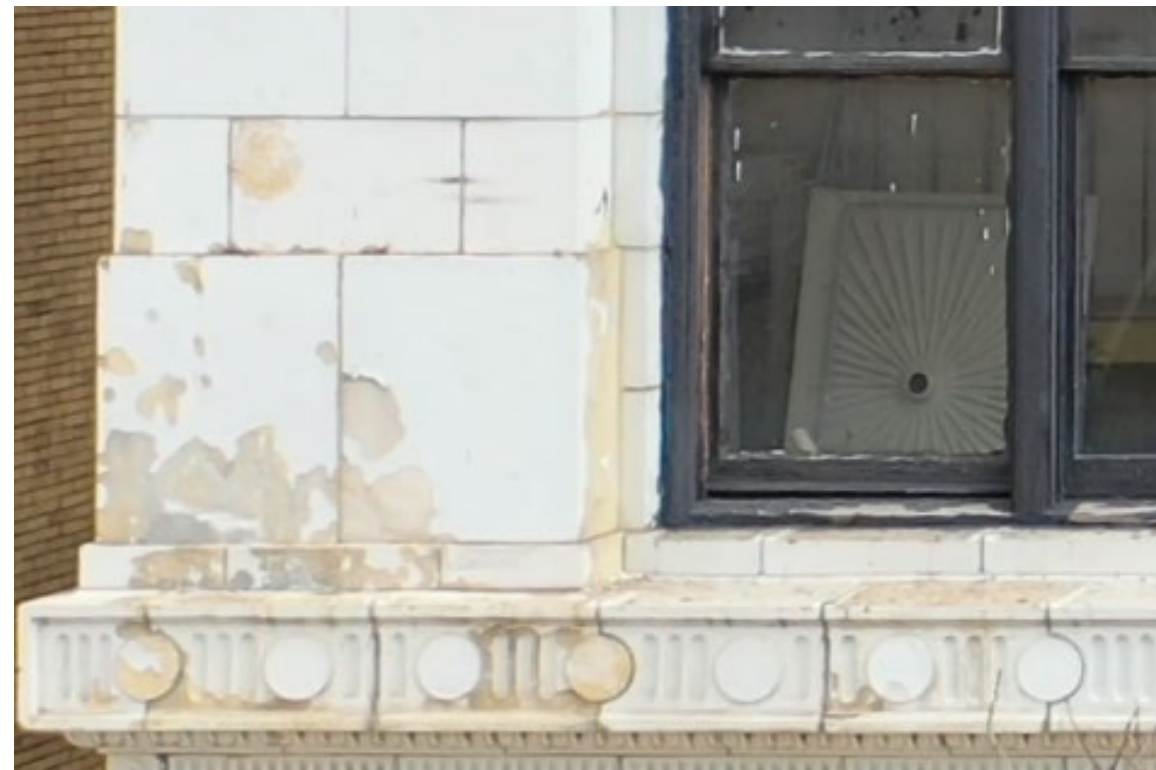
Example of typical terracotta delamination, April 2023

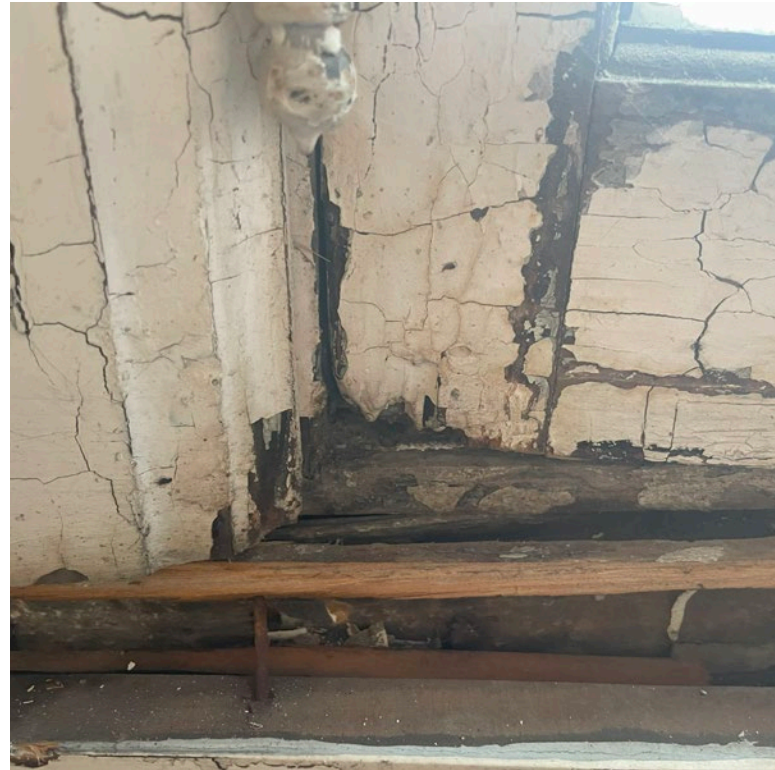
TYPICAL JAMB CONDITION

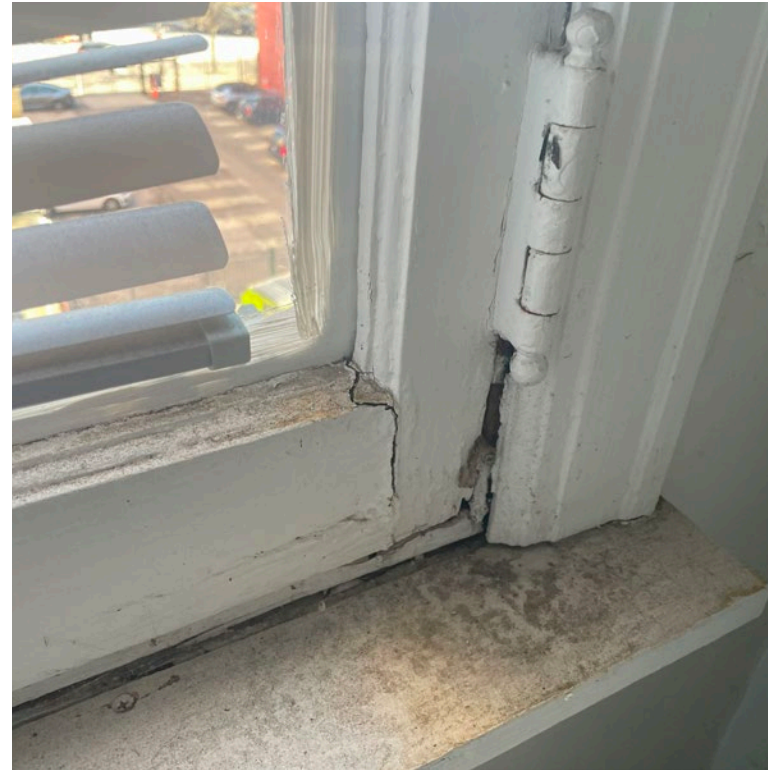
TYPICAL JAMB CONDITION

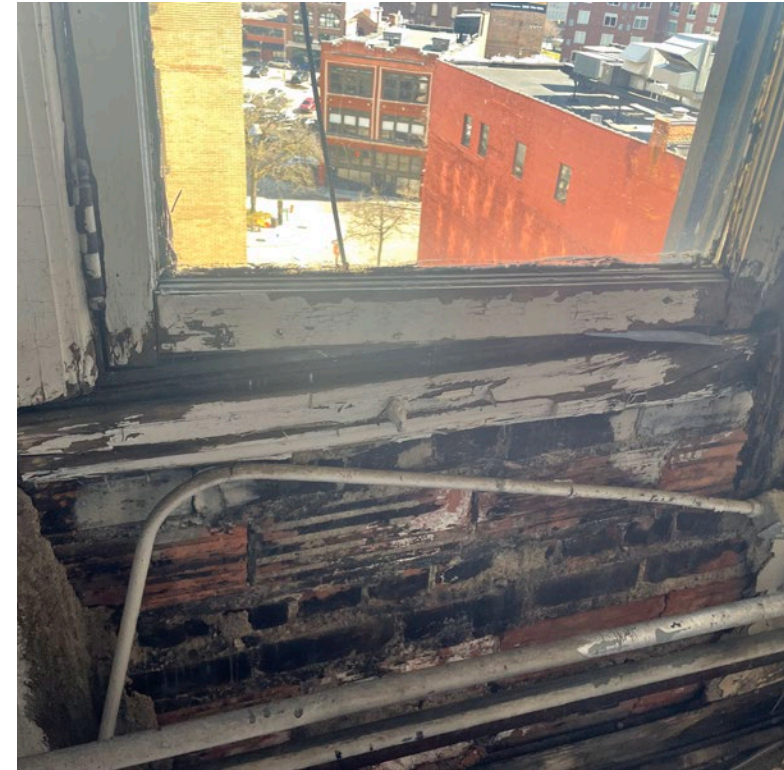
TYPICAL DETERIORATED INTERIOR SILL CONDITION

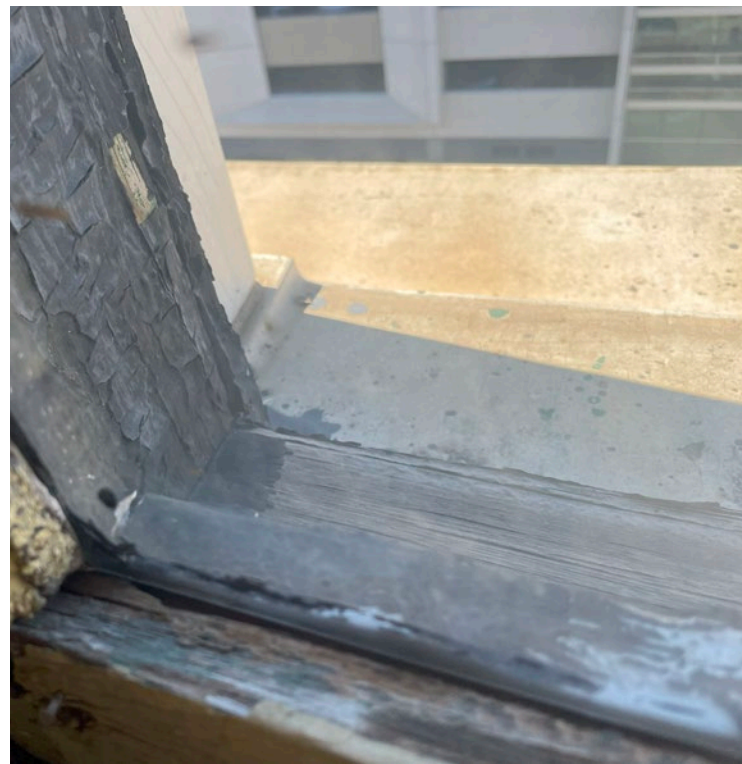
TYPICAL SILL CONDITION

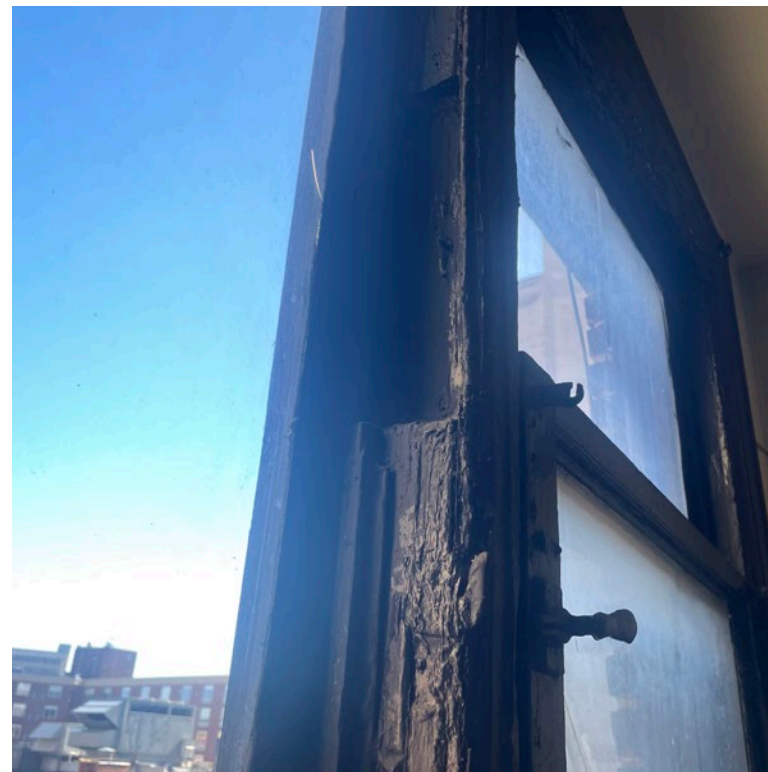
TYPICAL OVERALL WOOD CONDITION

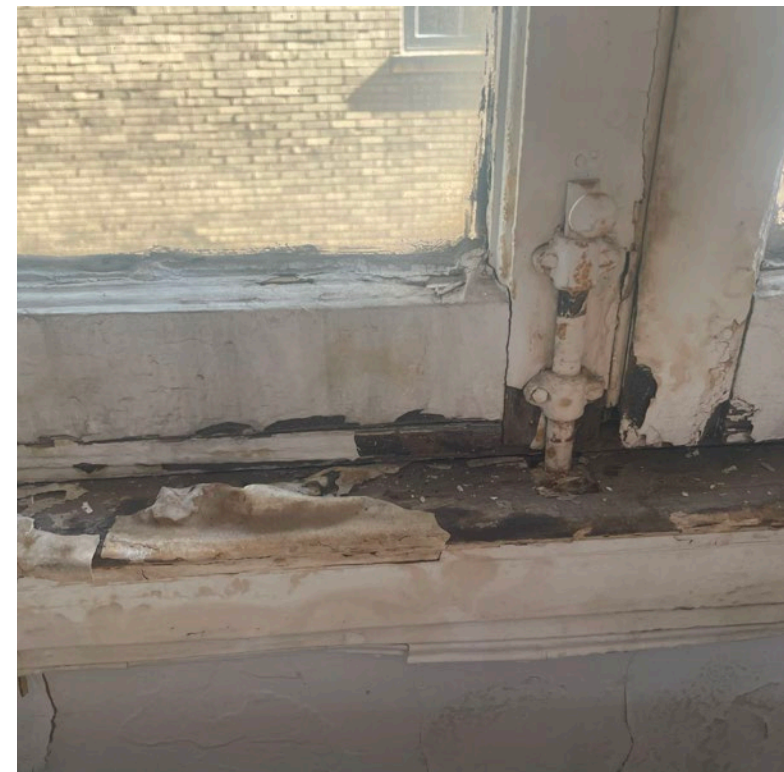
TYPICAL SASH CONDITION

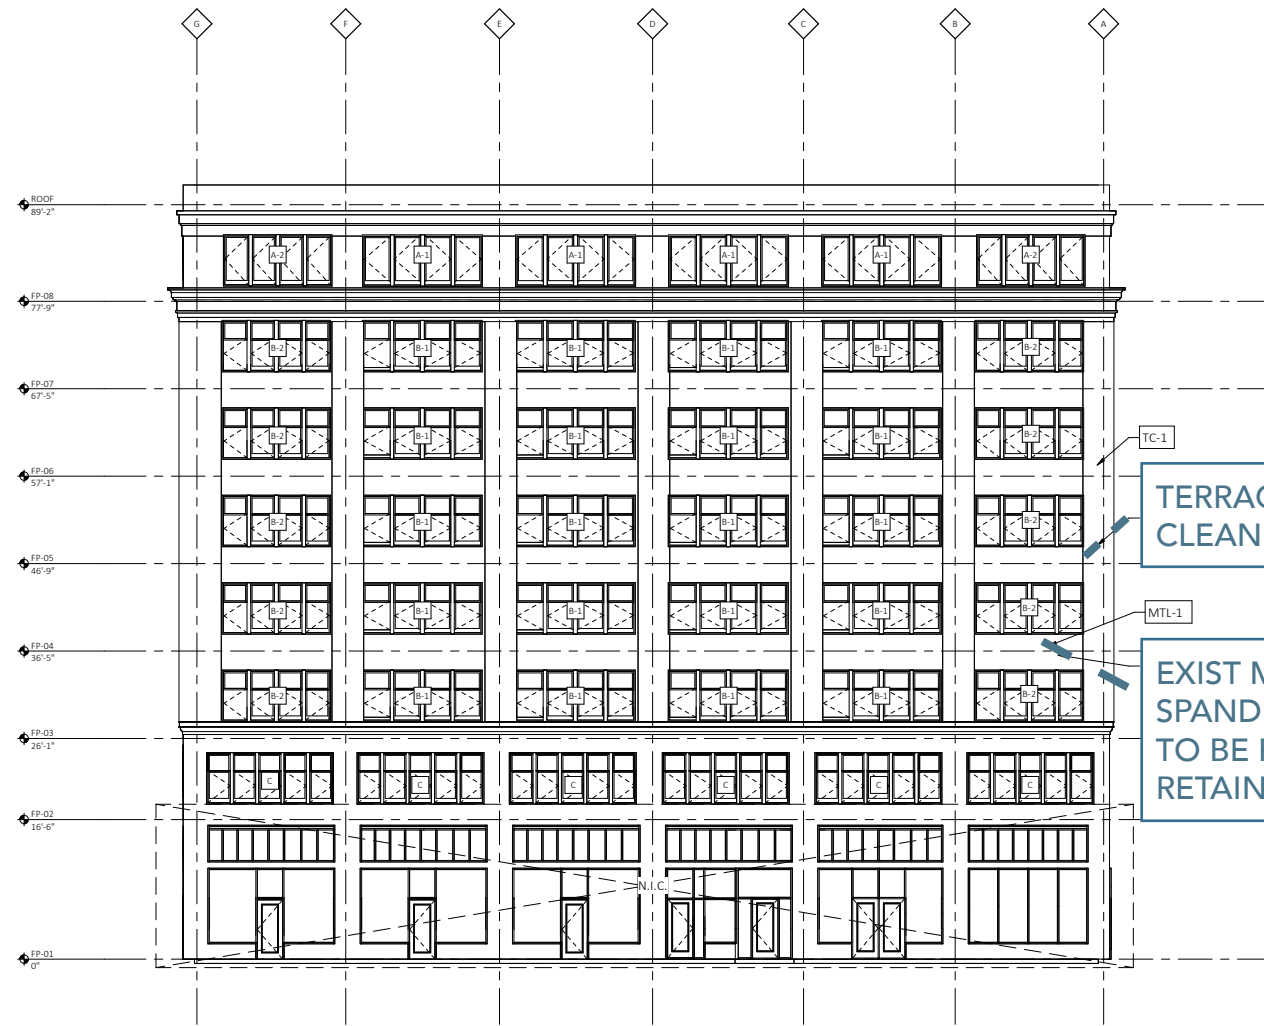
NORTH ELEVATION
SCALE: 1/8" = 1'-0"

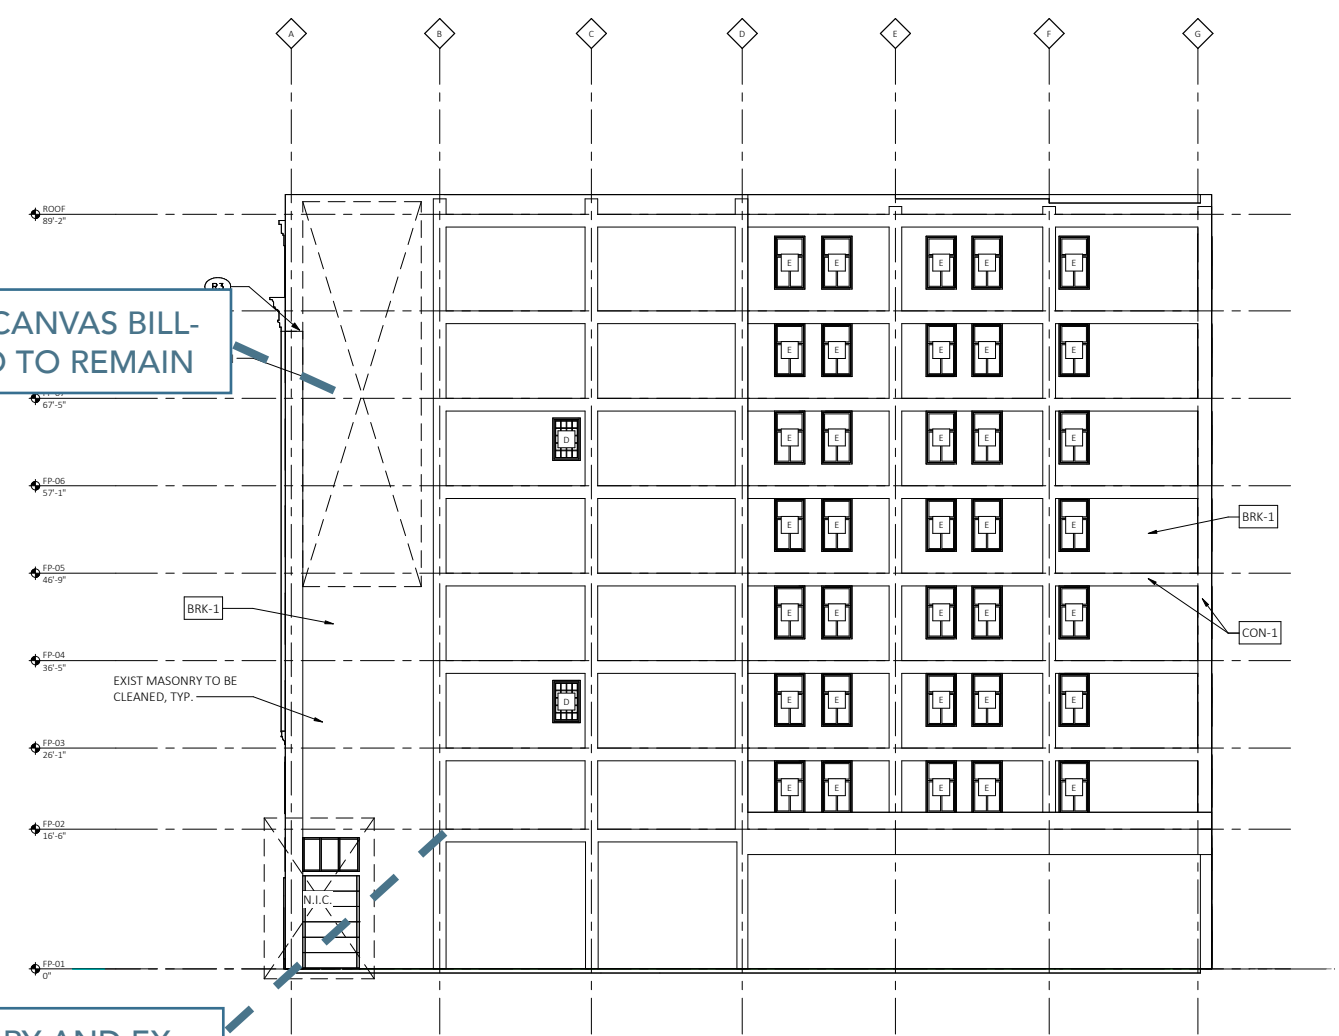
SOUTH ELEVATION
SCALE: 1/8" = 1'-0"

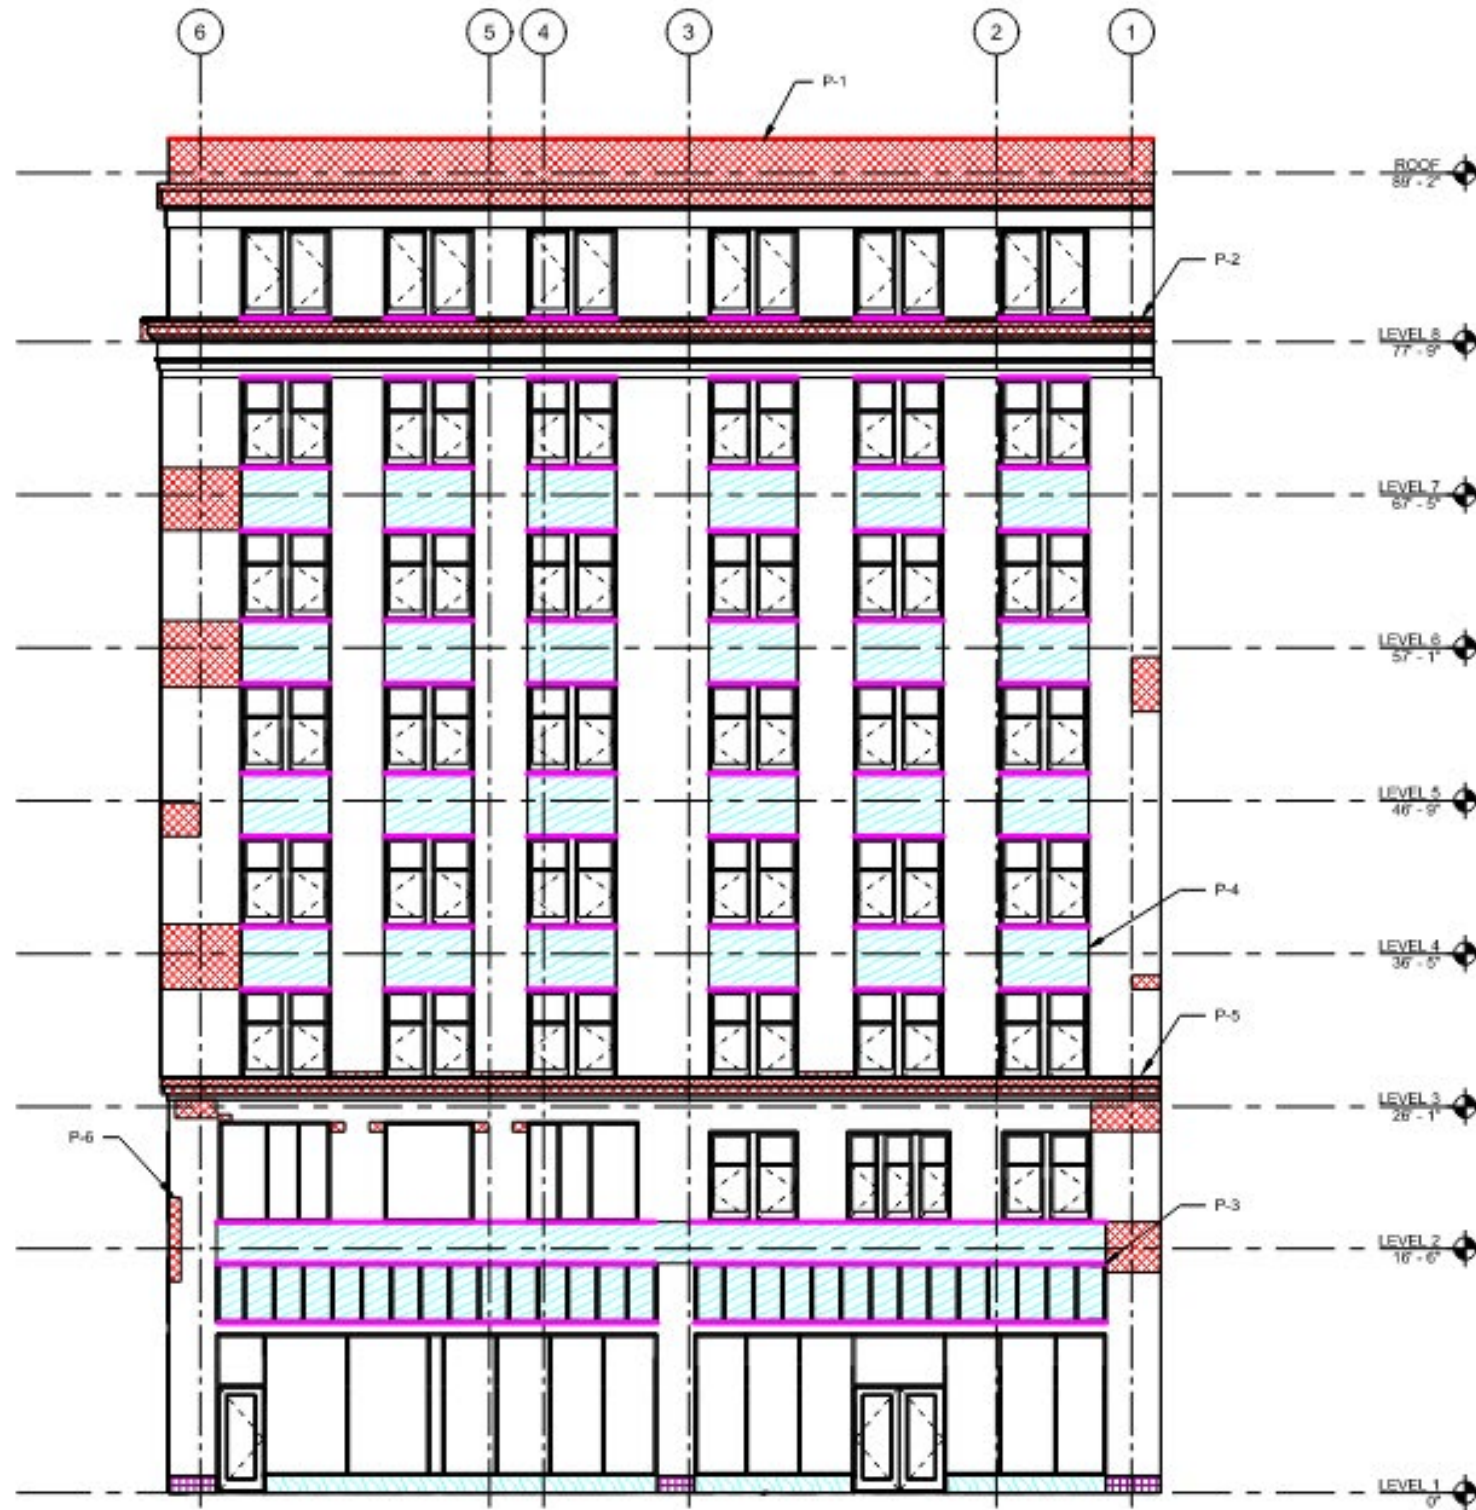
PRELIMINARY WEST ELEVATION REPAIRS

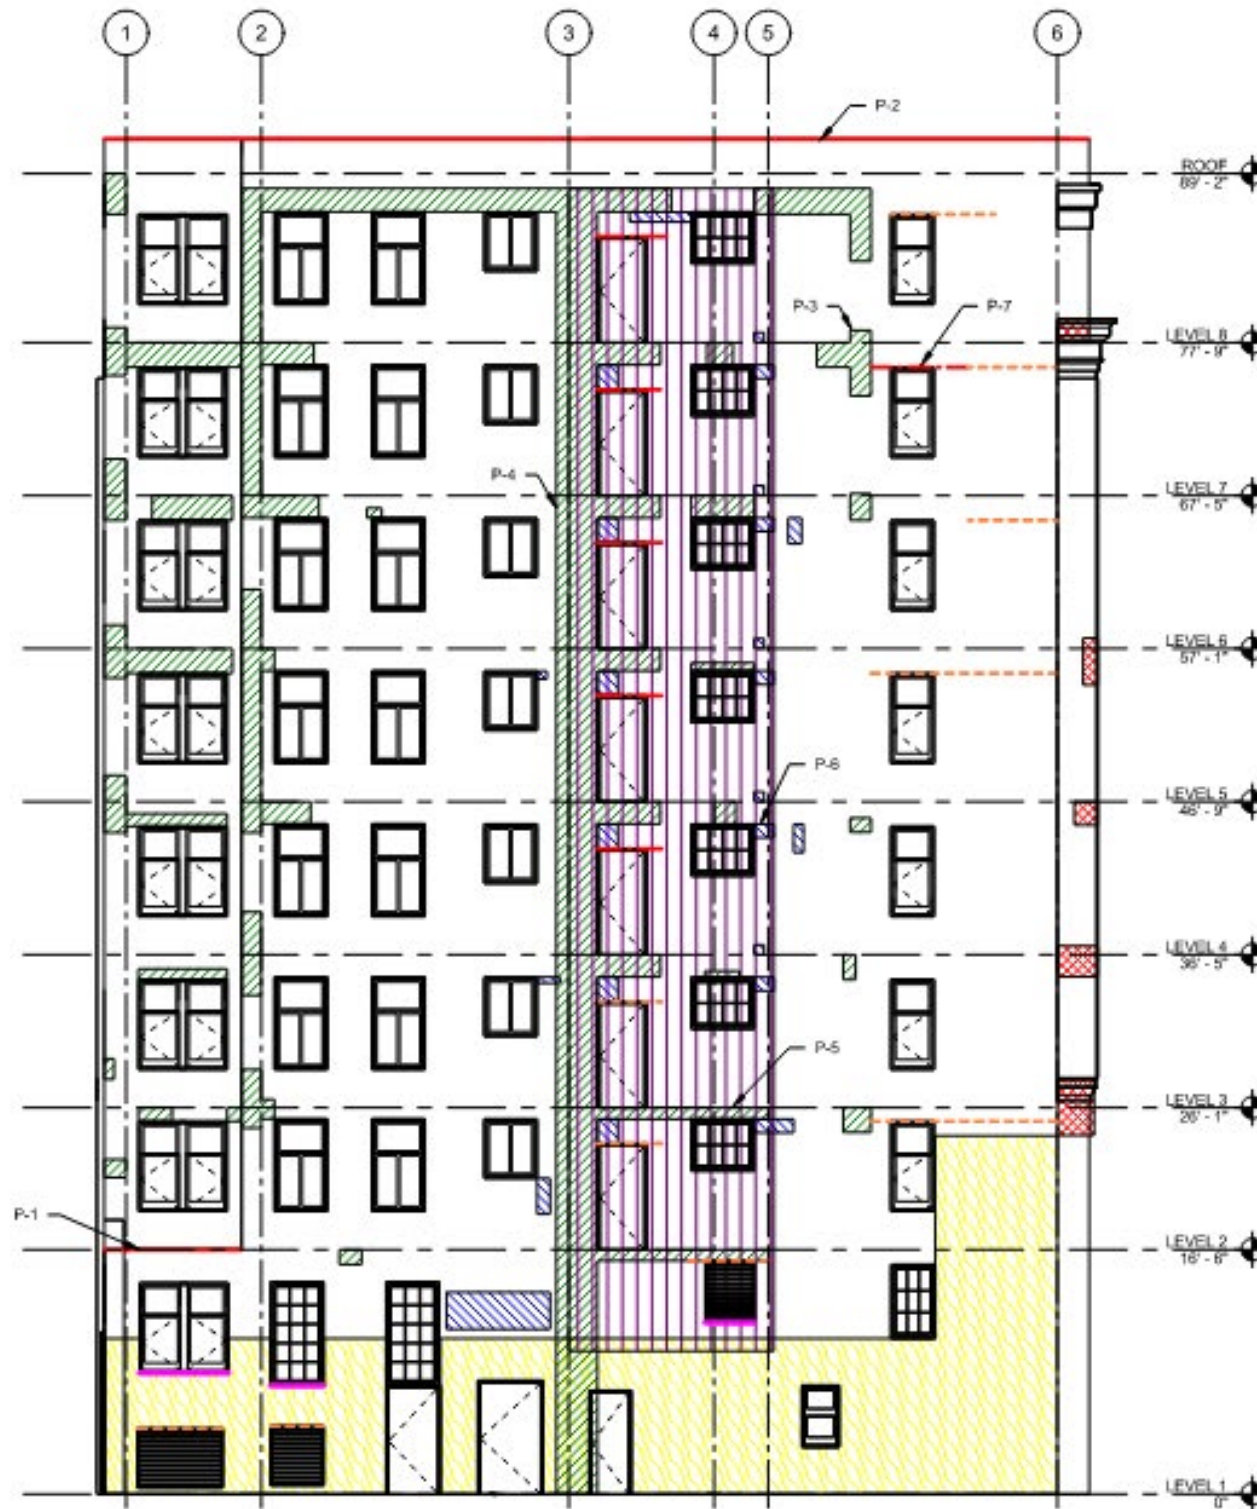
PRELIMINARY EAST ELEVATION REPAIRS
SCALE: 1/8" = 1'-0"

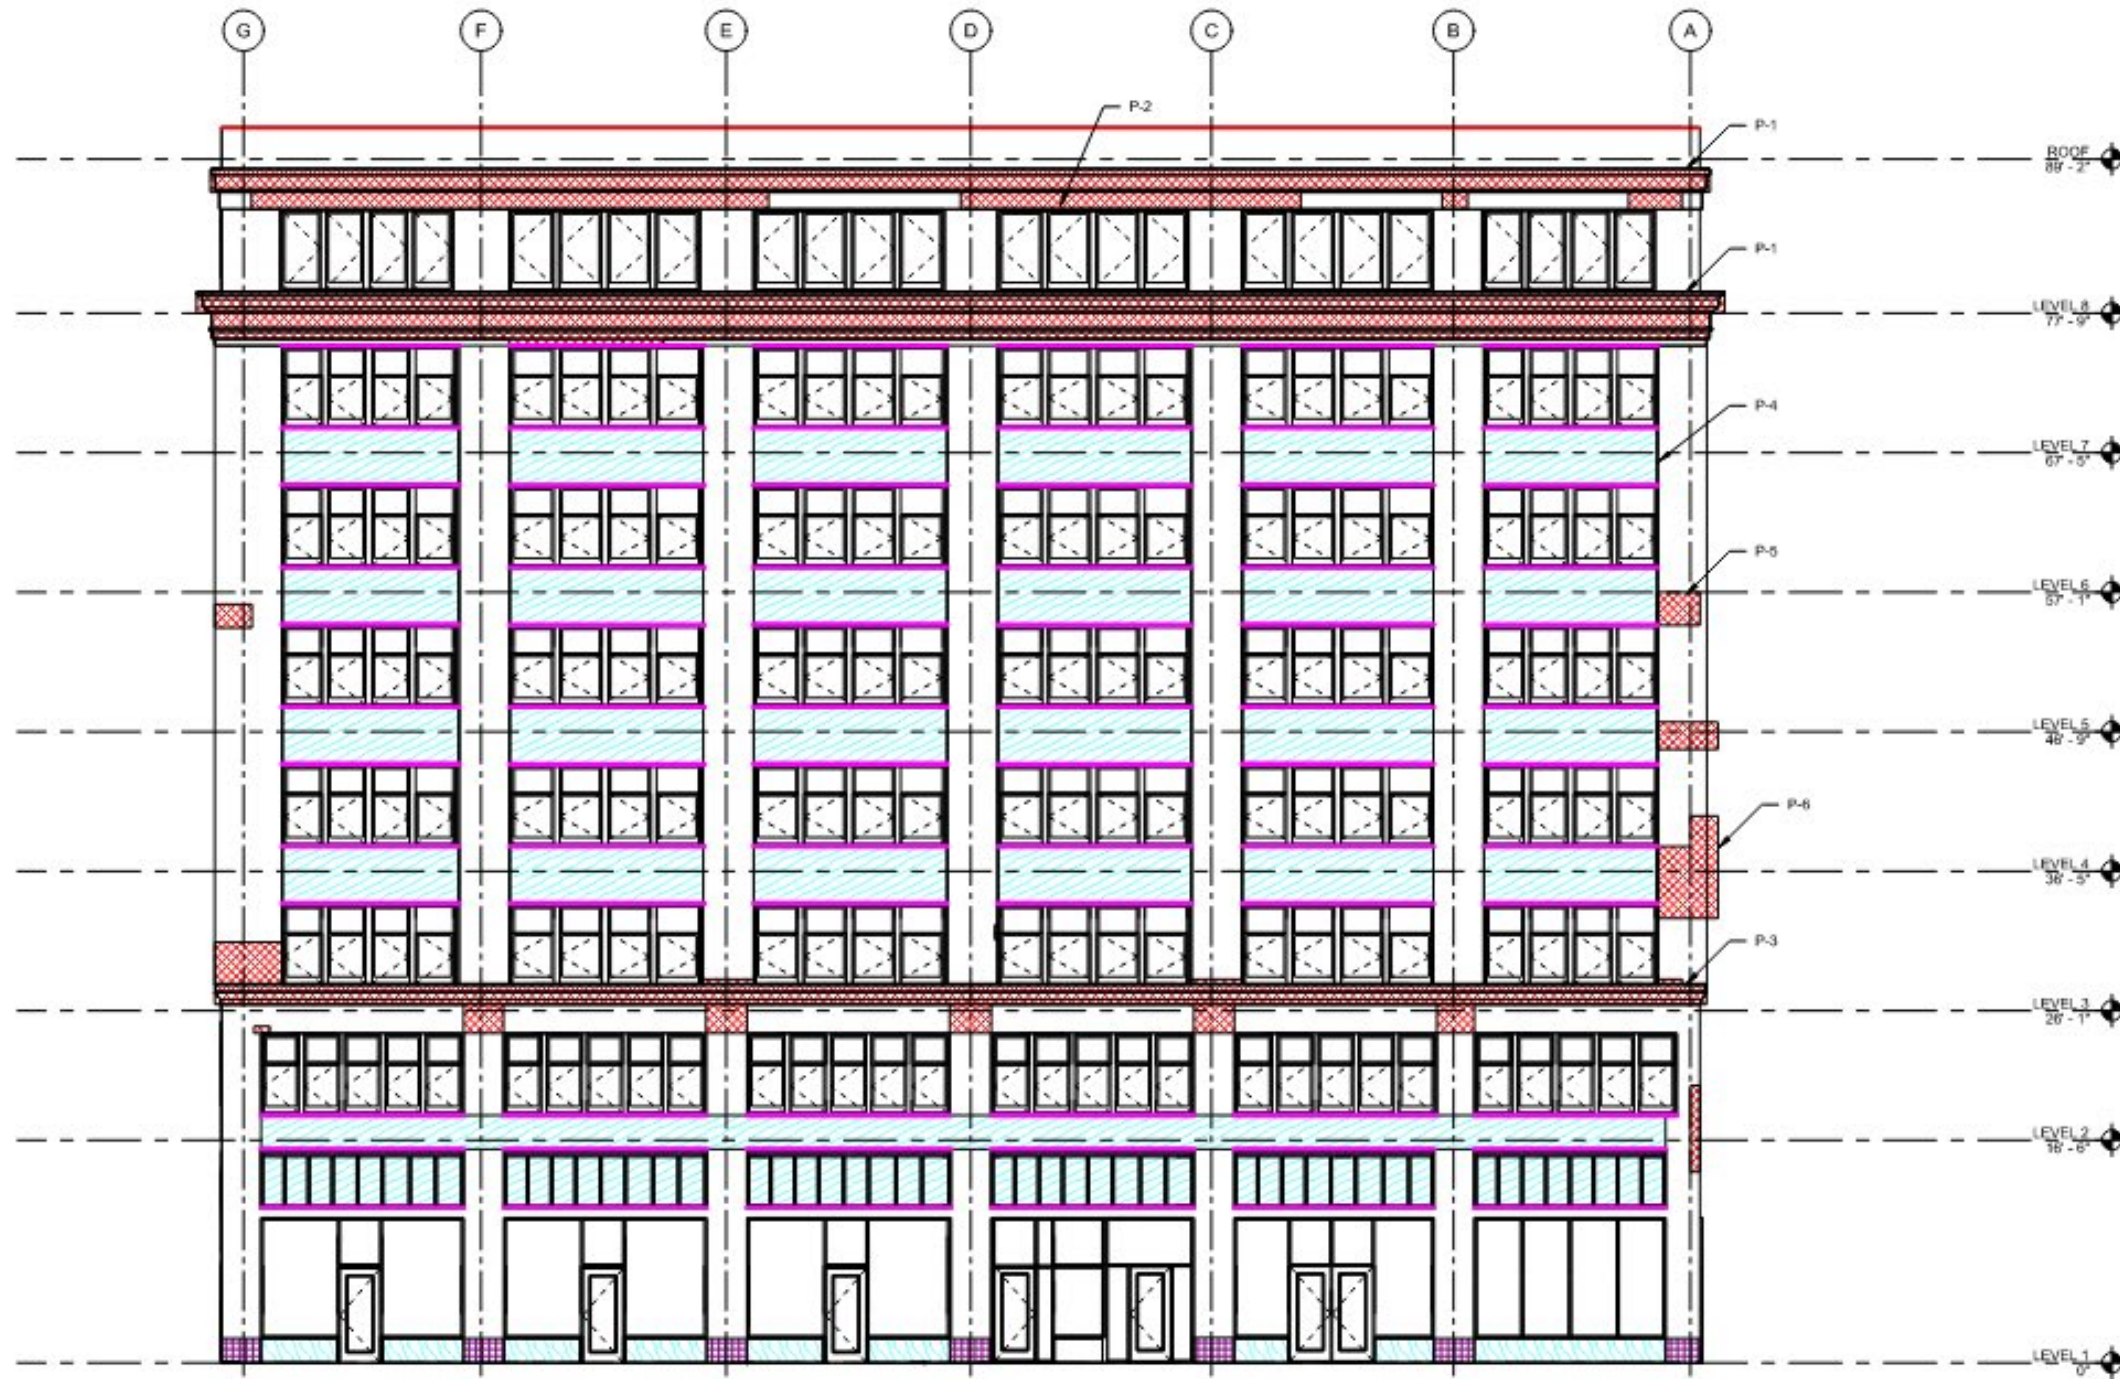
| HATCH PATTERN / LINE TYPE | TAG | REPAIR TYPE | RE QUANTITY | TOTAL QUANTITY | NOTE |
