MERCHANTS BUILDING - 206 E. Grand River

HDC Review

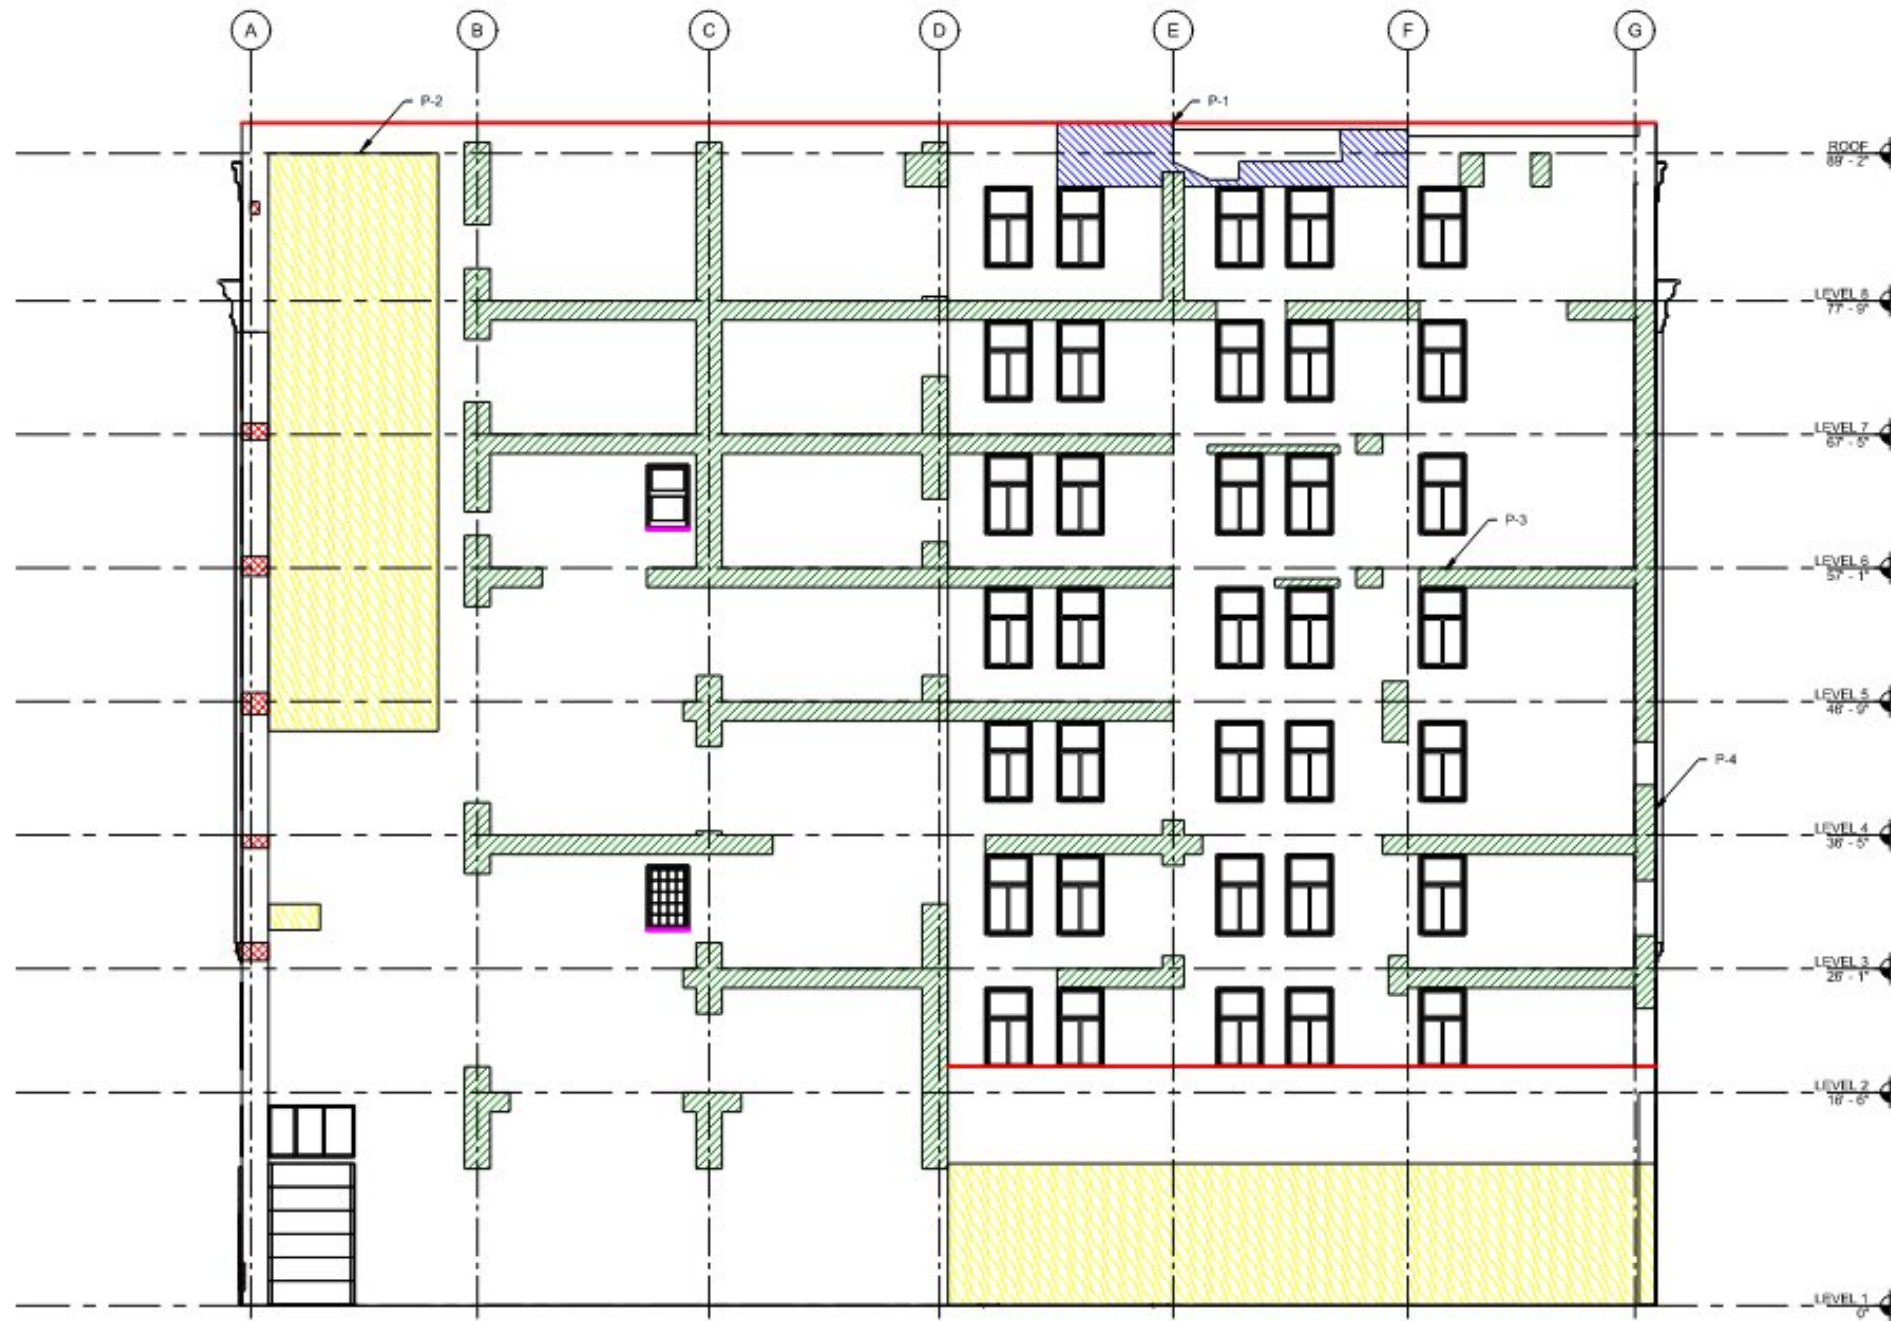
| HATCH PATTERN / LINE TYPE | TAG | REPAIR TYPE | RE QUANTITY | TOTAL QUANTITY | NOTE |
