APPLICATION NUMBER 04-342

104 EDMUND PLACE

Applicant/Owner: Debroe Co./Platinum Building &amp; Development

Brush Park Historic District

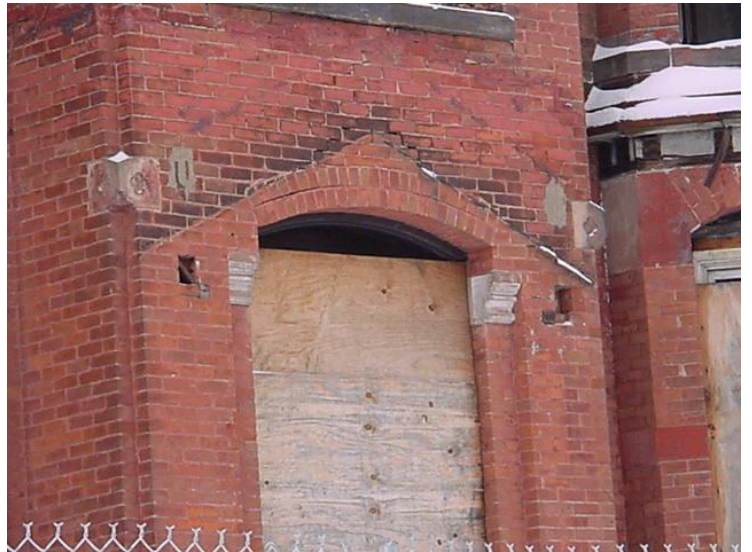
There is little evidence as to the design and location of the original front porch, which may have been off the building for many years. There is evidence, a building shadow, that there was a pediment shaped roof above the front door and maybe a porch across the front as well. Therefore, the application for a new front porch should be considered like new construction. In that case, the porch that is being proposed should be simplified in design and detail since the porch cannot be duplicated to match the original. The applicant has not supplied height measurements for any of the new construction. I recommend the Commission issue a Certificate of Appropriateness for the rear additions, the fencing and landscaping additions, the construction of the carriage houses, the construction of the rear porch with accessible ramp and the front porch with the conditions 1) the front porch design detail is reduced to a simpler form, and review by staff; and 2) measured drawings showing the height of all new construction is reviewed by staff. The work meets “The Secretary of the Interior’s

96-104 Edmund Place, evidence of pediment over front door in a shadow line.

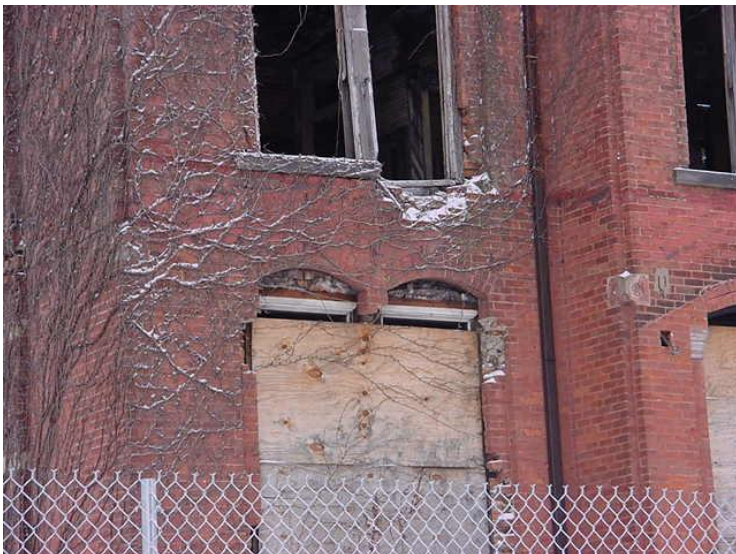
96-104 Edmund Place, more shadows of a front porch on the front elevation where a new porch is proposed.

The front porch, collapsed by designation in 1980, is proposed start in the same location as the original, from the front door, and wrapping around one side, longer than the original. A Sanborn map from 1887 shows the original footprint of the porch. The porch entrance is proposed to be 10' 10½" wide, 6' deep and one story high. The porch section that wraps around the east elevation is 7' deep along the front elevation and 5' 5½" deep along the side. The porch itself is proposed to have paneled plinths, arched apron, dentils, and a wood rail with a quatrefoil design. The rear porch has a three-sectioned ramp with landings between and a set of steps to the east. Each ramp is 4' wide and 16' long, extending 17' total beyond the rear face of the house. The exterior rail has a matching quatrefoil wood pattern while the interior rails are metal.

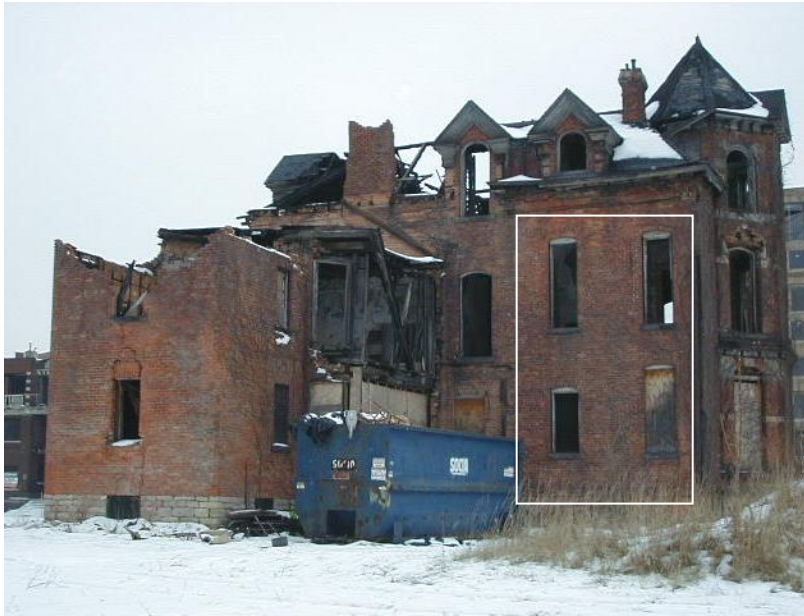
96-104 Edmund Place, rear elevation showing approximate area (box) of new addition.

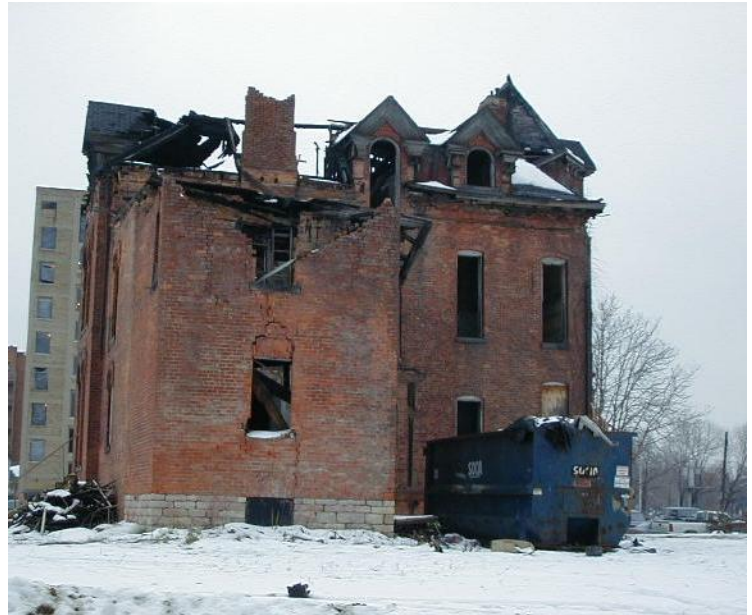
On the west end of the rear elevation are two, two-storied additions, both which appear on the 1887 Sanborn. The farthest to the rear, staff determined to be the oldest section of the house, is proposed to be demolished and rebuilt. This section has a clear line of construction between it and the rest of the house. The original roof appears to have not been integrated into the rest of the houses' roof as well. The reconstruction of this section will cover the rear hipped section under the roof, creating a 12/10 pitch. The reconstructed addition is proposed to be the height of the section before it, 12' deep and 23' wide. A new addition is proposed on the eastern portion of the rear elevation as well. This addition is proposed to extend to the rear elevation of the other rear addition, but is 37' deep from the rear face of the house and 18' wide. An area for the doorway is proposed between the rear additions. Both rear additions have a single window on each story at the back elevations and other windows along the sides.

96-104 Edmund Place, addition for the rear proposed to be rebuilt.

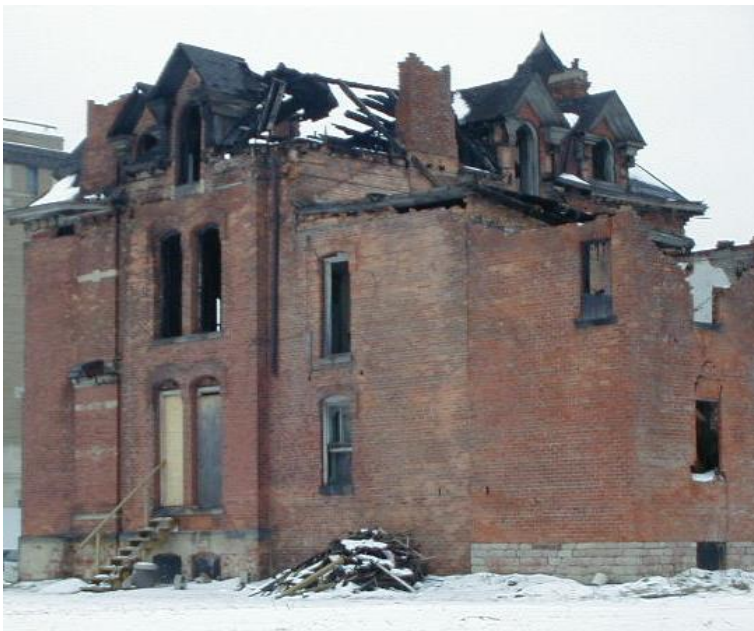
96-104 Edmund Place, side view of addition proposed to be rebuilt. Notice the brick line, the foundation change and lower eave line.

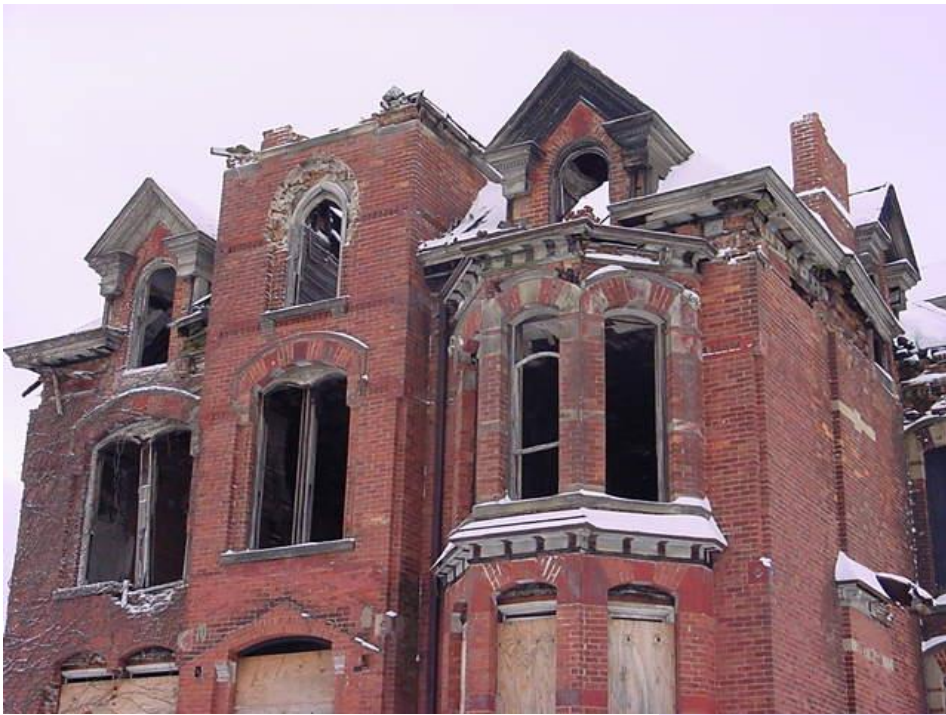
96-104 Edmund Place, detail of the second and third stories. Windows are proposed to be installed, masonry

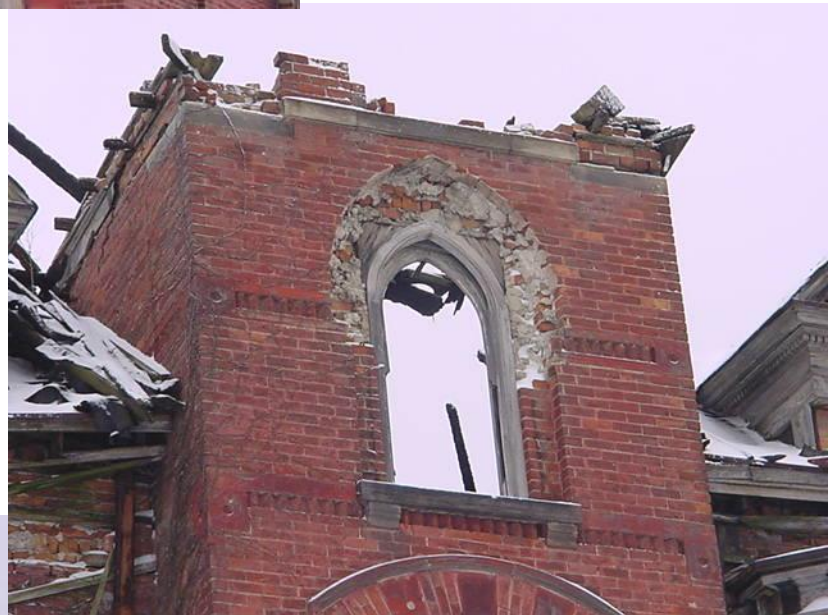
The very top portions of the roof have collapsed, leaving sections of roofing around eaves and dormers. The roof is proposed to have a hipped 12/12 pitch with asphalt shingles. The other sections of the roof are proposed to be rebuilt to match the remains. The central tower's roof was collapsed at designation, and the applicant proposes a convex tower roof with a front round window. Extensive masonry repair is needed throughout the building, reconstructing the tops of walls, chimneys for example. The windows are proposed to be replaced to match the existing openings. There has been no specified window product, but the applicant proposes to use the quatrefoil pattern in the tympanum of the arched window openings instead of full arched windows as original.

96-104 Edmund Place, third story tower that is proposed to be rebuilt with a convex roof and round window. Notice the brick detailing.

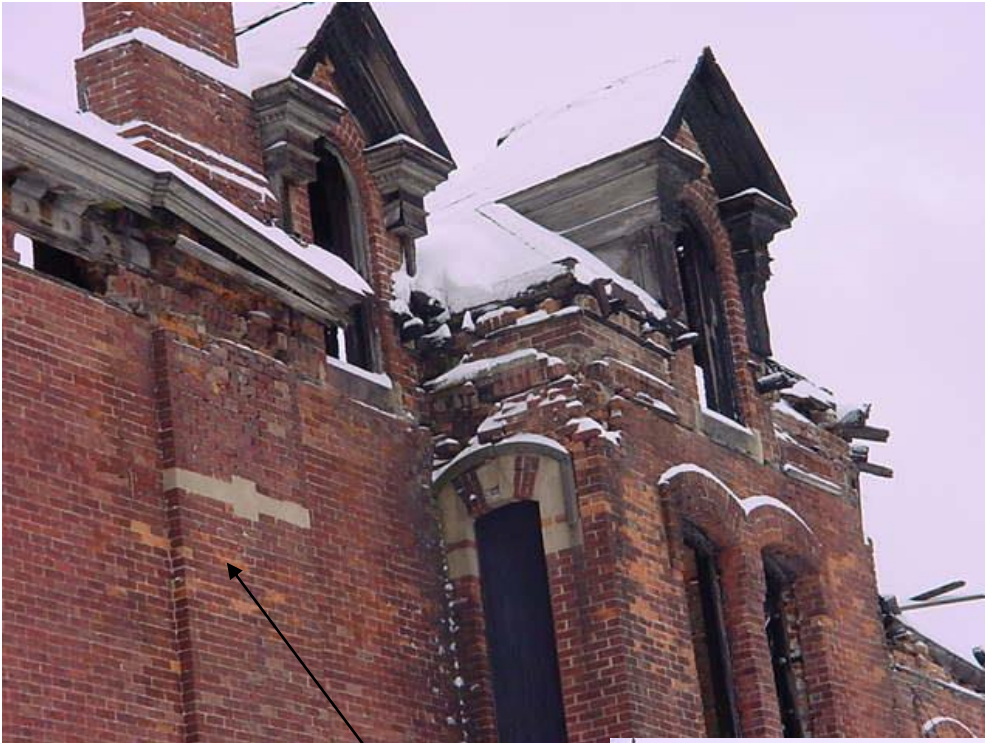
96-104 Edmund Place, second and third story detail of west elevation. Chimney (arrow) is proposed to be rebuilt.

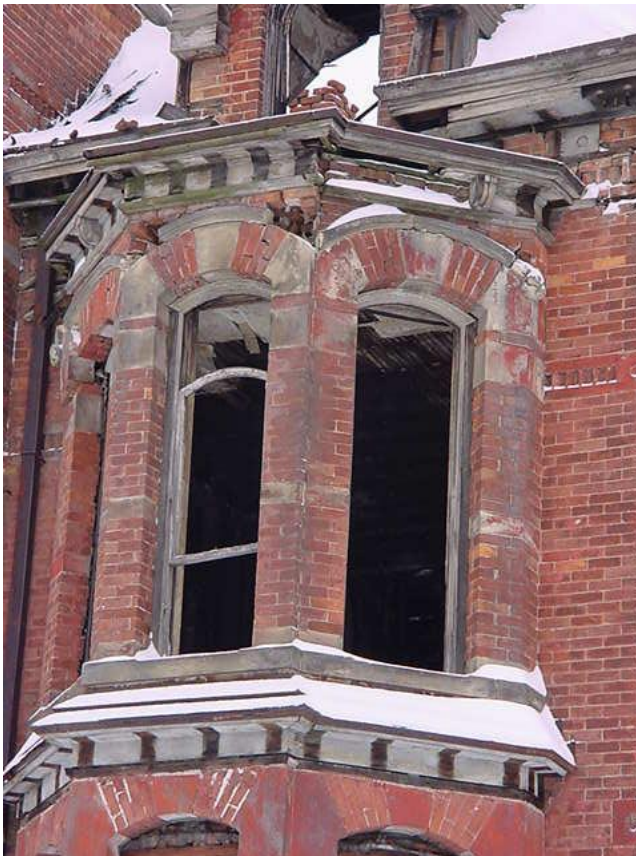
96-104 Edmund Place, the one remaining and visible sash. Notice the arched top.
