Applicant Response to Staff Report

2905 Garland- HDC approved concrete porch replacement (Exhibit 1)

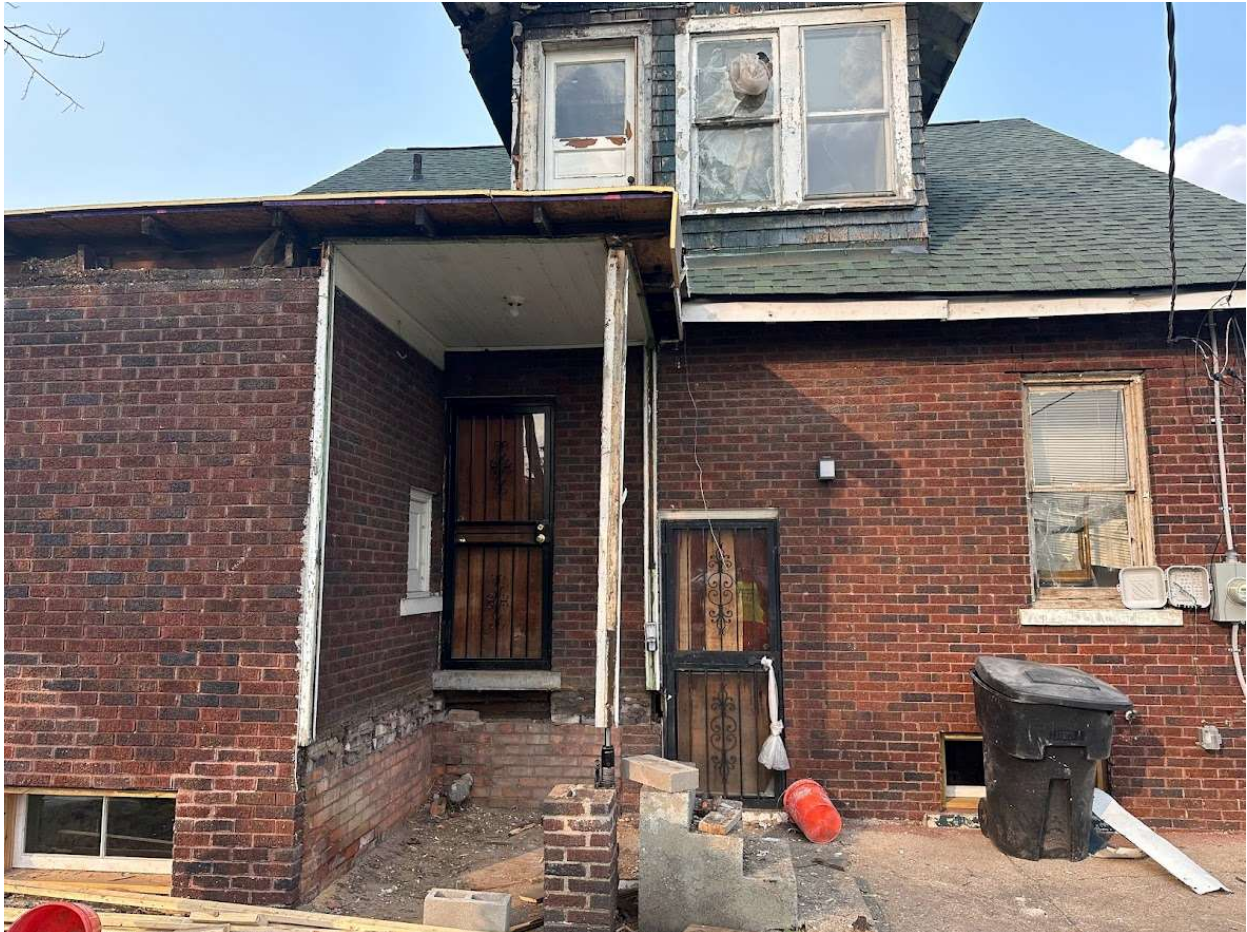
- The previously existing brick pier was assembled on top of a non-historic concrete porch without a footing. It was not properly placed under the support post as demonstrated in Exhibit 1 and 2. There was no evidence of brickwork underneath the prior concrete patio.

Former brick pier and concrete steps. Both are believed to be non-historic. Brick pier is not aligned with the corner of the porch and utilized modern mortar. Modern mortar is evident throughout the pier in Exhibit 2 and 3.

- The wood post in Exhibit 1 is believed to be original. An in-kind replacement is proposed that would sit on a below grade footing poured during the replacement of the patio.

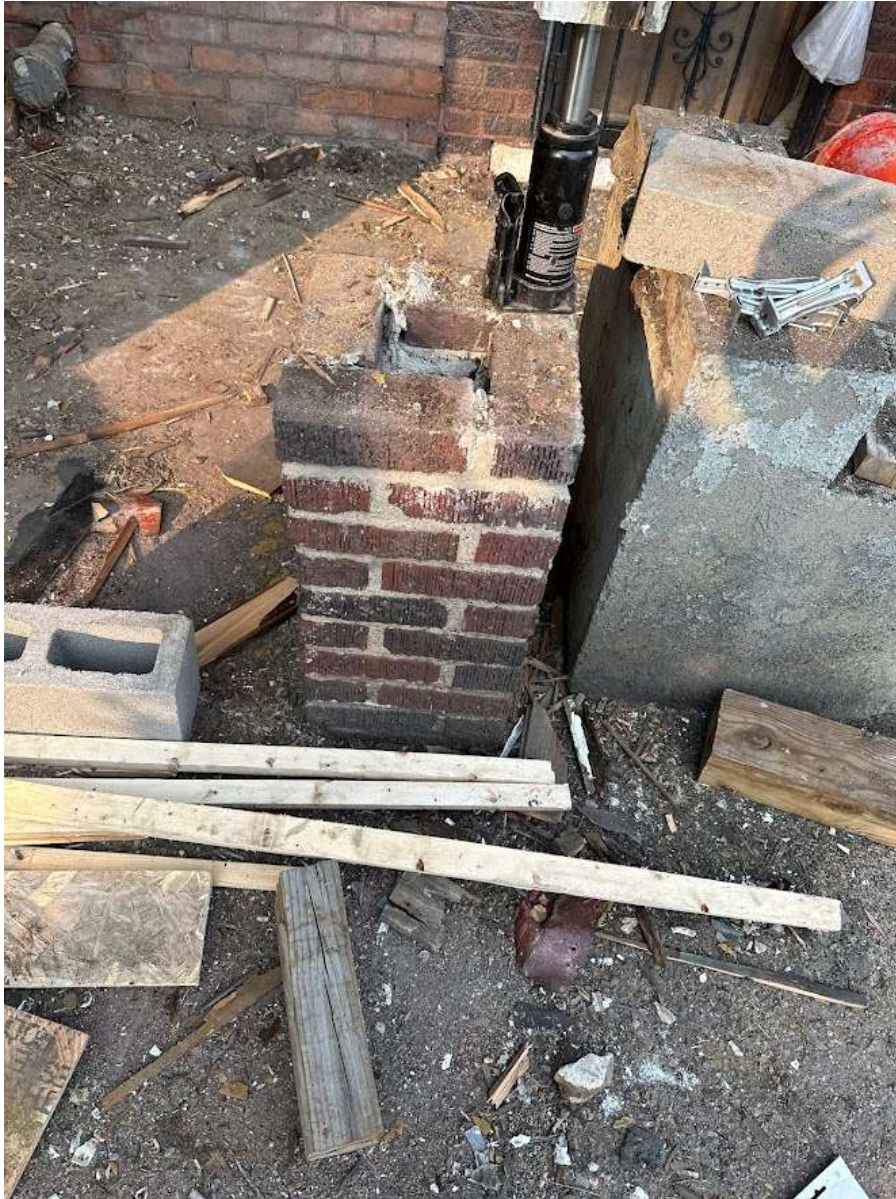
Brick Pier Detail (Exhibit 2)

Modern mortar is evident on historic brick throughout the pier. Note the placement of the temporary support jack. Pier is not located in correct location to provide structural support.

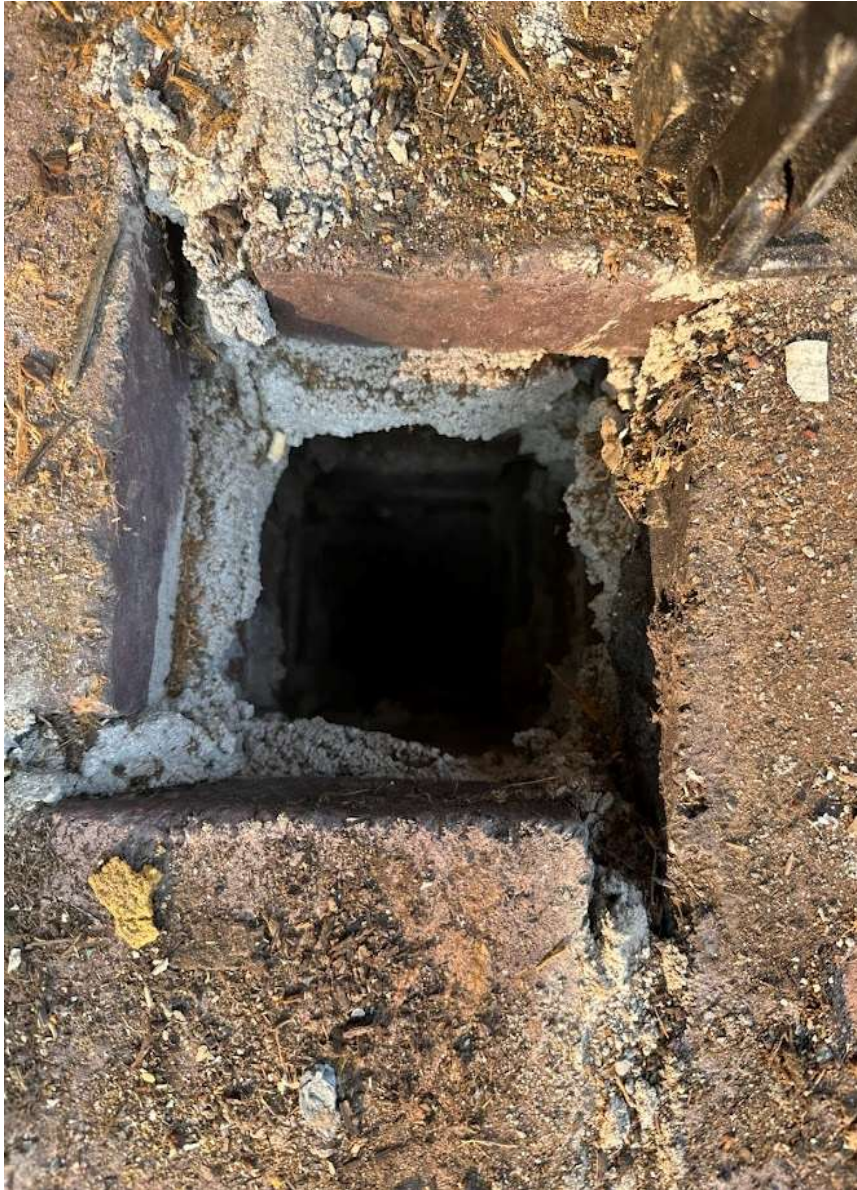
Brick Pier Interior Detail (Exhibit 3)

Modern mortar is evident throughout the interior of the brick pier. This demonstrates the exterior and interior mortar is the same from when the pier was constructed.

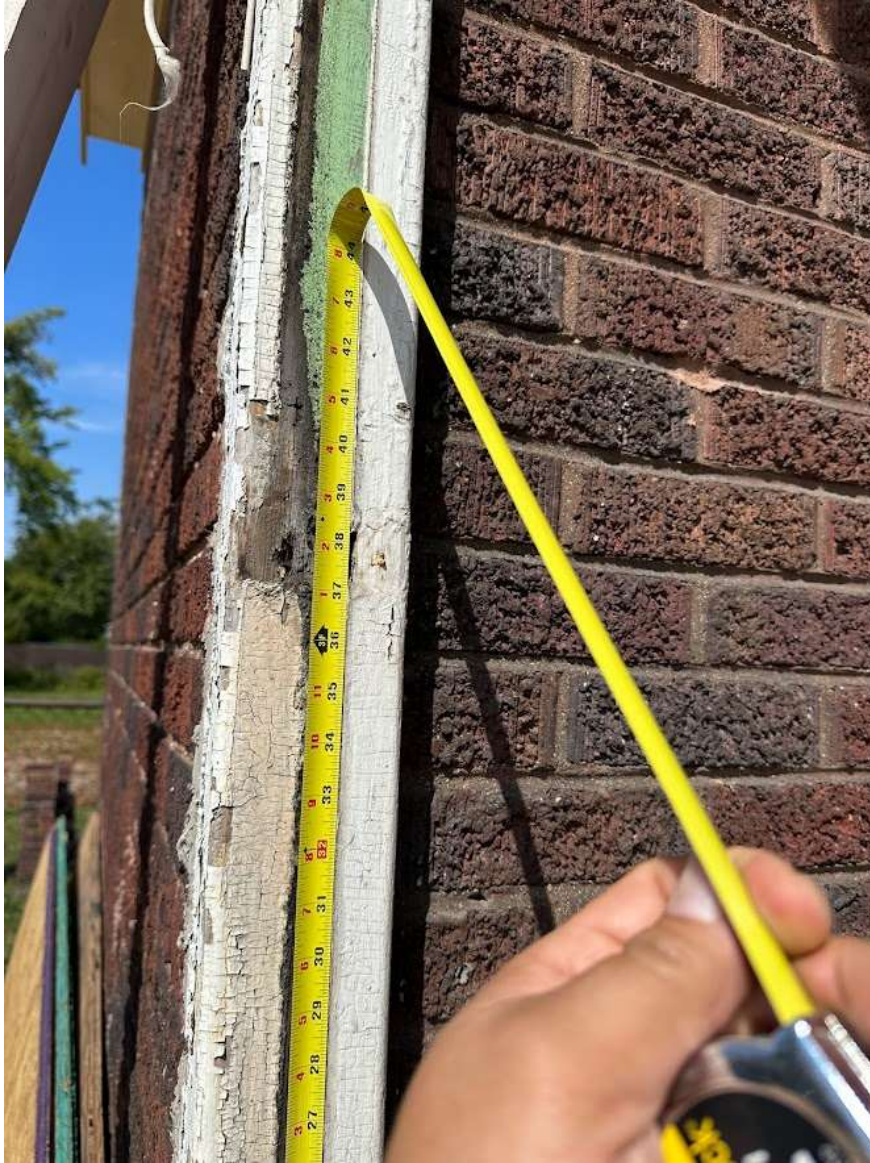
Lower Porch Original Hand Rail Shadow Line (Exhibit 4)

- The proposed second floor railing height of 40" was chosen to be symmetrical with the first-floor height as determined by the shadow line on the original first floor nailer (per Exhibit 4 below).

- The height the applicant proposed was based on the first-floor shadow line (Exhibit 4). This photo was shared with but omitted from the Staff report.

The original wooden nailer remains attached to the brick corner of the house. A shadow line can be seen at a height of 41" from the porch floor support. Note 5/4" Tongue and Groove pine porch flooring has yet to be installed. Adjusted for flooring, it is believed that the height of the top of the original railing was 40".

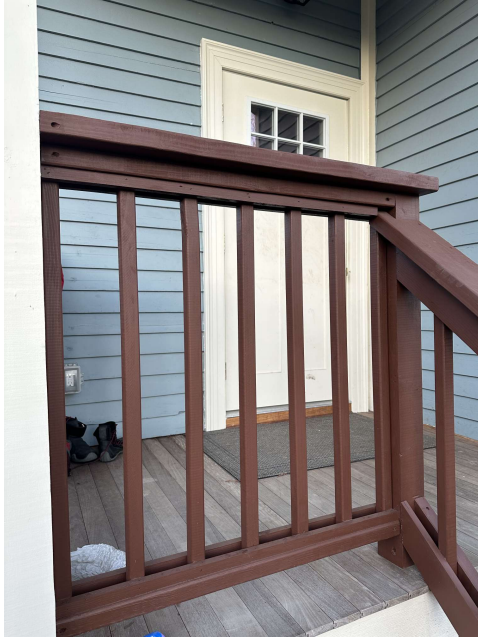
Railing Design Proposed on 4/13/23- Alternate Proposed Sample 1

The below railing photo was shared on 4/13/23 and discussed with Audra and Garrick on 5/8/2003. HDC representatives stated this railing was not appropriate and suggested driving around West and East Village to identify appropriate railing designs to propose.

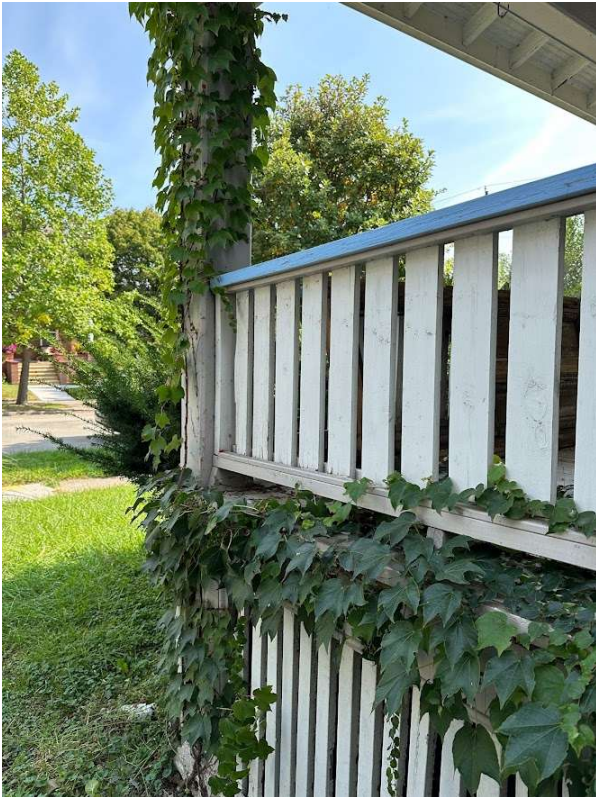
West Village Sample that was basis for proposed design- Alternate Proposed Sample 2

After reviewing the photographs, A. Dye suggested she believed Alternate Proposed Sample 2 as best suited to the home. A. Dye requested measurements of the elements of this railing. These measurements were added to the 10/16/23 proposal.

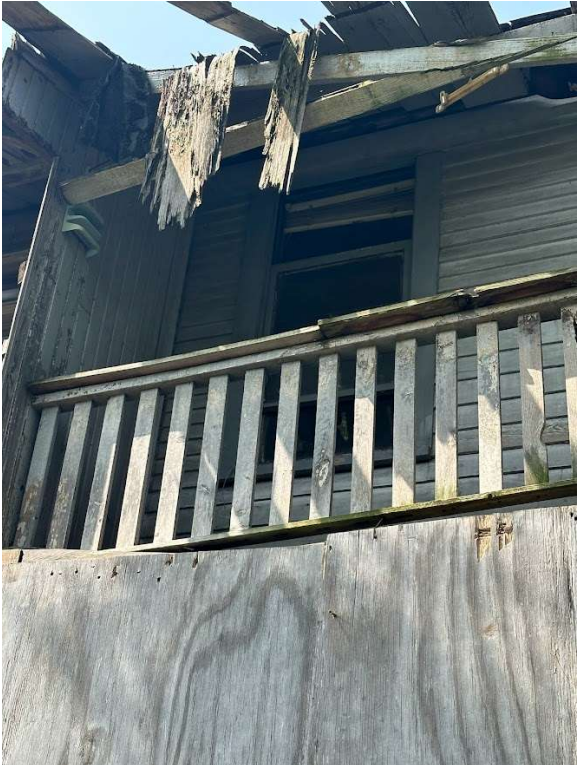
Garland Duplex Example- Alternate Proposed Sample 3

Applicant stated on the call with Staff, that there was no preference in design. Applicant highlighted Alternate Sample 3 as being utilized in a duplex across from the Dr. Sweet House on Garland. Applicant believes this to be an original railing design as the porch was later enclosed and protected the original wood.
