SCOPE OF EXTERIOR WORK
SINGLE-FAMILY HOUSE AT 1480 SHIPHERD ST., MI 48214

II. SCOPE OF EXTERIOR WORK

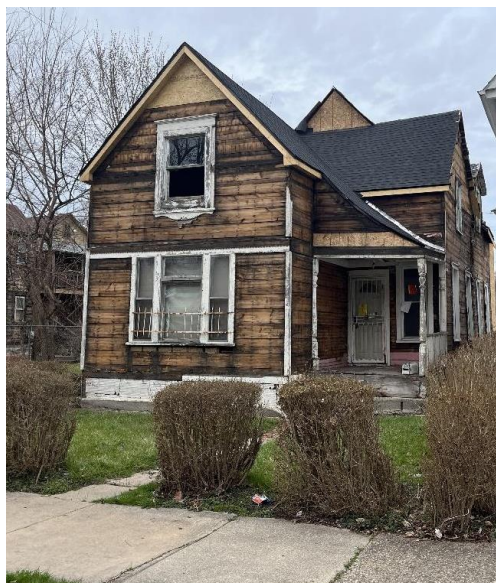
This picture shows how the property looks like. Siding and roof were removed before we knew about the requirements for the HDC approval. It is important to note that the new roof is very similar to the previous one, as you may see in the next pictures.

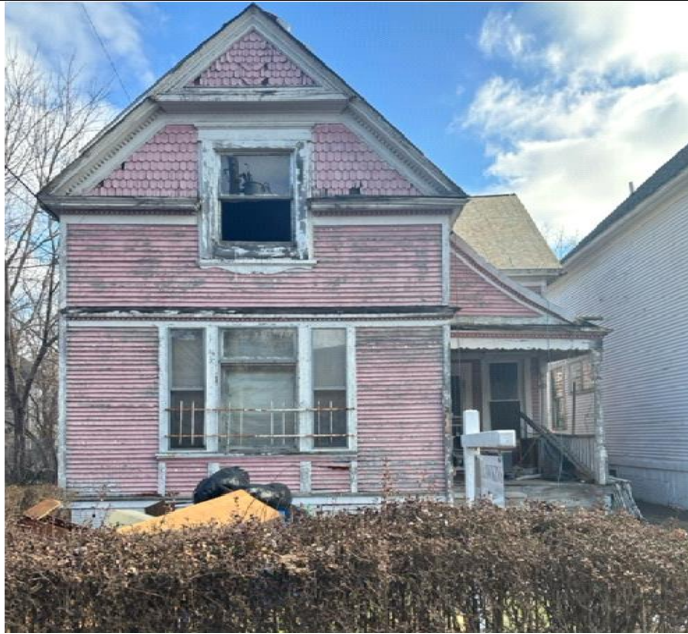
Following is the picture of how the property looked when we first bought it (picture from web).

As you may see it was abandoned with wooden details. We would like to bring it back to life while preserving its architectural characteristics.

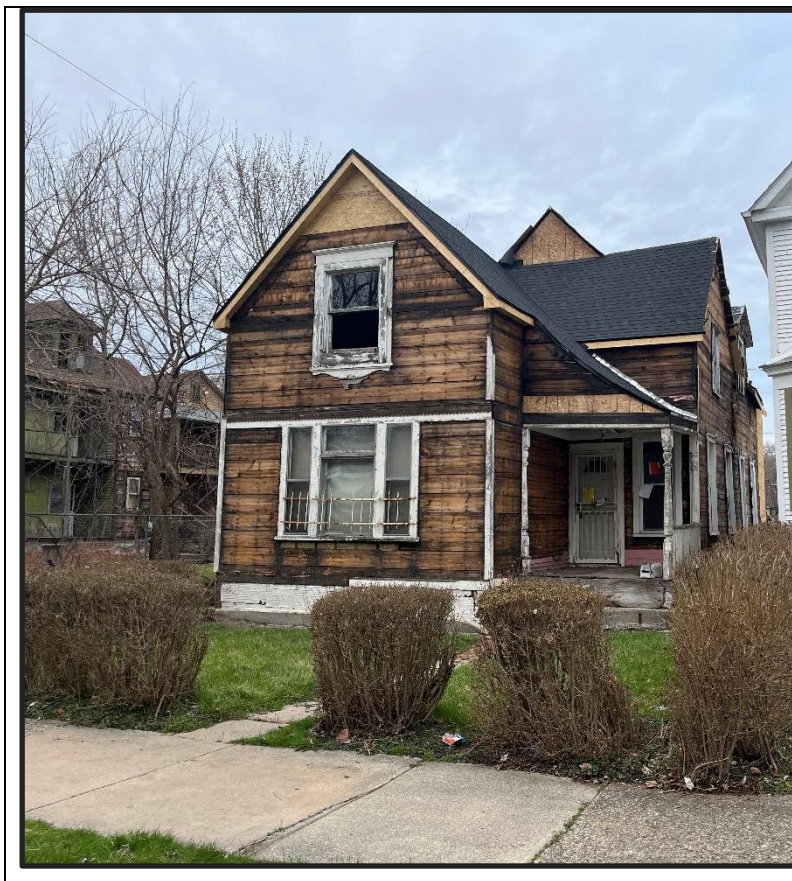
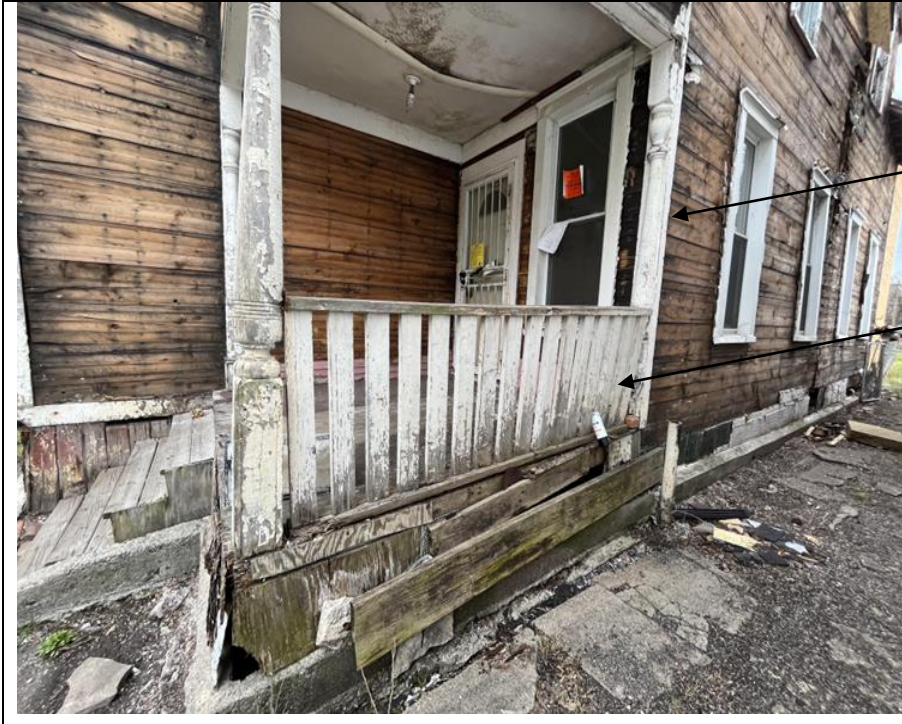
Current condition of the property:

All the existing historic details that you may see on the following picture will be preserved:

- Original columns
- Original pilasters
- Original floor
- Original ceiling
- Original dentils
- Original soffit
- Original steps
- Original frames
- 03 existing windows

All these wooden original architectural details will be kept (current condition).

The existing front porch will be preserved and repaired. No changes will be made on it.

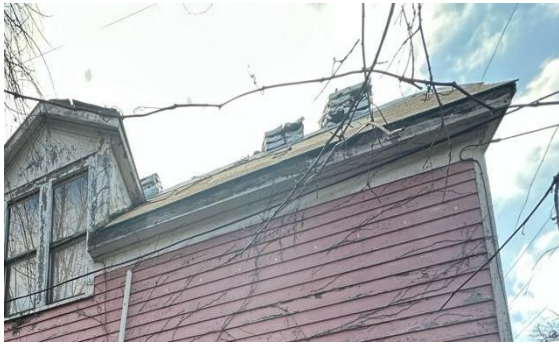
Old deteriorated and cracked former roof

The old roof has been replaced by replacing the structure with OSB Plywood followed by EPILAY SUPERIOR Fire-resistant Synthetic Underlayment and finally GAF Royal Sovereign Charcoal Algae resistant 3-Tab roofing Shingles.

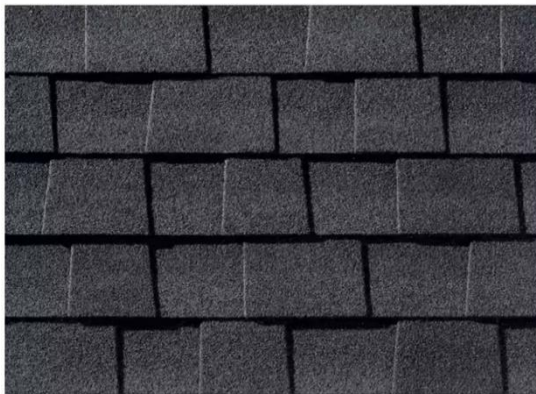
New roof currently installed

GAF Royal Sovereign Charcoal
Algae resistant 3-Tab roofing
Shingles

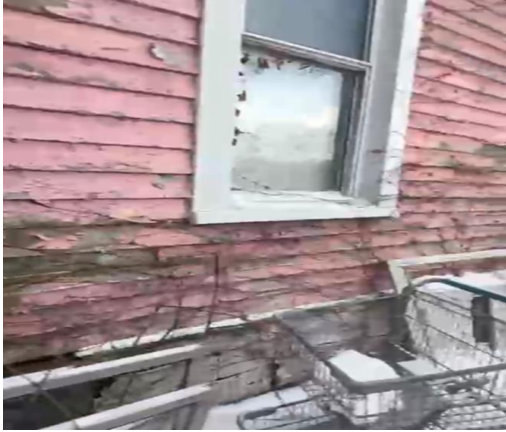
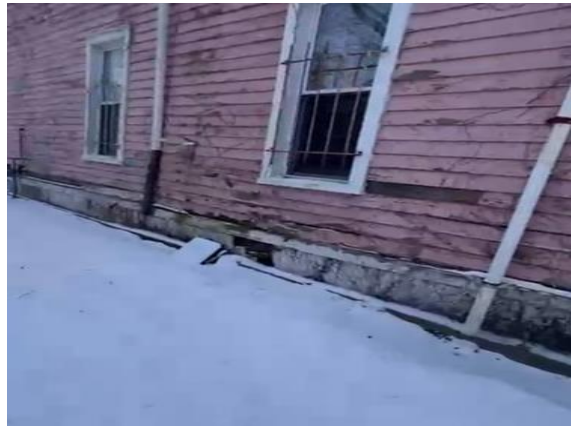
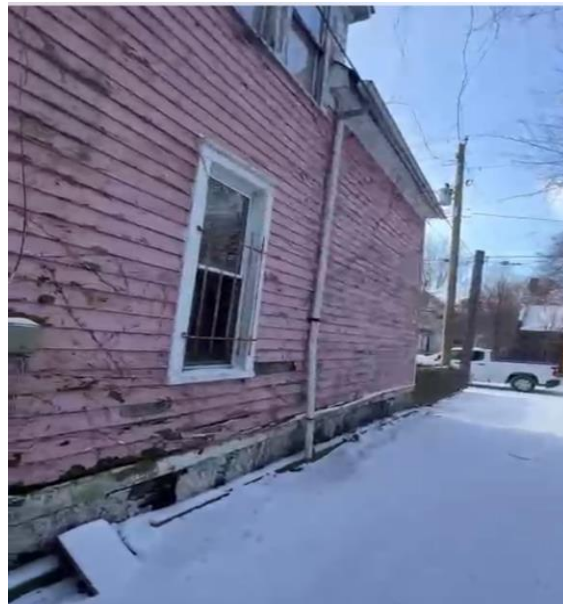
The process started with the removal of all rotten siding, as you may see next:

Siding will be replicated and current architectural details will be preserved. We are proposing to give a similar look as the previous siding by installing vinyl siding with the same patterns. It is a very durable and low maintenance option, having the ability to mimic traditional materials while preserving the historical aesthetics. The siding proposed Transformations vinyl siding from Ply Gem Performance Collection (featured profiles of Double 4 in., Double 5 in. and Double 4-1/2 in. Dutch Lap) is practical and a visually respectful choice for preserving the charm of the historic property and is energy safe (0.040 thickness).
