STAFF REPORT: OCTOBER 11, 2023 MEETING PREPARED BY: A. DYE

APPLICATION NUMBER: HDC2023-00024

ADDRESS: 2244 WABASH

SCOPE: DEMOLISH REAR OF HOUSE* (WORK COMPLETED WITHOUT APPROVAL);

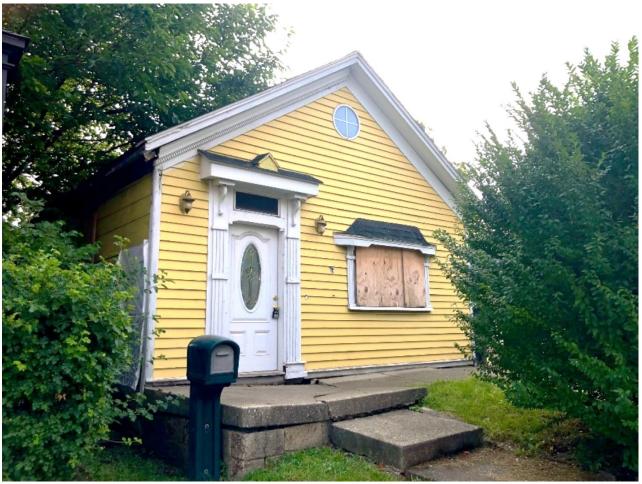
The front elevation at Wabash. Staff photo, September 12, 2023.

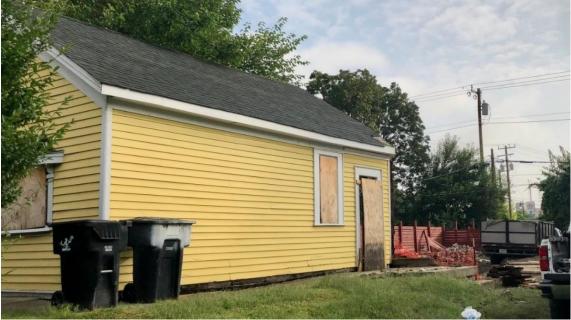
The south-side elevation. Staff photo, September 12, 2023.

The rear extensions of the house and side wing were recently demolished without HDC approval; a large deep hole currently covers this area of the lot.

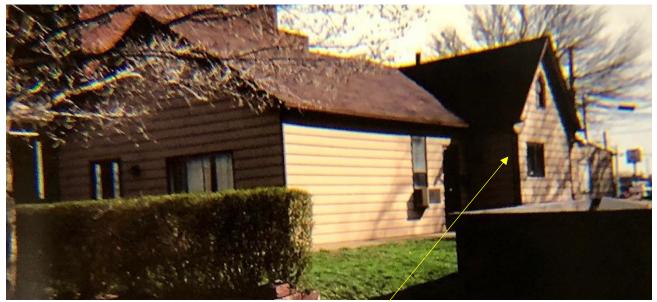
Designation photo – view from Wabash showing front and south- side elevations, 1984. HDAB.

No changes to the footprint of the pre-1884 addition are present (i.e., bay window).

Pre-1921 rear addition is visible and has a shed roof.

• Aluminum siding covered the house at time of designation. The front elevation's window opening appears to have a non-historic window. The pointed window in the side gable is a shape that was common on Gothic Revival structures. Staff doesn't know when this window was removed and replaced with a rectangular fixed window.

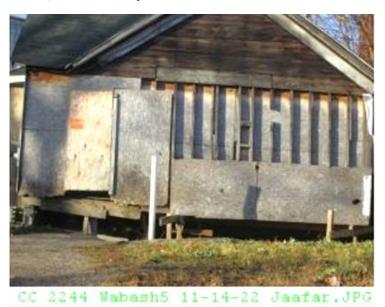
Staff obtained photos from BSEED's Dangerous Buildings Division that show the condition of the rear wall prior to the recent demolition of the rear section of the house. This view shows the historic gable's wood sheating and rake board were intact. Staff believes this section of the house could have had temporary support while the structural issues were corrected.

4 BSEED Dangerous Buildings Division site visit photo, November 14, 2022.

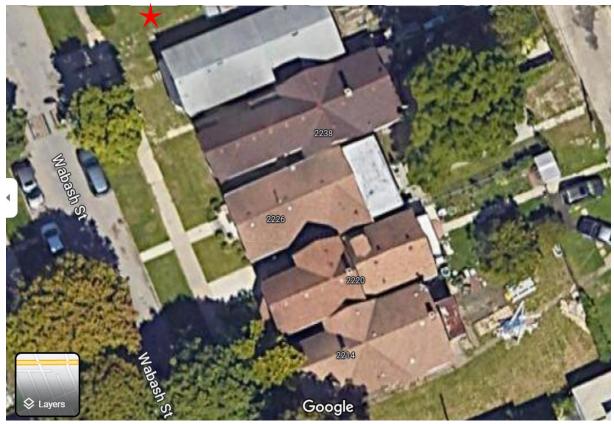
Google aerial image. 2244 Wabash is not visible but is directly above where the star is located. This view shows how four of the five houses have cross gable roofs, many of which cover extending walls (identical to what was in place at 2244 Wabash). The photos on the following page offer streetscape views of the above dwellings.

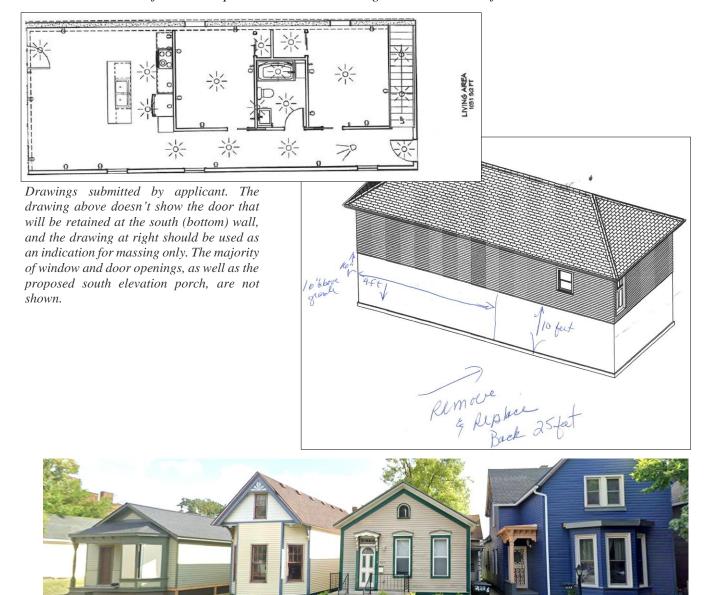
- In addition to the new construction, the applicant is proposing a new foundation/basement for the remaining existing portion of the house, and the re-grading/lowering of the front and side lawn to match the tree lawn and adjacent yards. 19th century houses in Corktown were typically built on piers and many houses have had full foundations added to the structures. Staff doesn't know if the raised yard is original to the site, or if it was added in 1954 along with the retaining walls. Staff doesn't dispute the idea of lowering the grade so that the lawn is similar to the other houses on the street. However, staff doesn't know if the applicant proposes to cover the area between the wood siding and grade will some type of skirting, which is a typical detail for houses in the district which are of similar age.

Google street view. 2244 Wabash is partially seen on the far-left side of the photo. This view shows the flat yards of the neighboring houses.

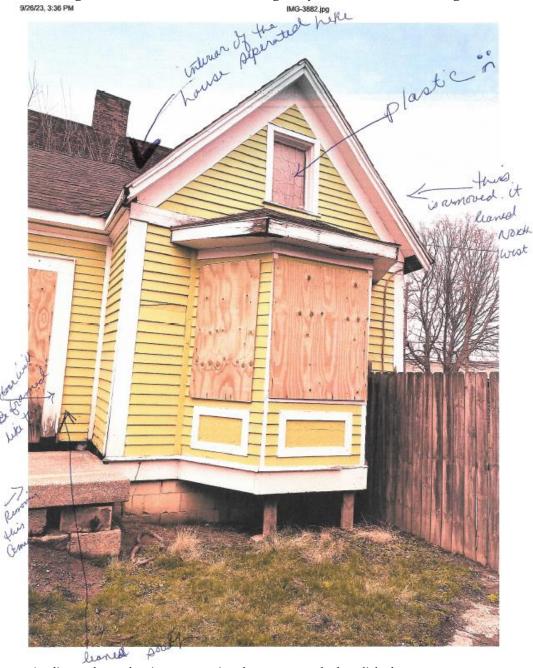
• While the rear portion of the house, shown in the below photo, may have had structural issues, this section of the dwelling could have been stabilized or rebuilt to retain the historic footprint. It is staff's opinion that the smaller pre-1921 extension that had a lower shed roof (as seen in the designation photo on page 3) was not a distinctive character-defining feature of the dwelling. Therefore, erecting a rear addition in that location might meet the Standards and achieve the additional square footage desired by the applicant while retaining the distinctive character-defining footprint of the 1884 dwelling.

Applicant photo, showing rear section that was recently demolished.

- The historic side wing was removed without substantiation that it was beyond repair. Its removal destroyed the house's historic massing and its contextual relationship to other 19th century houses within the district.
