RE: 1710 Van Dyke Roof Rehabilitation

Kraemer Design Group, LLC (KDG) is writing to submit information to the Detroit Historic District Commission (HDC), on behalf of 1710 Van Dyke LLC (Owner) regarding the proposed roof rehabilitation at 1710 Van Dyke. The following is a description of the proposed scope of work.

Historic District Commission Application for Roof Repairs
August 2, 2024

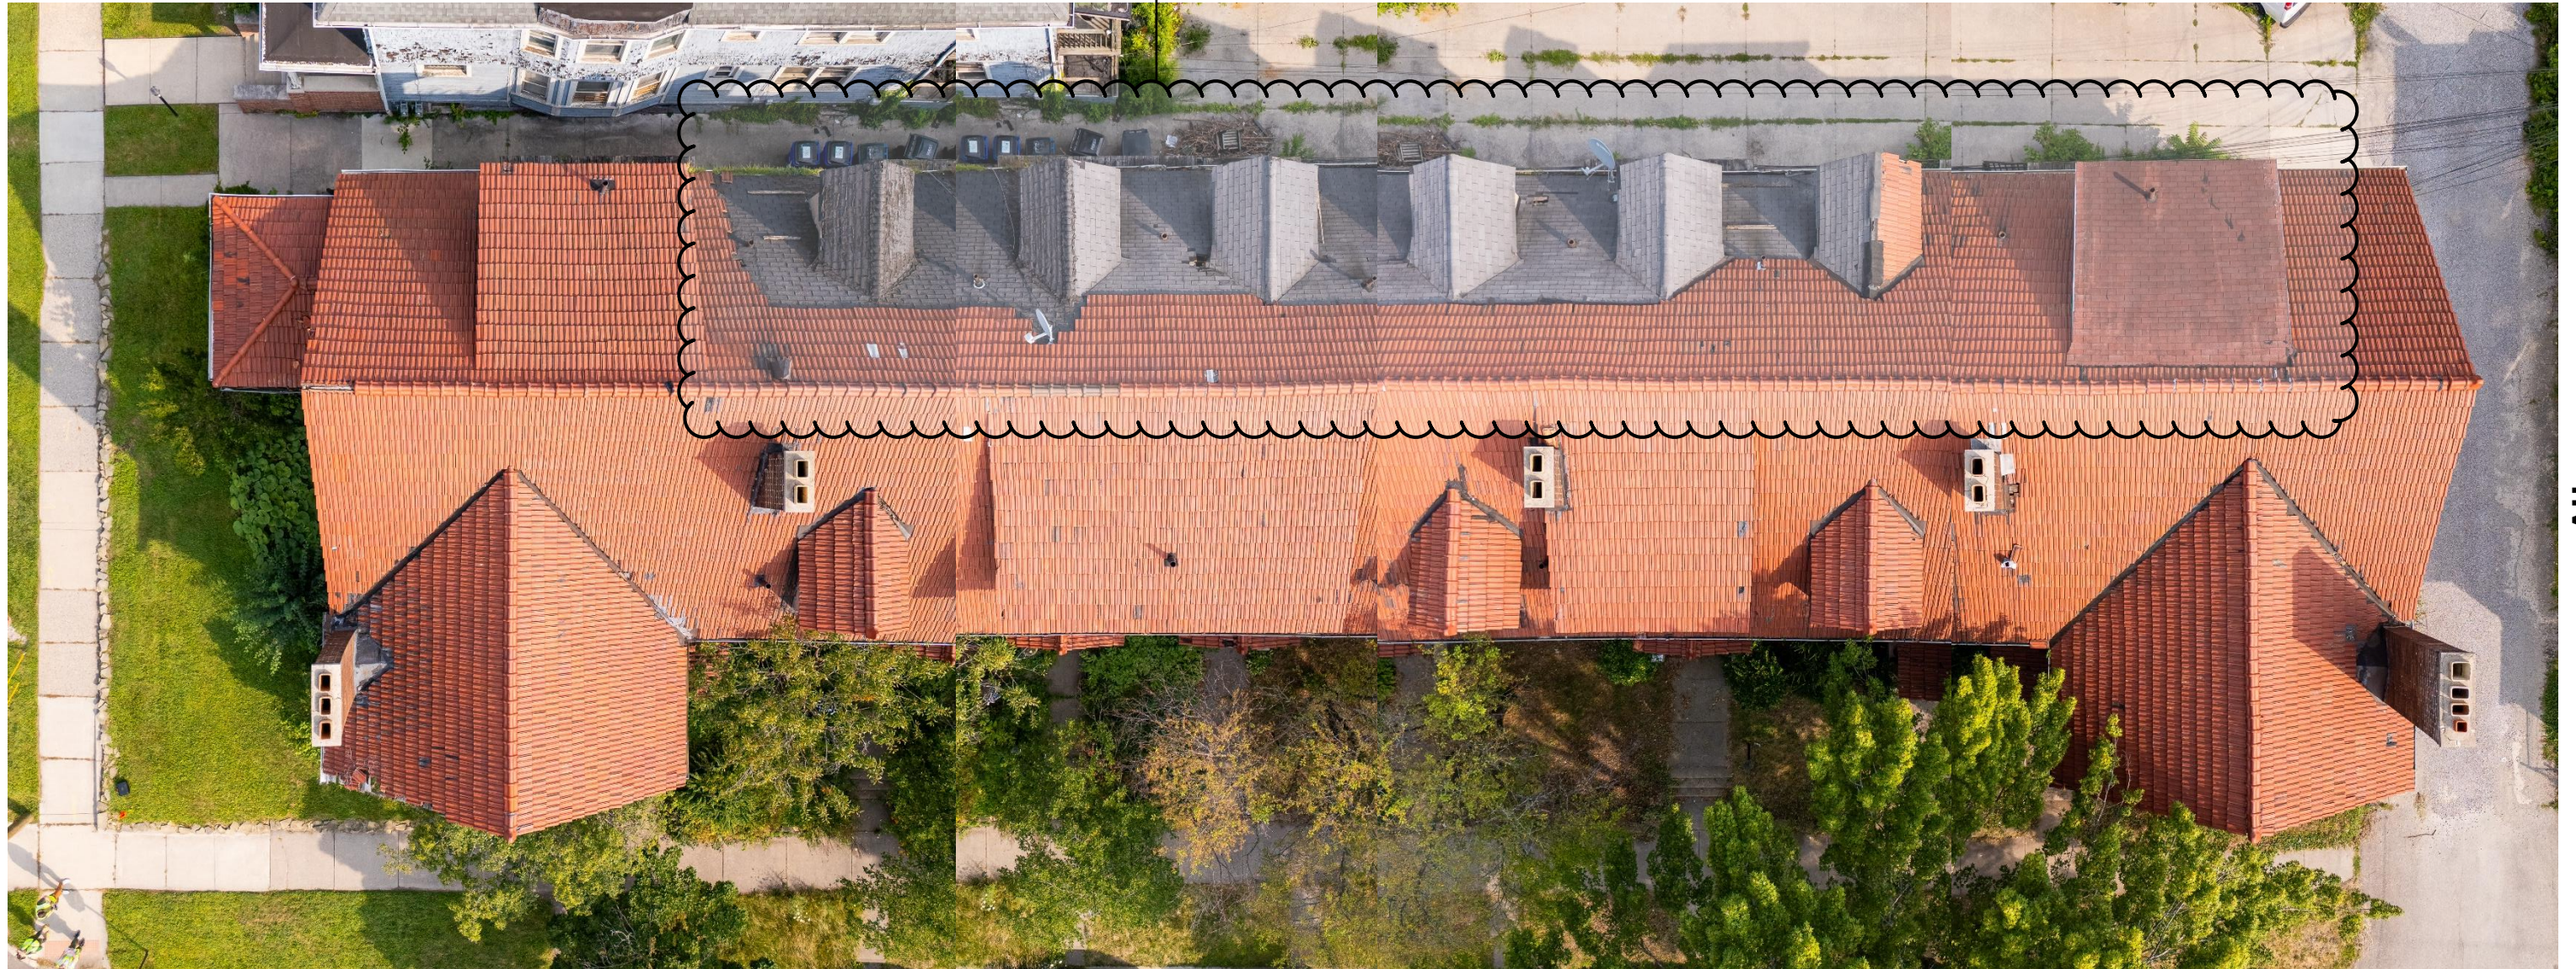
OVERVIEW OF EXISTING ROOF

Generally, the clay tiles appear to be in good condition across the roof area; however, the total roof assembly is in poor condition with numerous areas of broken or missing tiles, notably at the different edge transitions of the roof, leading to several openings through the roof decking into the attic space below. Moreover, a large area of tiles at the rear of the building was replaced by a previous owner with asphalt shingles of varying character, all of which are in poor condition with a few visible openings into the attic space below. We estimate that approximately 15% of the original clay tile has been replaced with asphalt roofing. See page 2 of attachment.

Area of tile roof previously replaced with asphalt shingles

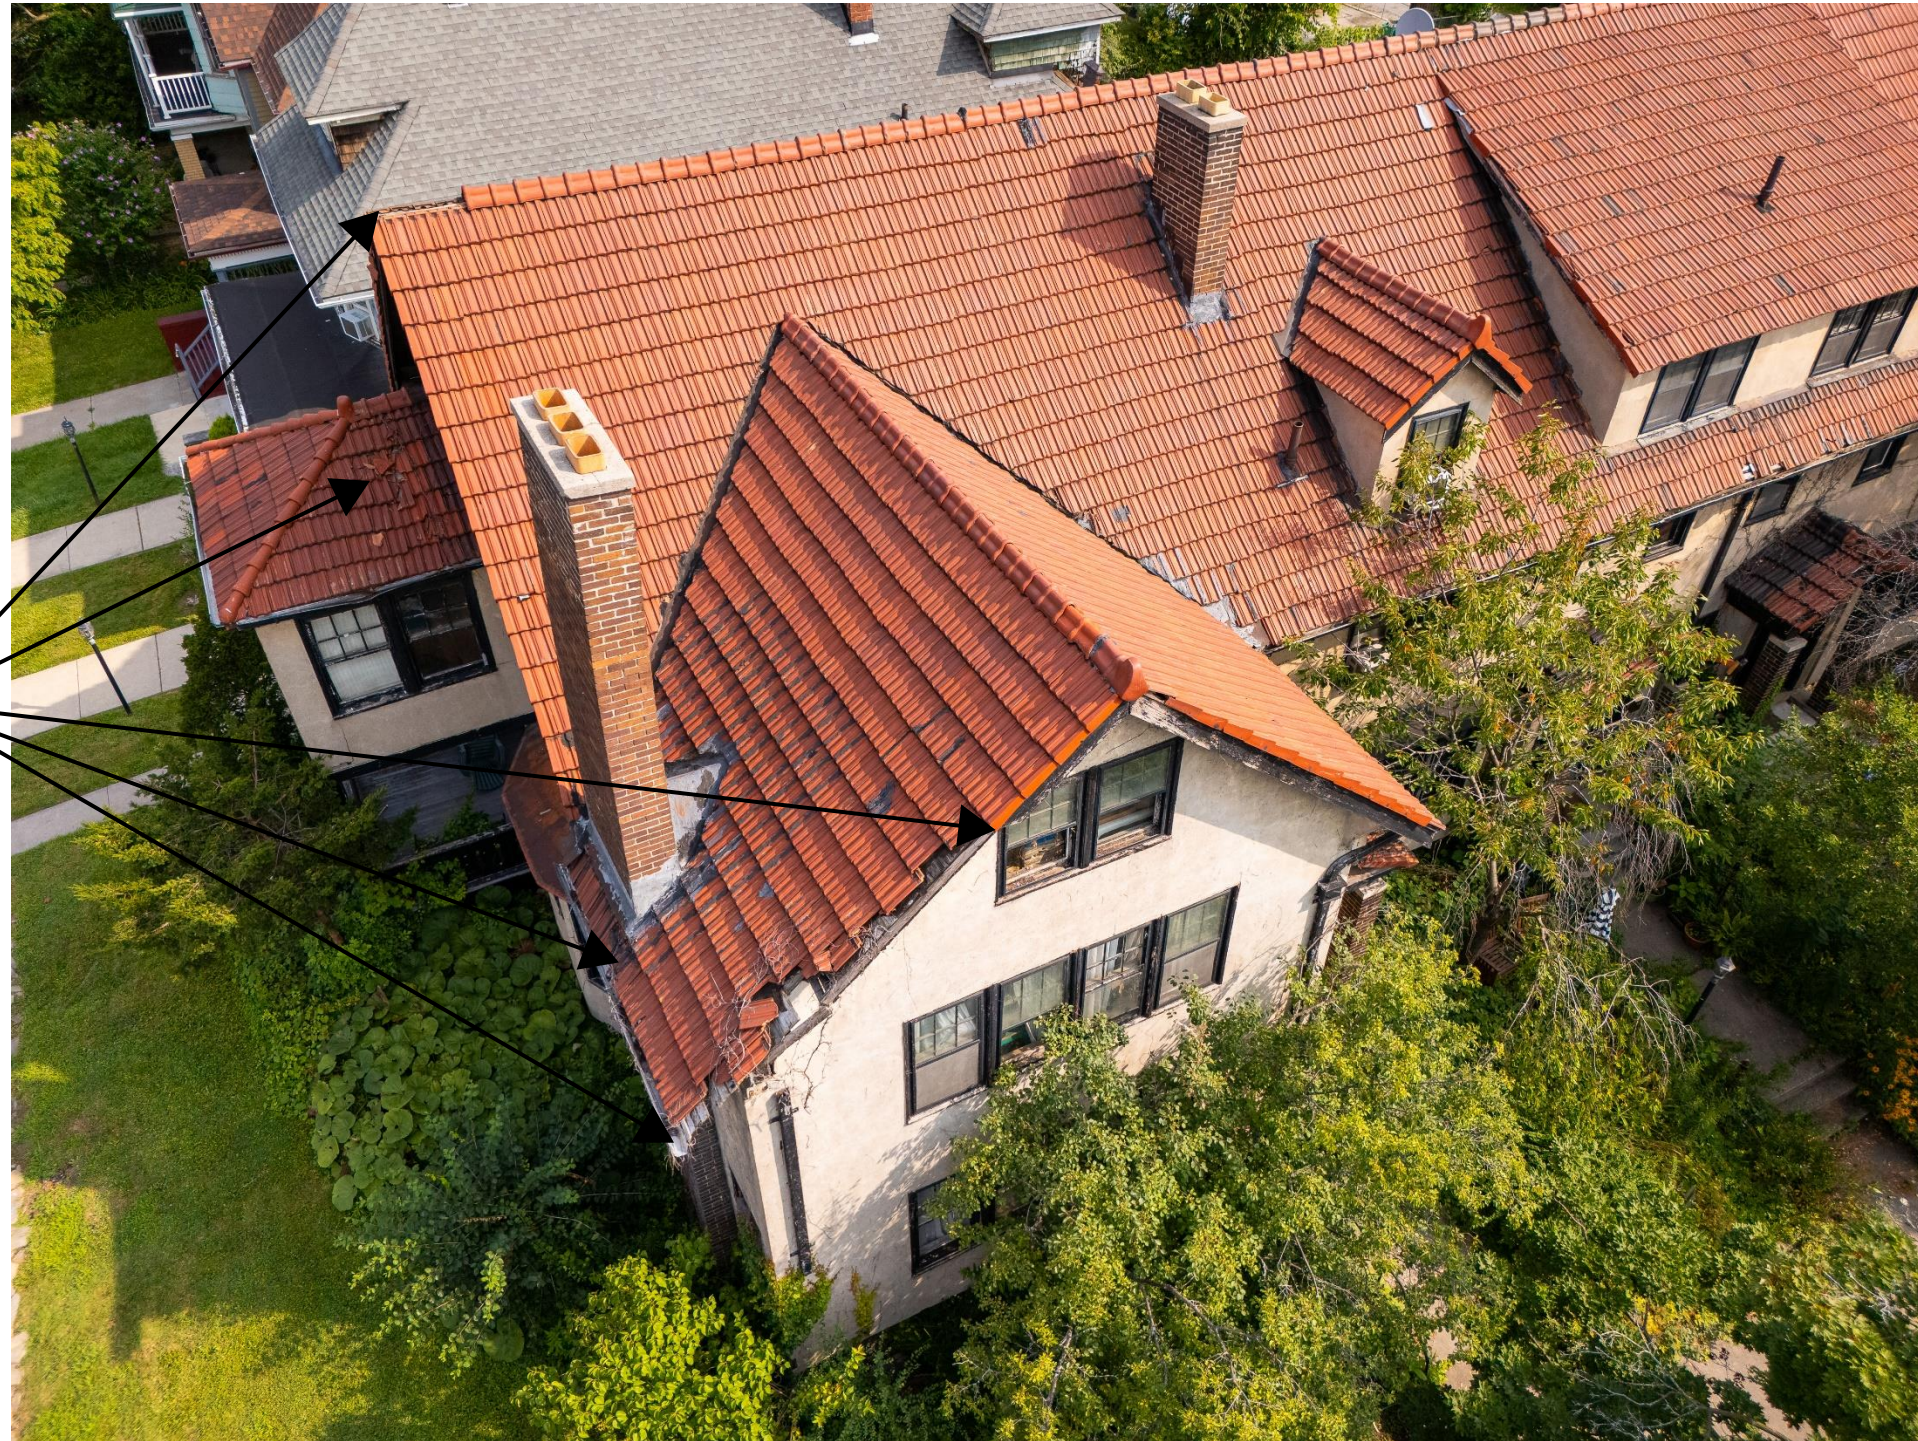
DRONE VIEW AT SW CORNER OF BUILDING

Damaged/missing tiles

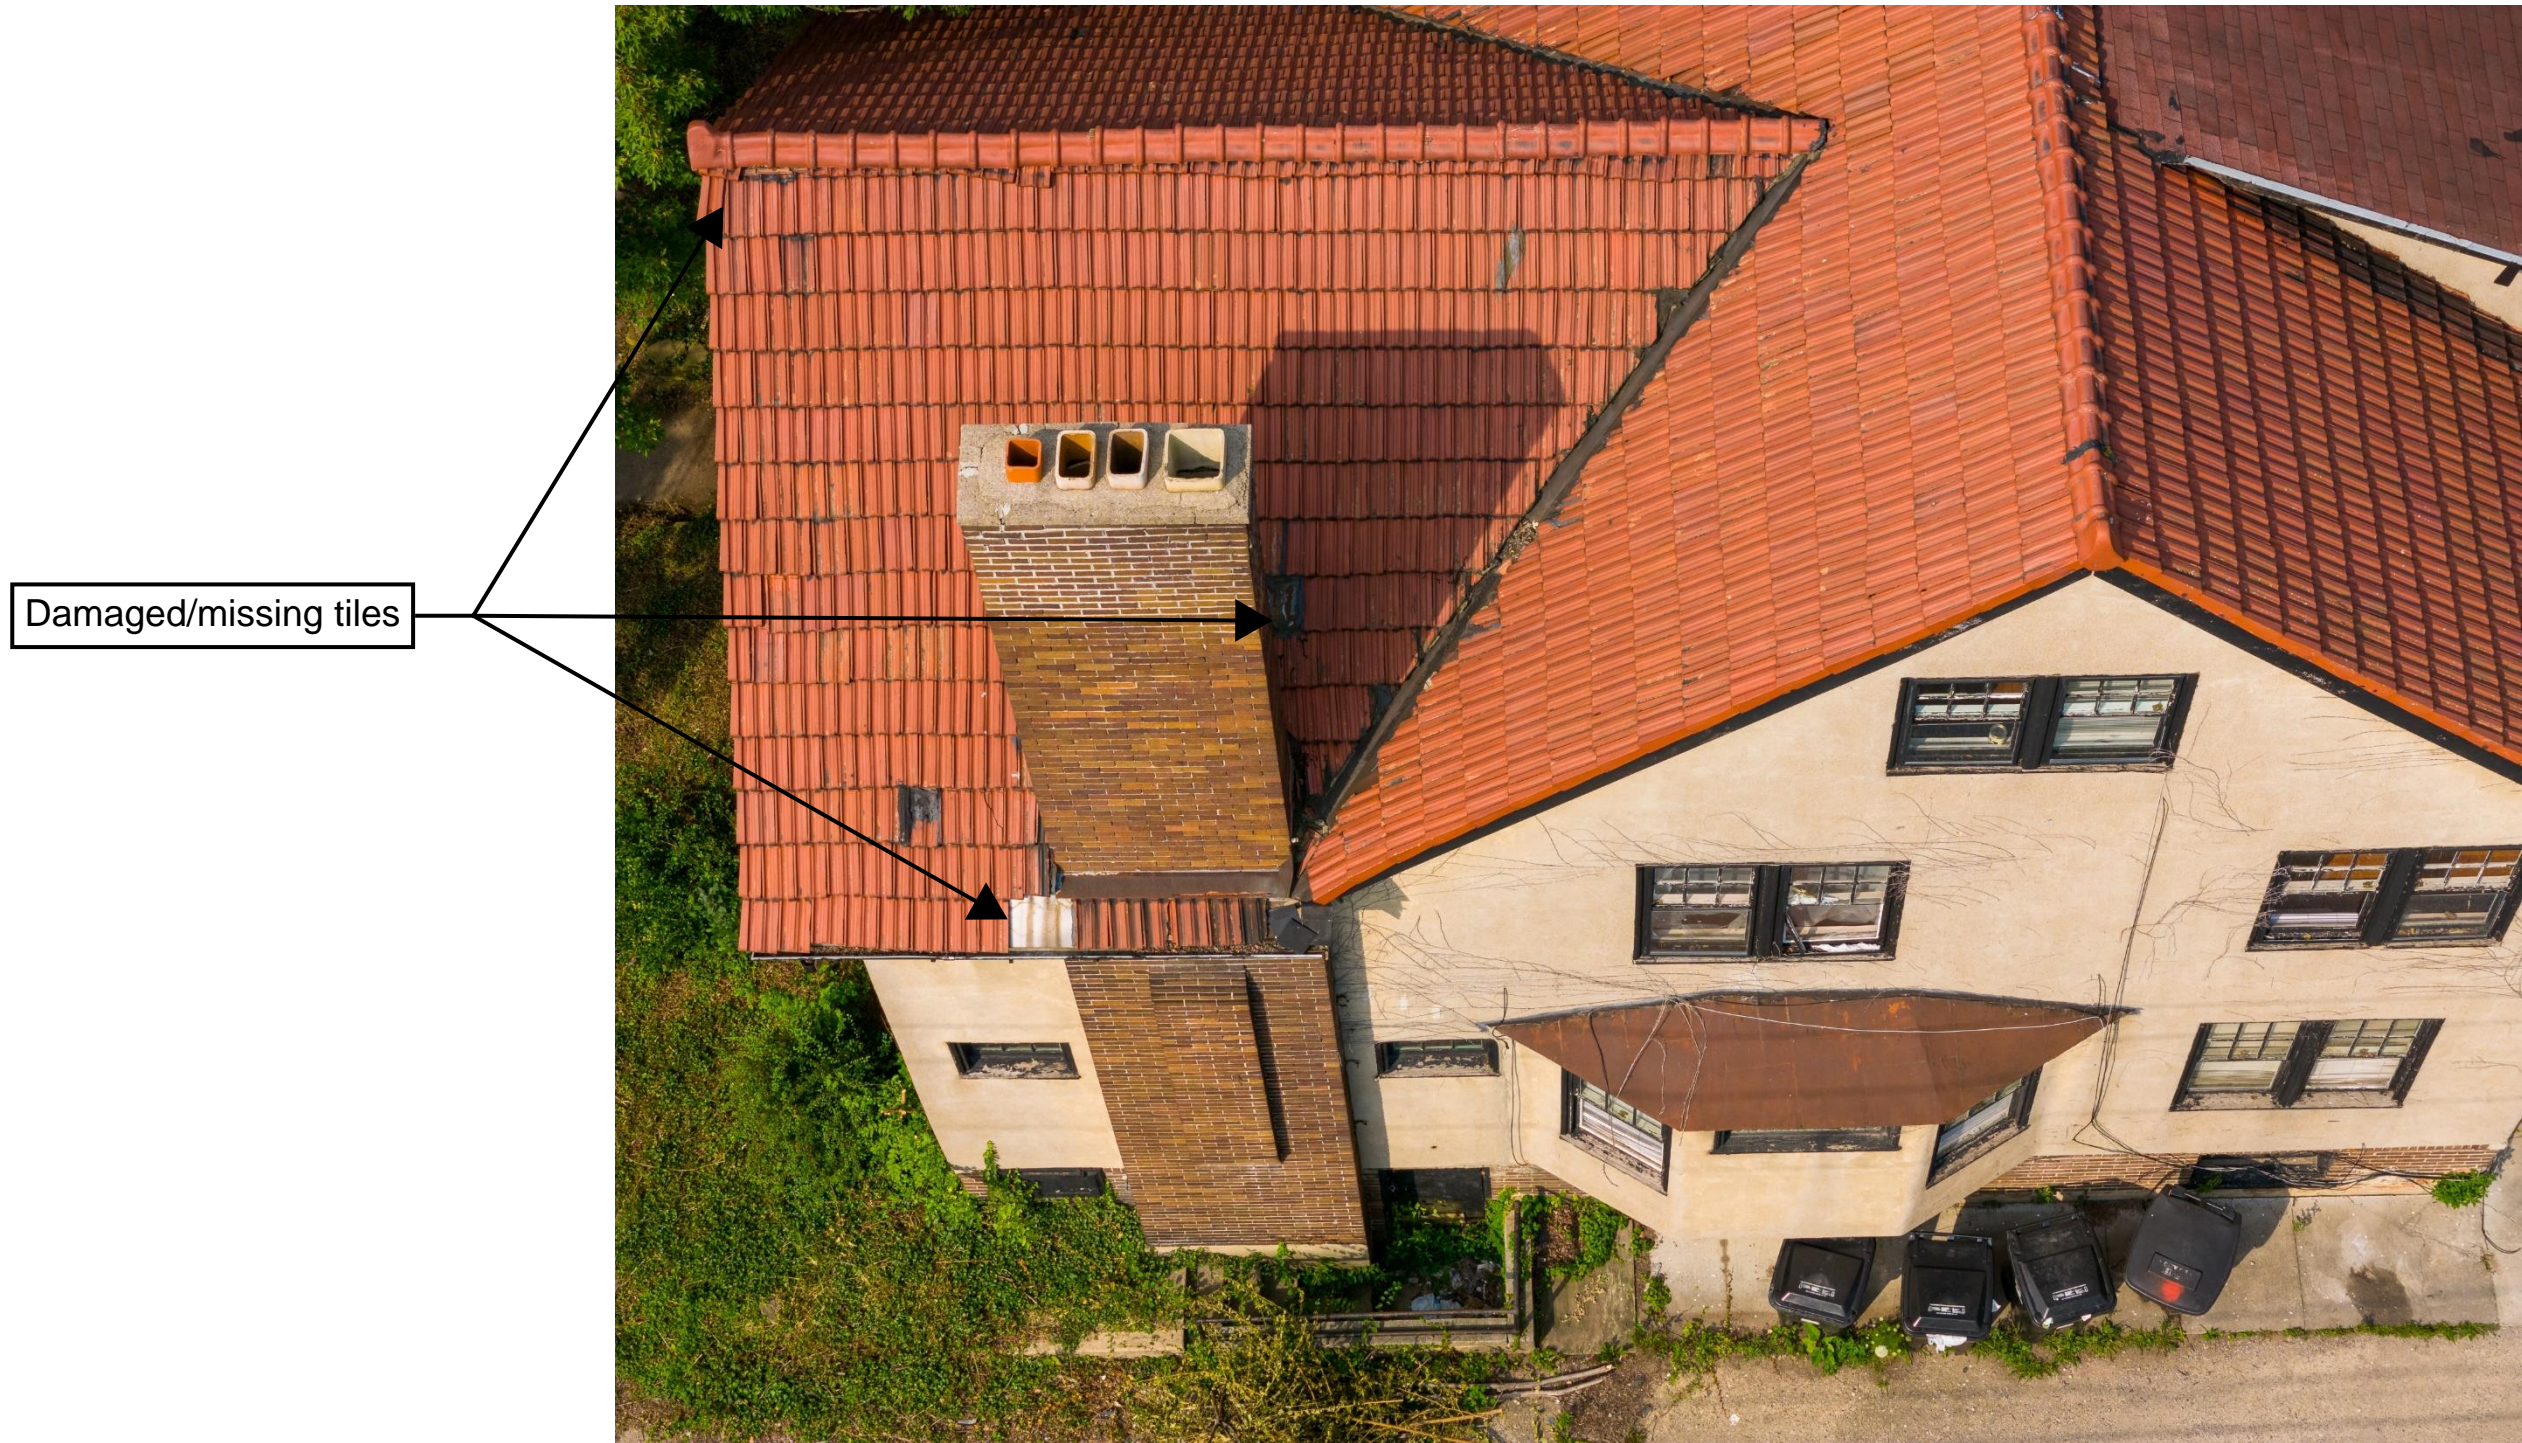
DRONE VIEW AT EAST END OF ROOF FACING ALLEY

Open holes through
roofing and decking
below

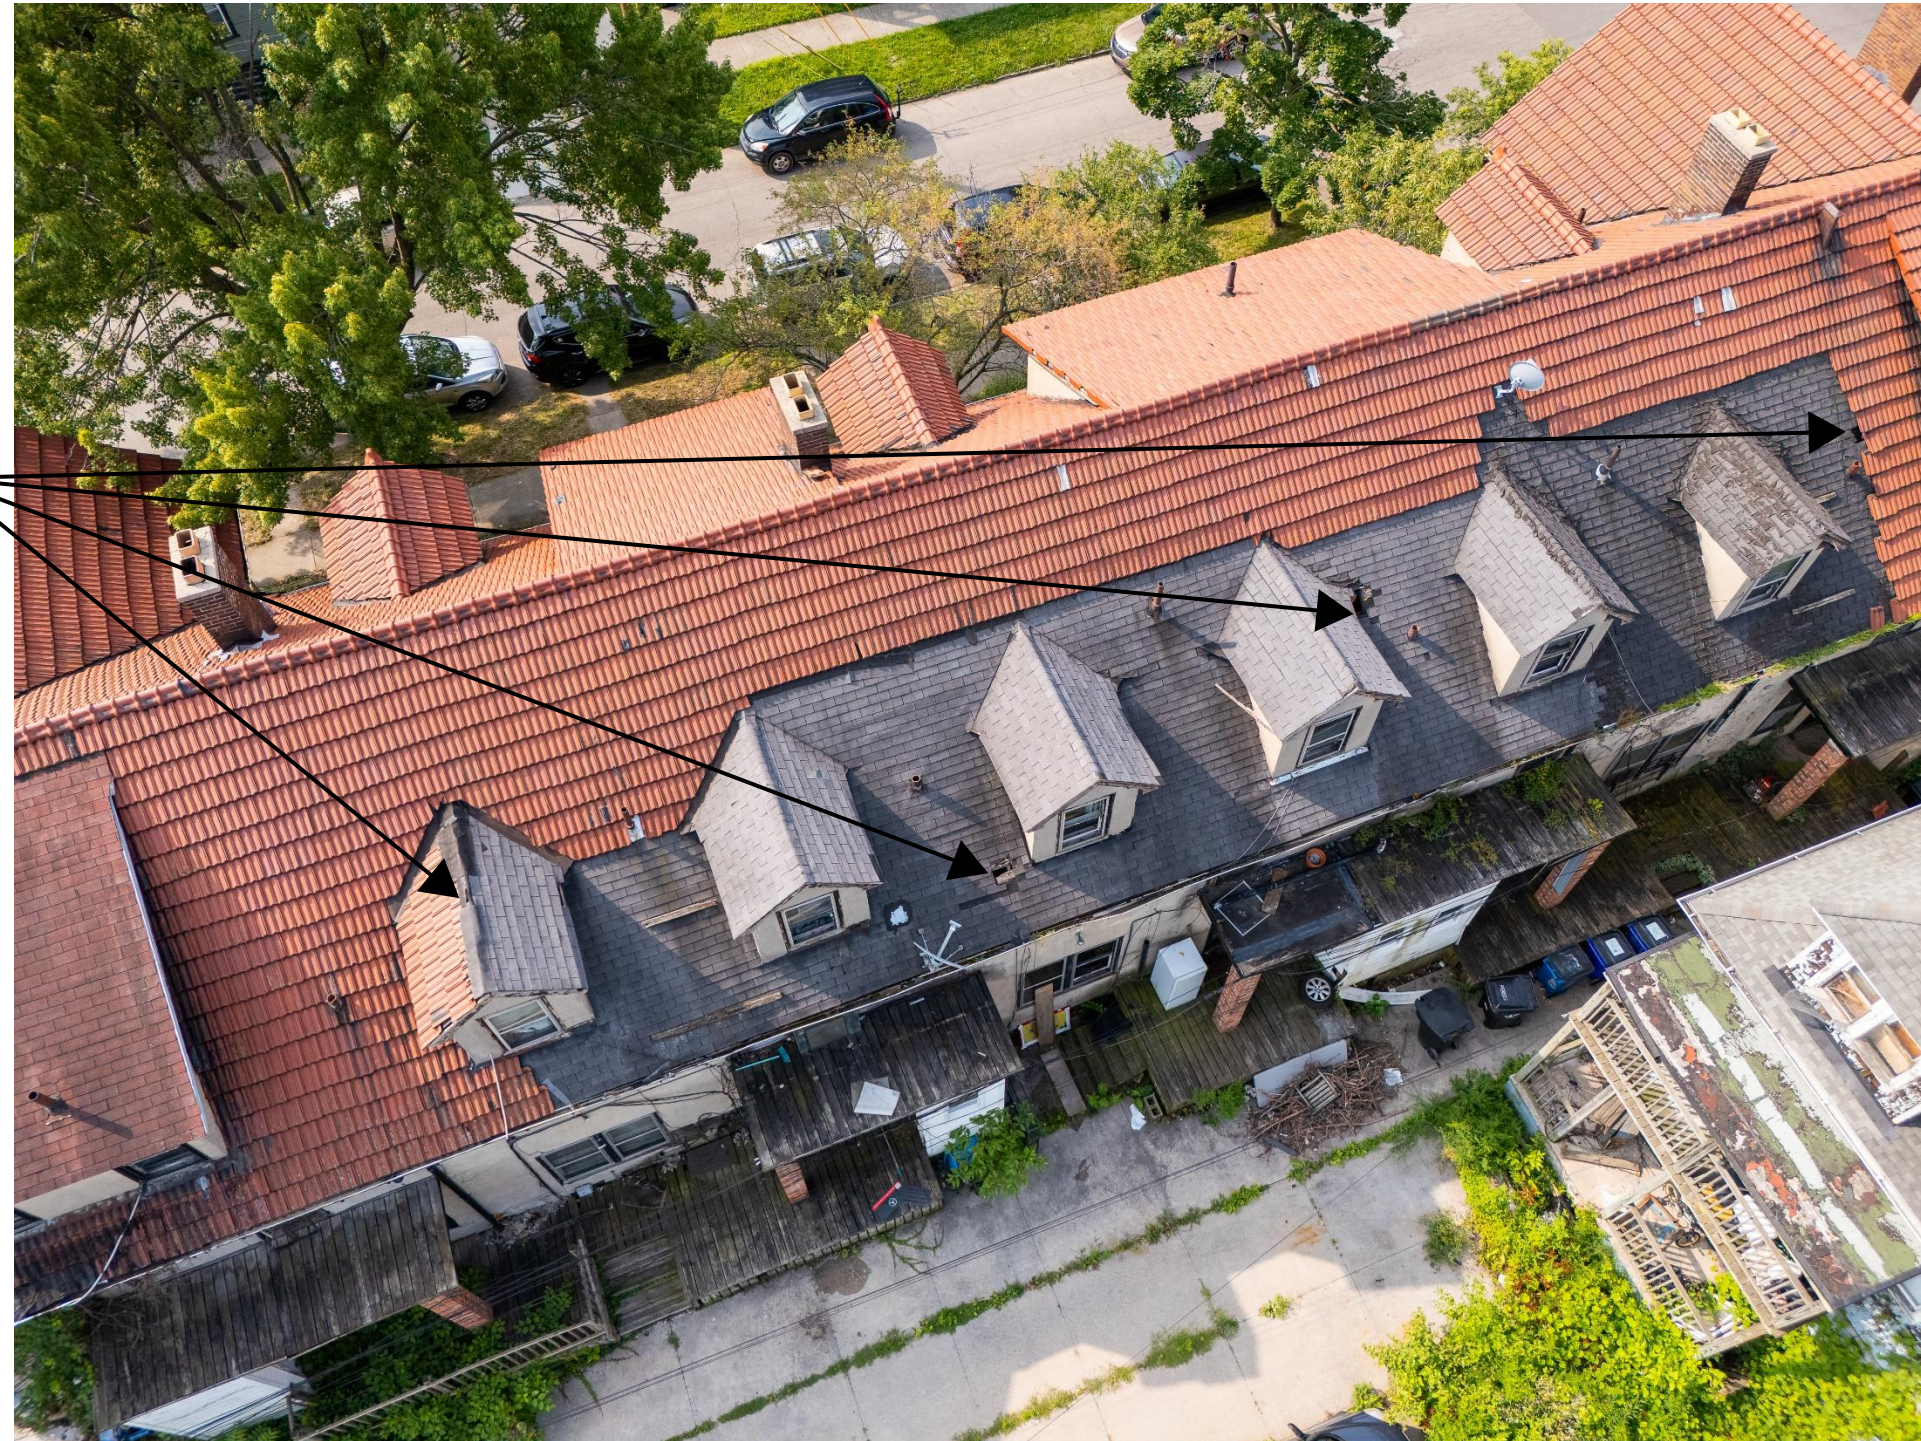
**DRONE VIEW OF NORTH FACE OF ROOF SHOWING
REPLACEMENT ASPHALT SHINGLES**

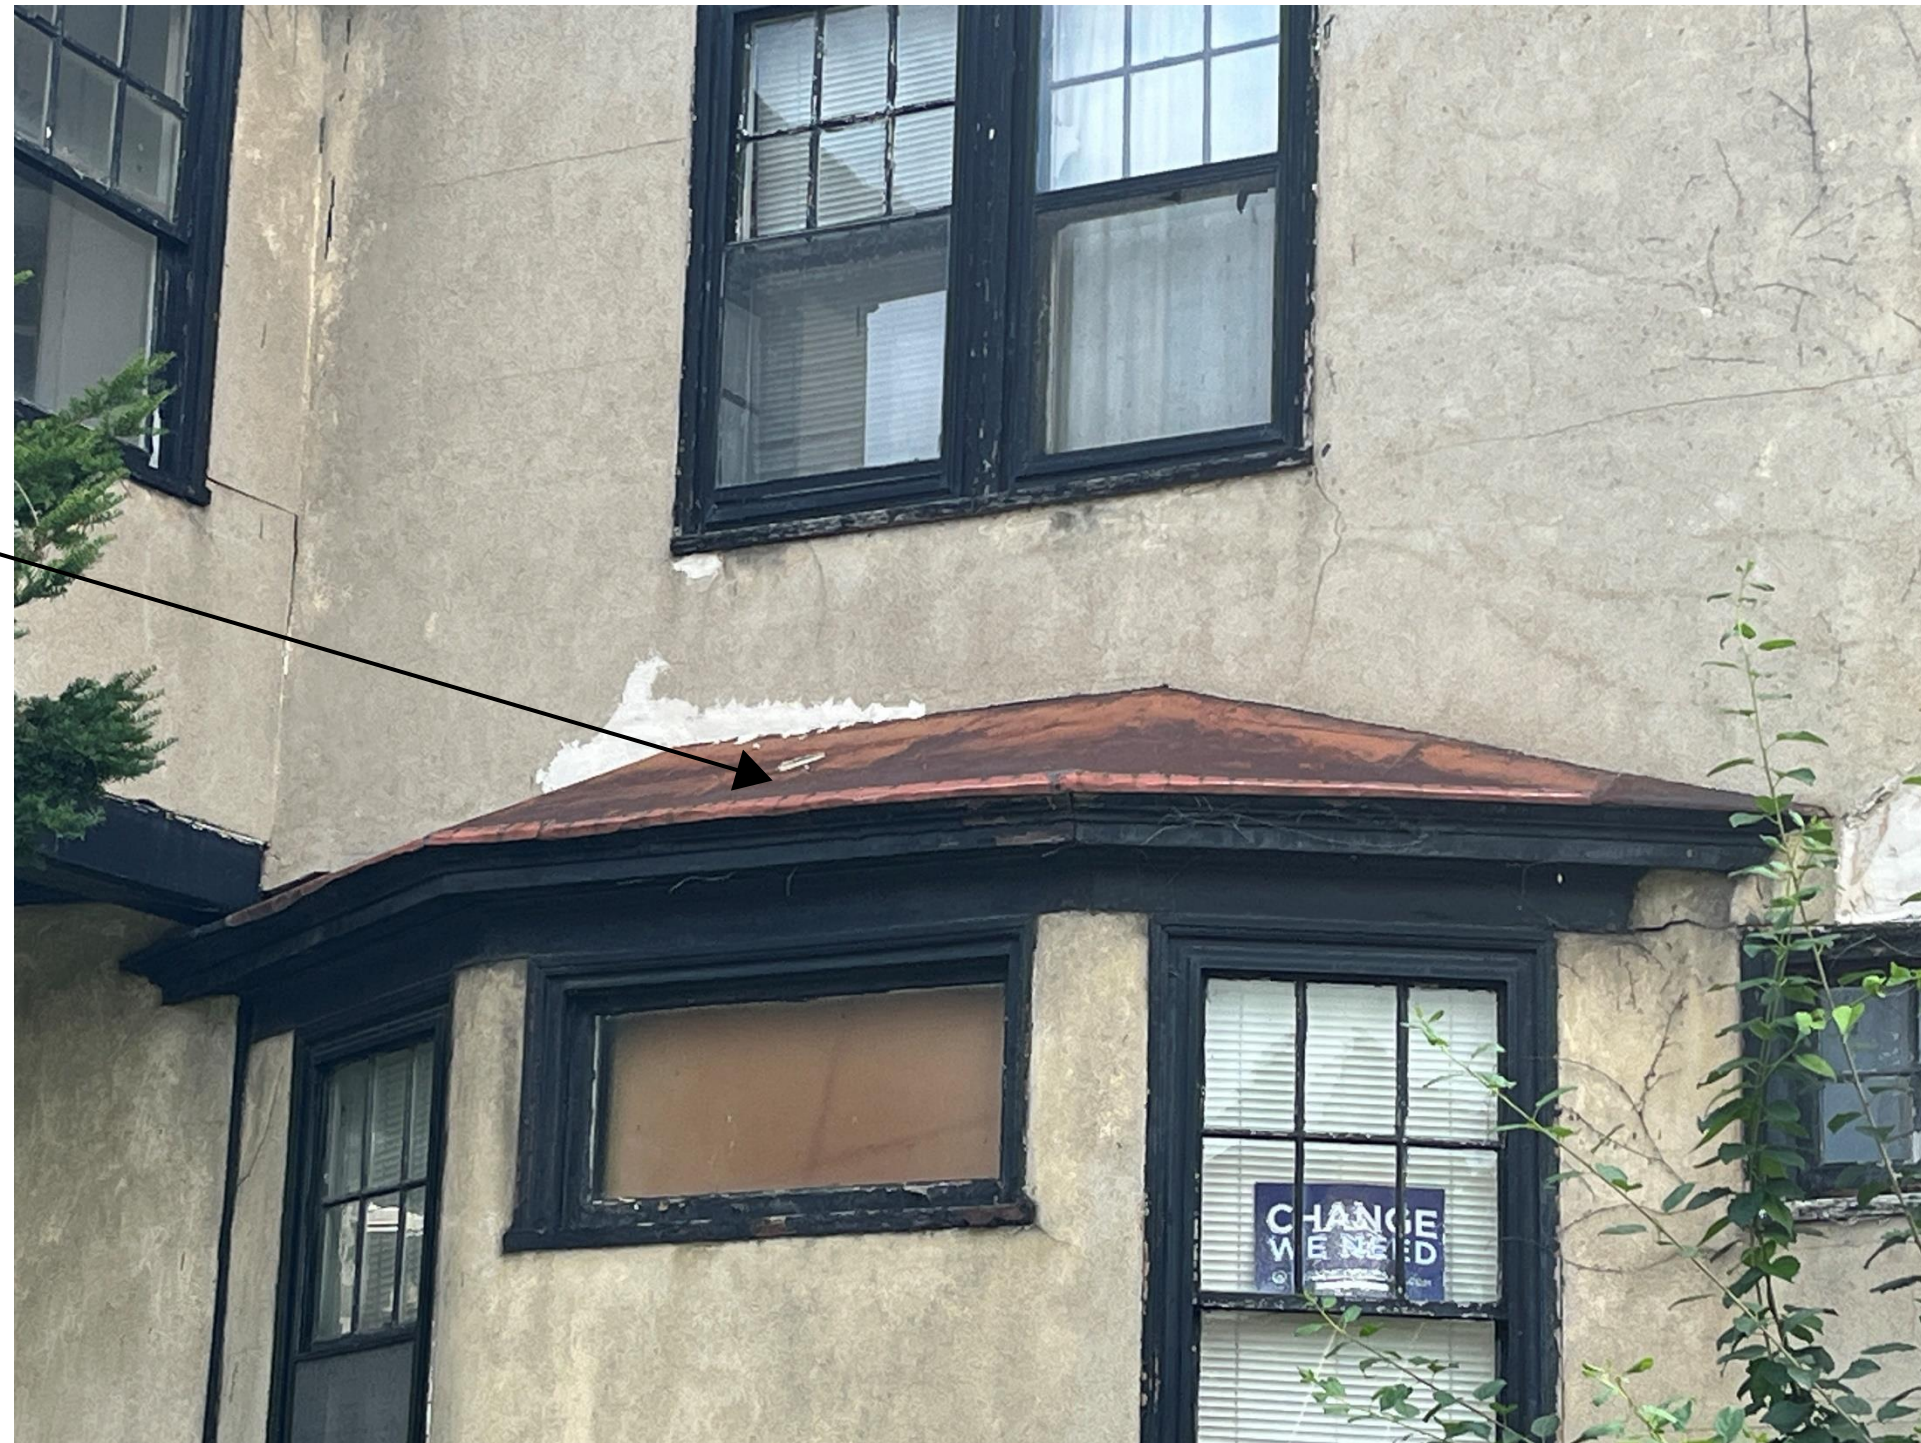
Small projecting bay window roof example

VIEW OF TYPICAL PROJECTING BAY WITHOUT TILE ROOFING

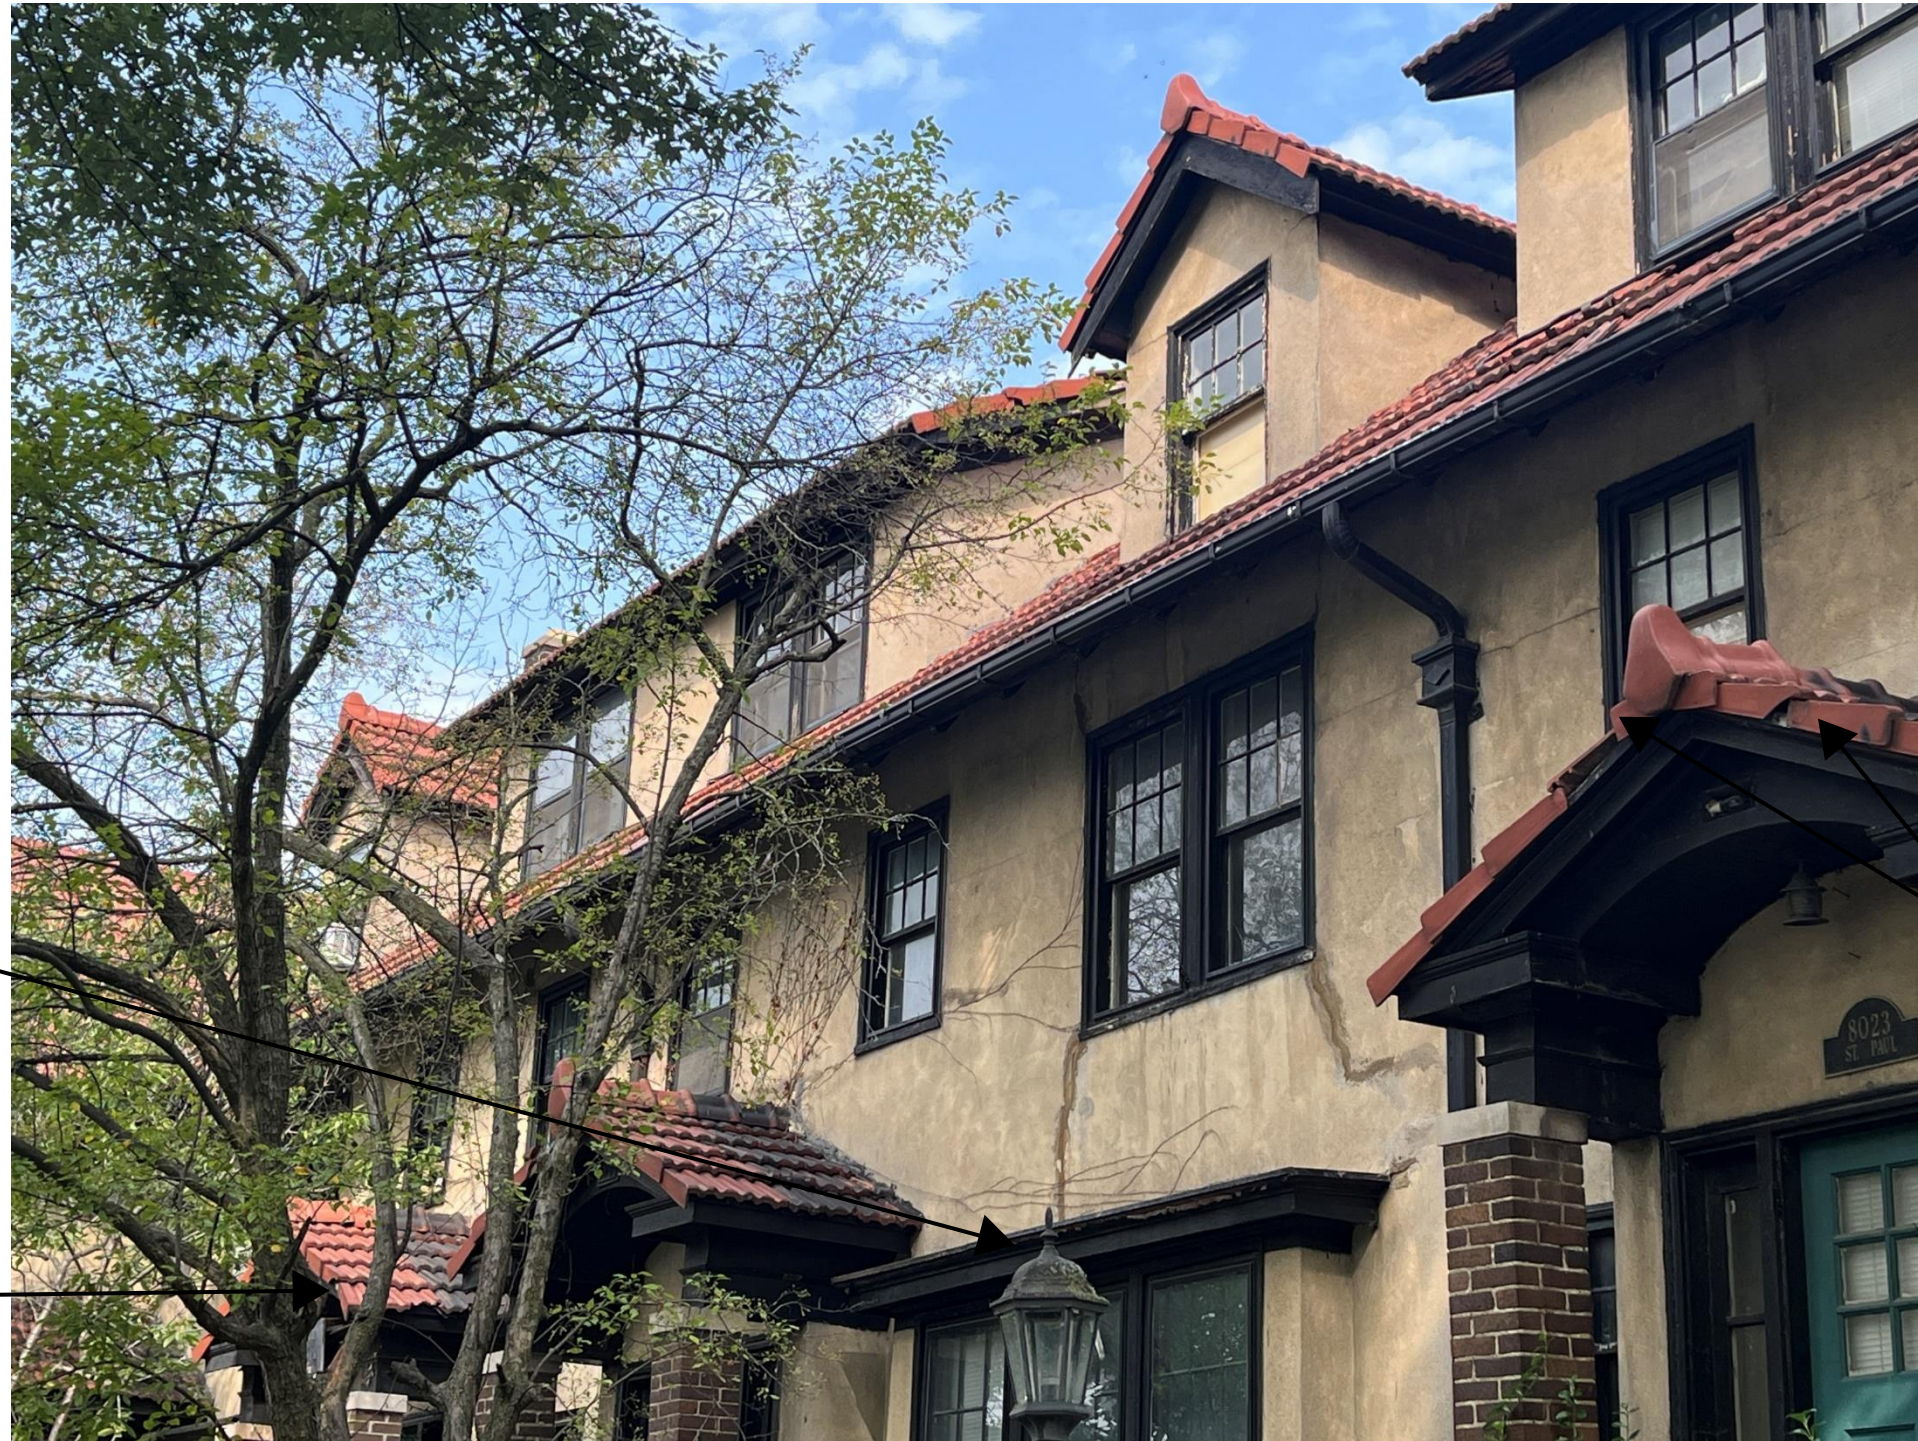
VIEW OF SOUTH ELEVATION FACING ST PAUL

Small projecting bay window roof example

Damaged/missing tiles

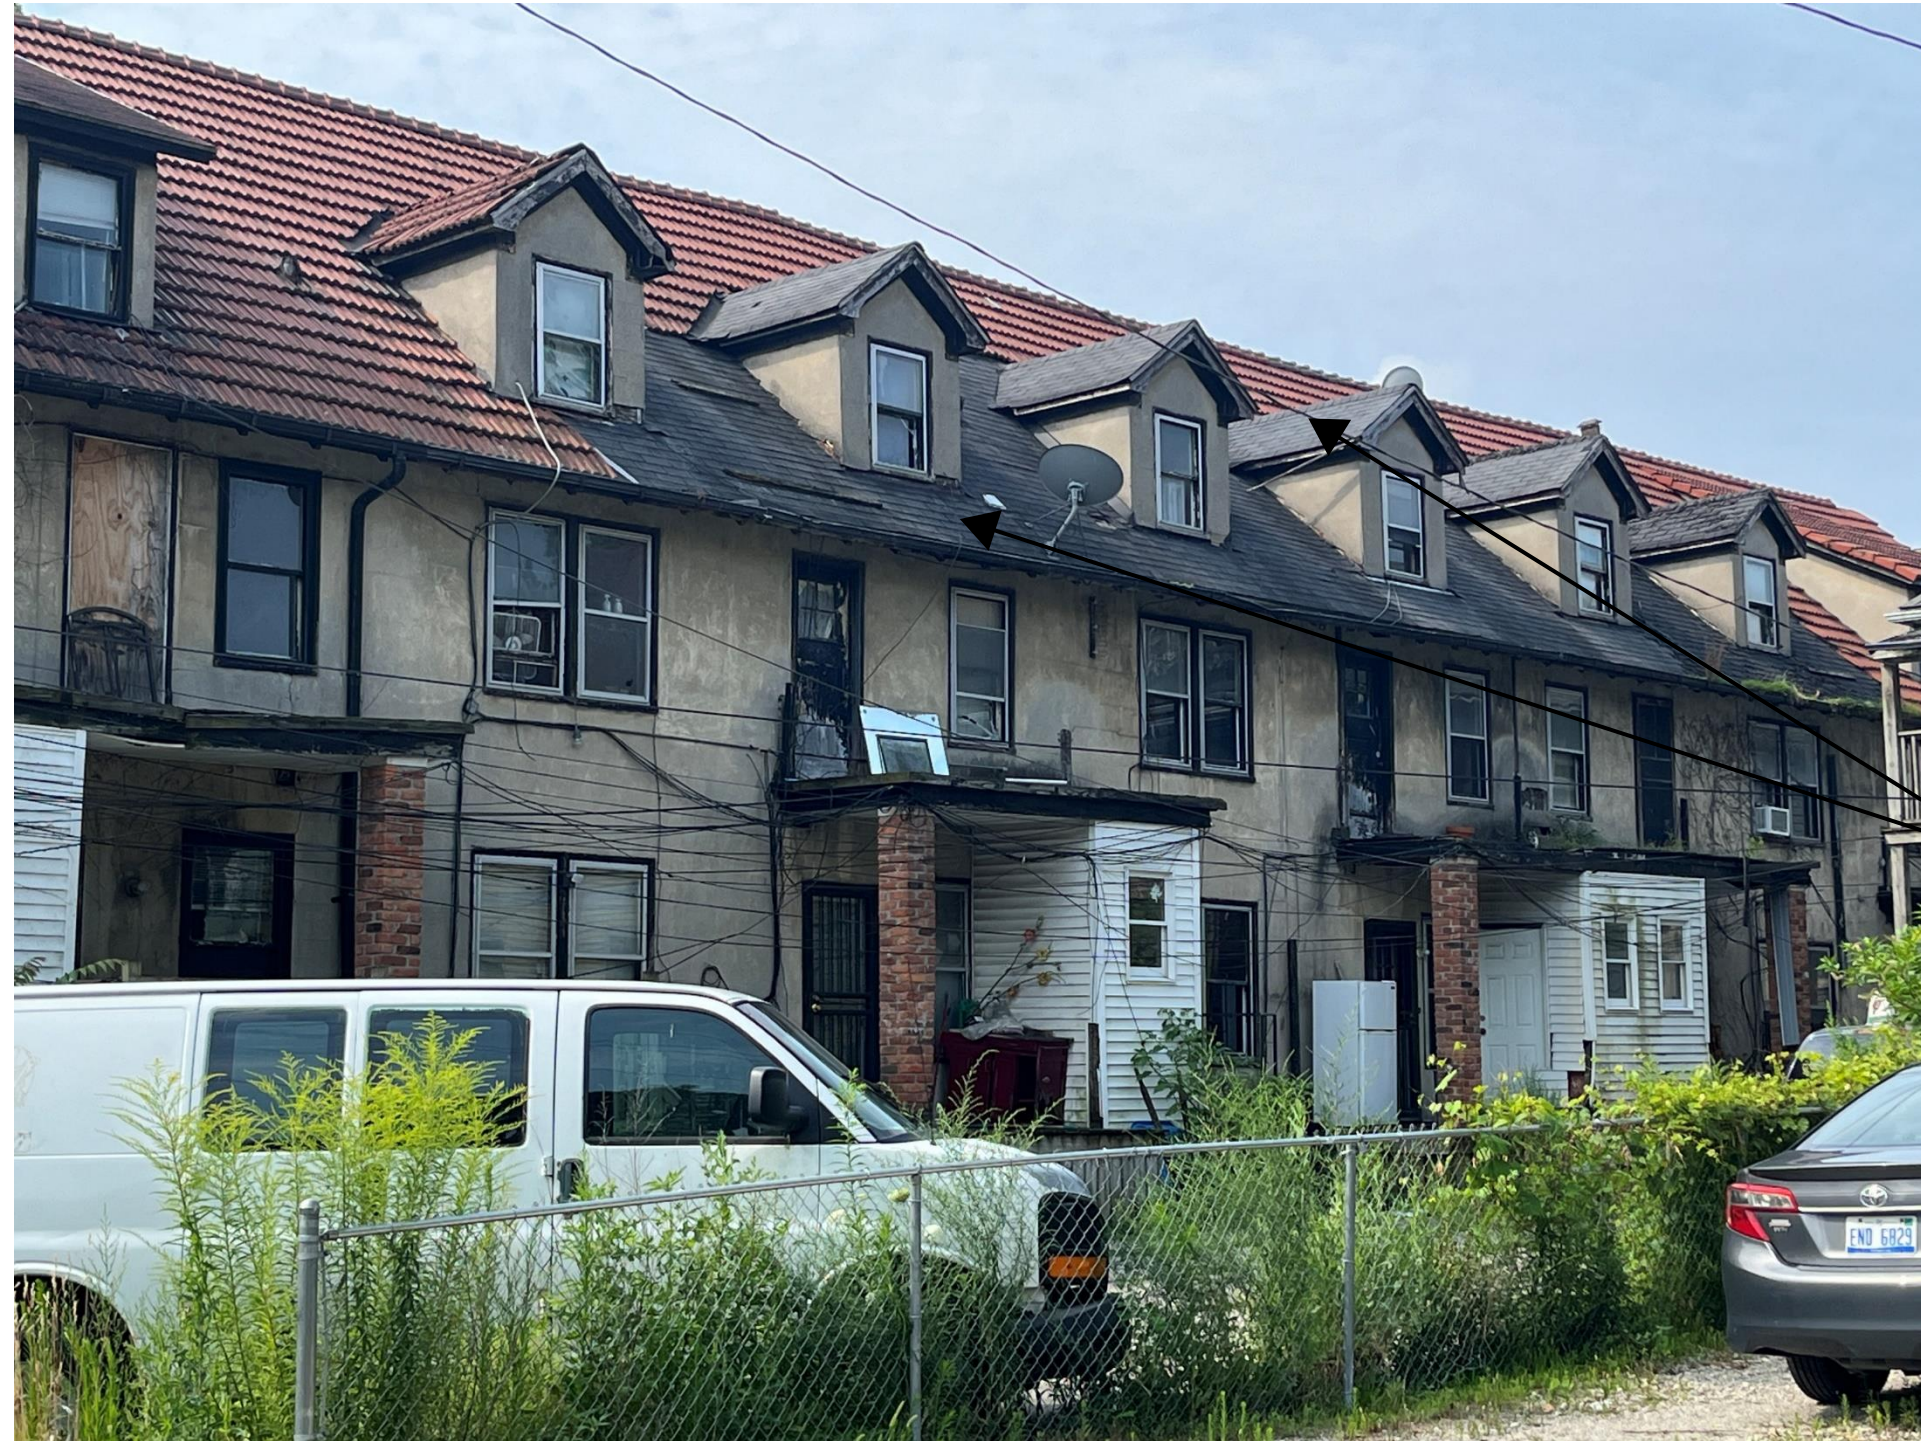
VIEW OF NORTH ELEVATION FACING ADJACENT PROPERTIES

Areas of shingle roof replacement

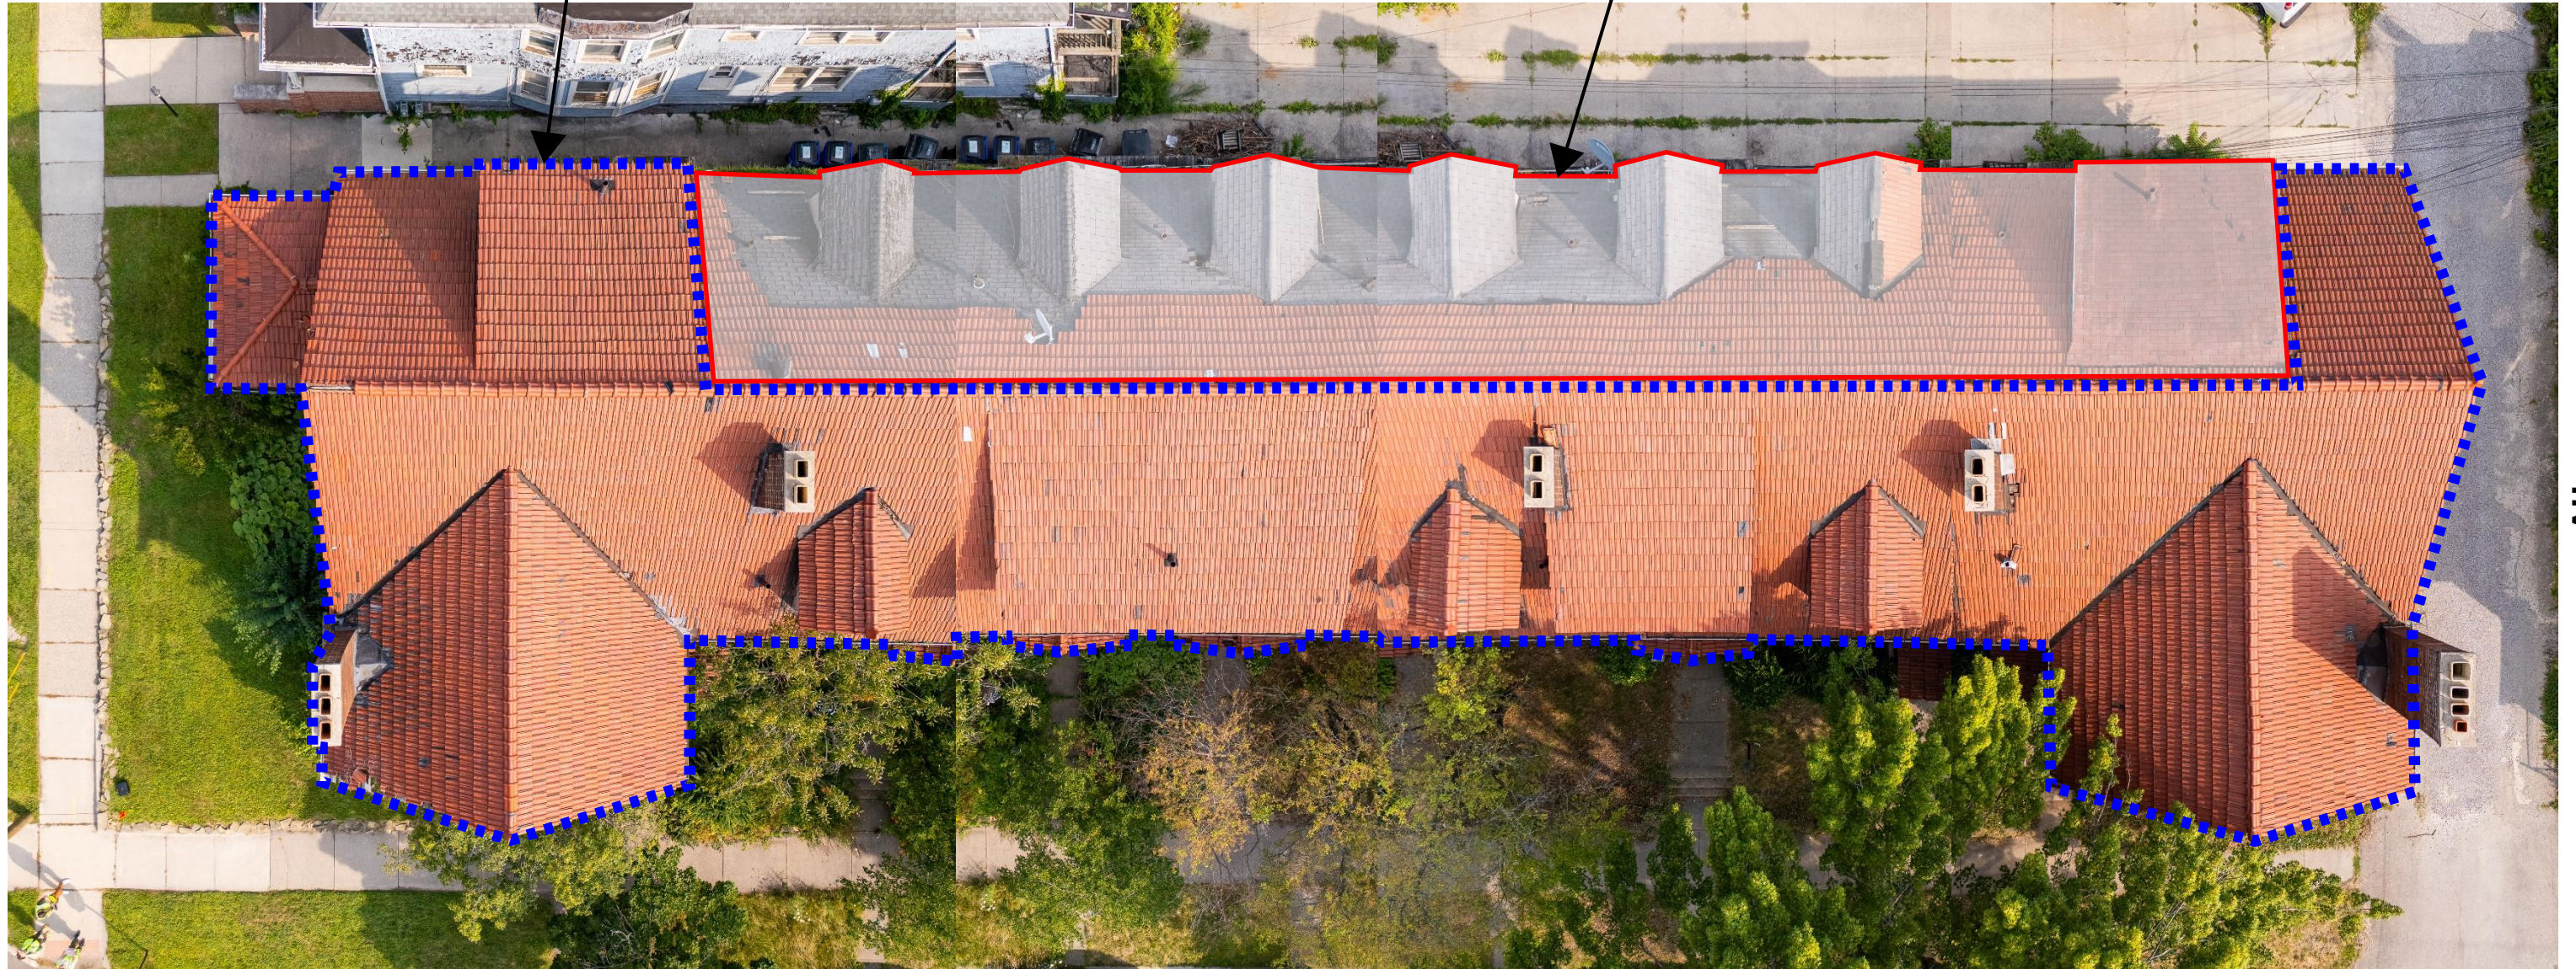
OVERVIEW OF ROOF SHOWING PROPOSED SCOPE OF TILE AND ASPHALT SHINGLES

The goal is to maintain clay tile roofing on all areas visible from the primary facades along Van Dyke and St Paul. Areas of clay tile replacement shown in the attached photos have been strategically selected to maintain views of the existing tile roof as well as the "crenulated" profile of peaks and drip edges of the clay tile components. Areas not in view from the primary facades are proposed to utilize asphalt shingles.

BLUE DASHED OUTLINE:
Area of proposed tile
repair/replacement

RED OUTLINE:
Area of proposed asphalt
shingle replacement
