# HISTORIC DISTRICT COMMISSION ADDITIONAL INFORMATION REQUEST

**Application Number:** HDC2025-00511

**PROJECT ADDRESS:** 19545 shrewsbury rd. Detroit, MI

**HISTORIC DISTRICT:** Sherwood Forest

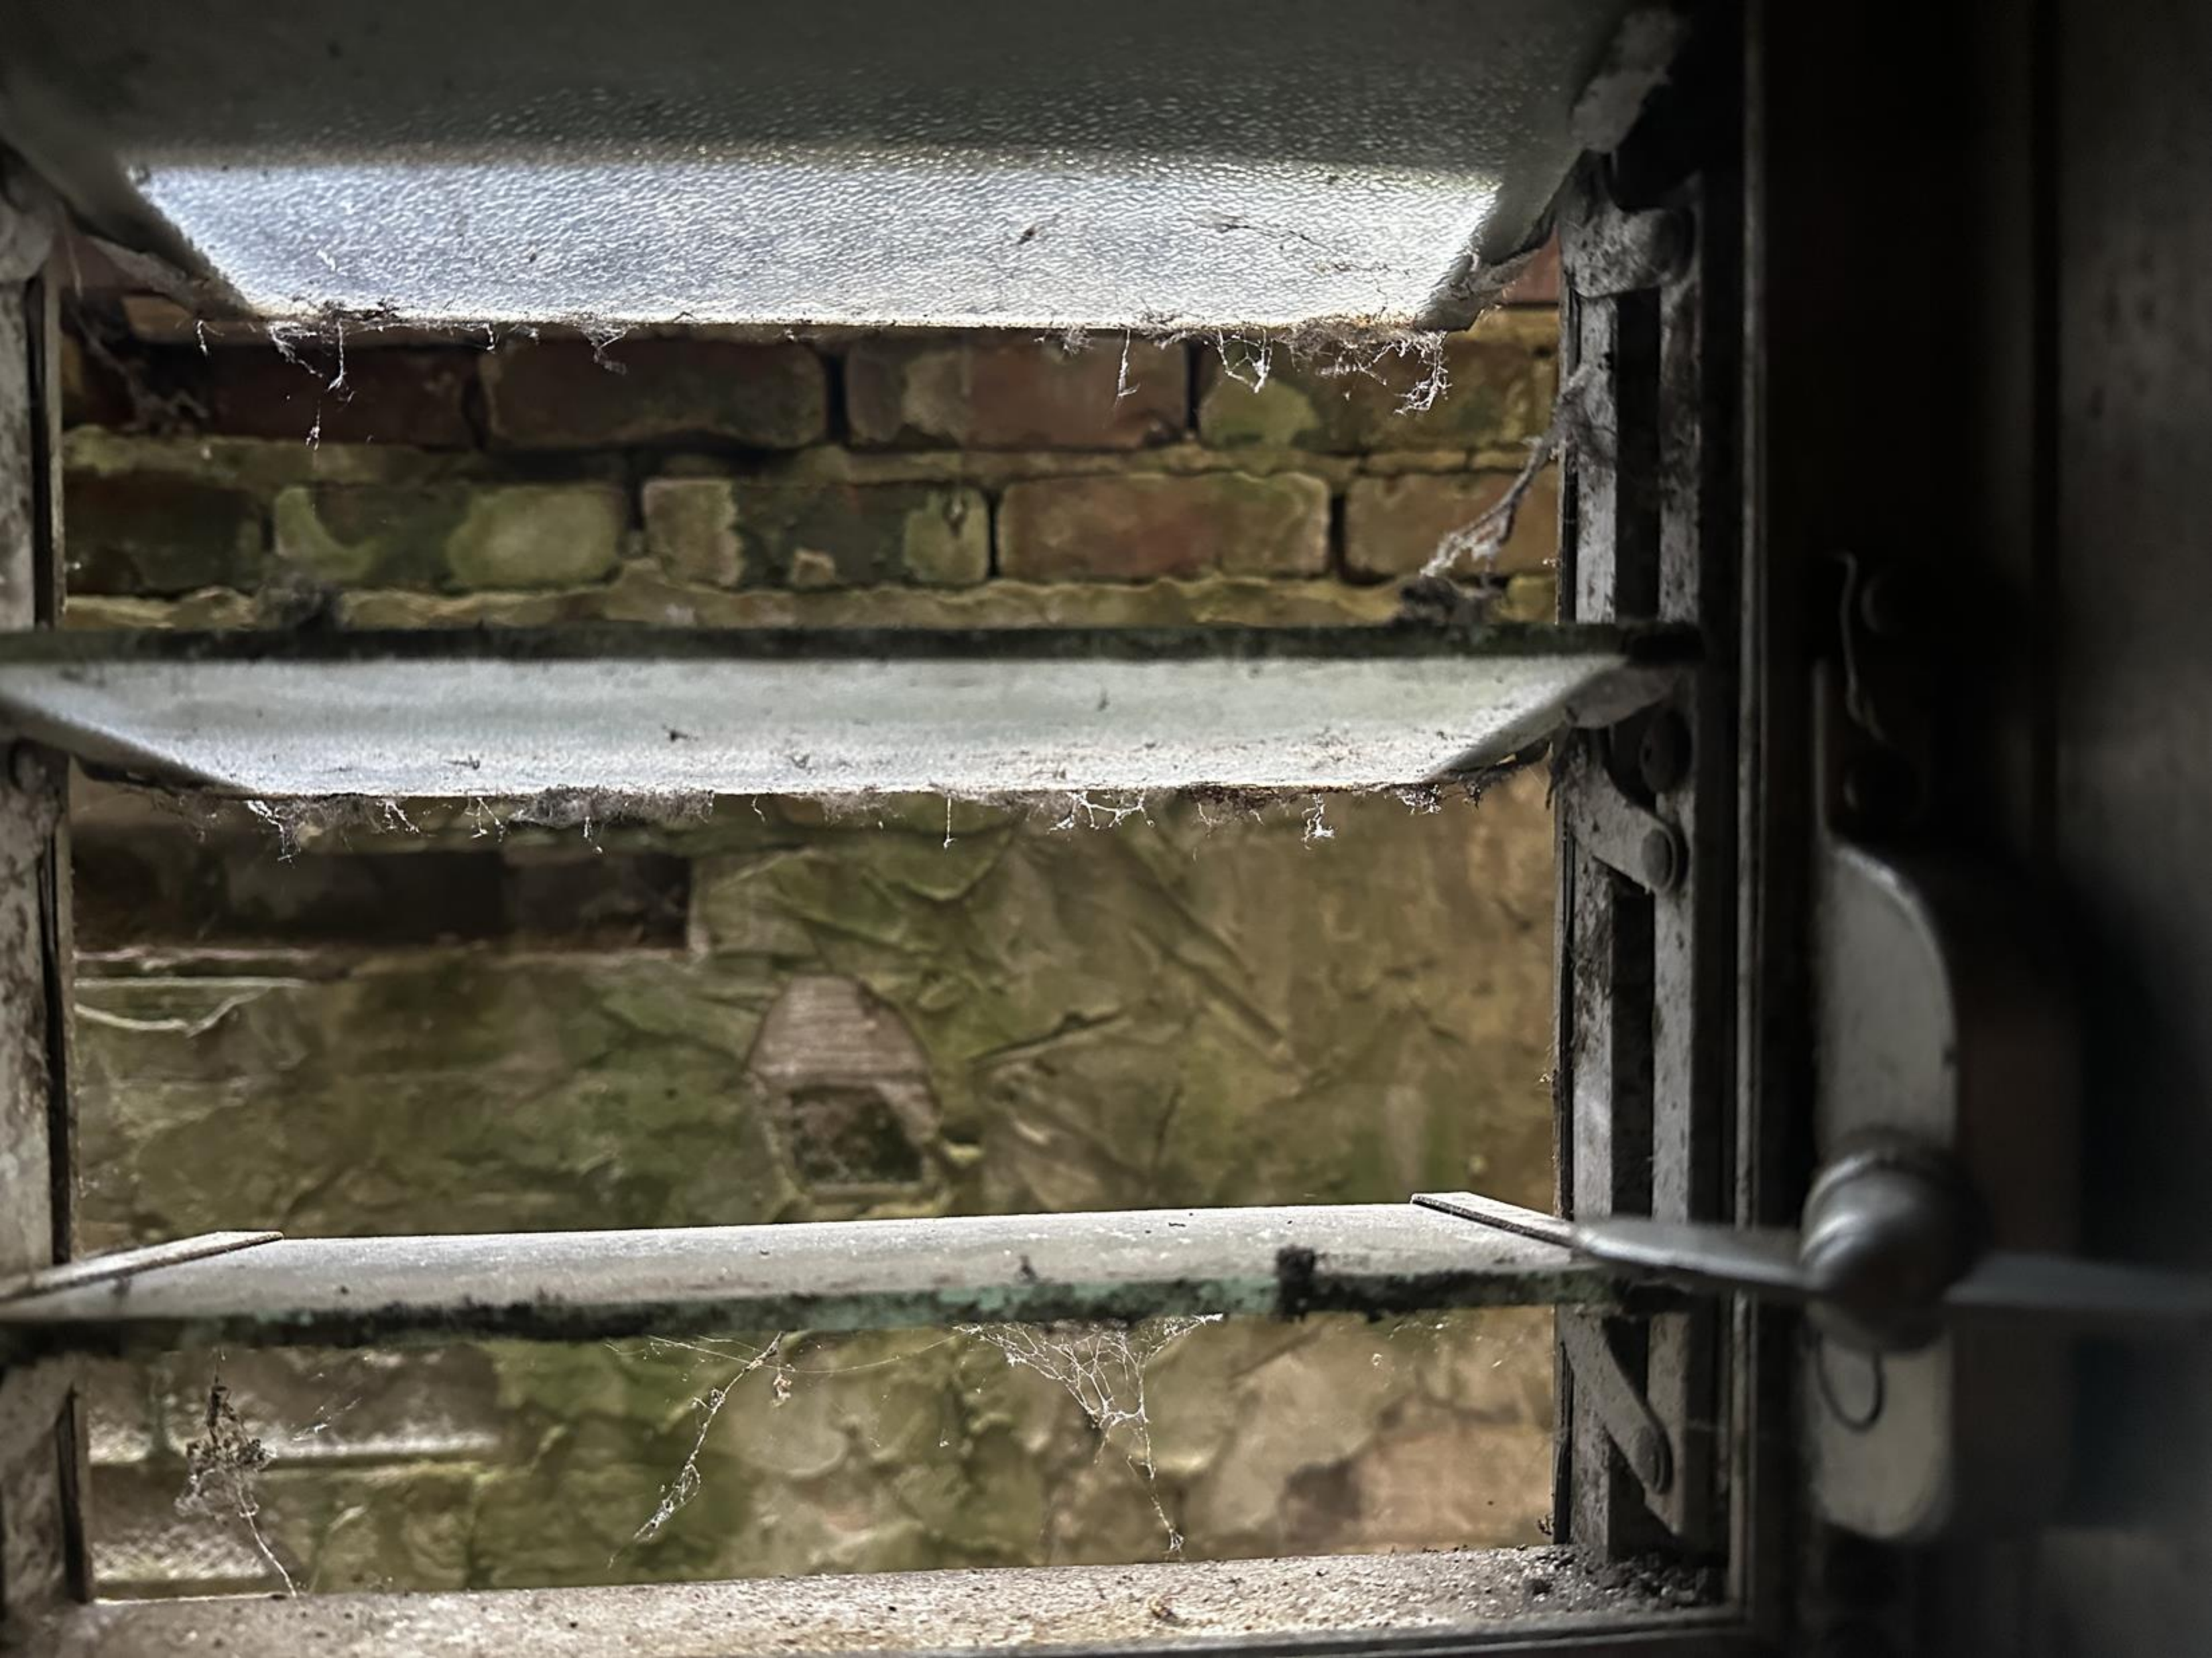
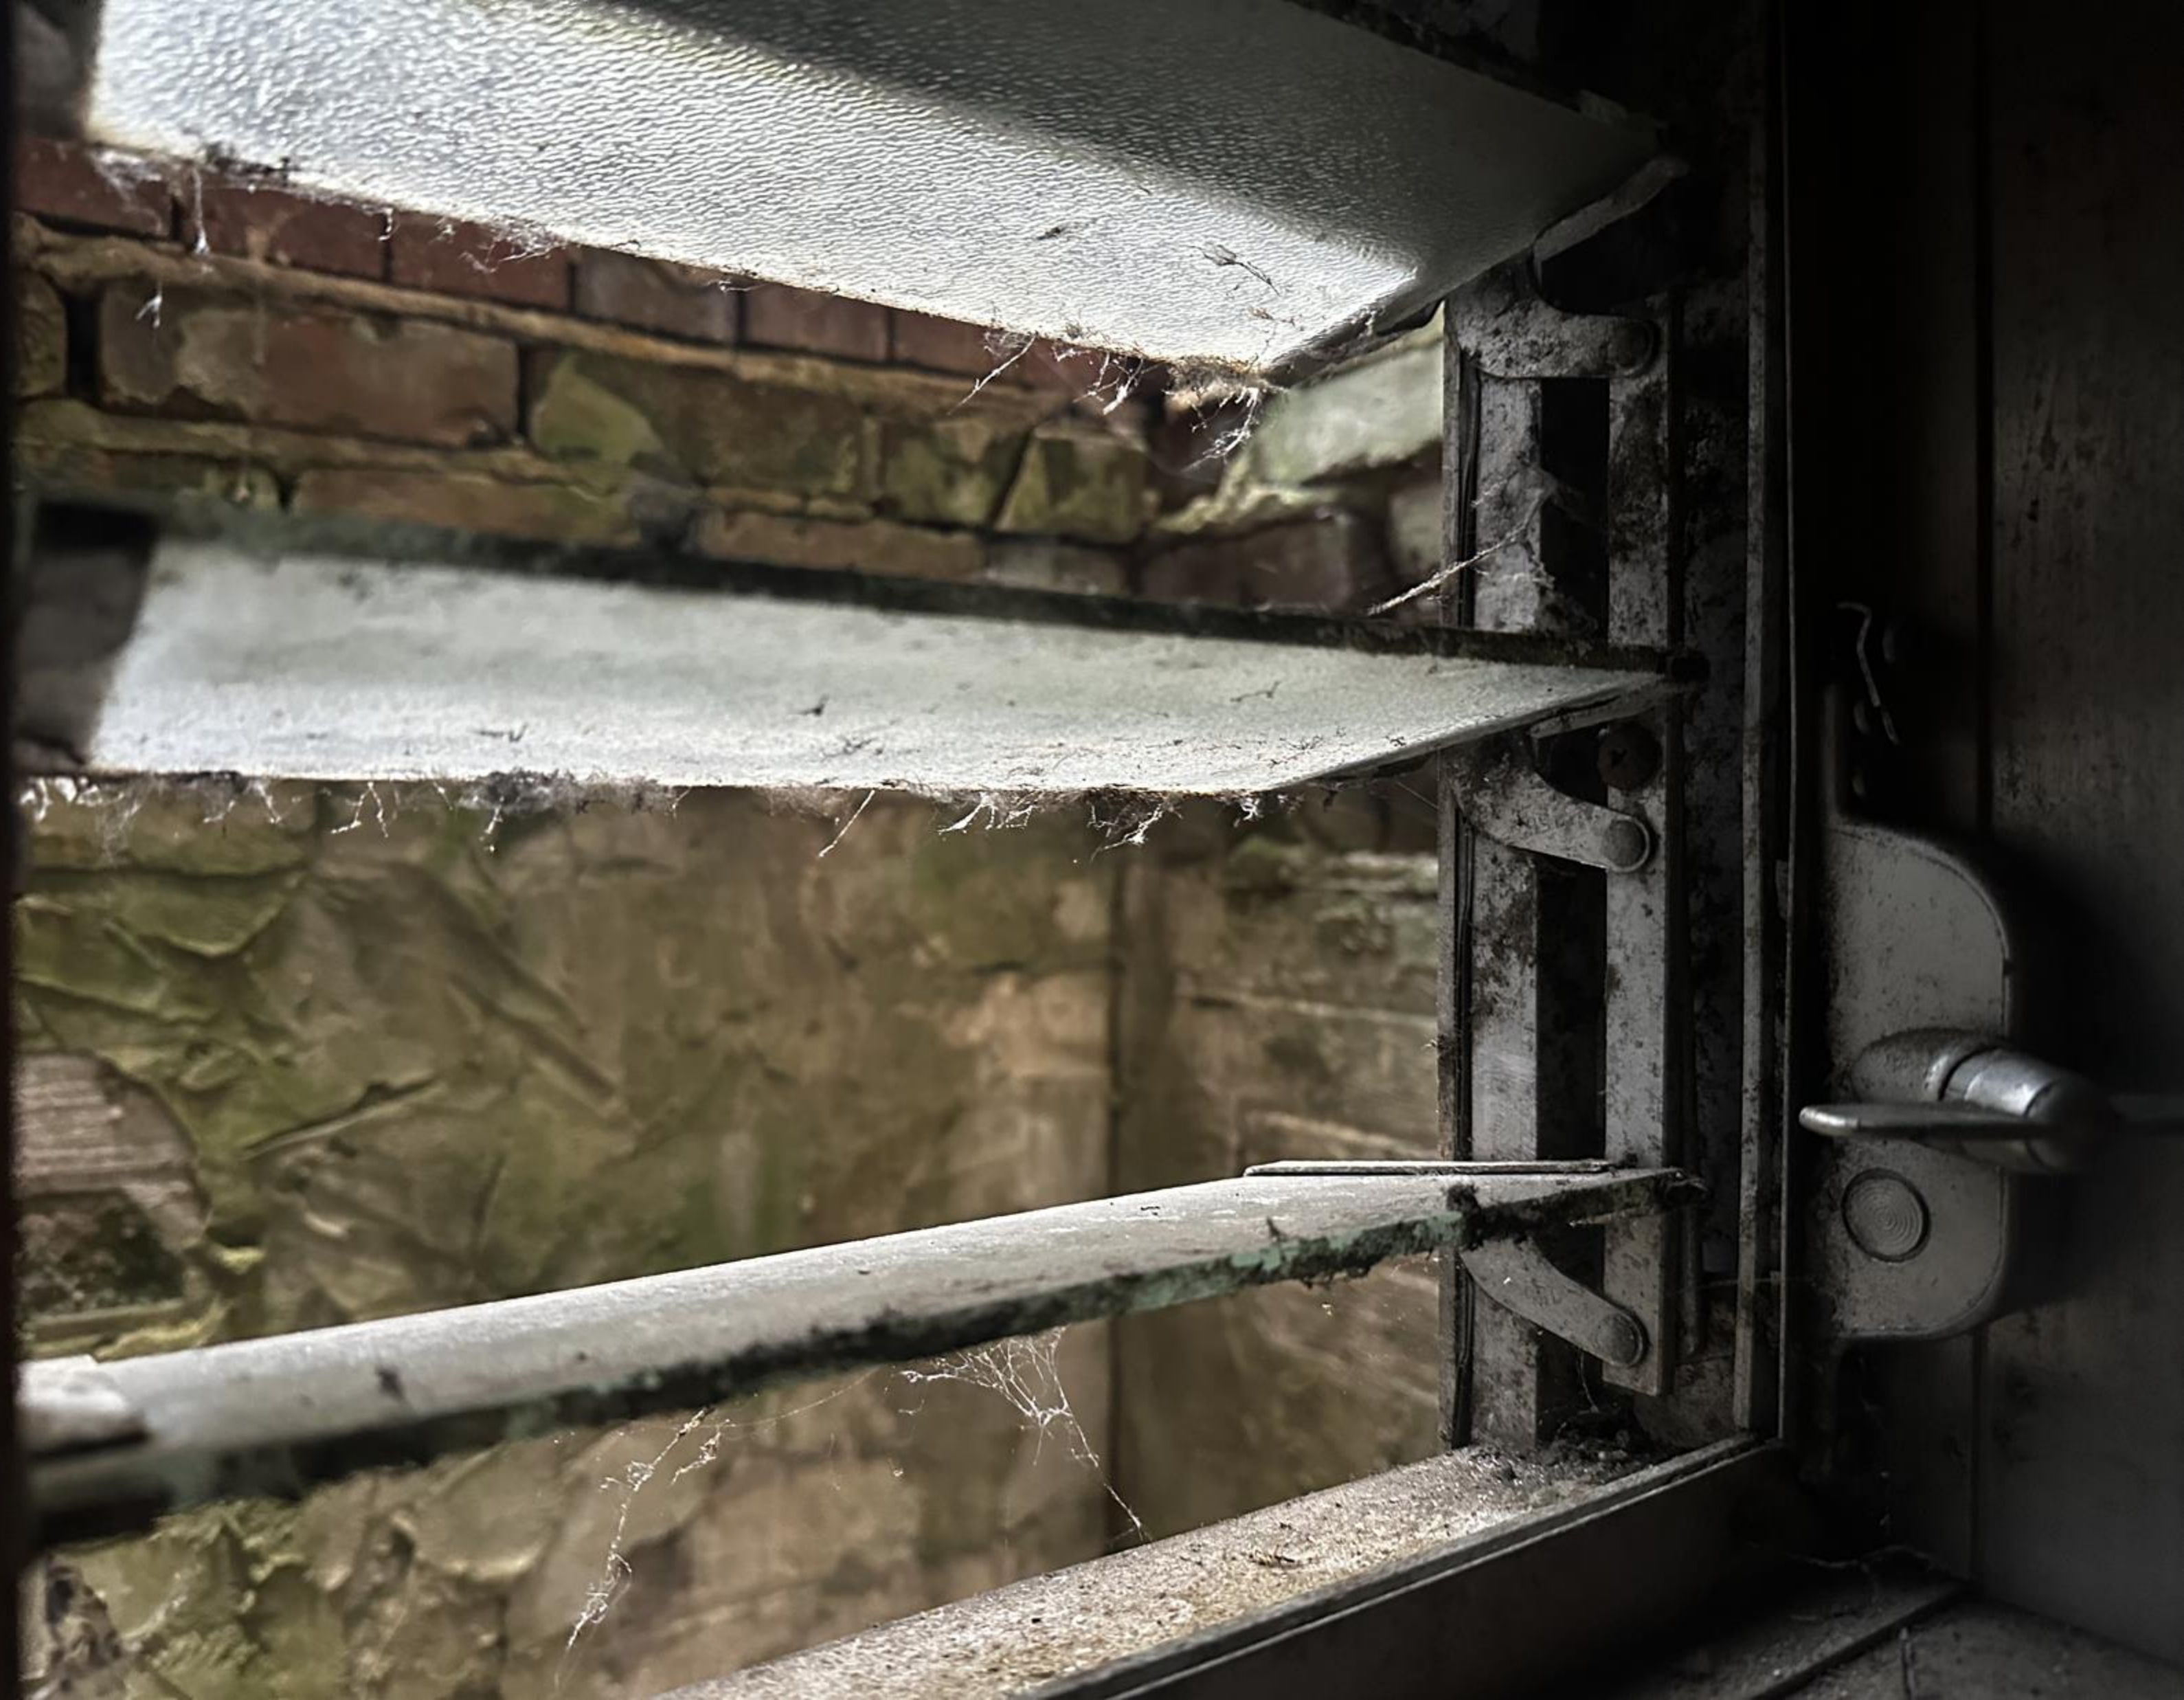
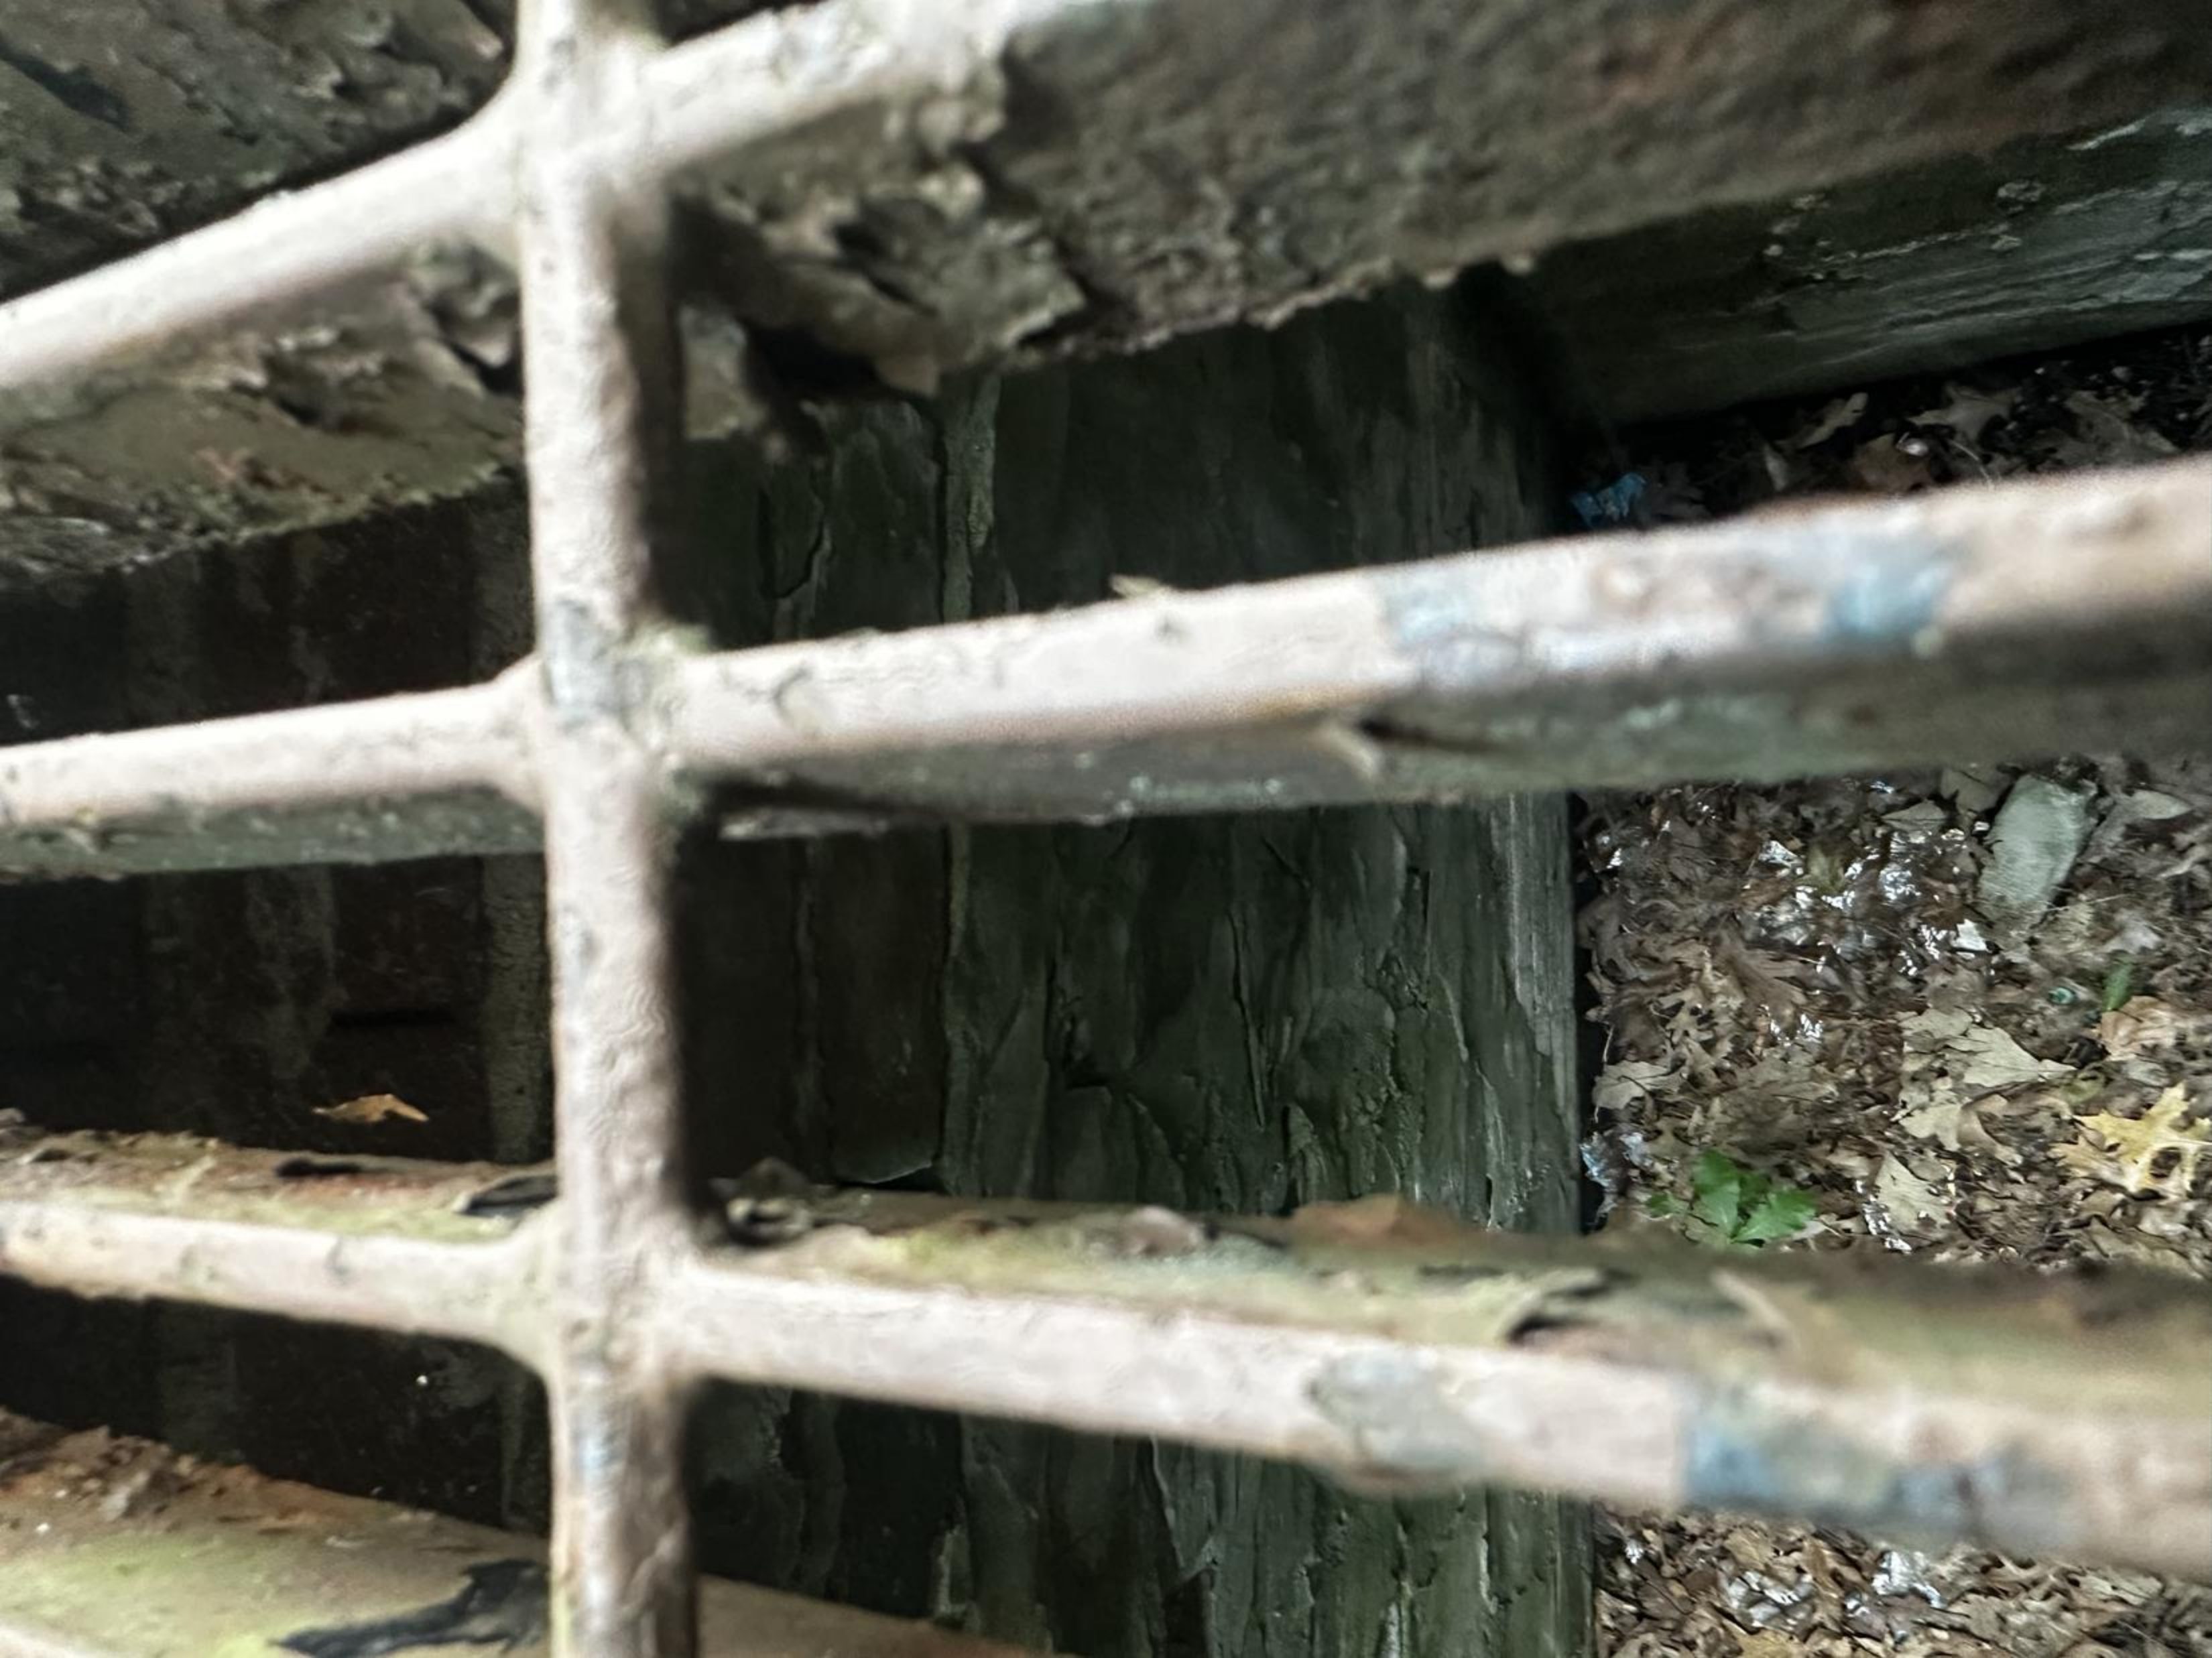
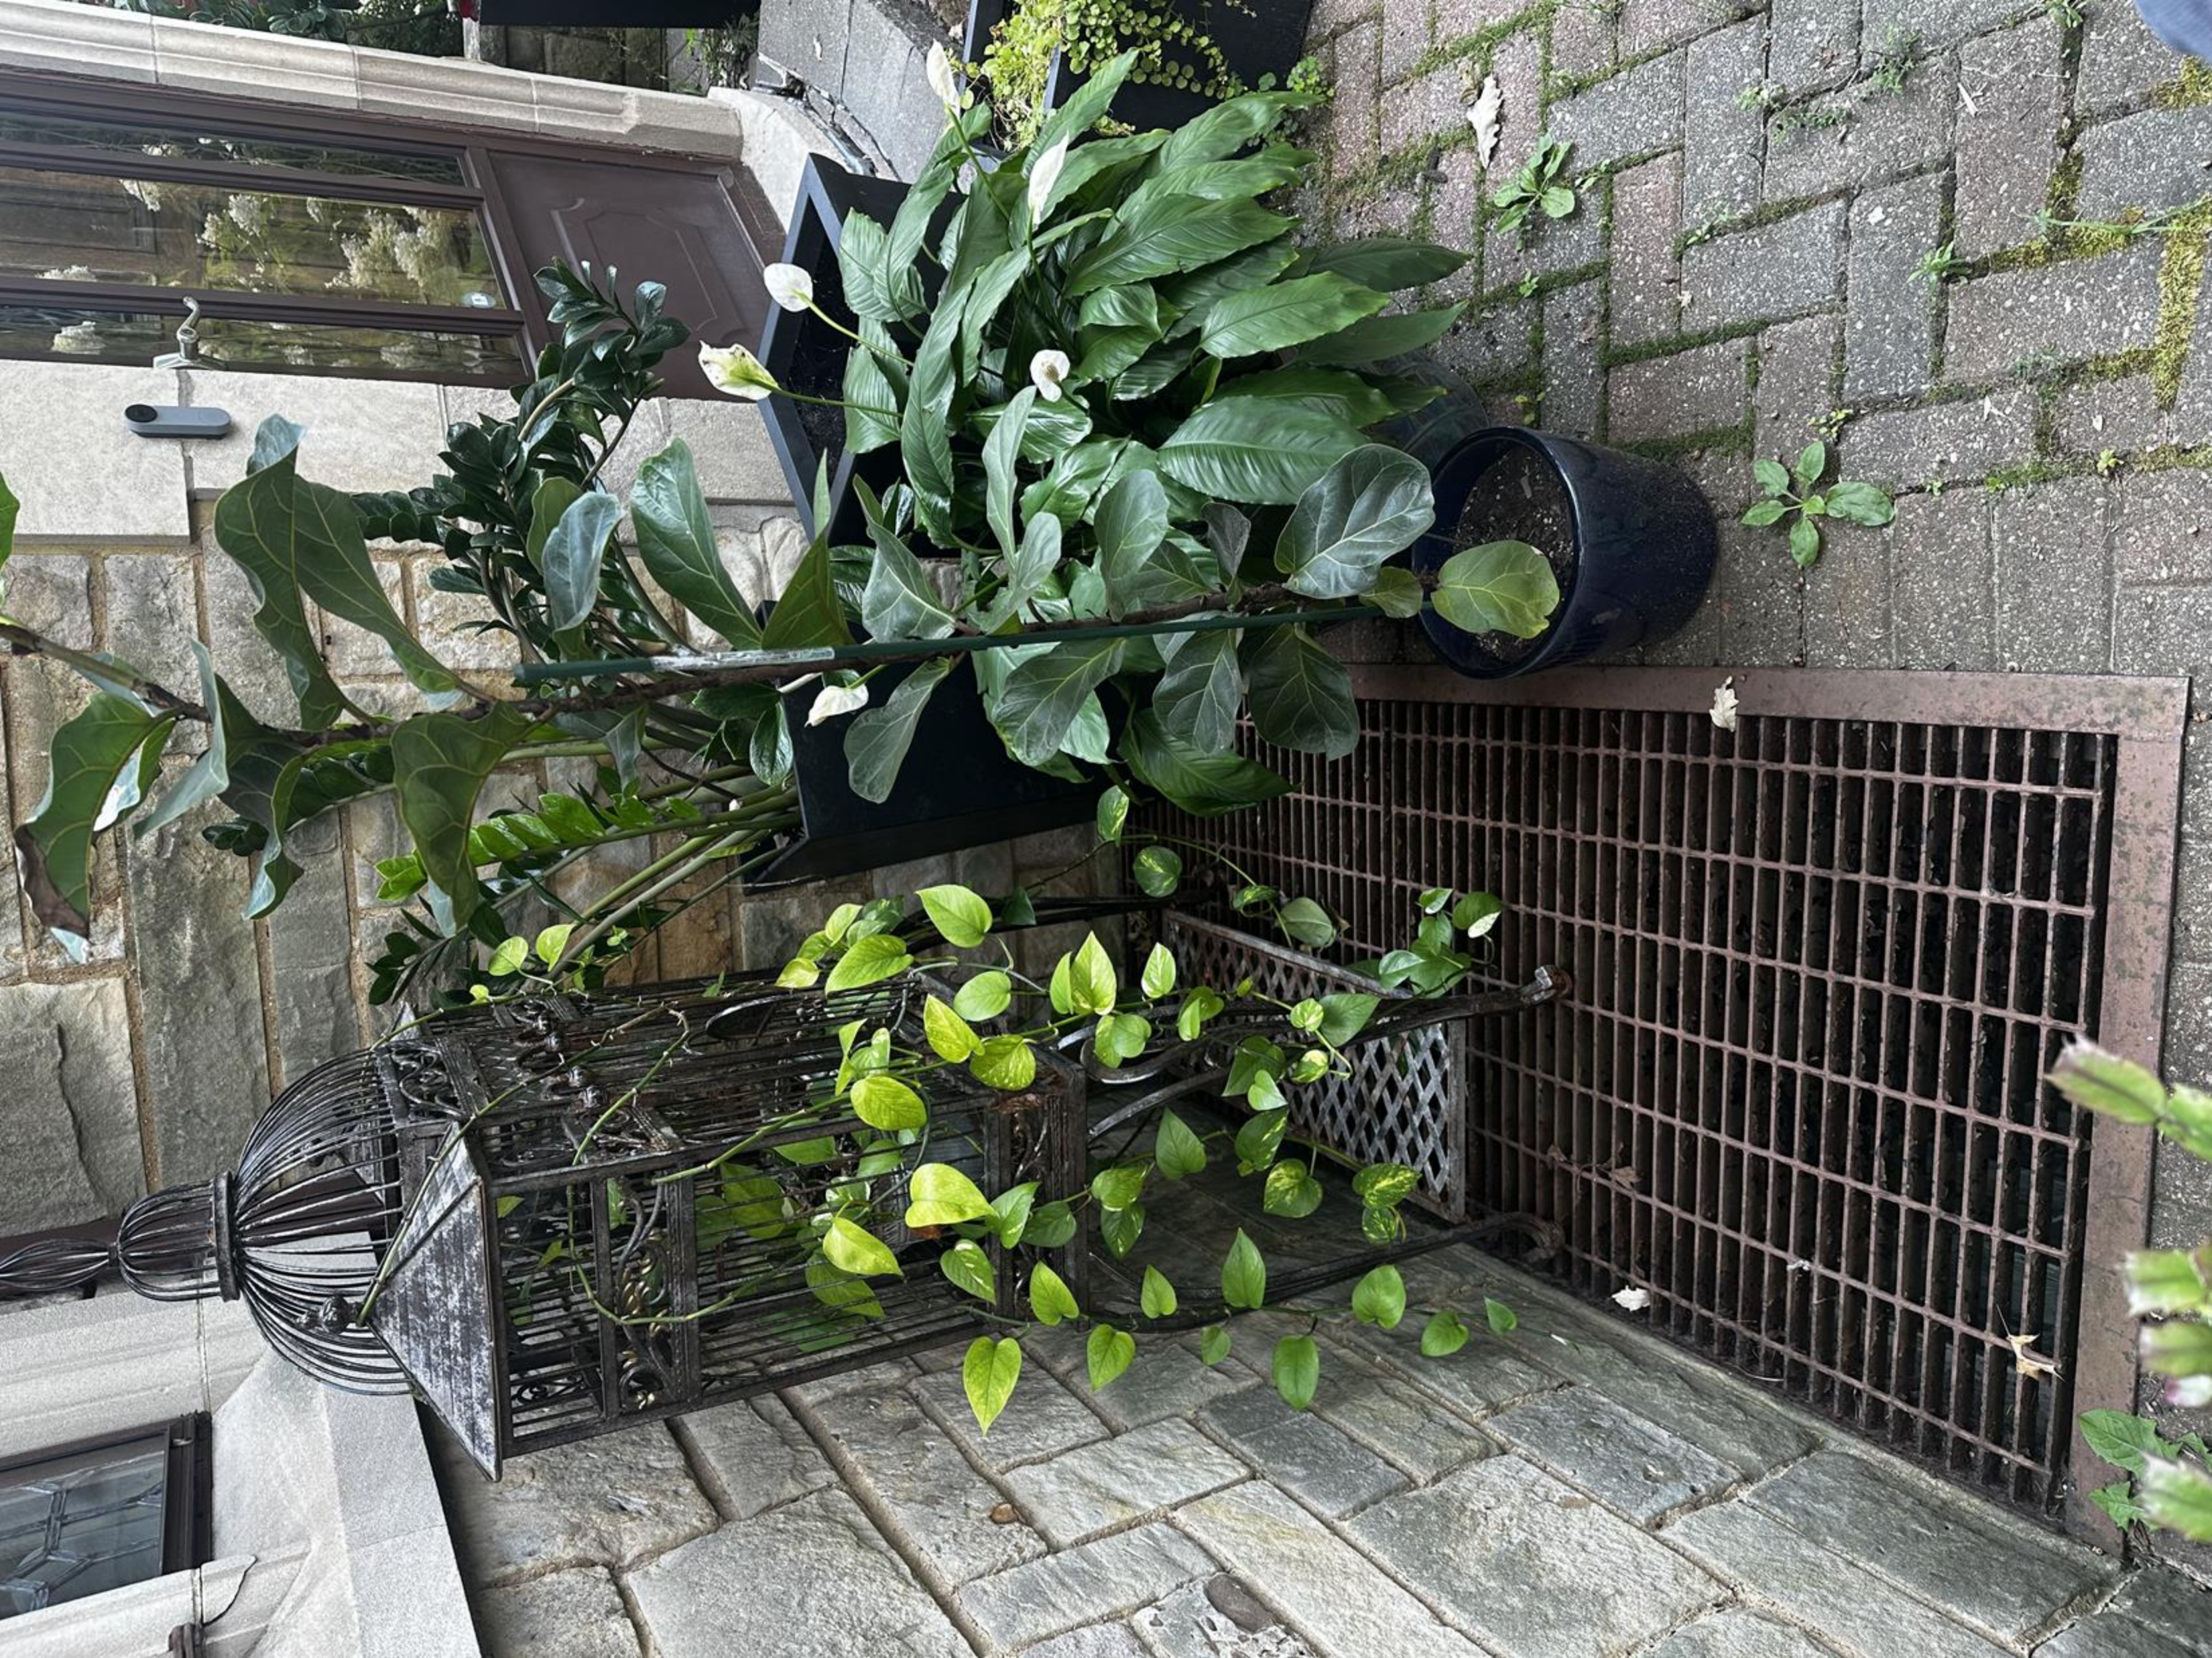
Regarding the parging, apologies, I should have included more information around that. The window well currently has approx. 1" thick layer of mortar covering the brick however it has started to break apart. Madison Maintenance would repair the damaged pieces to ensure the integrity of the window well. I have included pictures of the window well. Note: It's a little hard to show the whole area with the porch grate and limited window access below.
