# HISTORIC DISTRICT COMMISSION APPLICATION FOR WORK APPROVAL

HDC2025-00655

### **Existing Analysis Report**

Existing Historic Accessory Structure

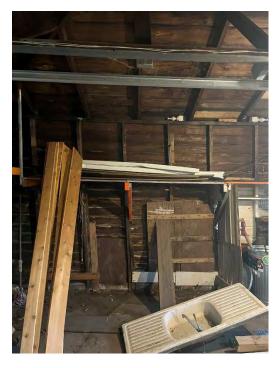
Stud and rafter spacing, single top plate,

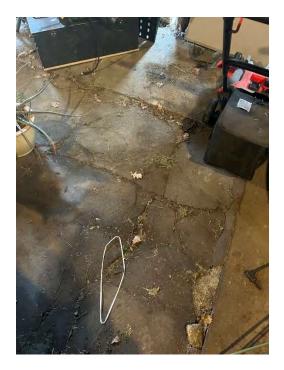
Interior concrete slab deterioration

- Remove slab
- Install new foundation to frost depth, min 42" below grade.
- The interior slab should be replaced and should rest on a minimum 6" compacted sub-base with a vapor barrier separating the slab from the sub-base.
- Raise height of slab above grade min 4".

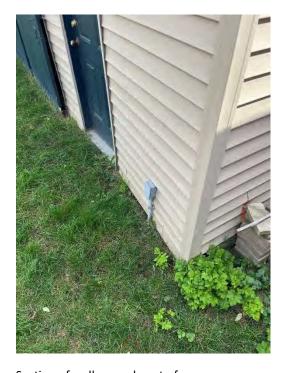
Section of wall severely out of square – not supported by foundation

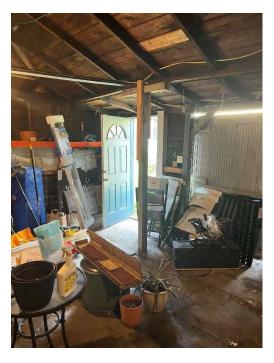
Excessive deflection in supporting member

The roof structure is severely overloaded and shows signs of significant deflection as a result. The condition has persisted since the structure was constructed. The roof entire roof system requires replacement.

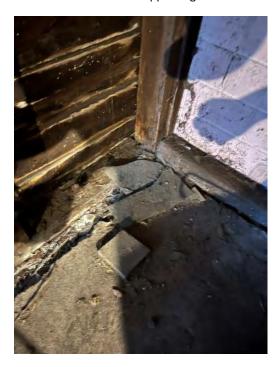
Deterioration of slab and sill

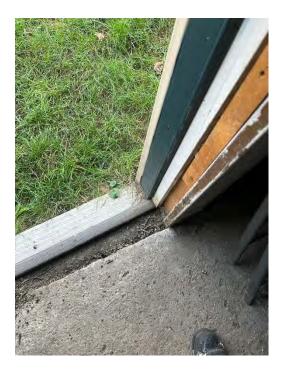
Level of exterior grade compared to slab

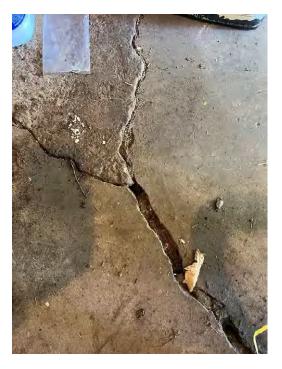
Deterioration of slab

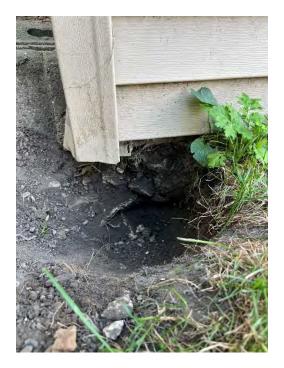
Test pit showing bottom of slab +/- 8" below
Top of slab

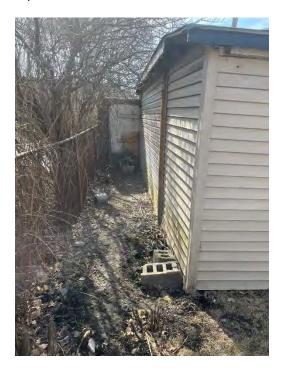
Walls out of plumb, missing fascia, rodent den (at CMU blocks)

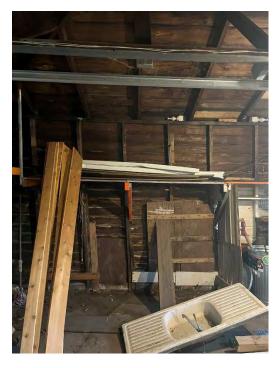
Stud and rafter spacing, single top plate,

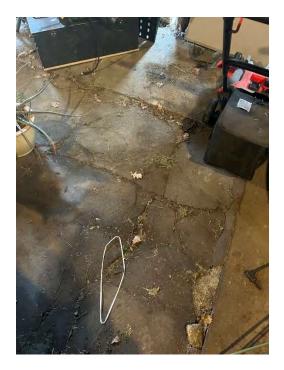
Interior concrete slab deterioration

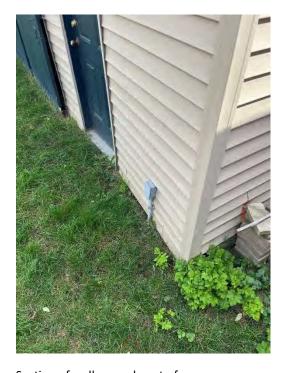
Section of wall severely out of square – not supported by foundation

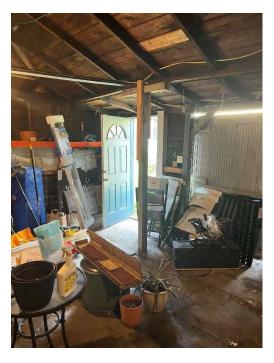
Excessive deflection in supporting member

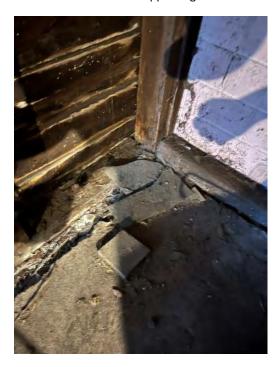
Deterioration of slab and sill

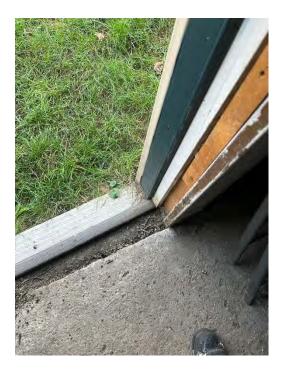
Level of exterior grade compared to slab

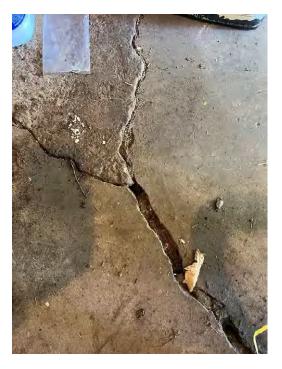
Deterioration of slab

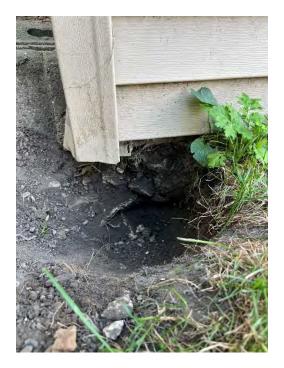
Test pit showing bottom of slab +/- 8" below
Top of slab

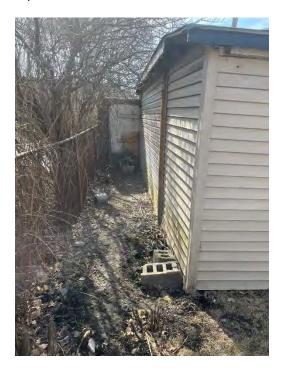
Walls out of plumb, missing fascia, rodent den (at CMU blocks)
