# HISTORIC DISTRICT COMMISSION ADDITIONAL INFORMATION REQUEST

**Application Number:** HDC2025-00495

**REBUILD REAR  
SECTION OF HOME**  
**899 EDISON**  
**DETROIT, MI**  
**48202**

Subject: Structural inspection of two-story structure at rear of dwelling at 899 Edison Ave. in the City of Detroit, MI

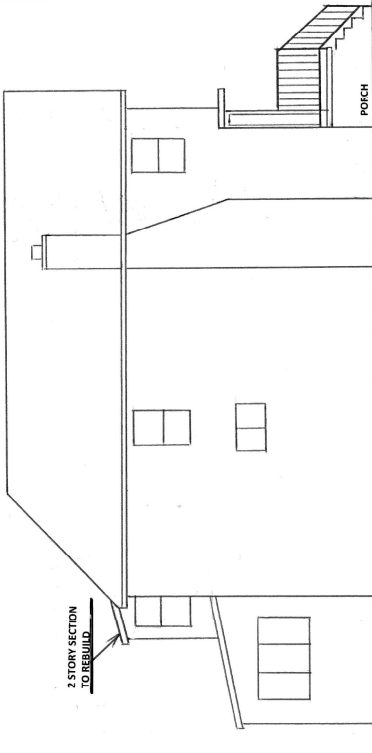
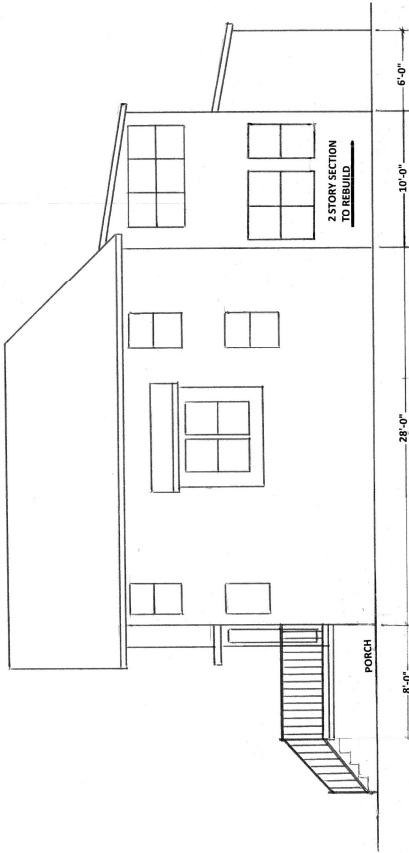
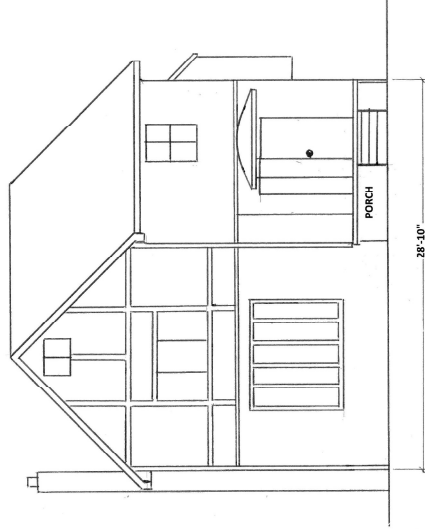
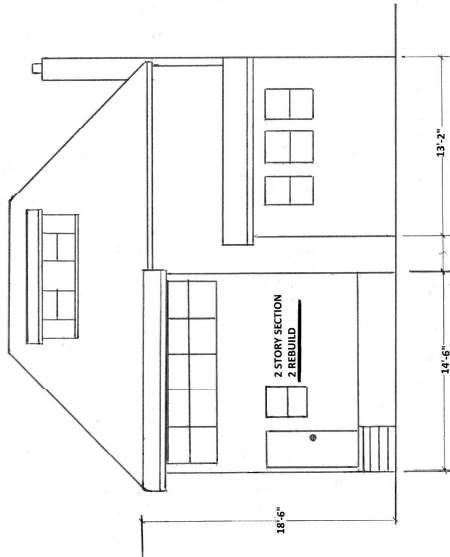
**EXISTING  
ELEVATIONS**

Regarding the existing drawings, I am confused by the small elevations at the top of A-101. Are these trying to show how the new construction will look upon completion? If so, they don't show any exterior doors, however cut sheets of a single door and a vinyl sliding door were submitted. You also mention replacing vinyl with cedar shingles; however, the small drawings specify vinyl siding. Would the stucco finish at the second floor be replicated?
