HISTORIC DISTRICT COMMISSION APPLICATION FOR WORK APPROVAL

HDC2026-00004

ADDRESS(ES): 4825 Fullerton

Proposing to replace two story porch in rear of the property.

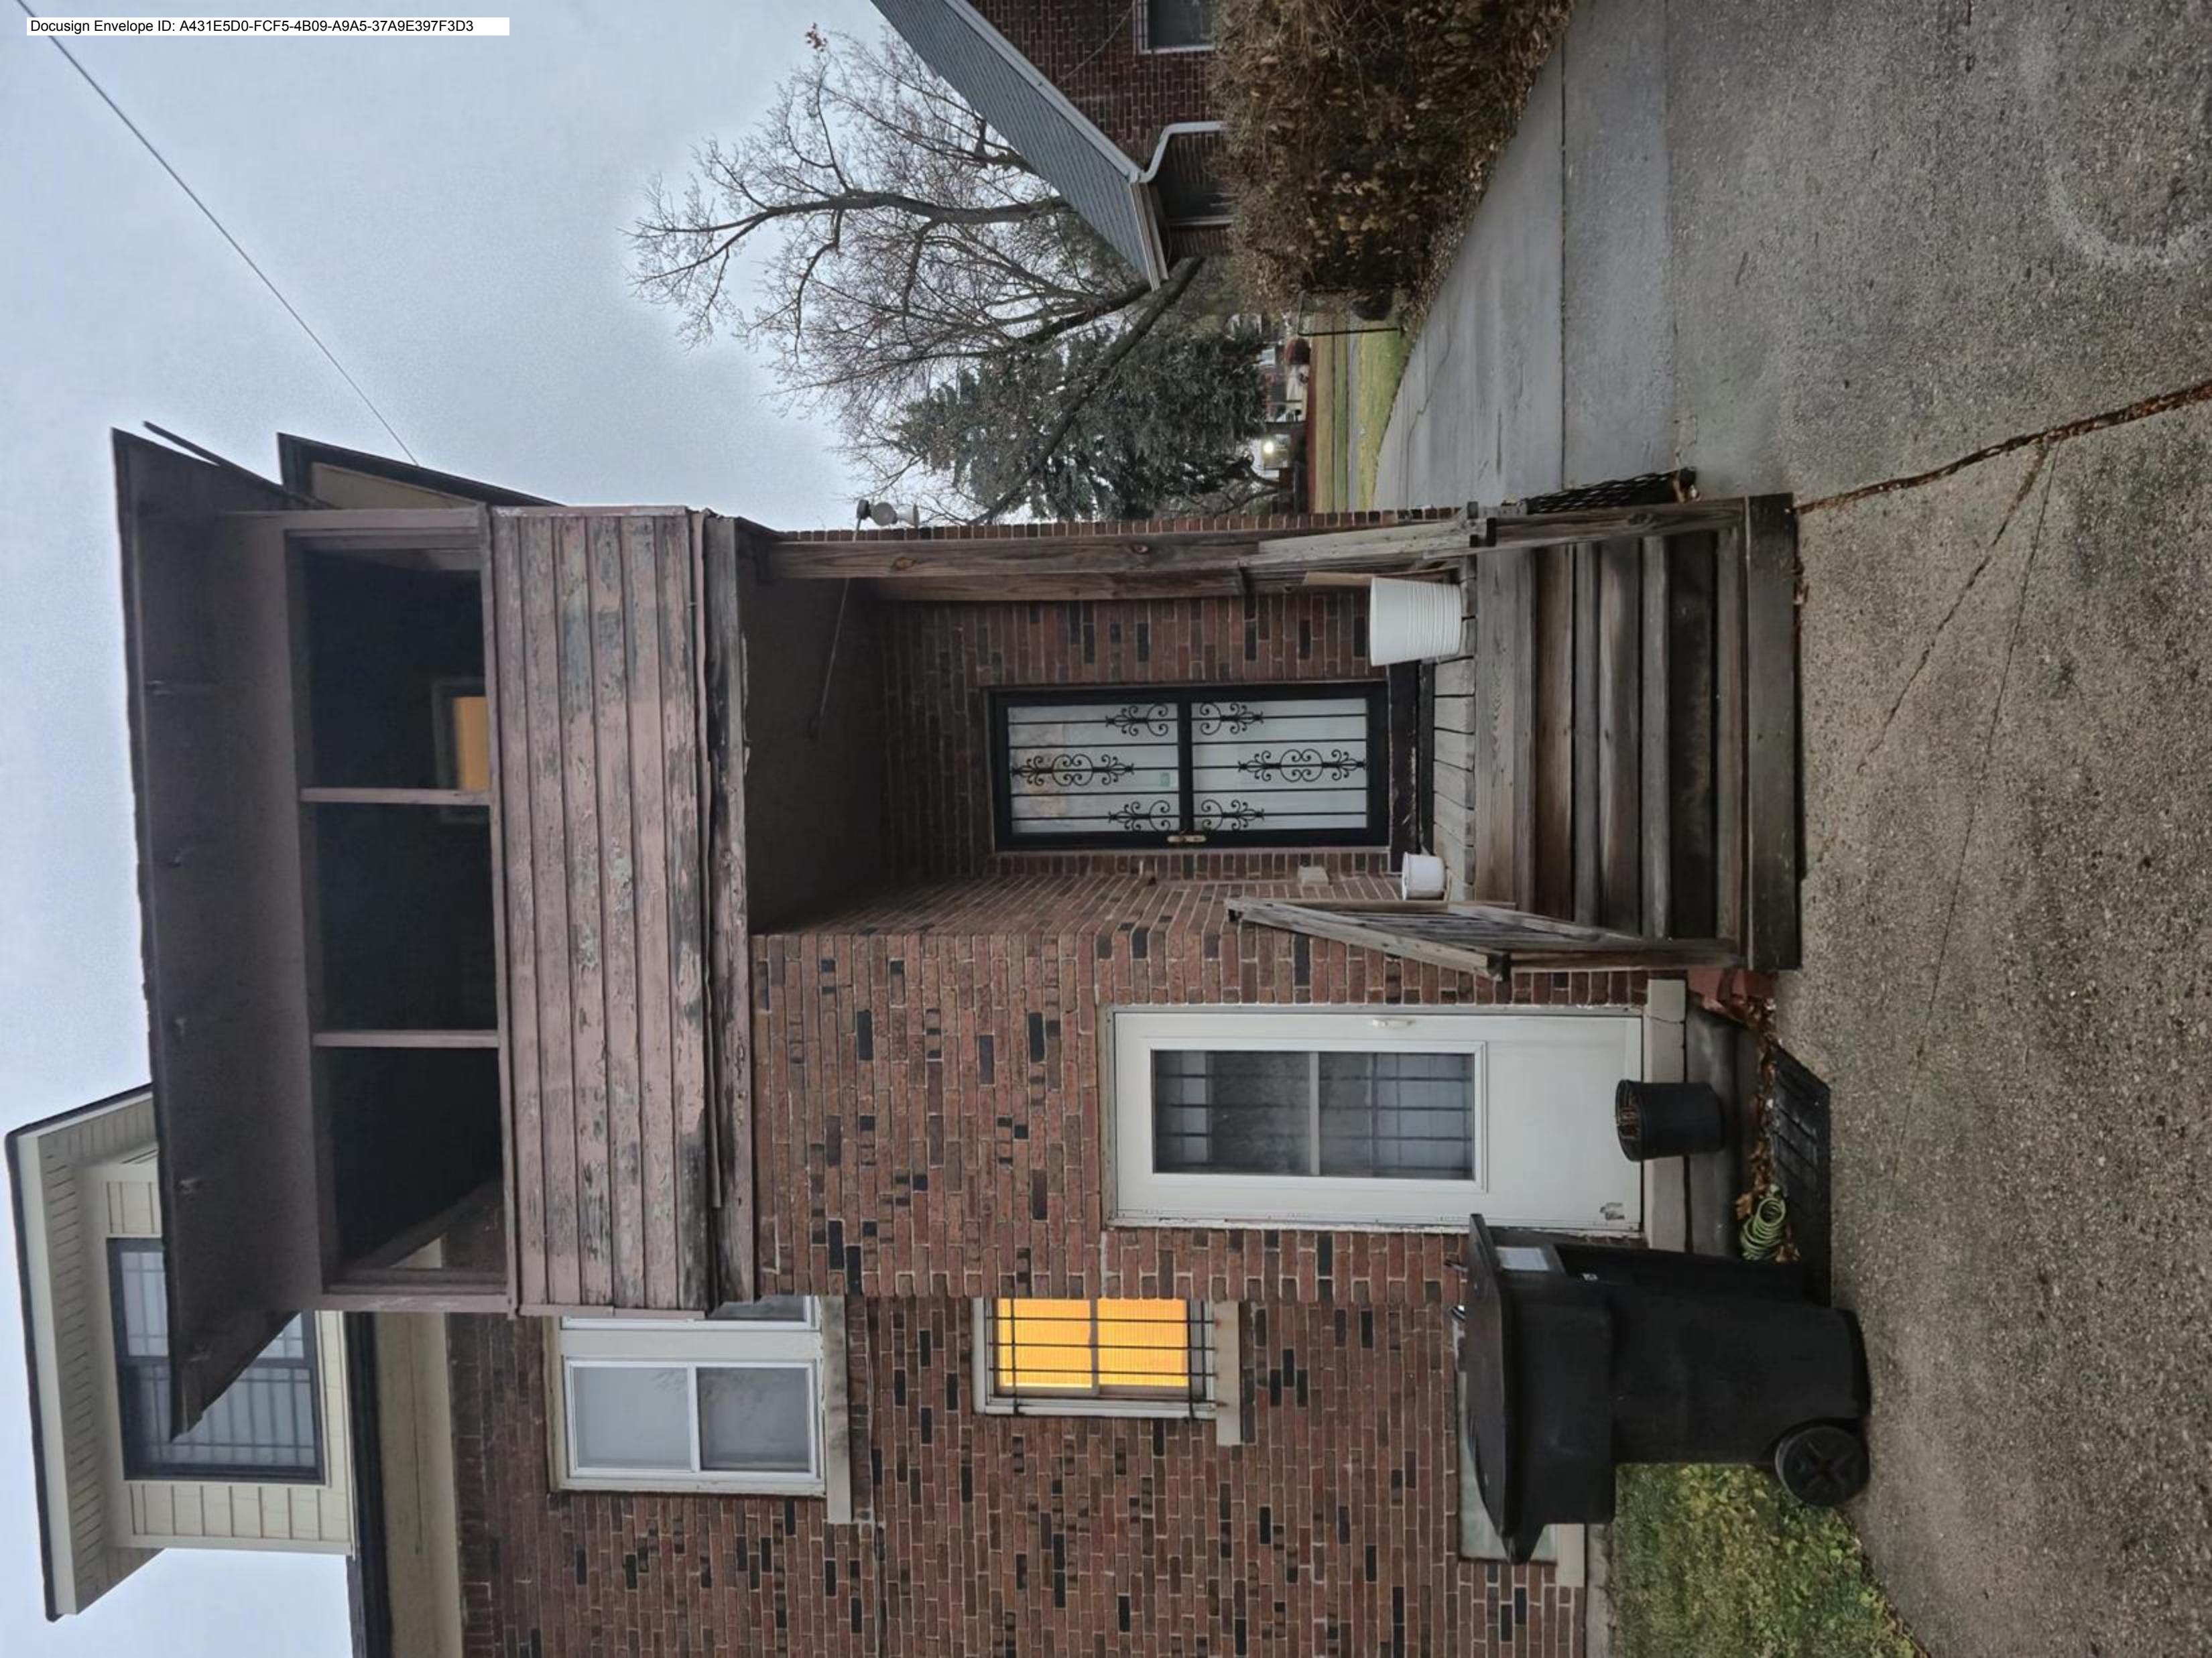
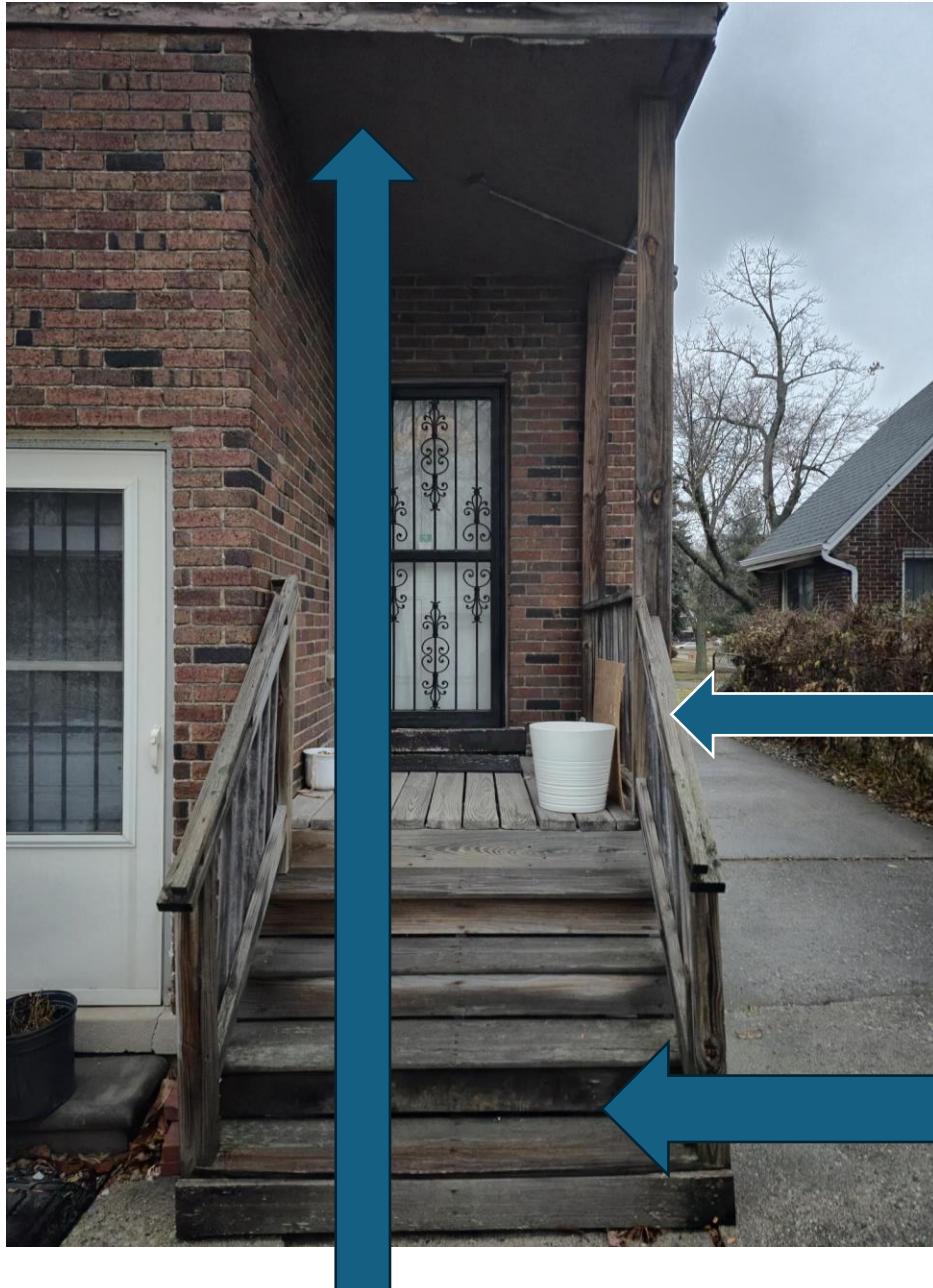
54" Long wood handrail
with 7 1x1 Balusters.

Four wood steps. 5' long
with 11" tread and 6"
Risers

Current first floor porch has tongue and groove ceiling. To be replaced in kind with new exterior light fixture. 64" W X 80 L

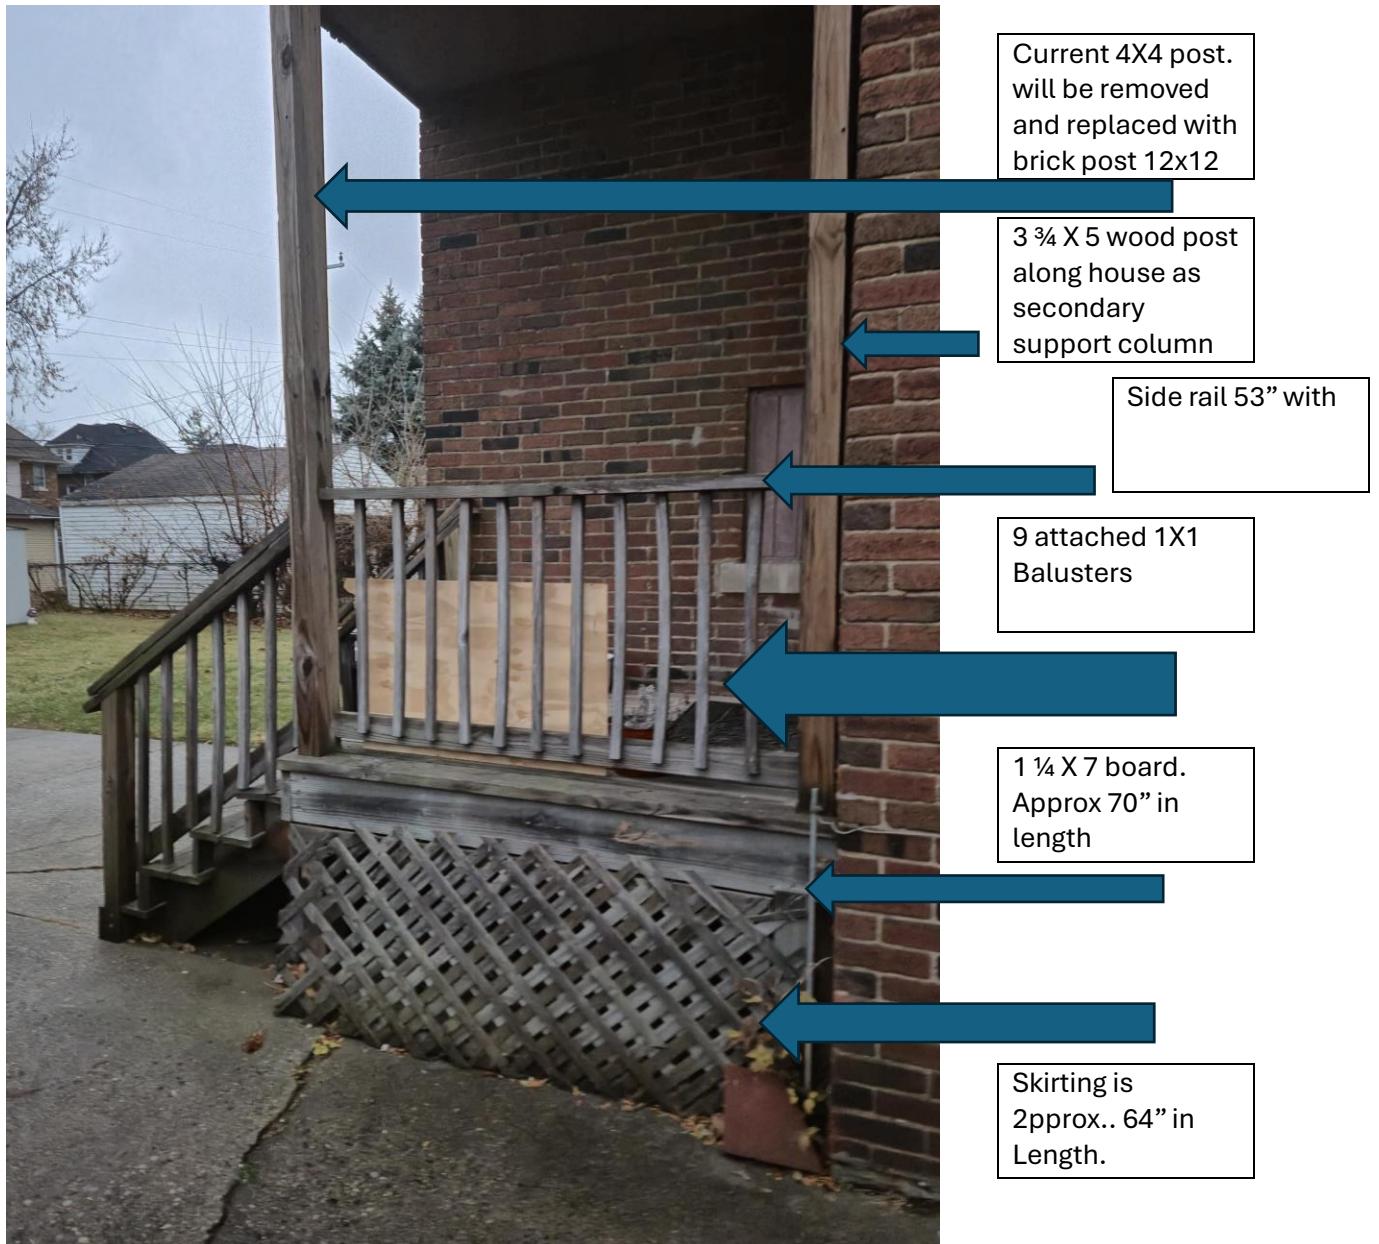
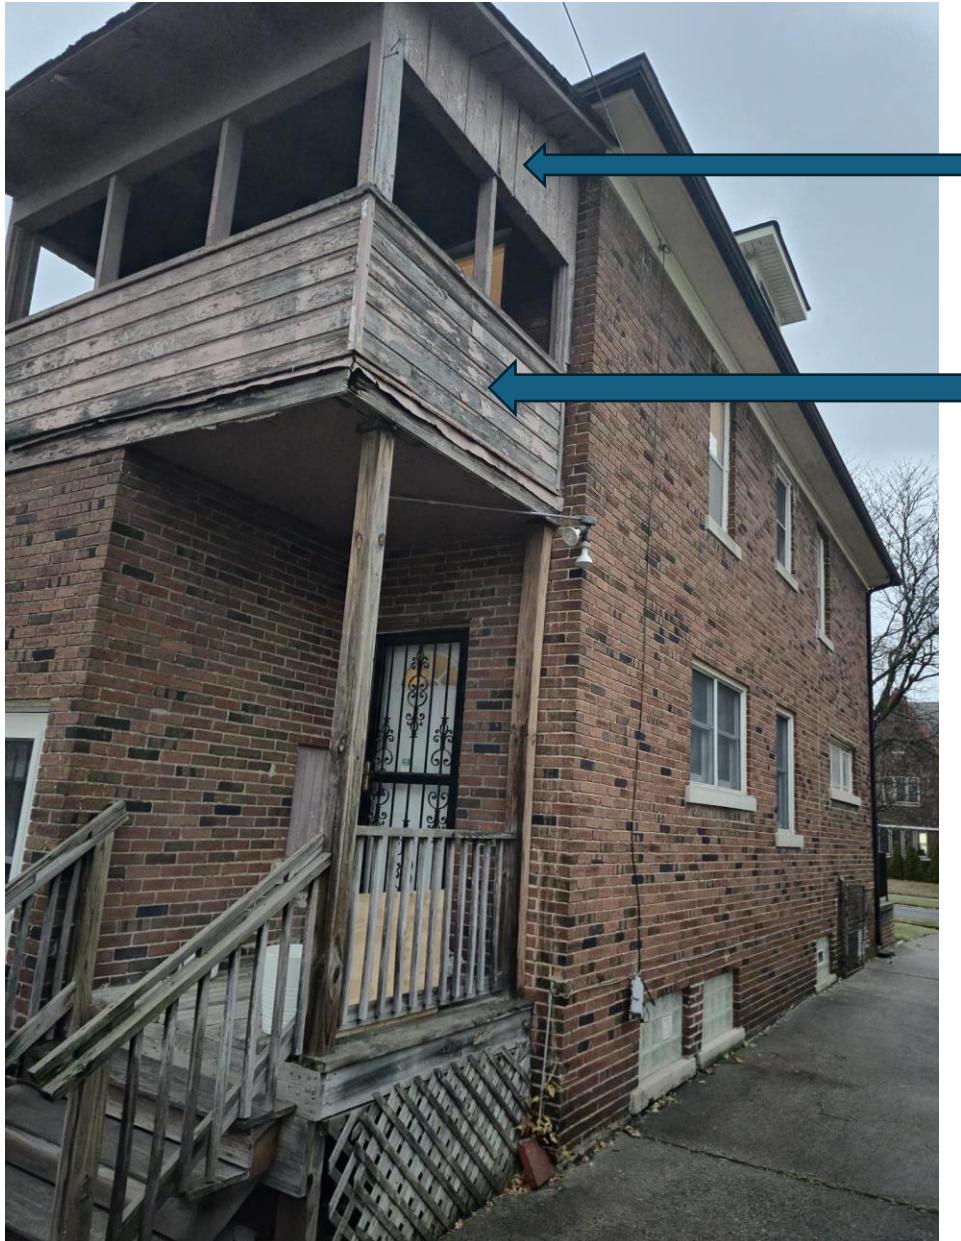
East and West framing on second floor porch opening is 73" wide.
Looking to install three (3) new storm windows on each side

South framing on second floor porch opening is approx. 116" wide.
Looking to install four (4) new storm windows on each side.

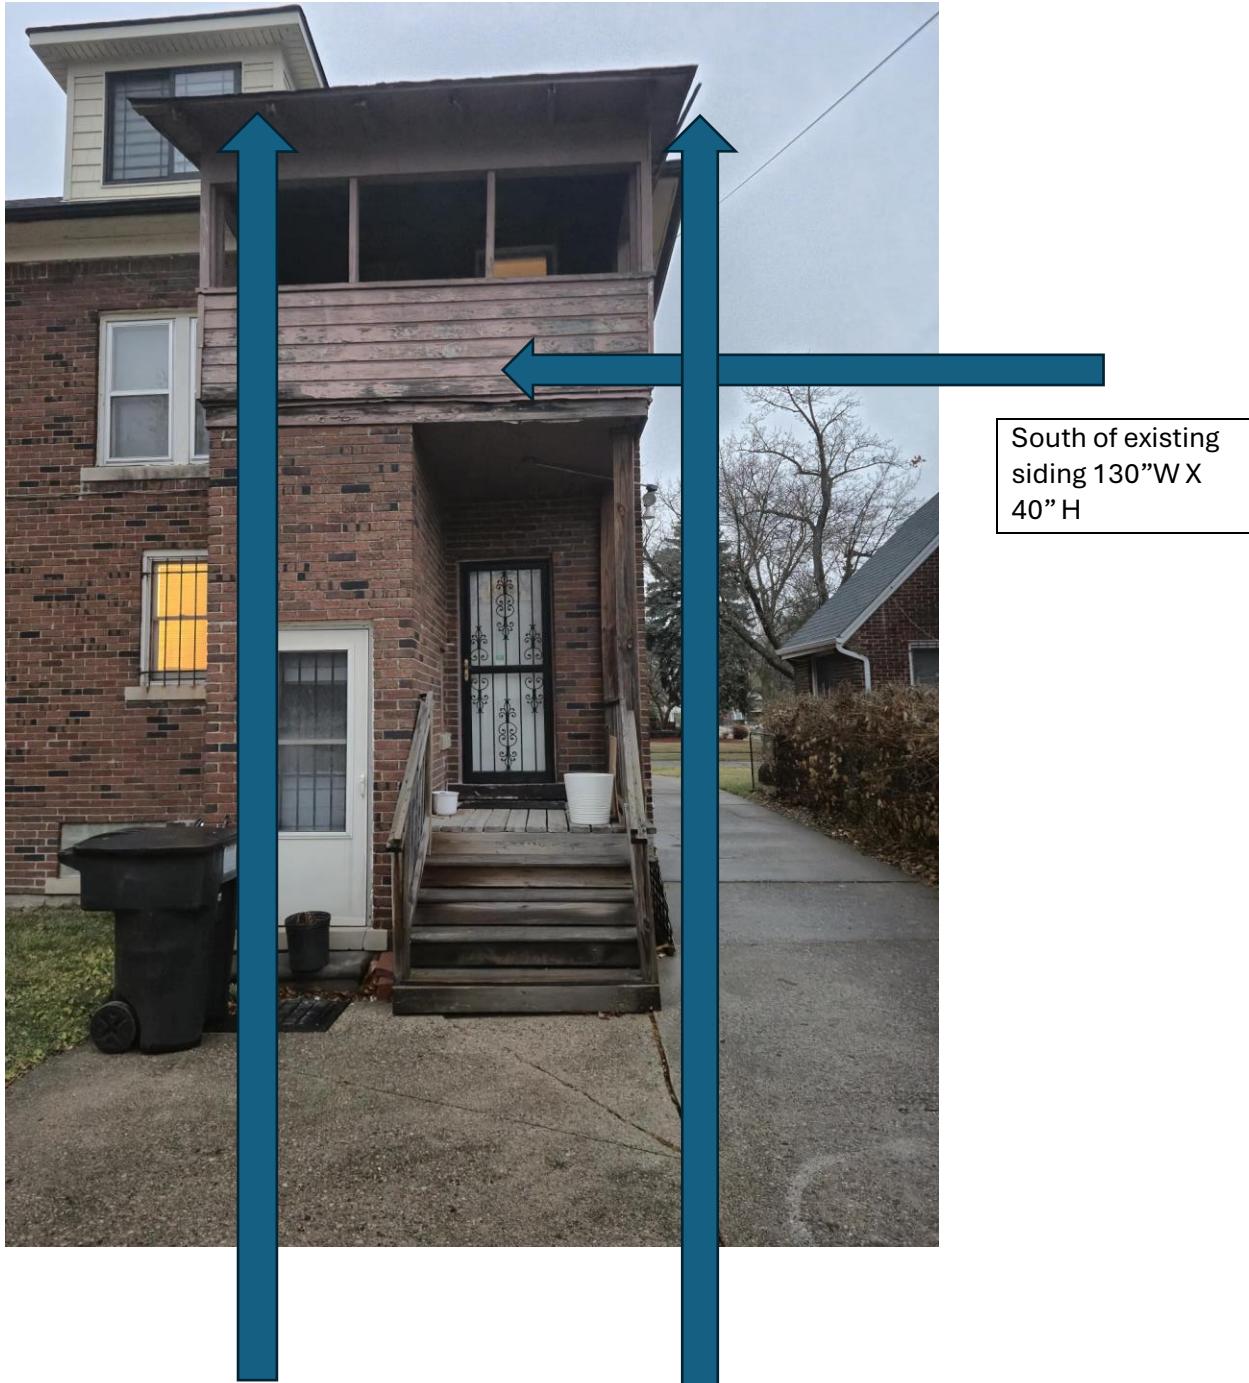
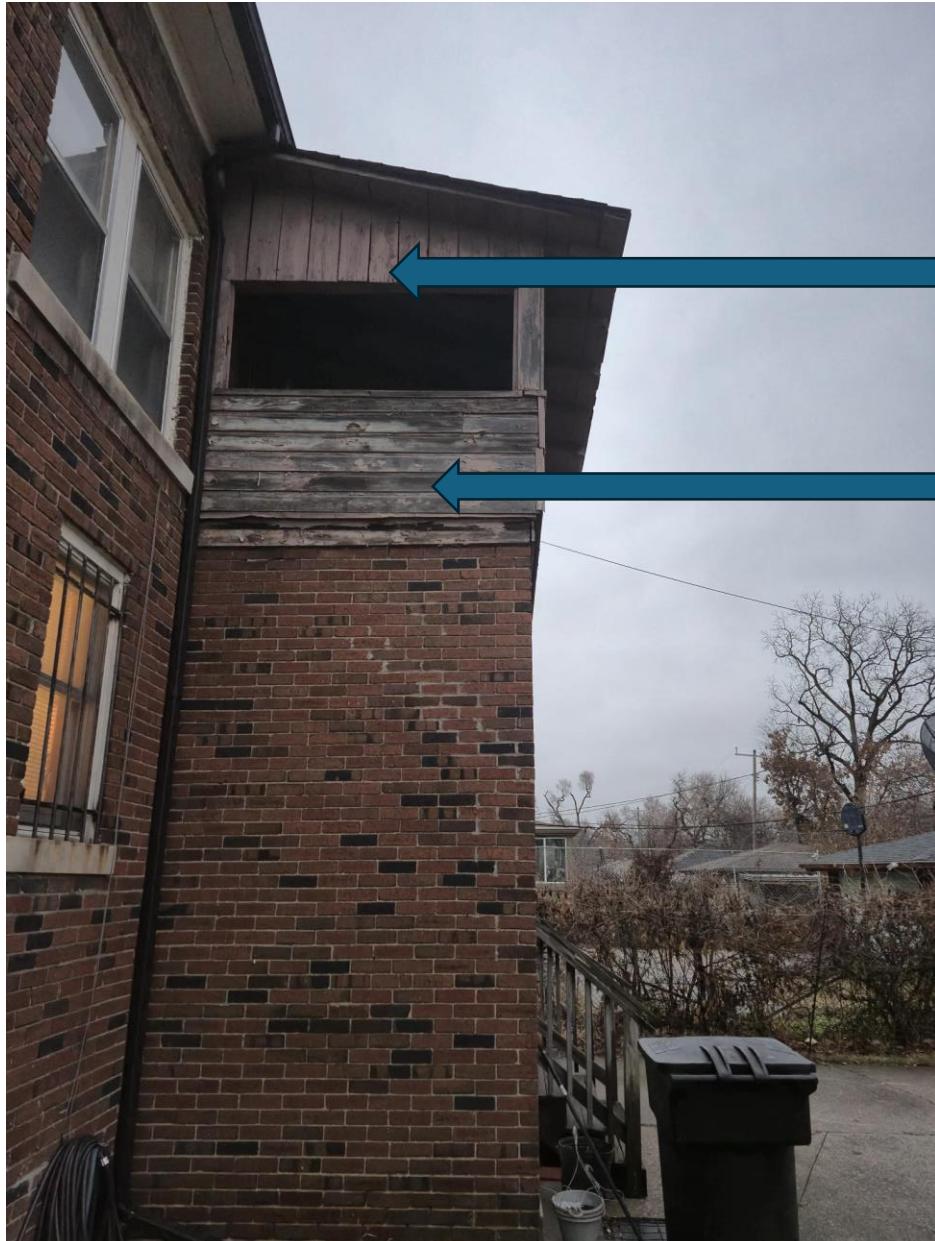
Board closest to
house 32" and
descends 1 1/4
inch.

East of existing
siding 84"W X 40"
H

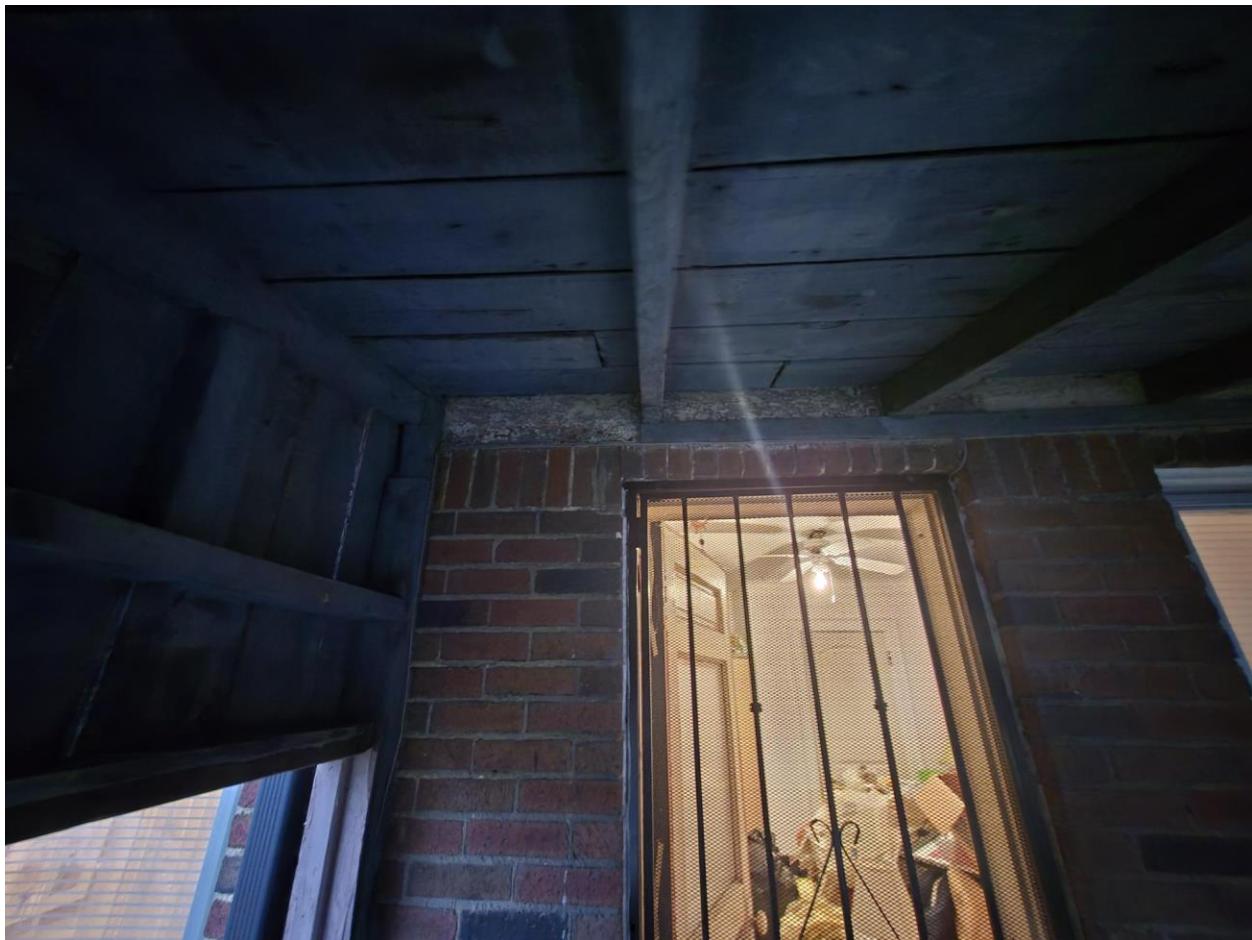
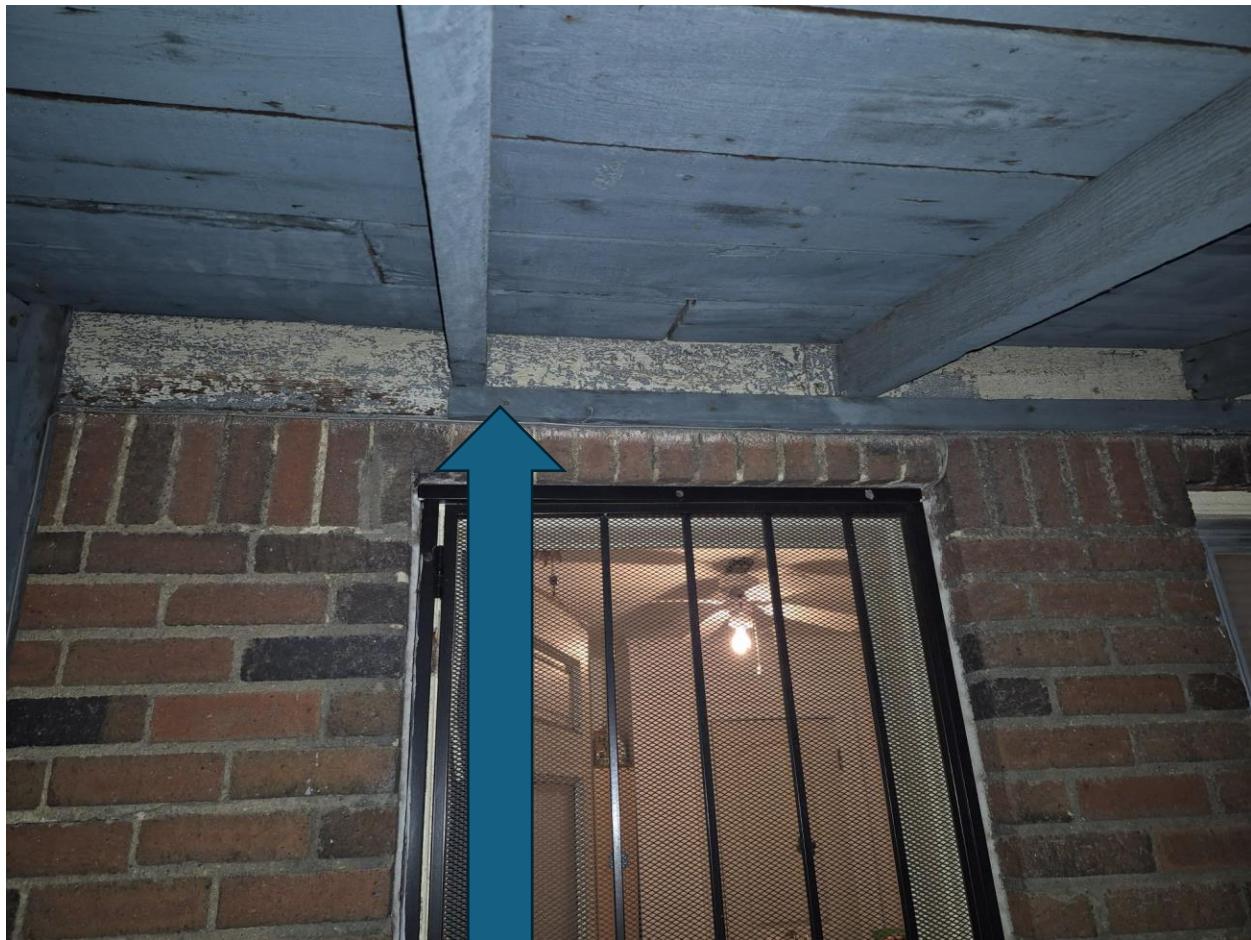
Roof structure is supported by wood currently nailed into the house frieze board

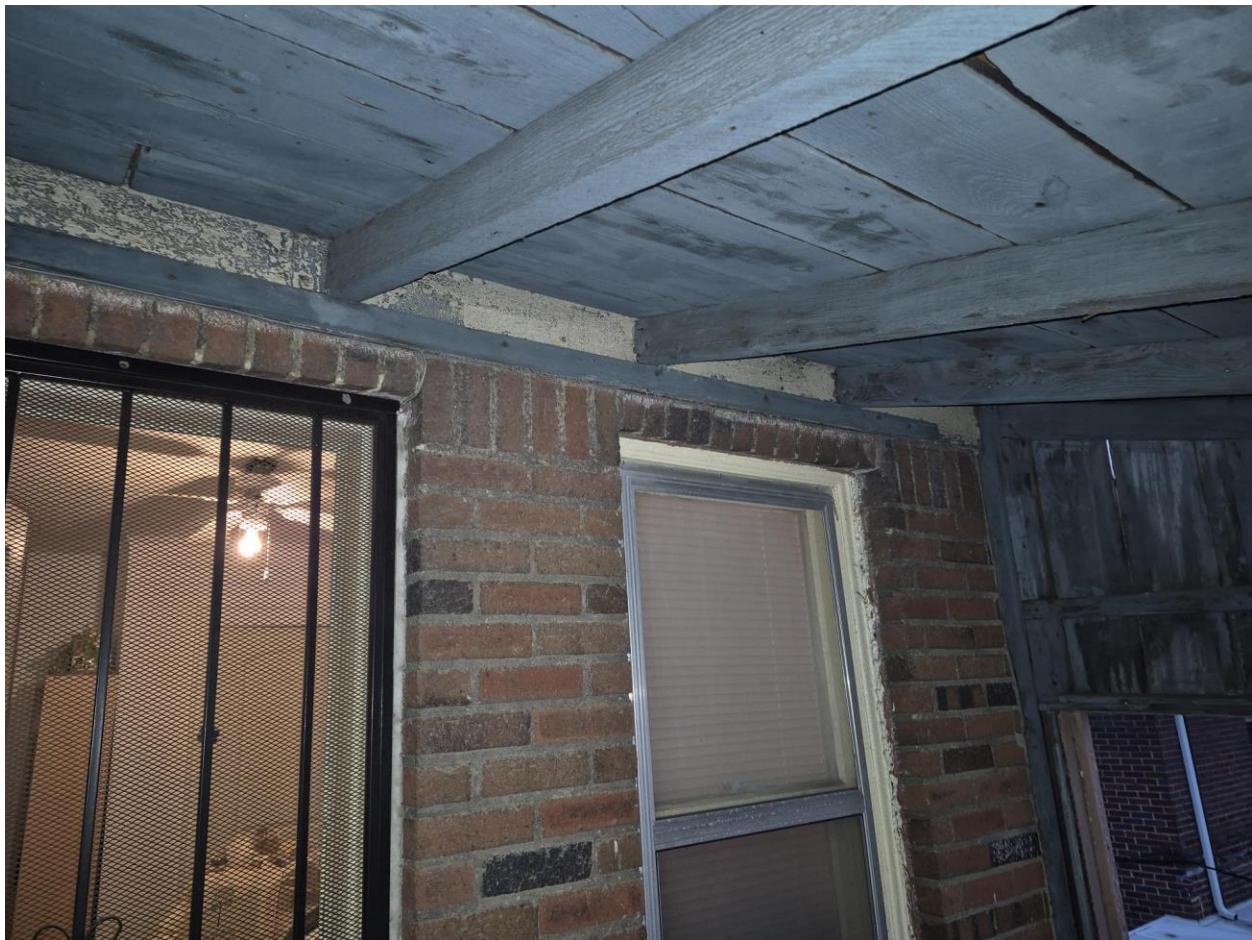
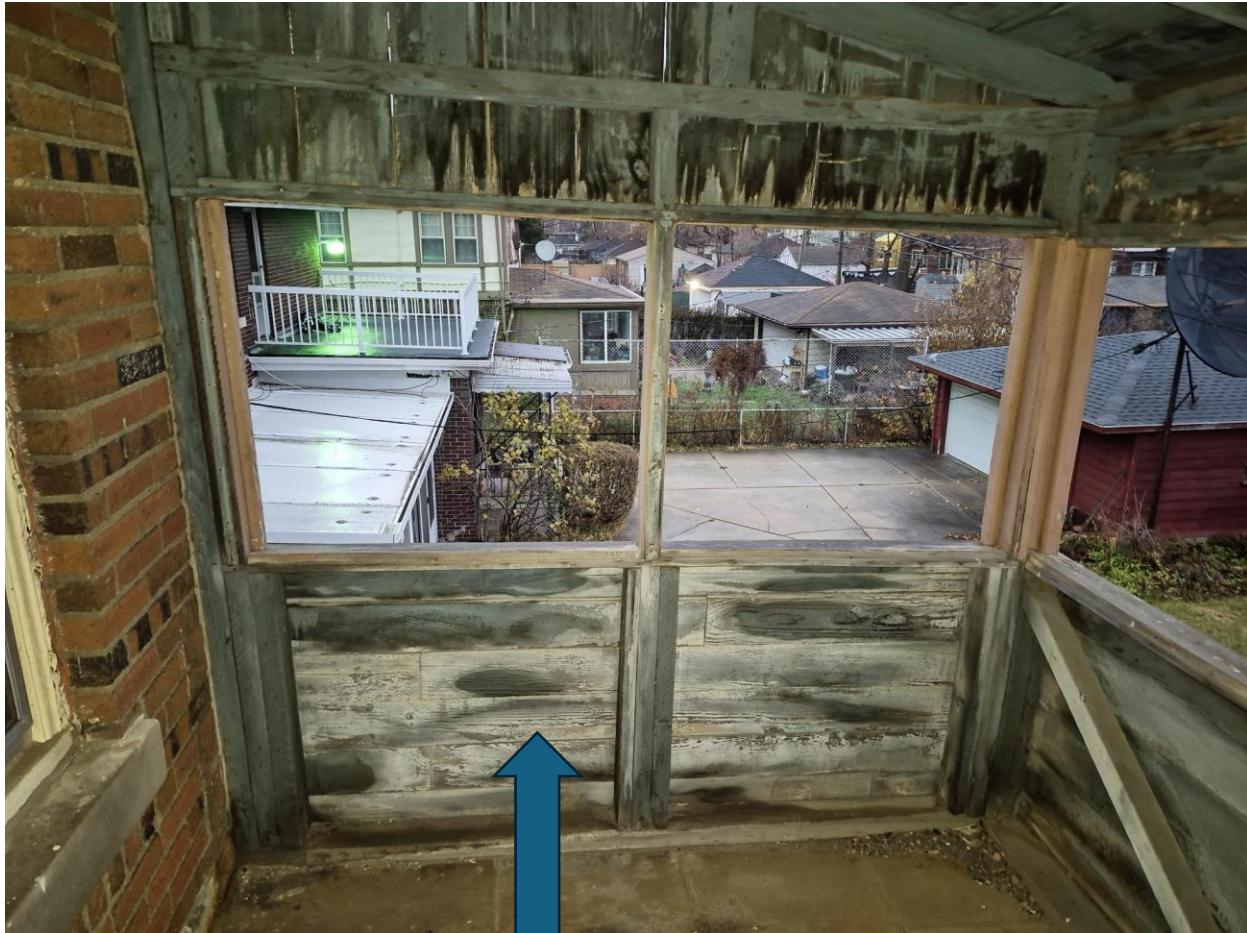
Interior of second
story porch east
side

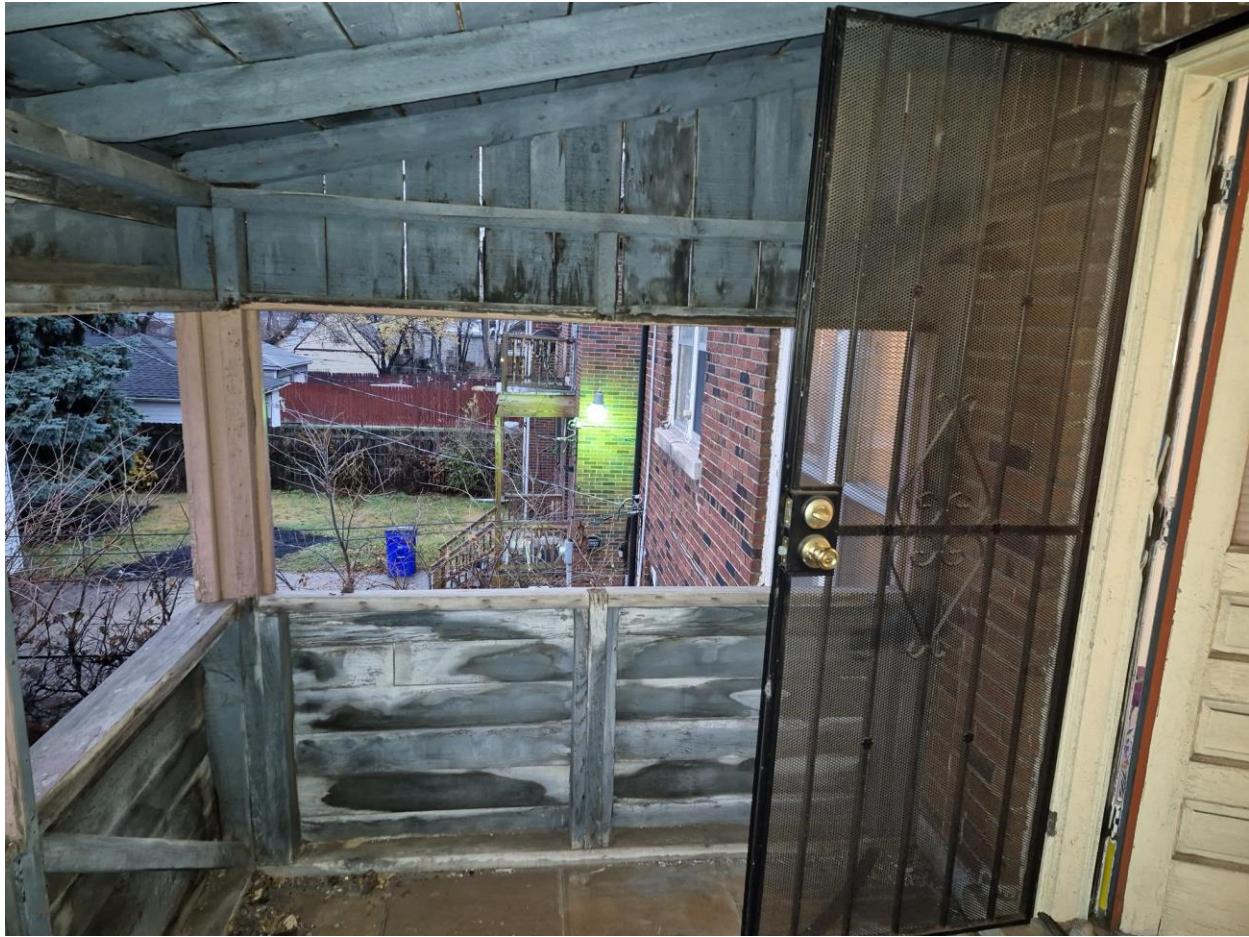
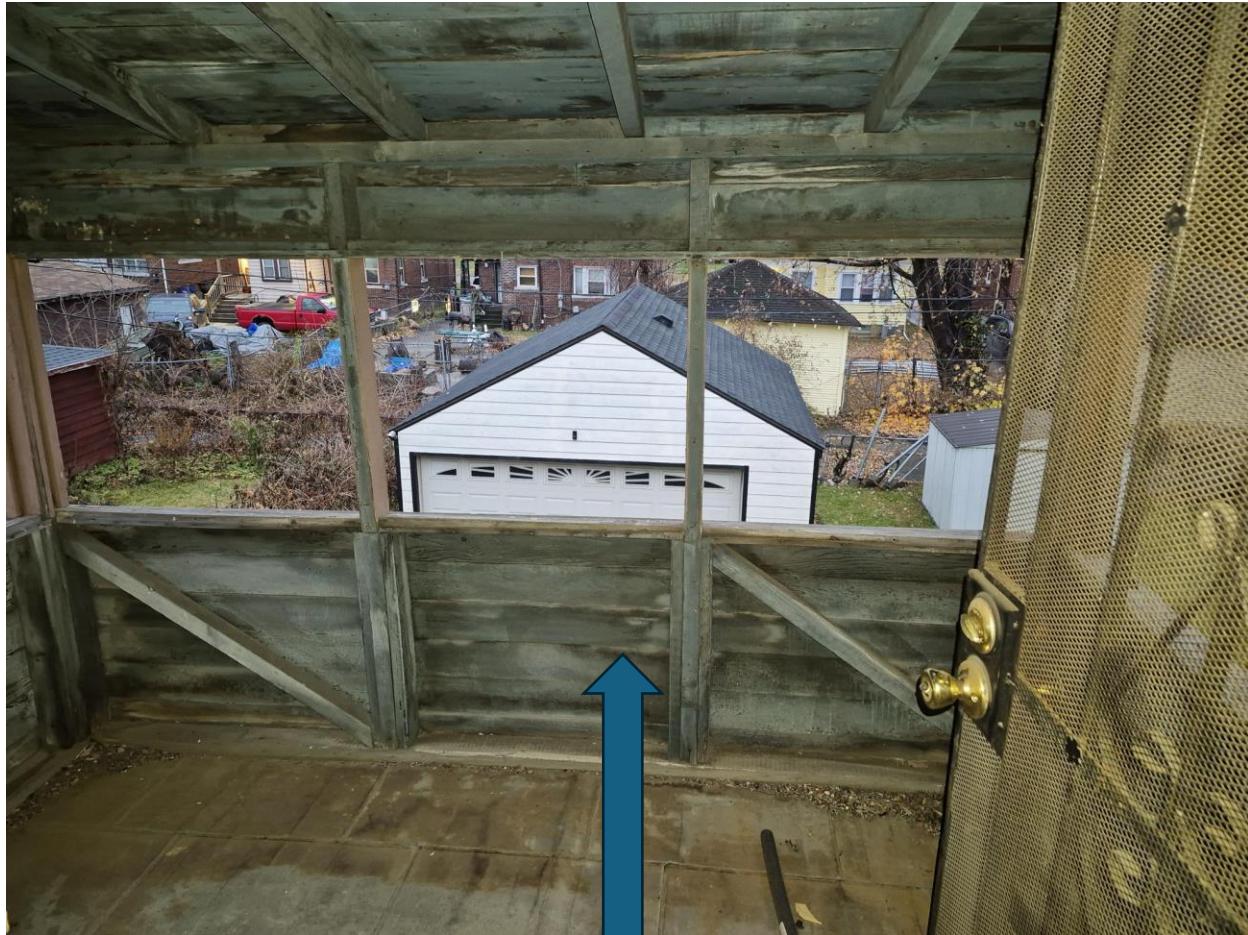
Interior of second
story porch south
side
