HISTORIC DISTRICT COMMISSION APPLICATION FOR WORK APPROVAL

APPLICATION ID
HDC2026-00039

ADDRESS(ES): 892 W. Boston Boulevard
HISTORIC DISTRICT: Boston-Edison

<p>BRIEF PROJECT DESCRIPTION:</p> <p>New swimming pool, restoration of hardscape surfaces (walks, terraces, driveway), landscape, and lighting.</p>
--

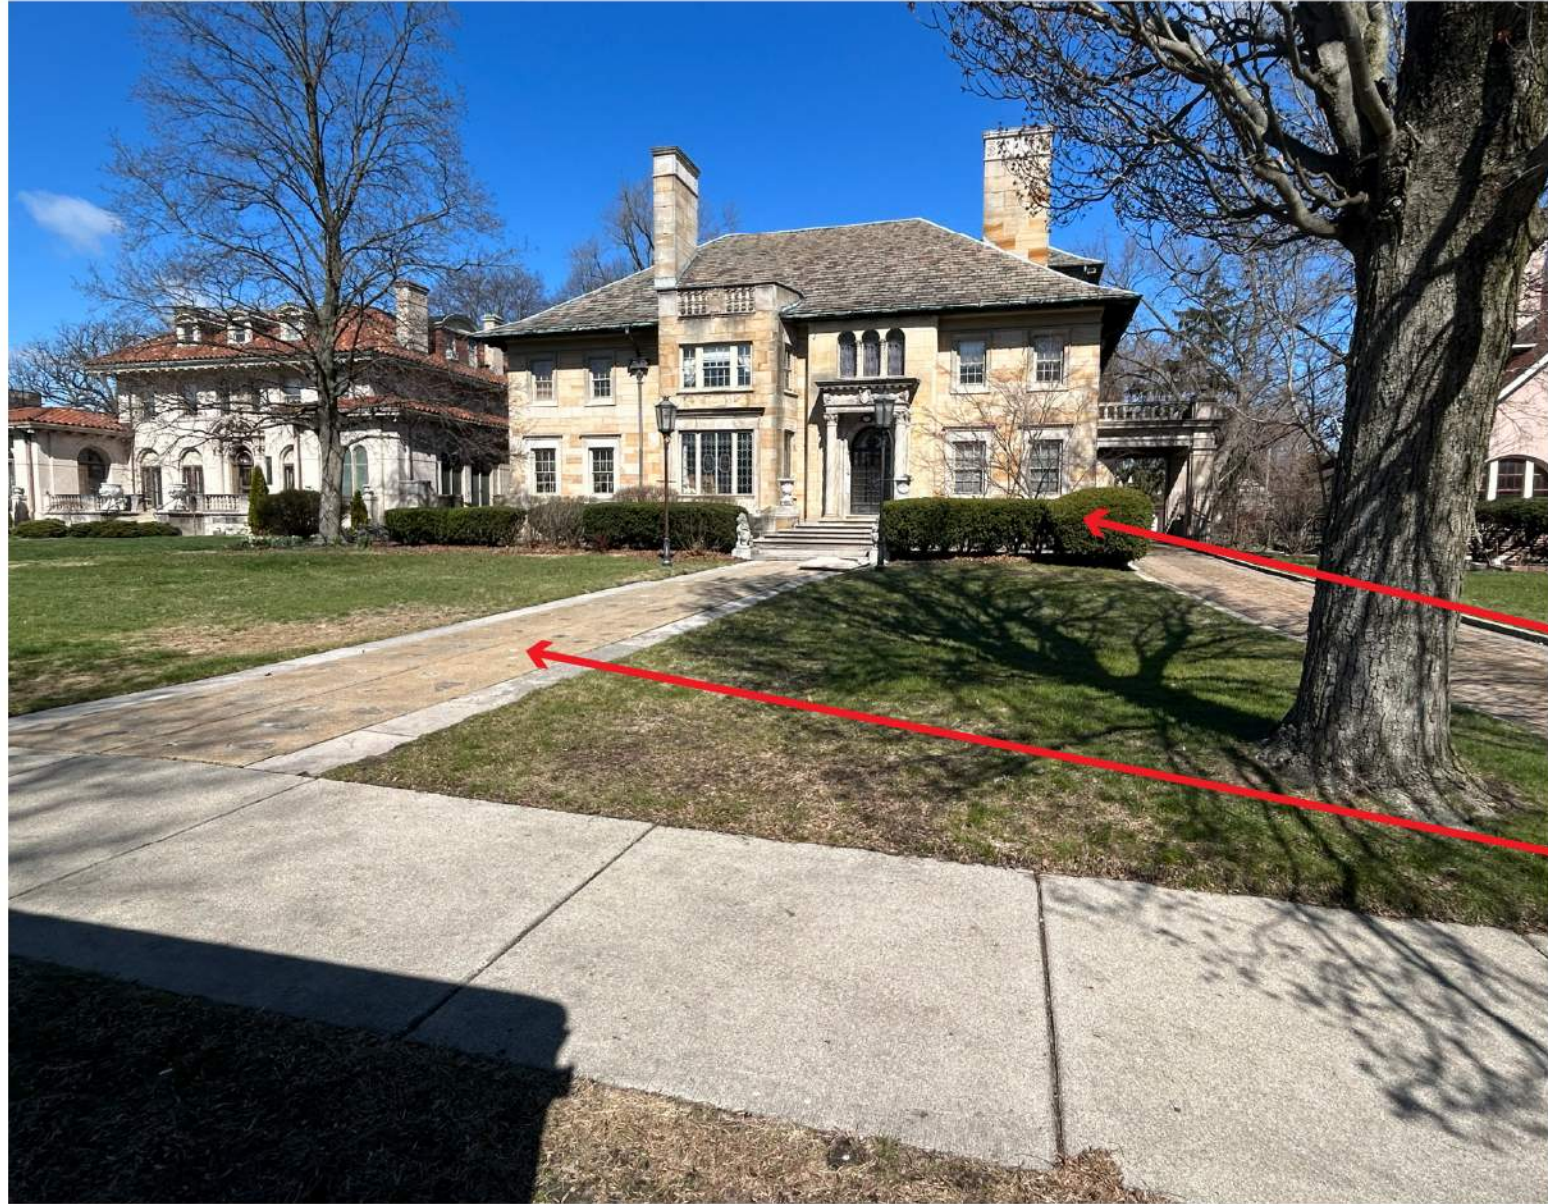
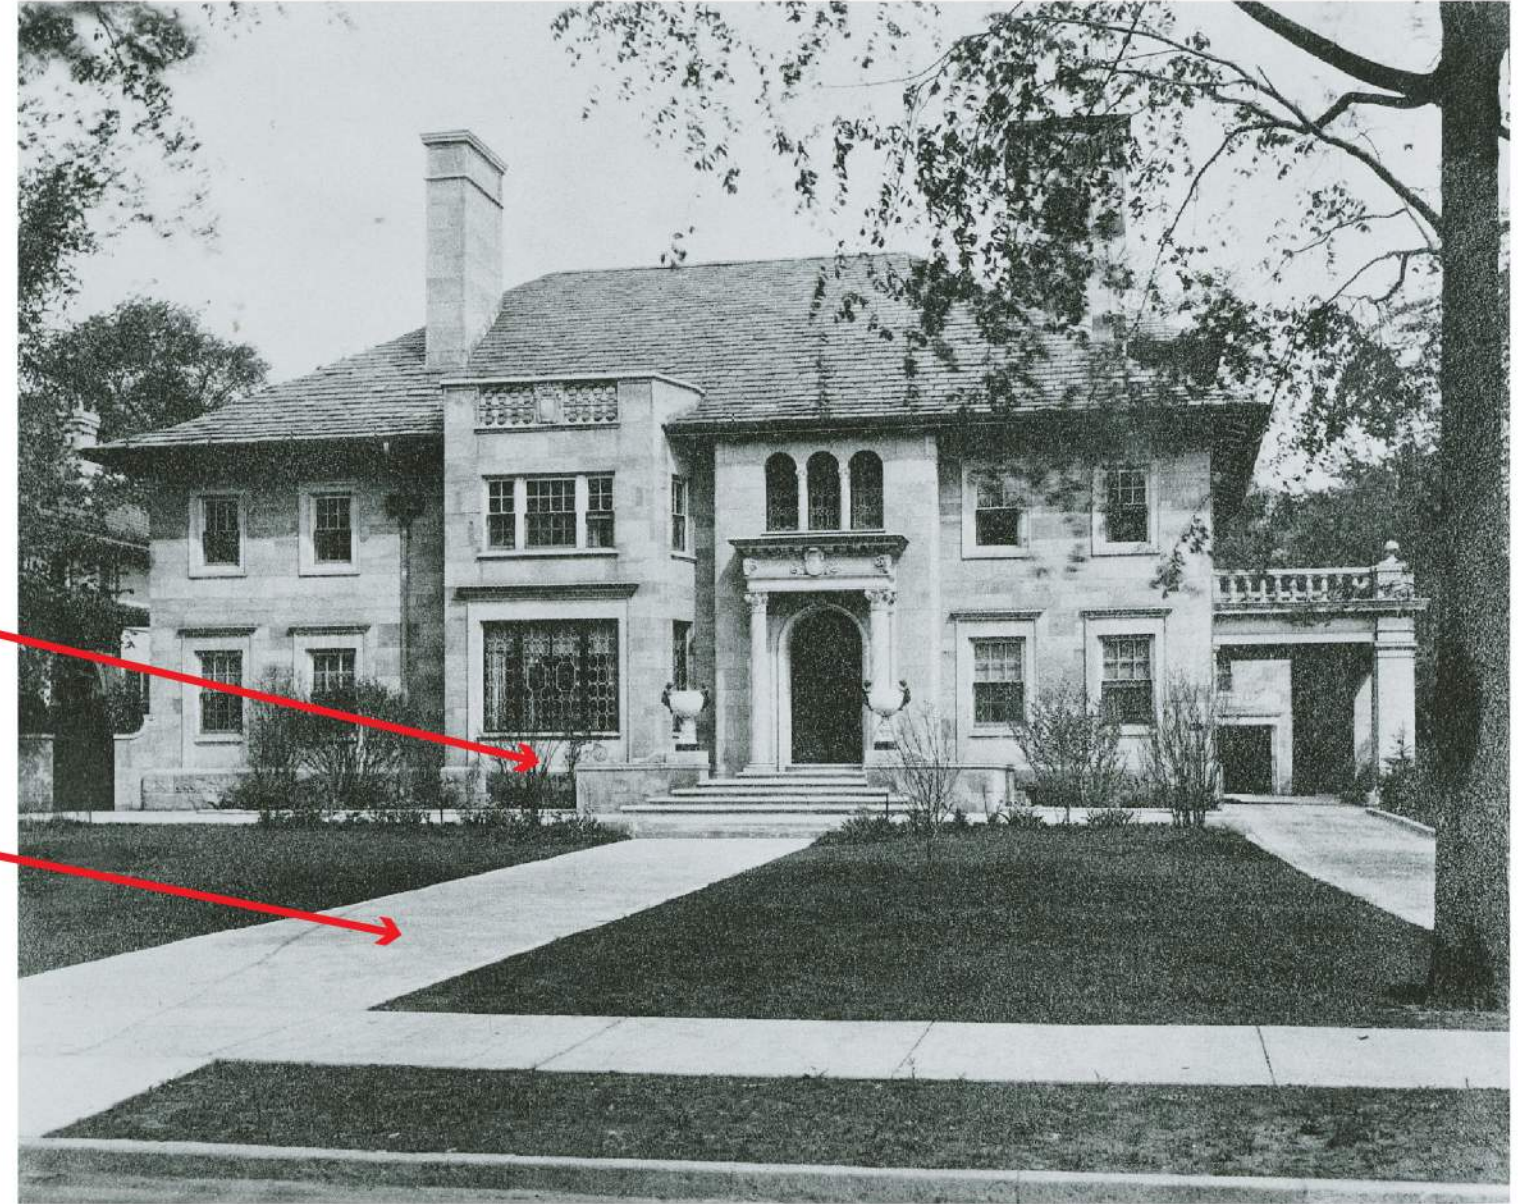
- 1.) Front walkway was originally concrete, it is currently a dyed concrete/paver combination.
- 2.) Deciduous plants in front originally, currently large evergreens.

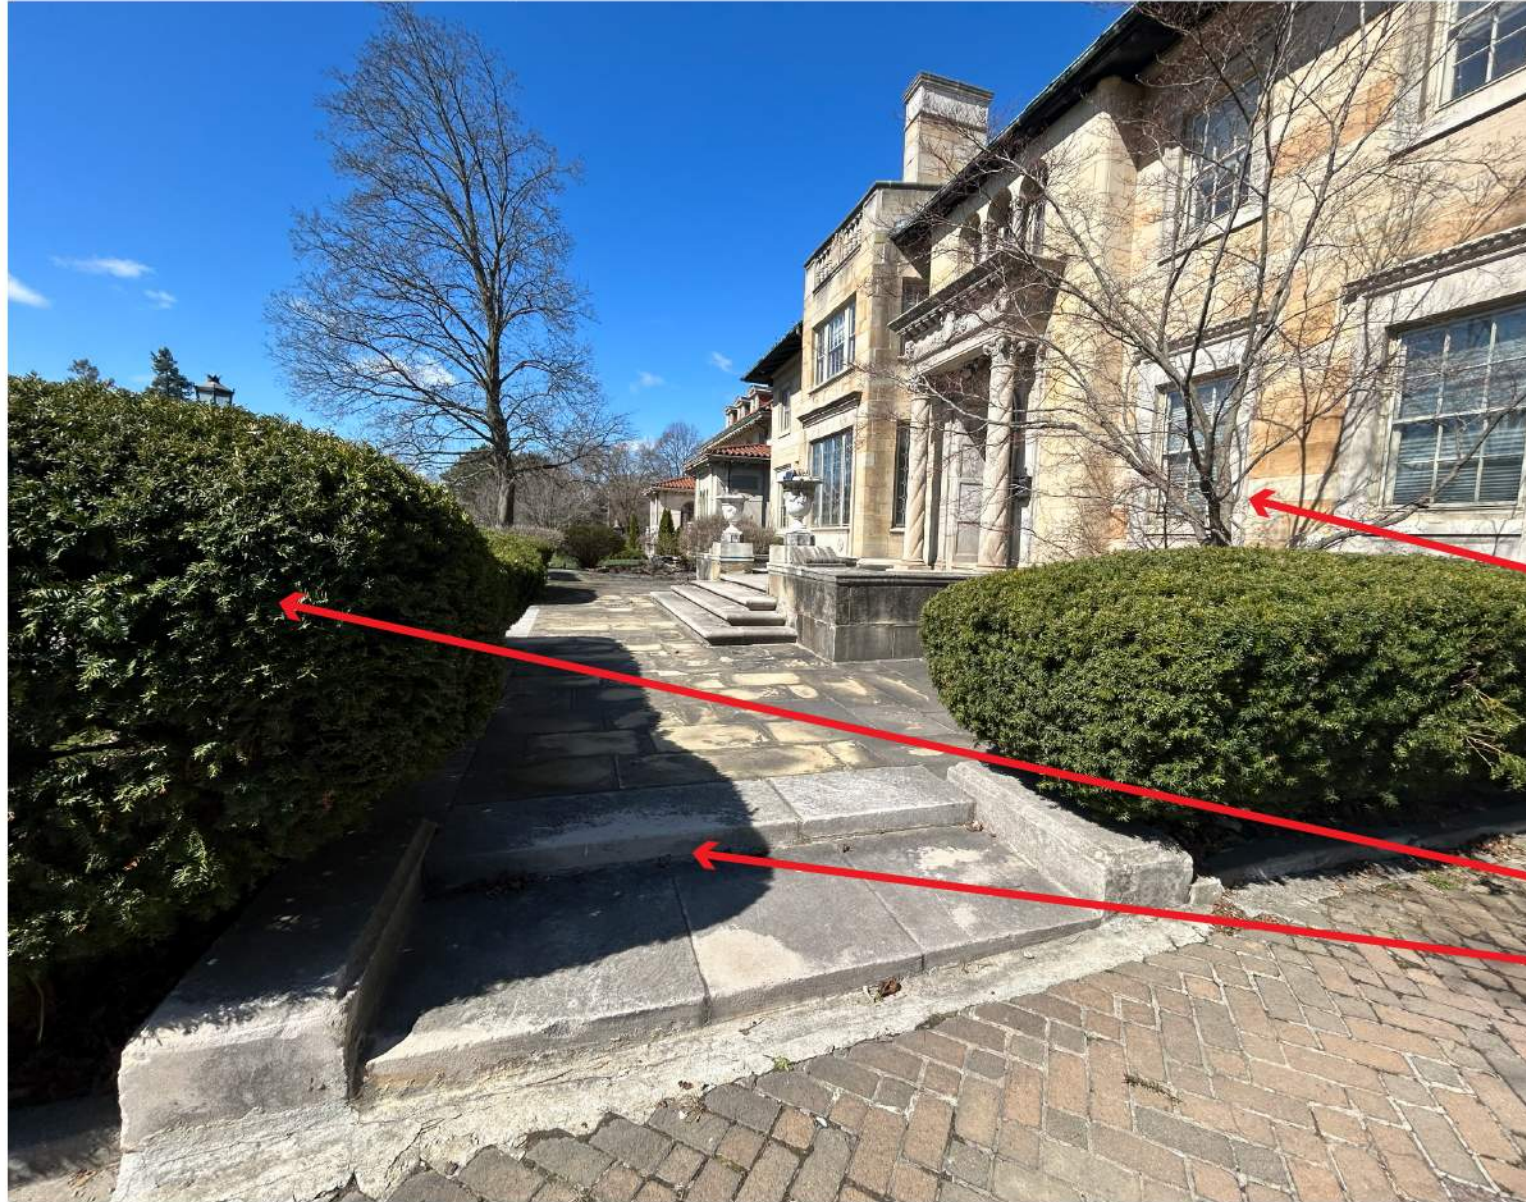
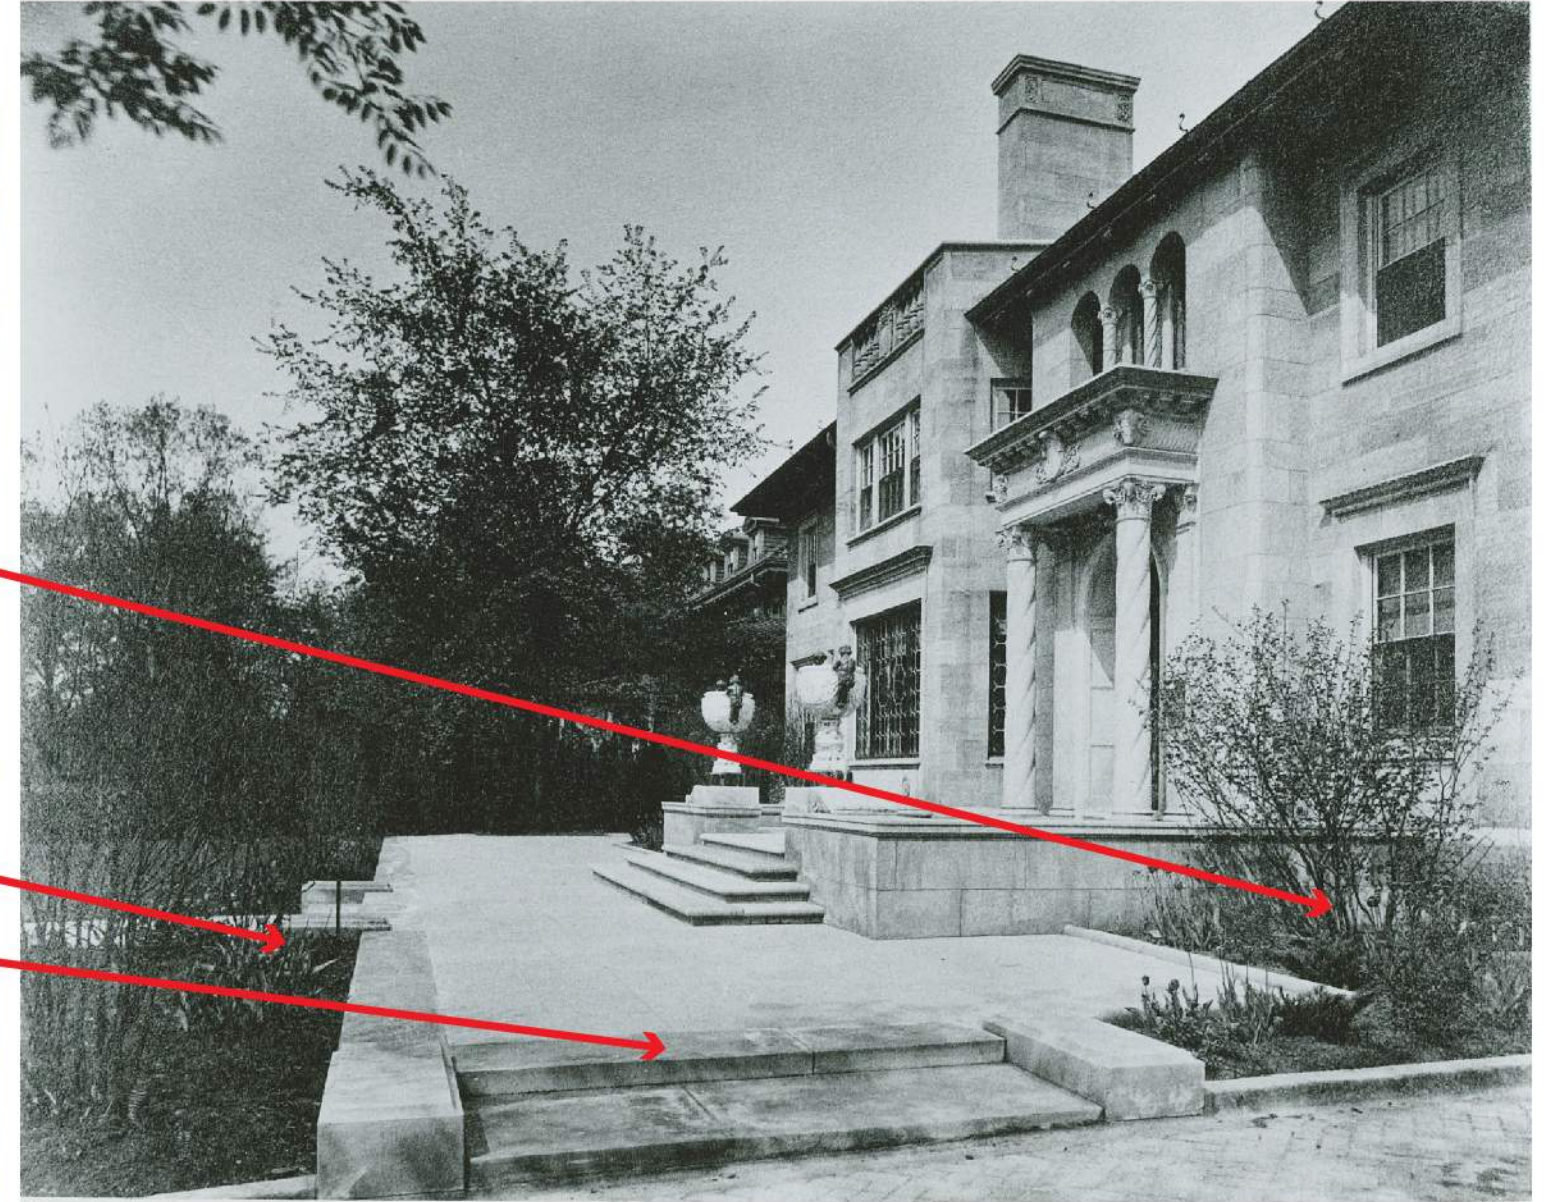
- 1.) Originally open space. Currently is enclosed with large vegetation.
- 2.) Current steps & porch are original (now in poor condition)

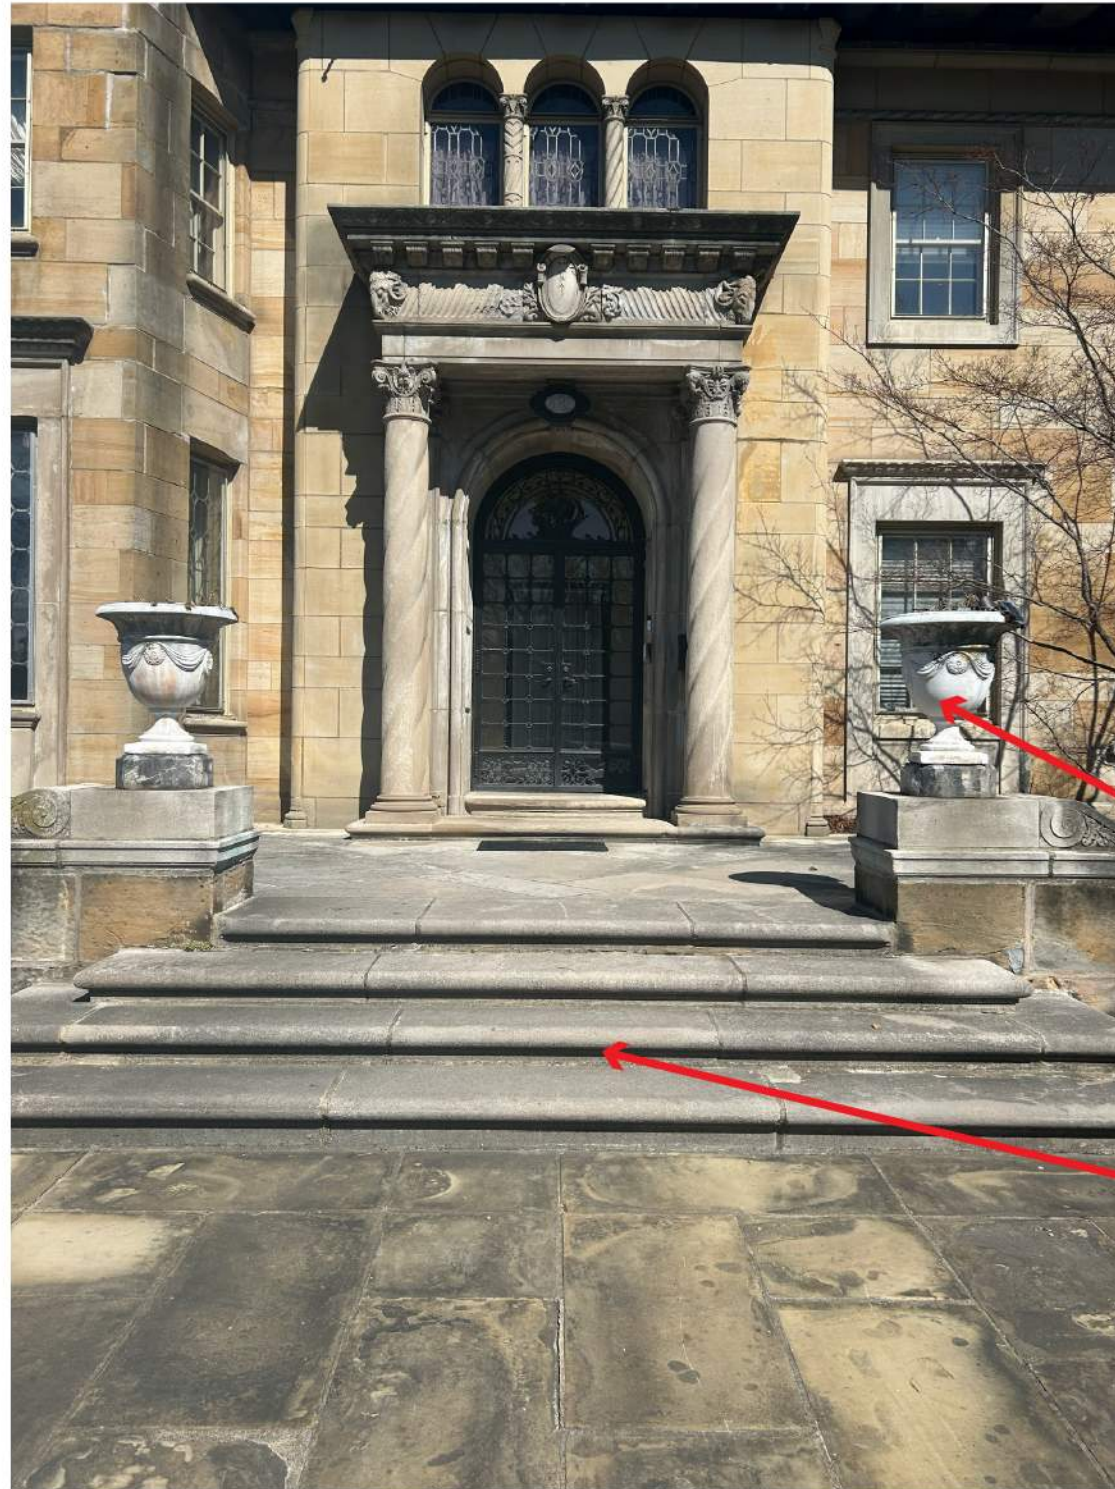
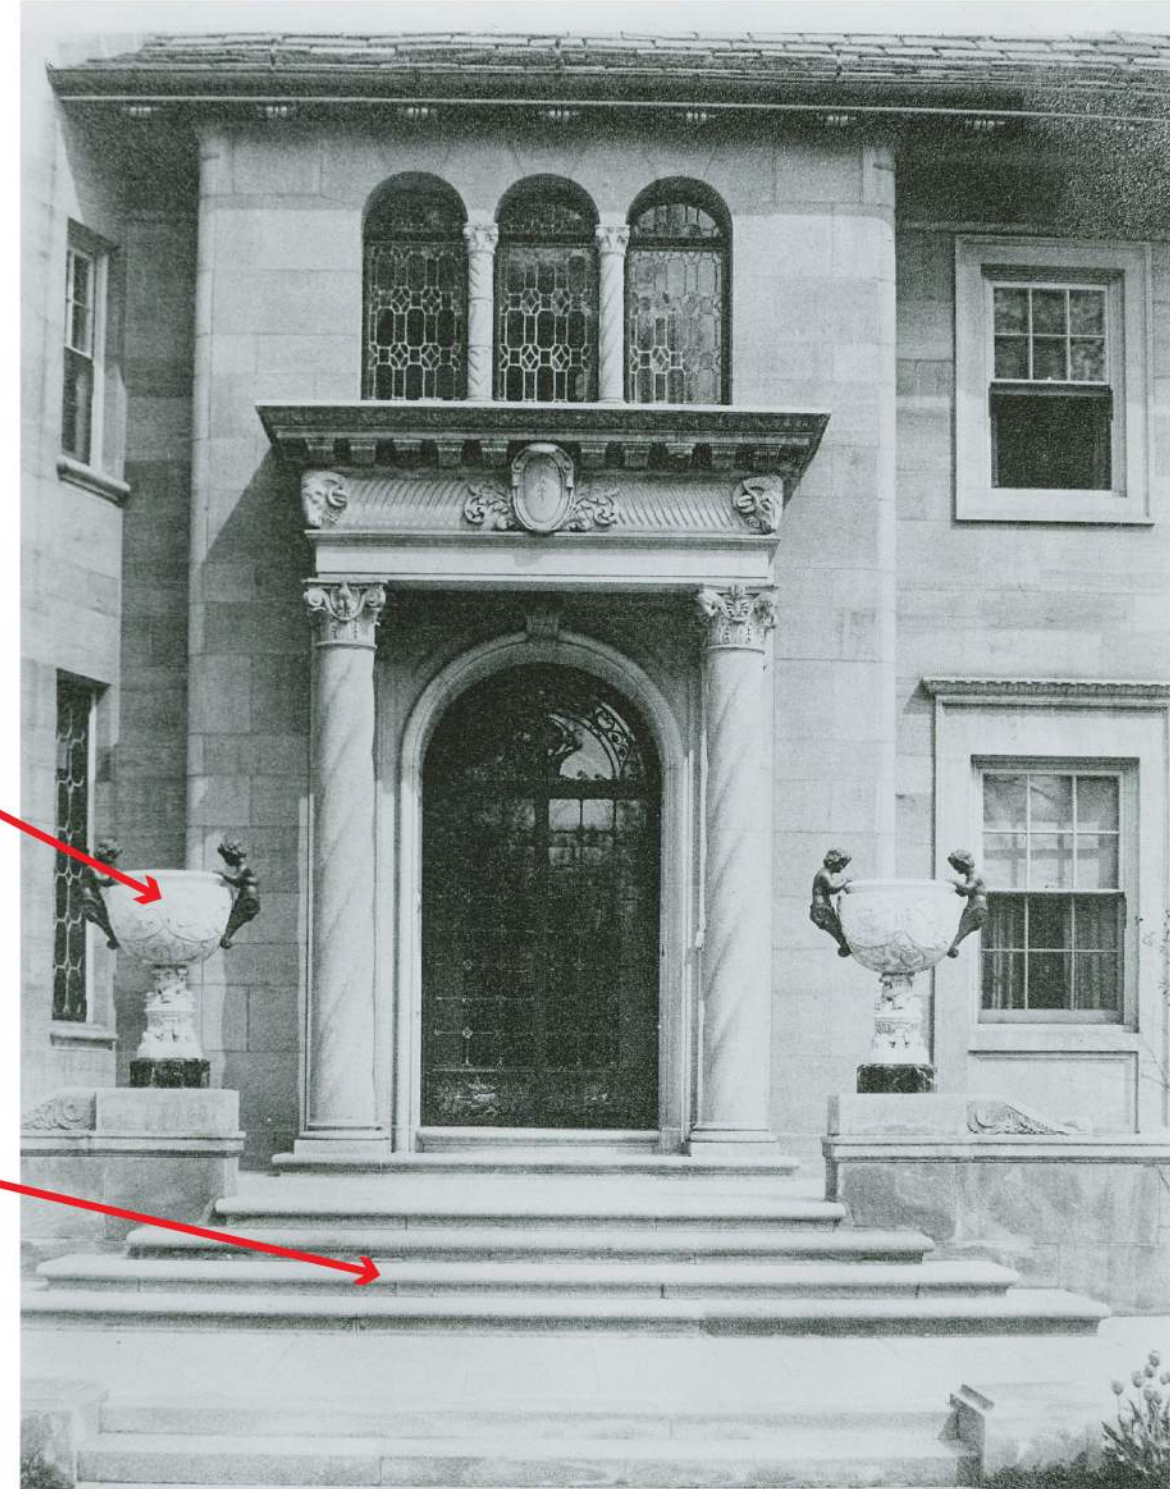
- 1.) Current planters are not original, however, the blocks they sit on are original.
- 2.) Current steps & entry porch are original (now in poor condition)

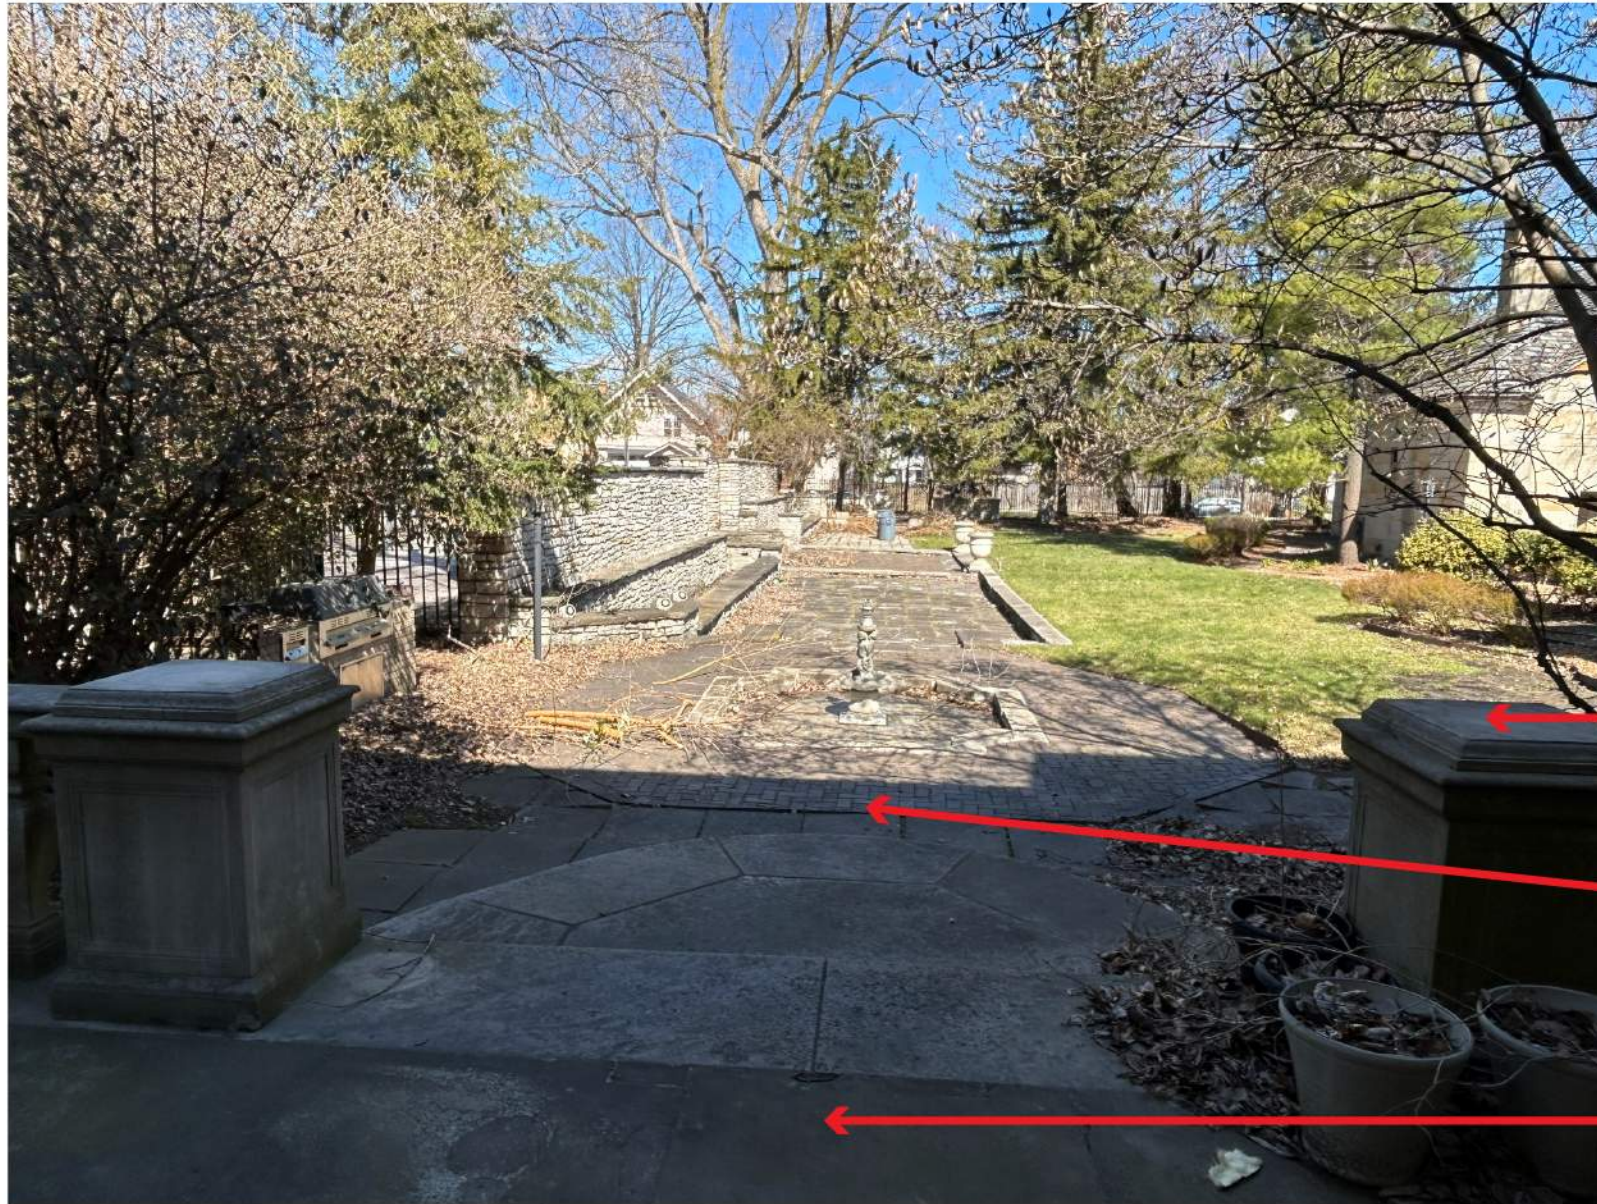
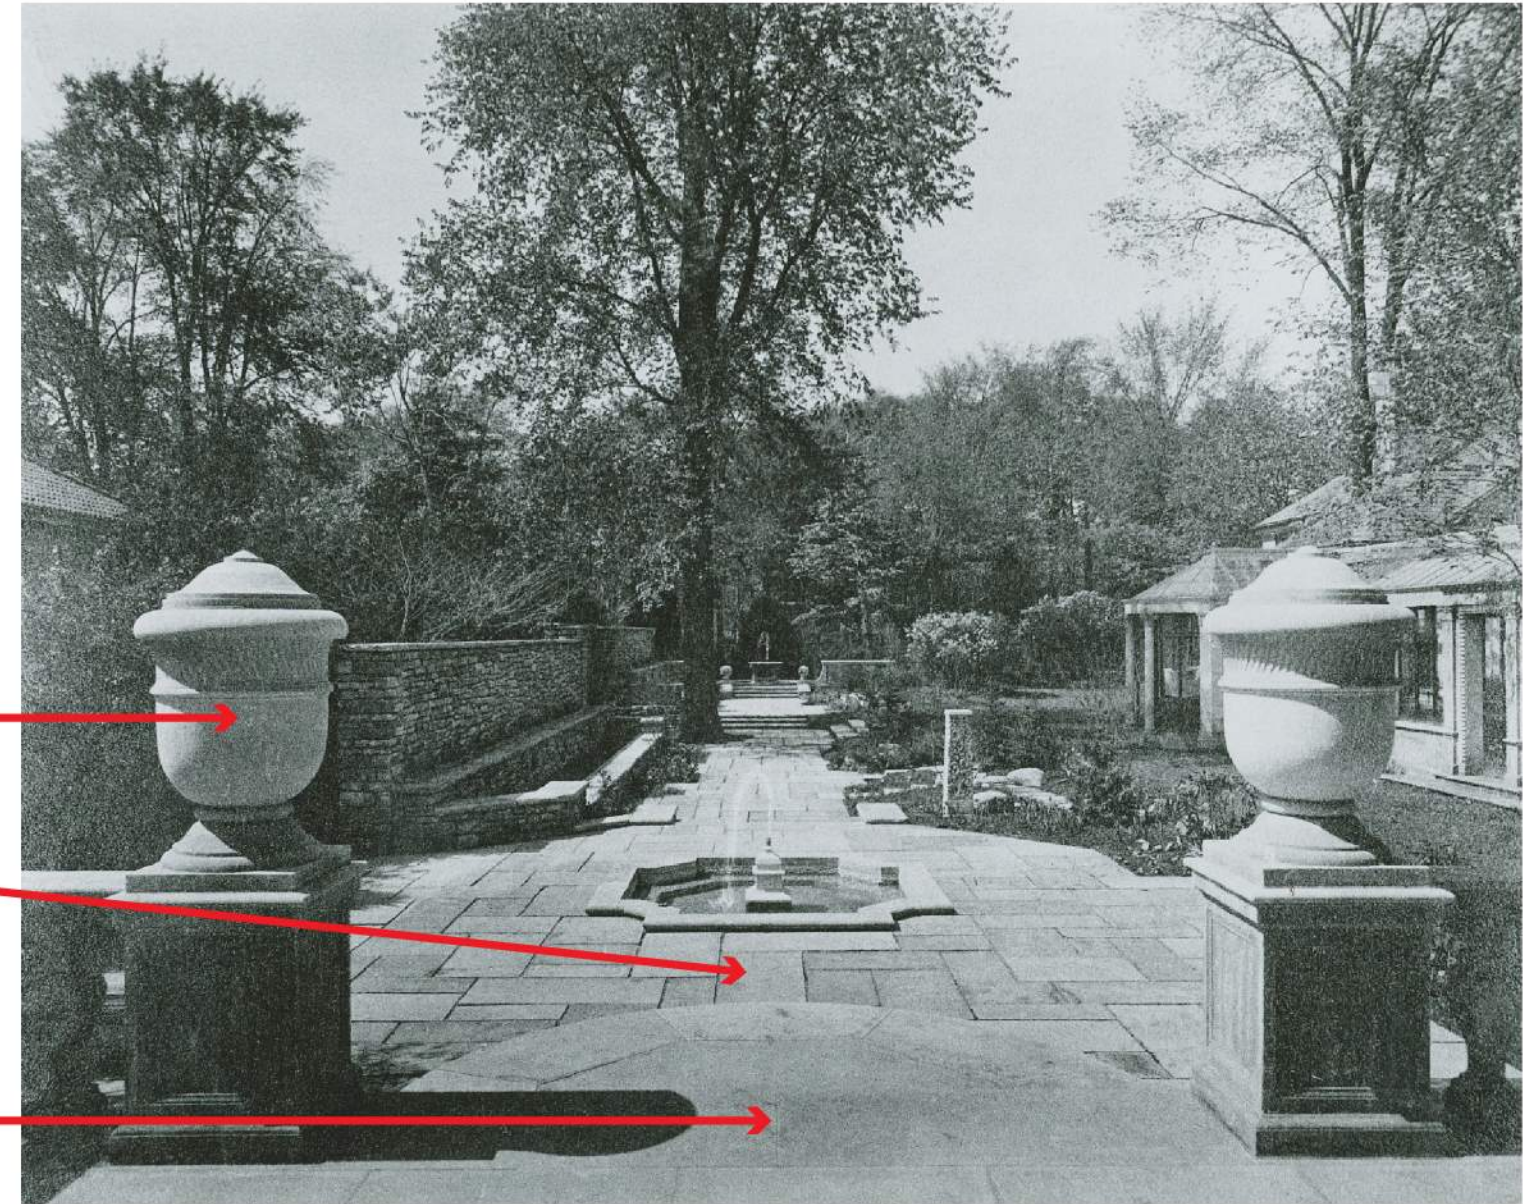
- 1.) Original urns are not located on pedestals (placed elsewhere on site).
- 2.) Upper terrace paving and steps are original (now in poor condition and failing).
- 3.) Paving at bottom of steps are not original.

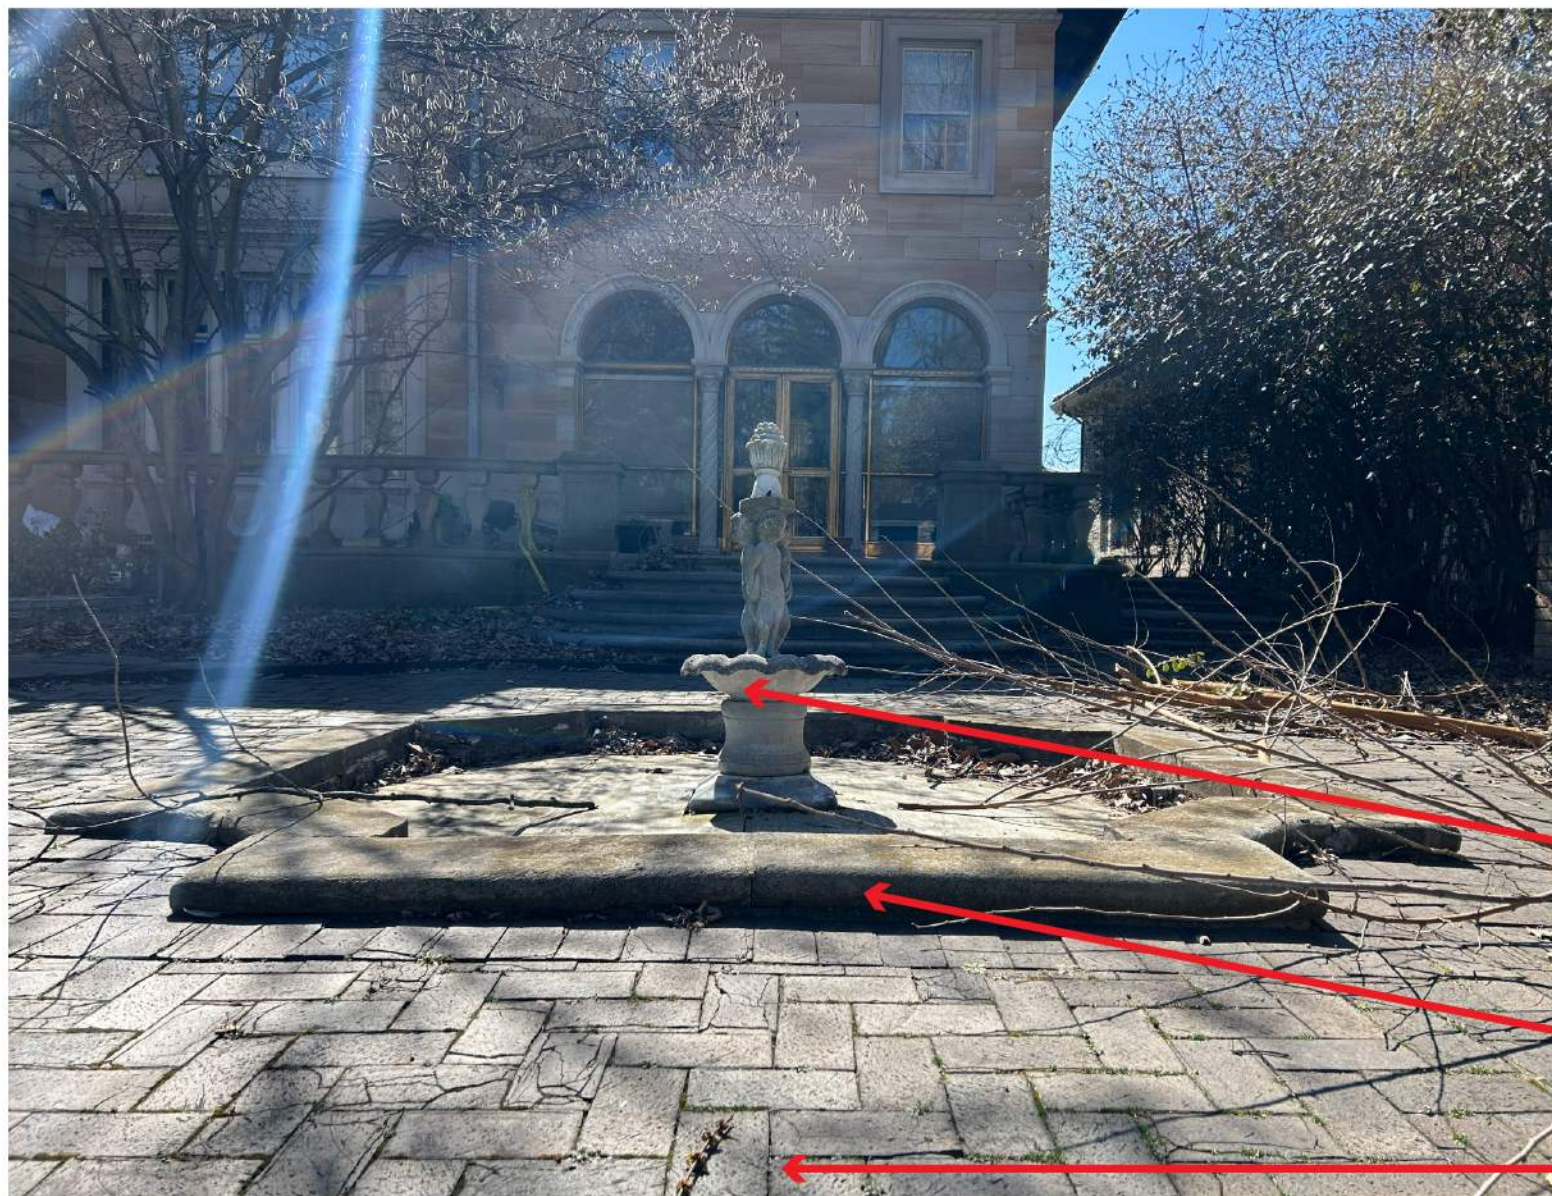
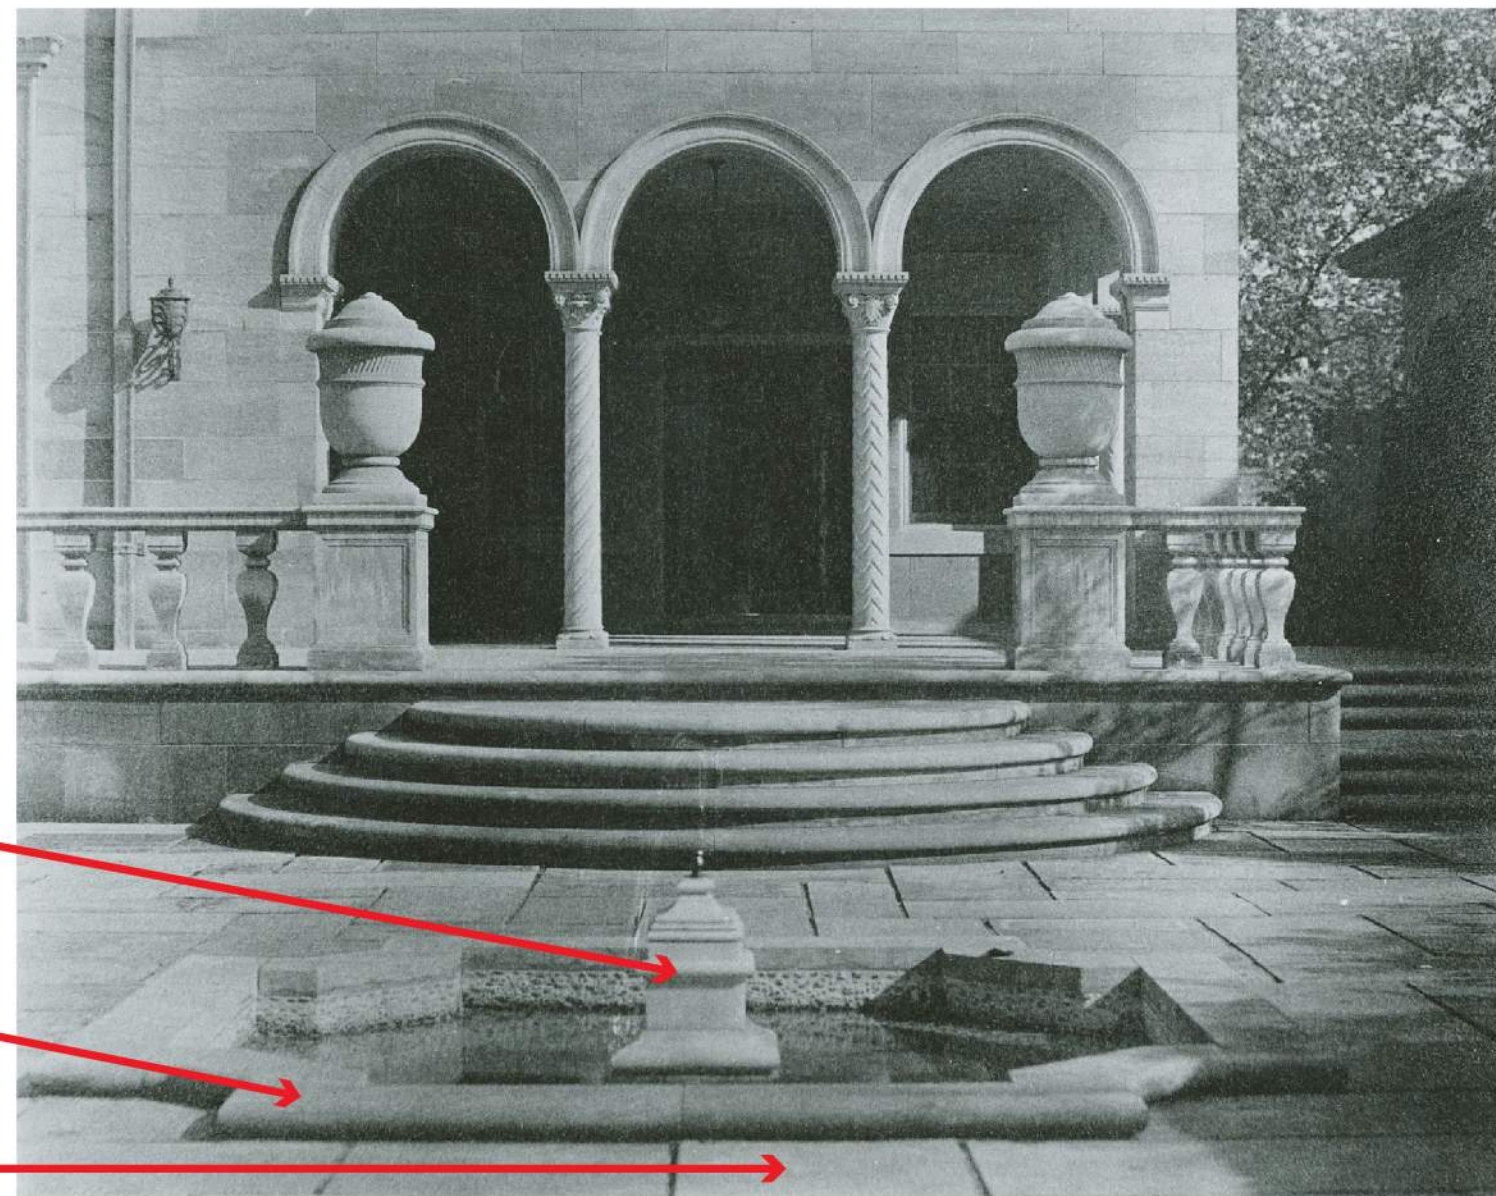
- 1.) Fountain coping is original (now in poor condition and failing).
- 2.) Current fountain is not original.
- 3.) Current paving around fountain is not original.

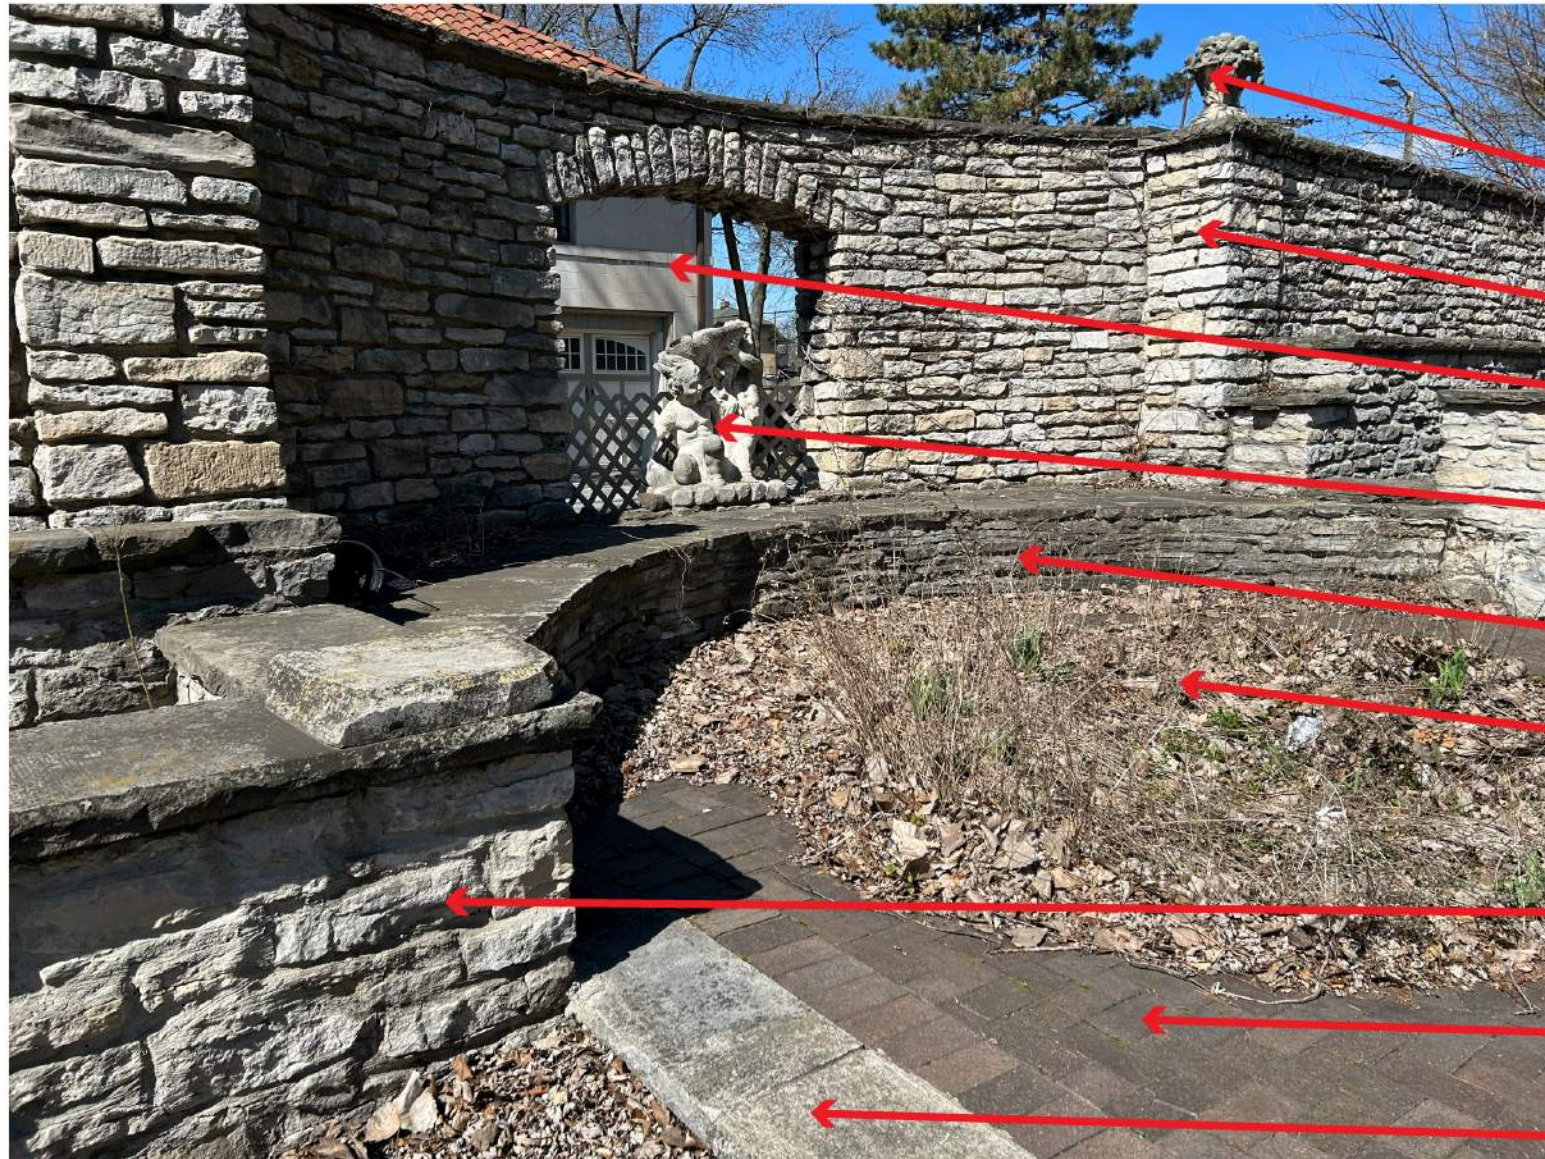
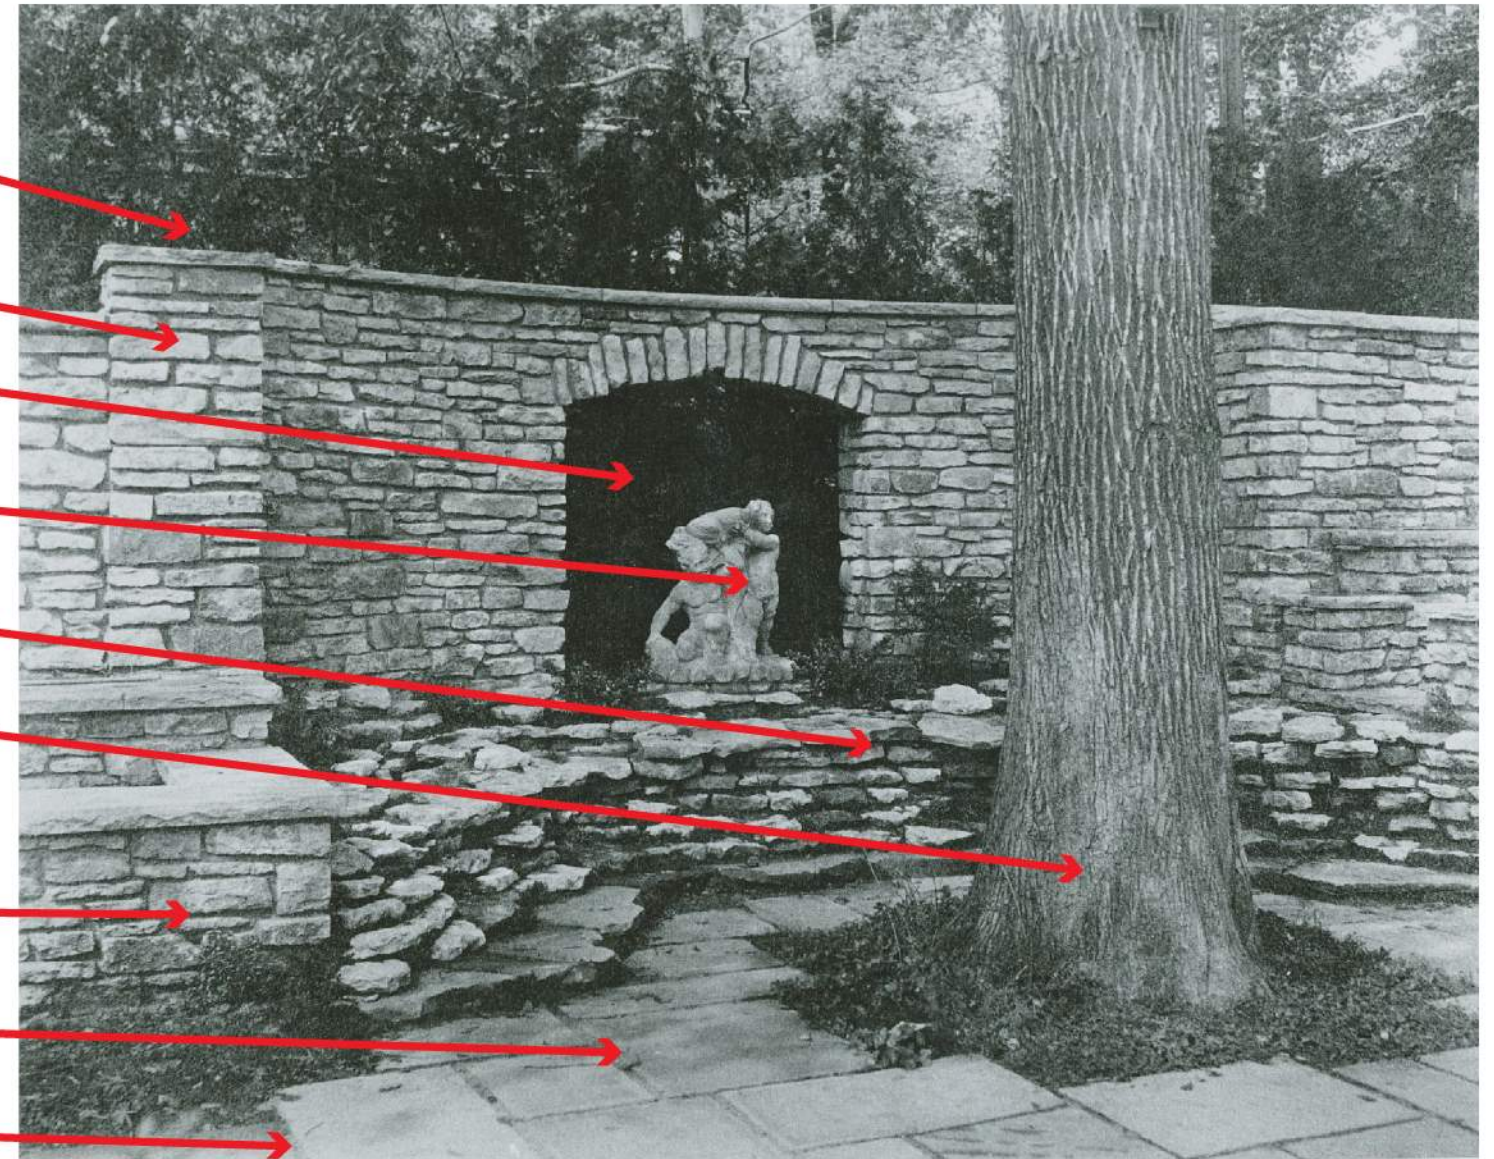
- 1.) Statue is original.
- 2.) Low radial wall is not original.
- 3.) Low linear fountain is original.
- 4.) Tall back wall is original.
- 5.) Current paving is not original.
- 6.) Step is not original.
- 7.) Evergreen Arborvitae screen behind wall and large tree in center no longer exists.
- 8.) Planters are original - have been relocated to current position.
