HISTORIC DISTRICT COMMISSION APPLICATION FOR WORK APPROVAL

APPLICATION ID
HDC2026-00039

ADDRESS(ES): 892 W. Boston Boulevard
HISTORIC DISTRICT: Boston-Edison

<p>BRIEF PROJECT DESCRIPTION:</p> <p>New swimming pool, restoration of hardscape surfaces (walks, terraces, driveway), landscape, and lighting.</p>
--

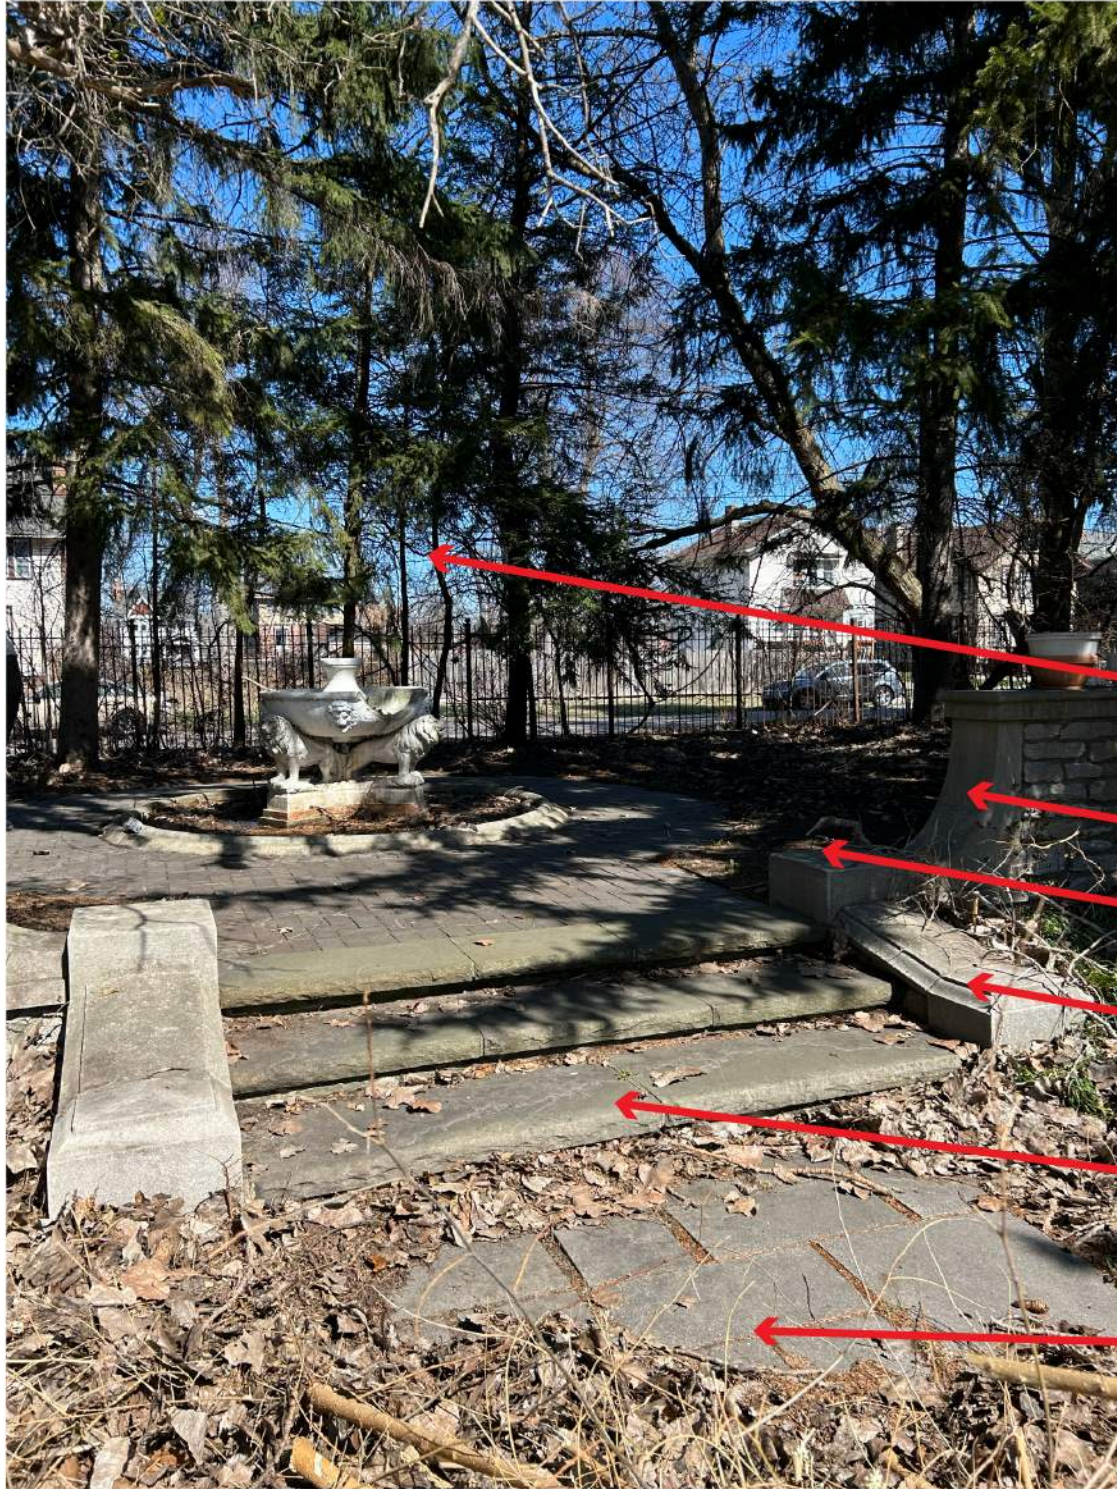
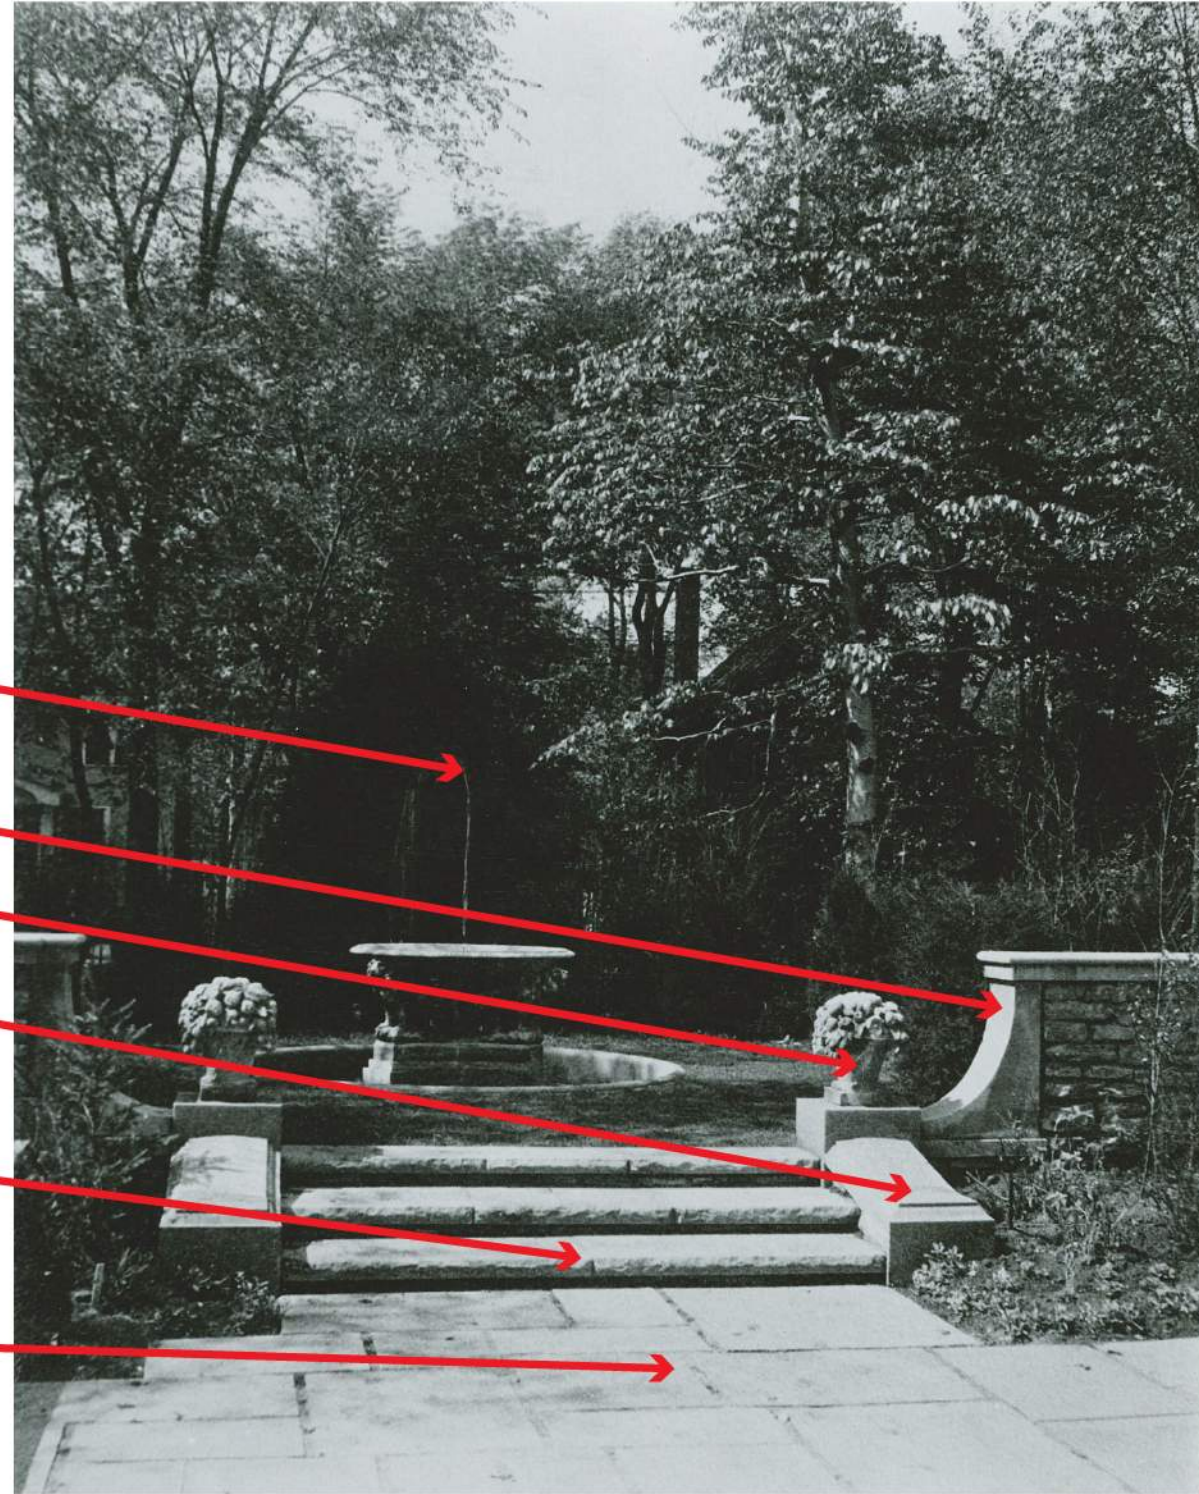
- 1.) Current steps are not original.
- 2.) Masonry piers are original.
- 3.) Current paving is not original.
- 4.) Planters have been relocated on site.
- 5.) Evergreen screen wall no longer exists.

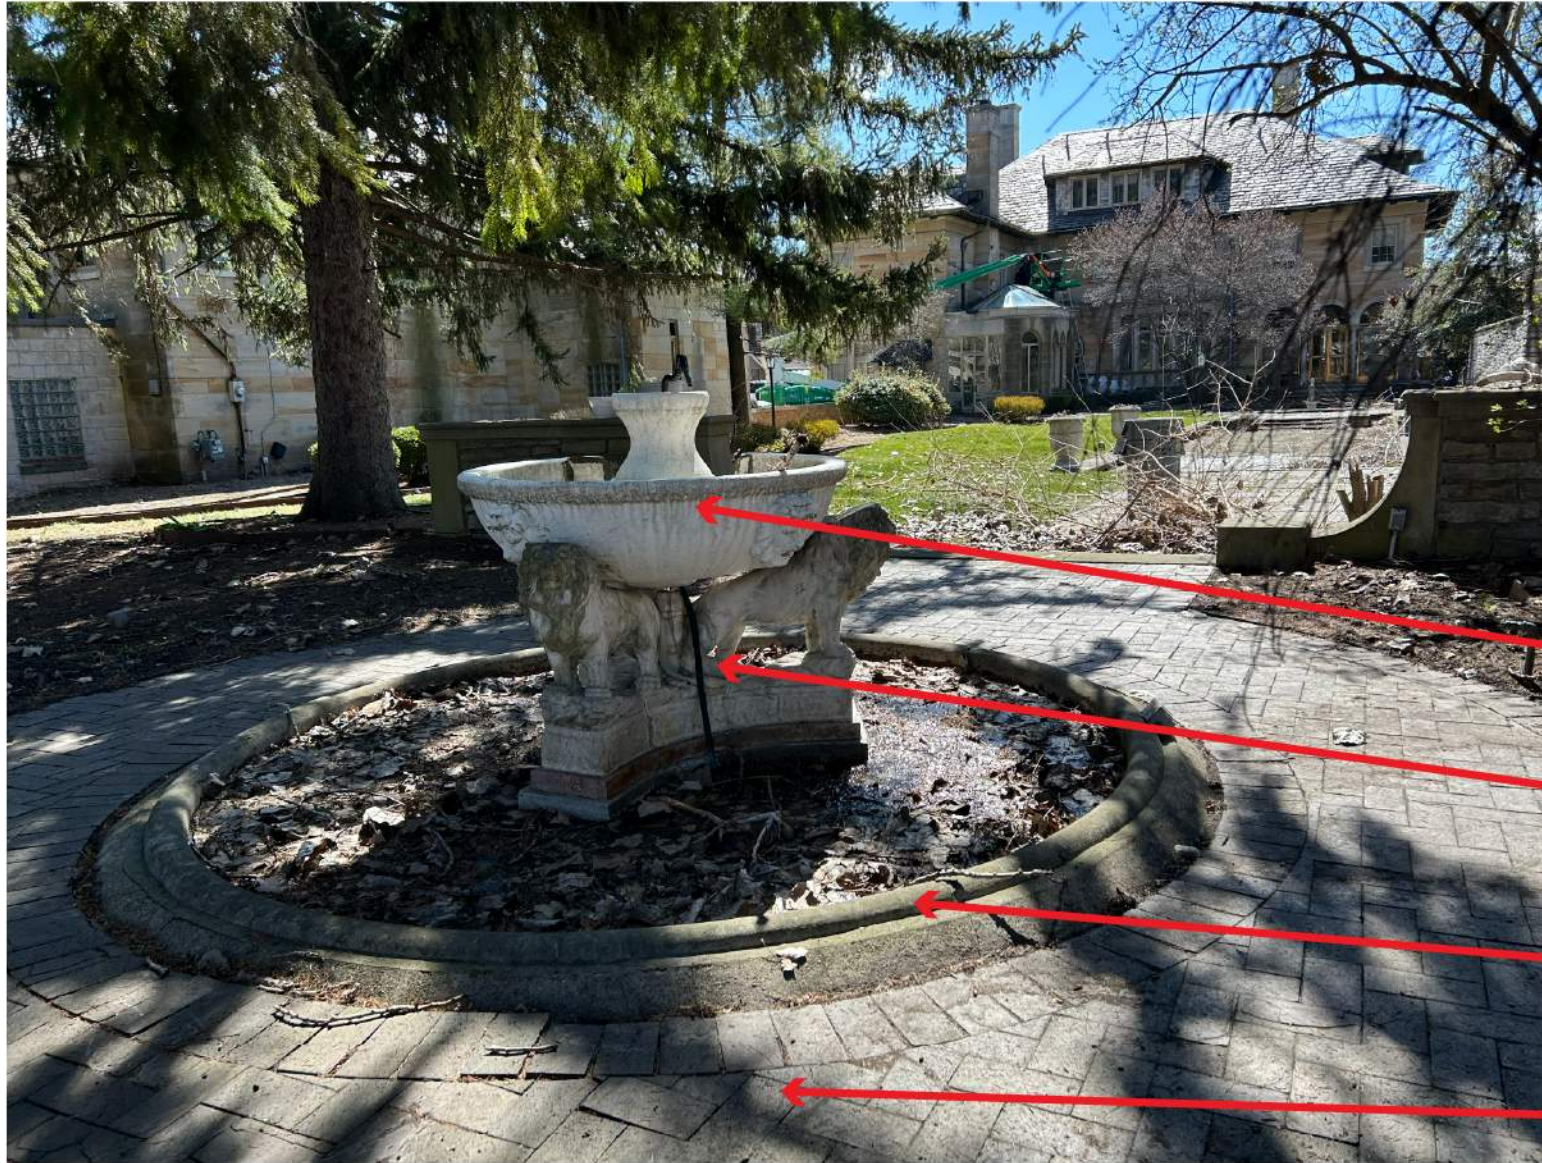
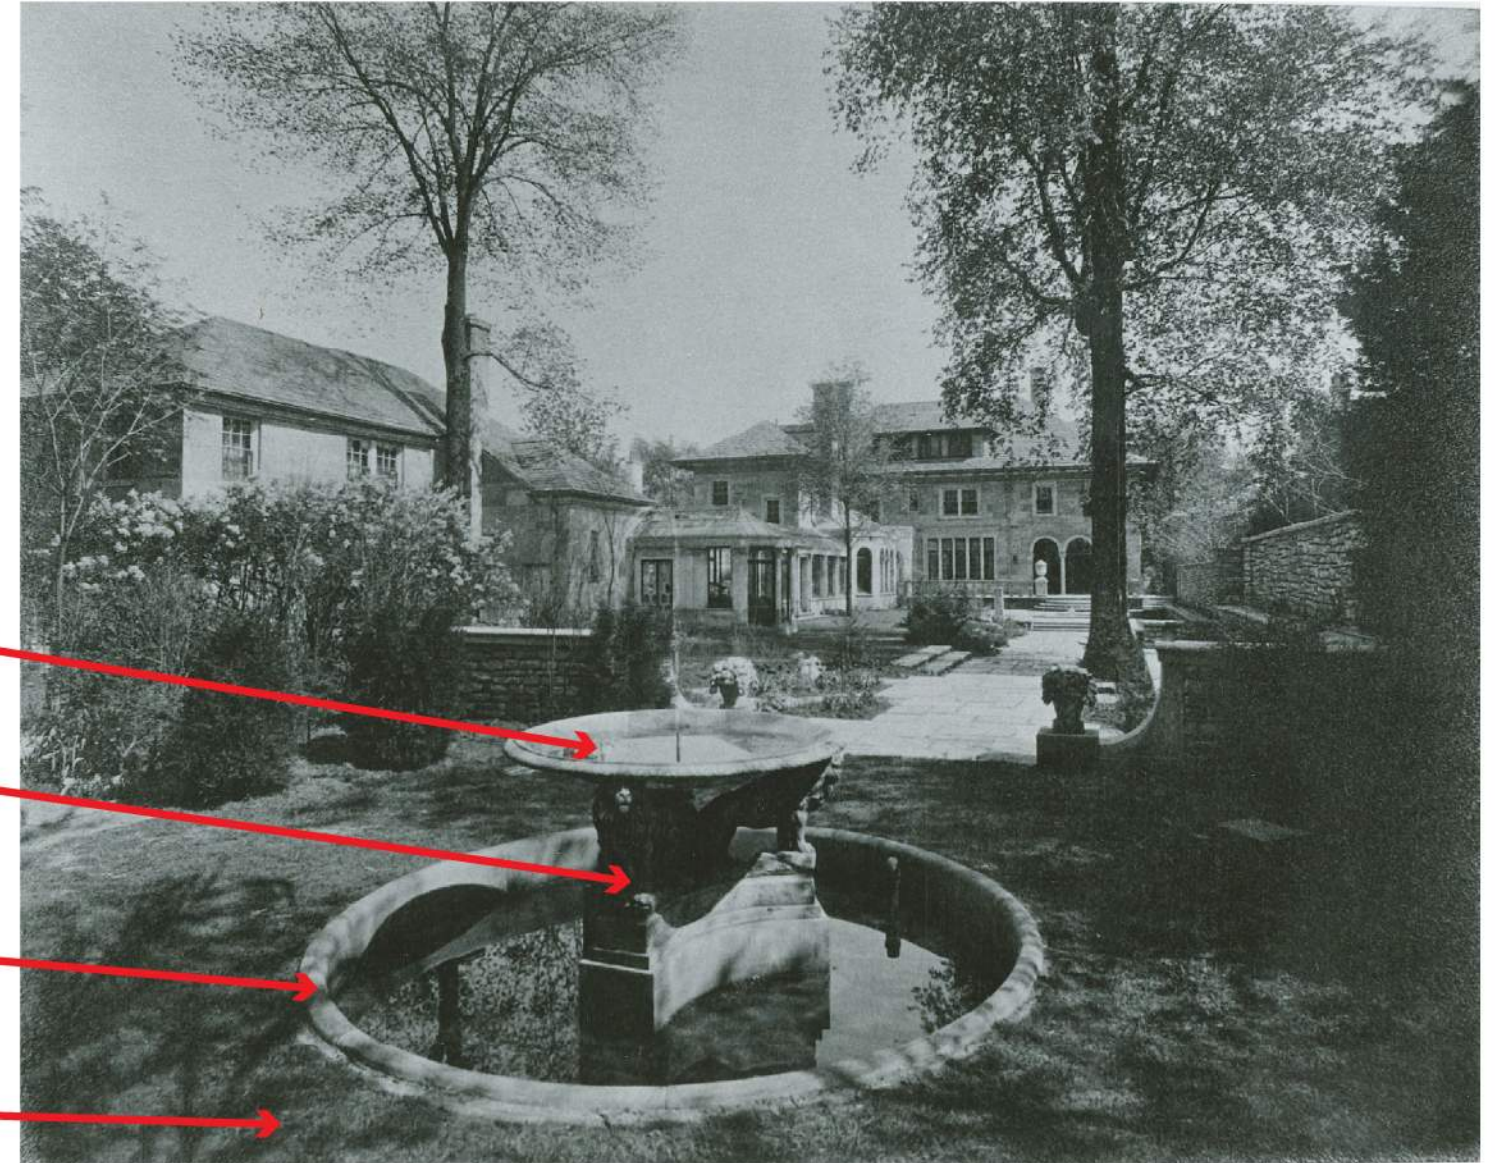
- 1.) Current paving is not original.
- 2.) Curb around fountain is original (now in poor condition and failing).
- 3.) Fountain base is original.
- 4.) Fountain bowl is not original.

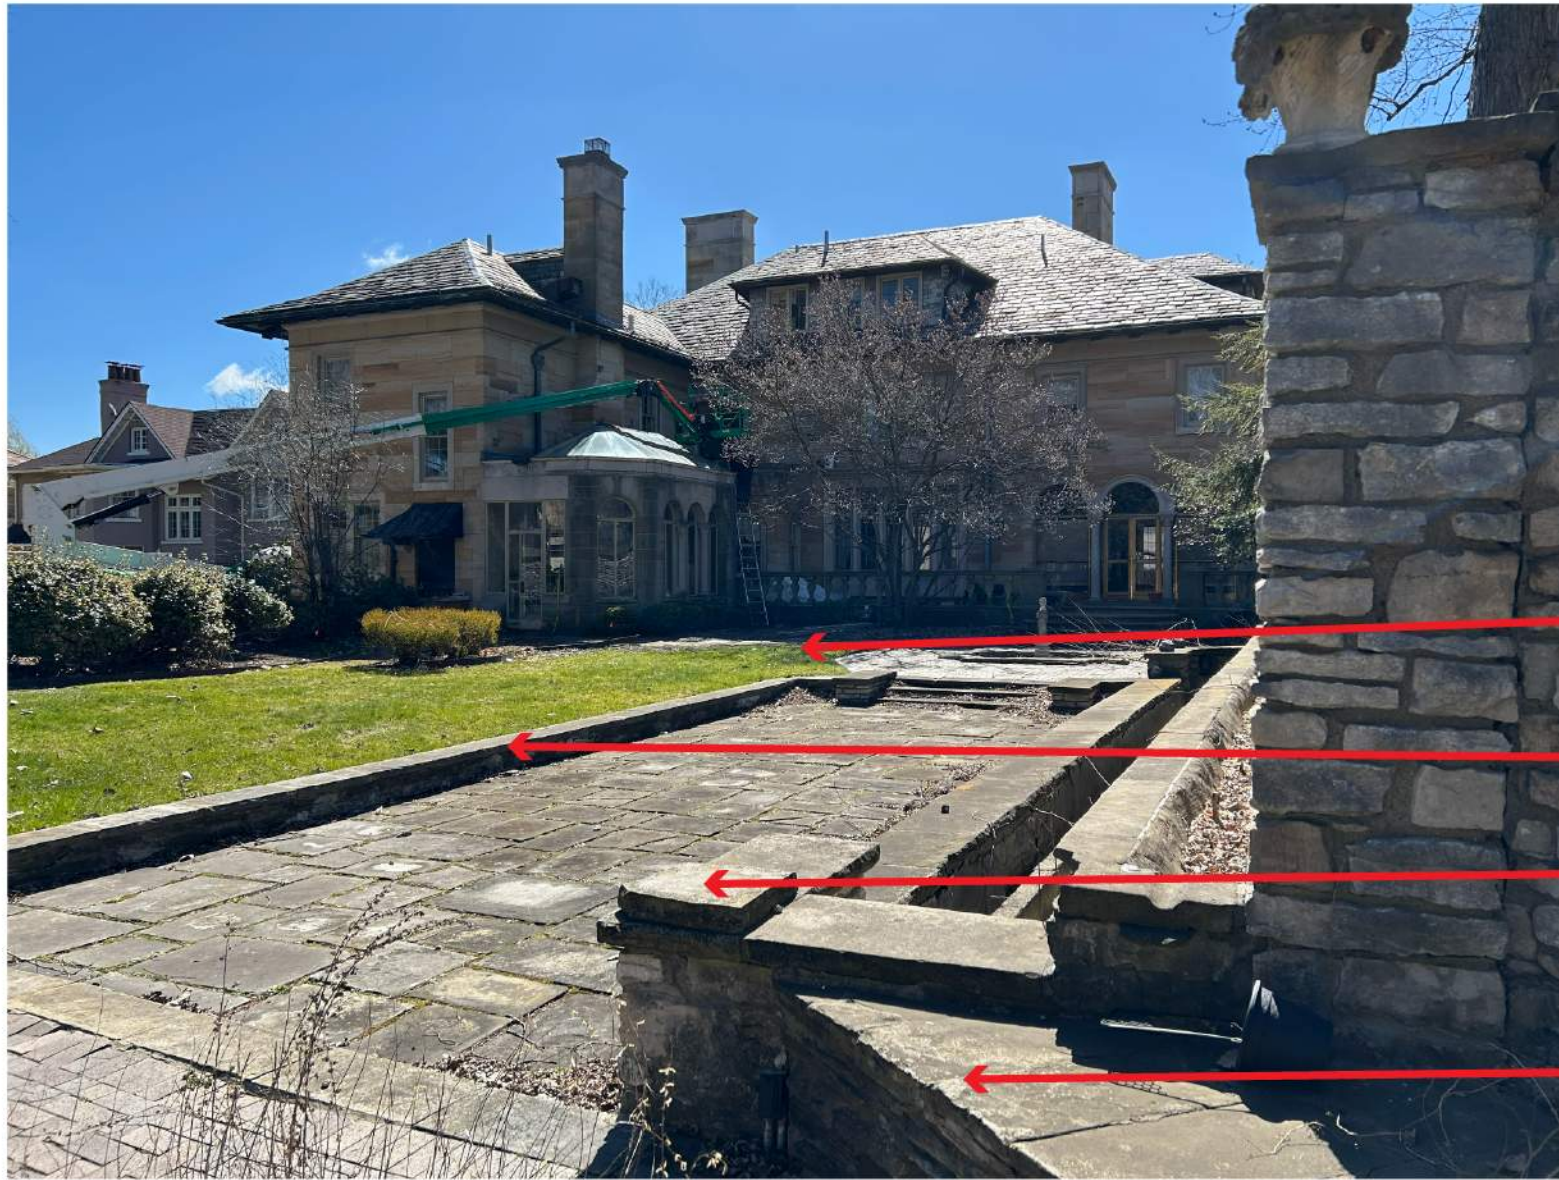
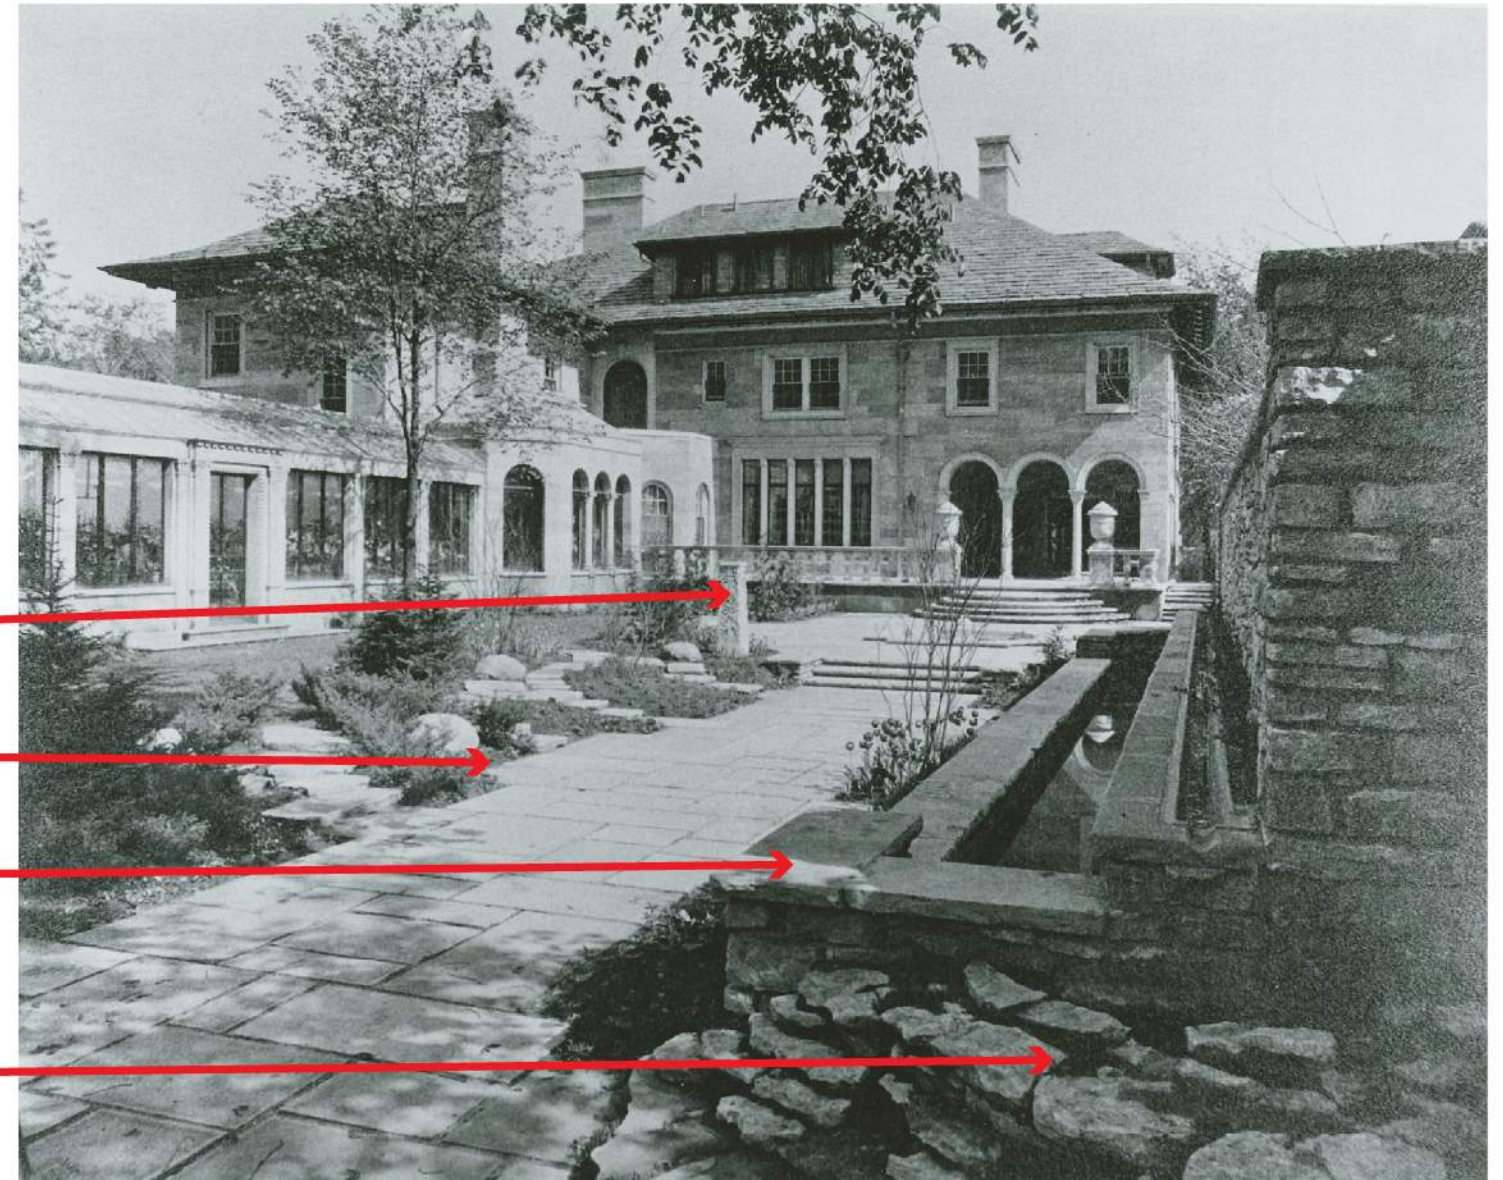
- 1.) Current paving is not original.
- 2.) Current pedestal is not original.
- 3.) Current linear masonry wall is not original.
- 4.) Masonry column no longer exists.

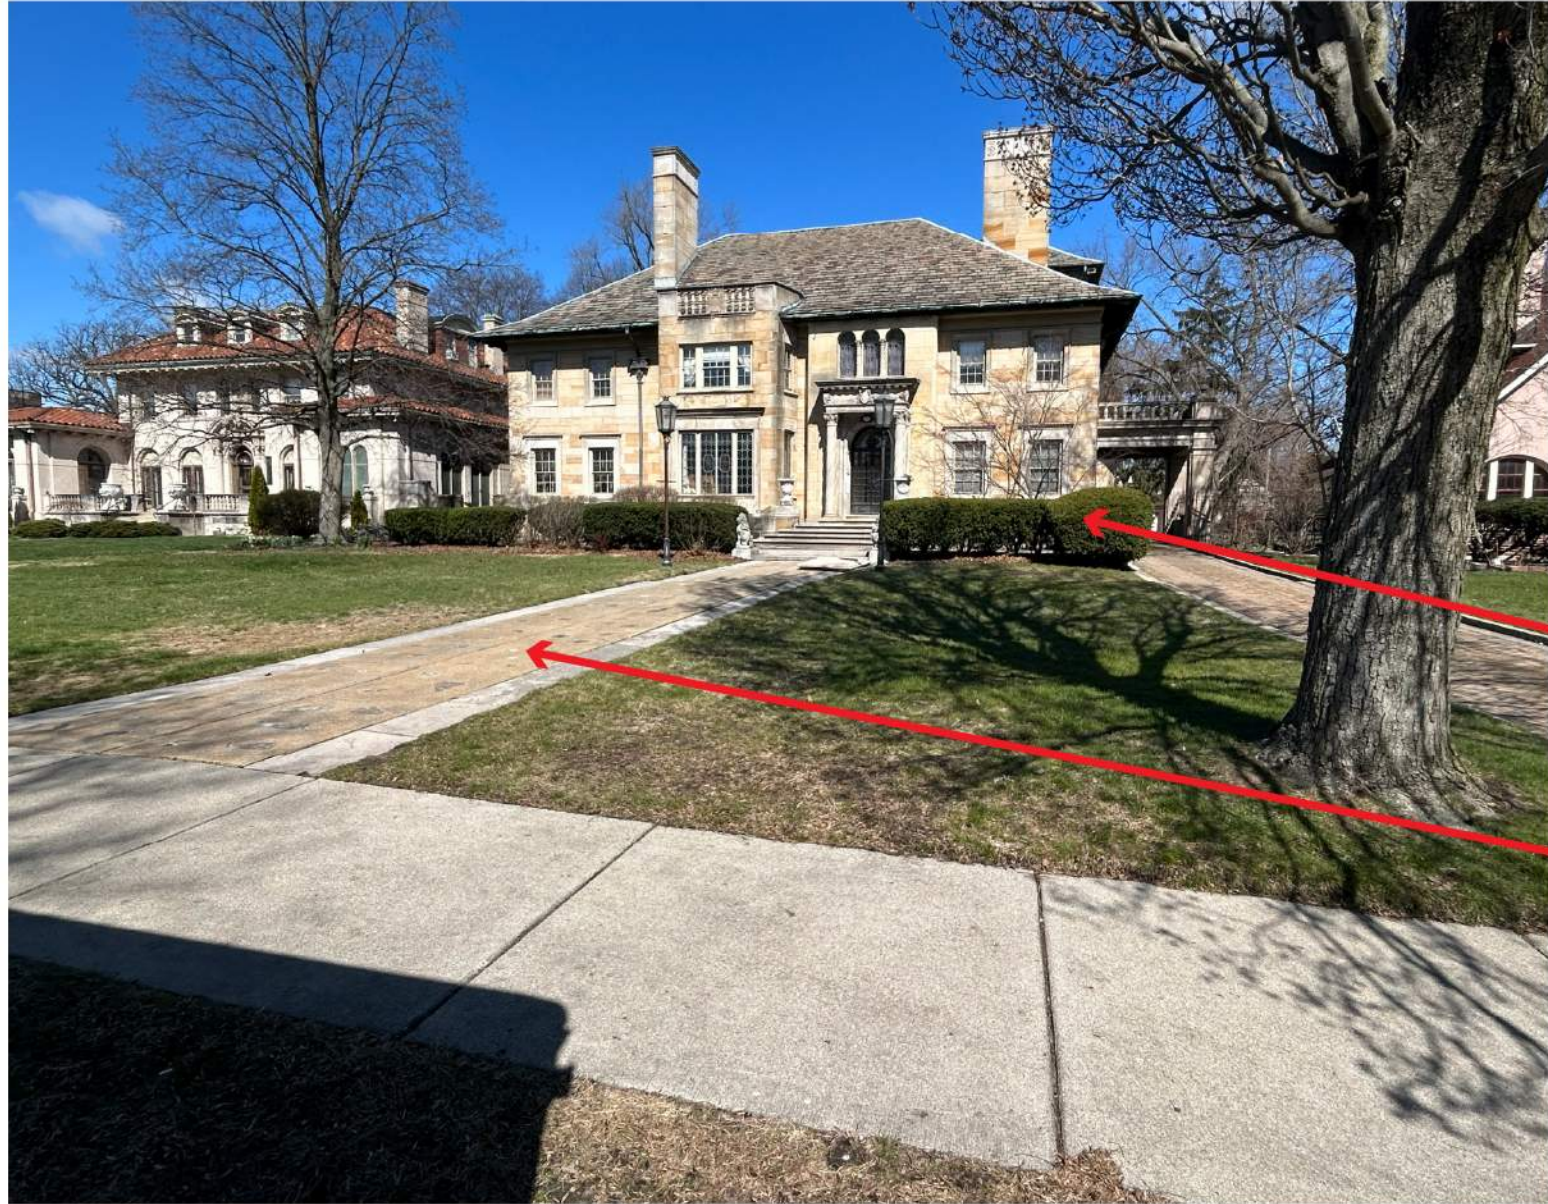
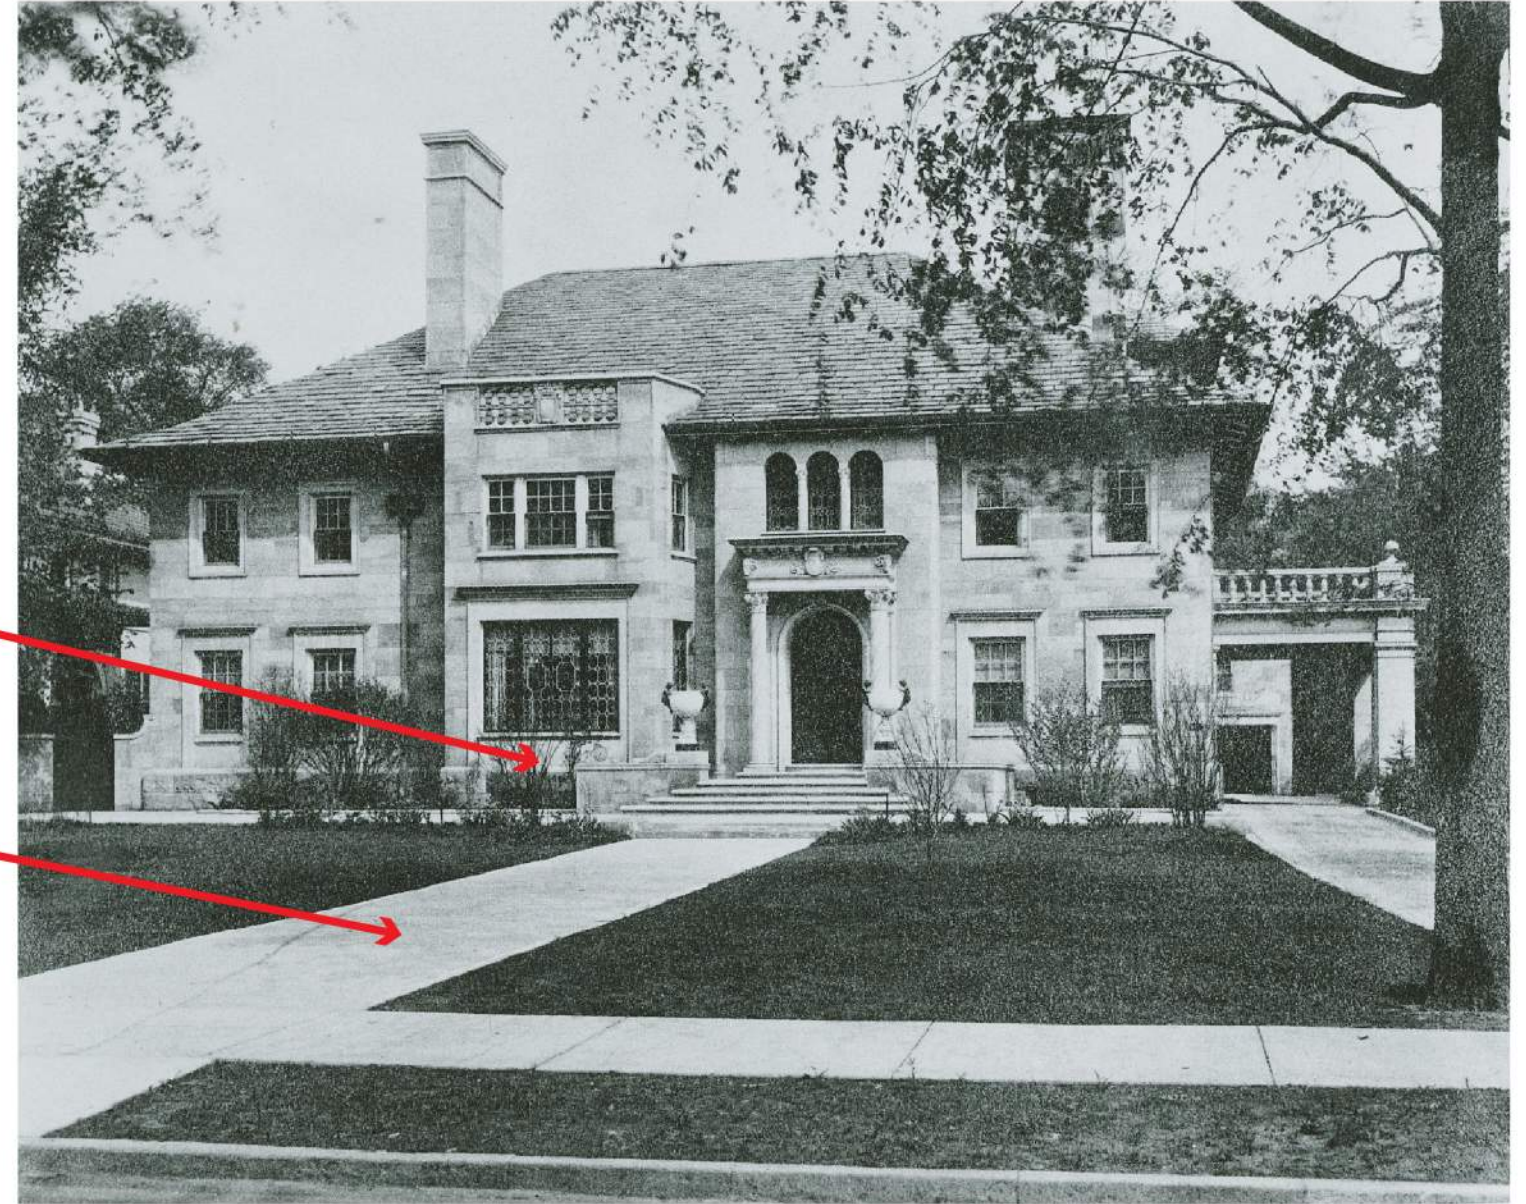
- 1.) Front walkway was originally concrete, it is currently a dyed concrete/paver combination.
- 2.) Deciduous plants in front originally, currently large evergreens.

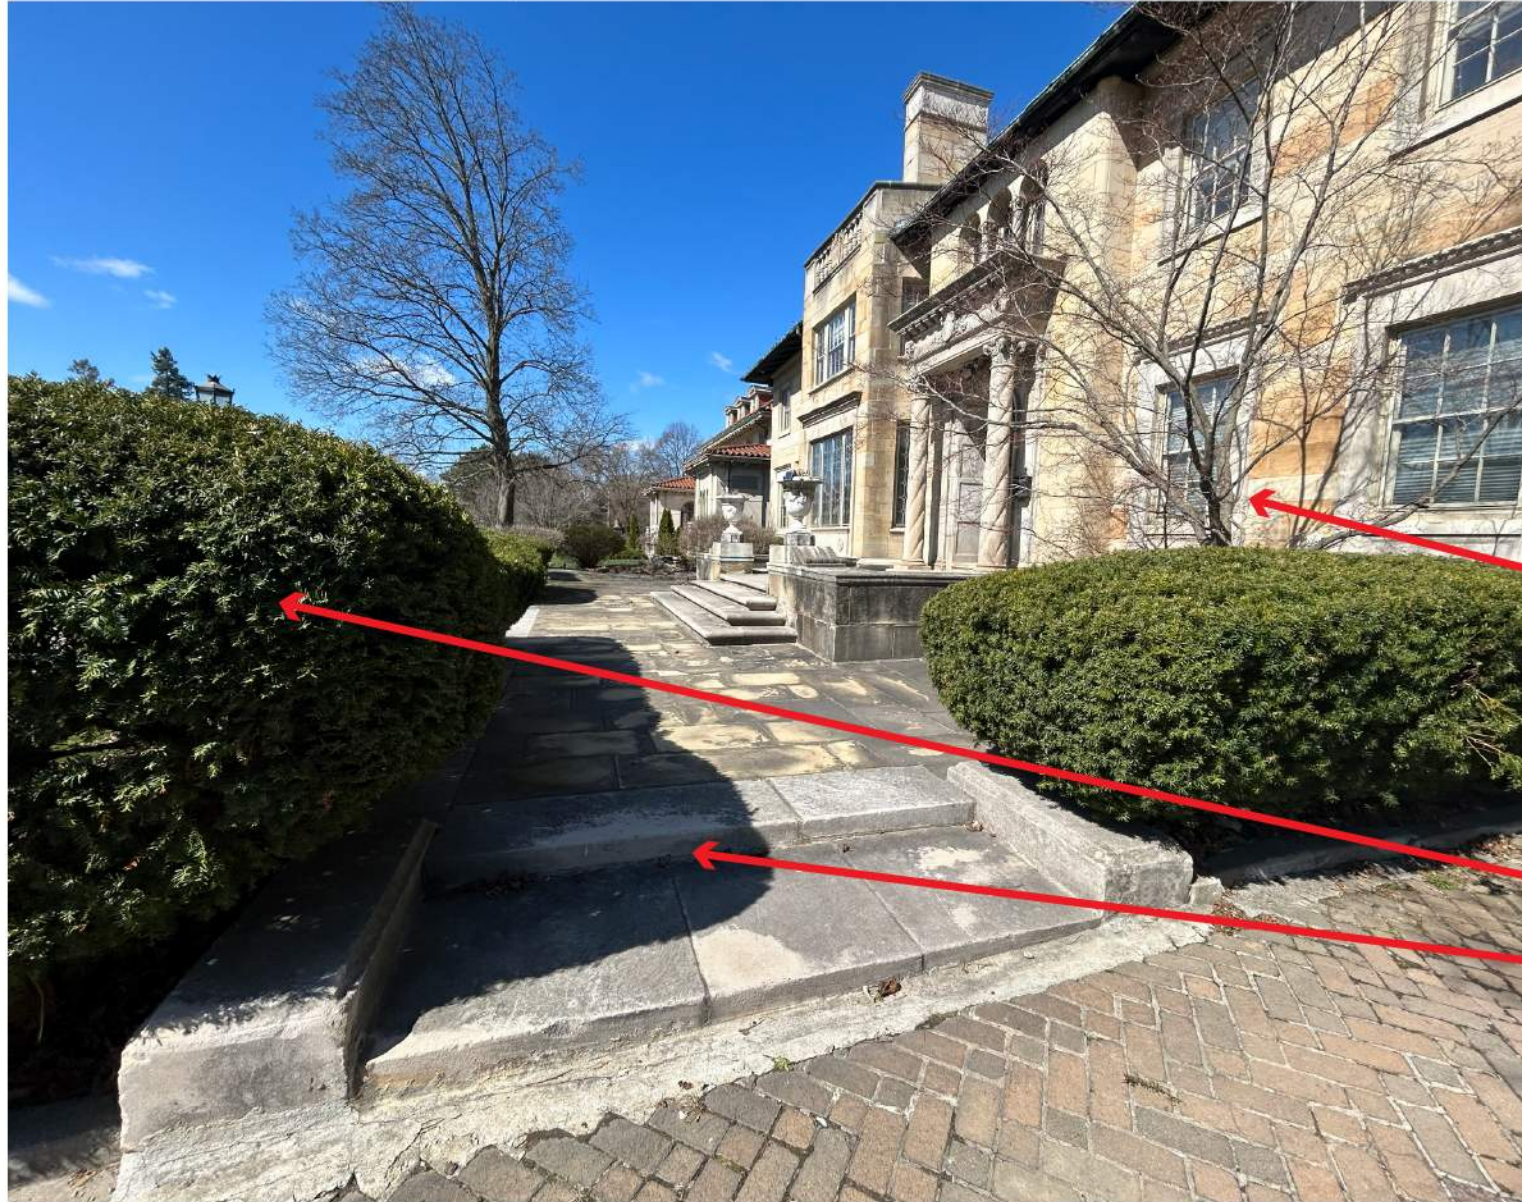
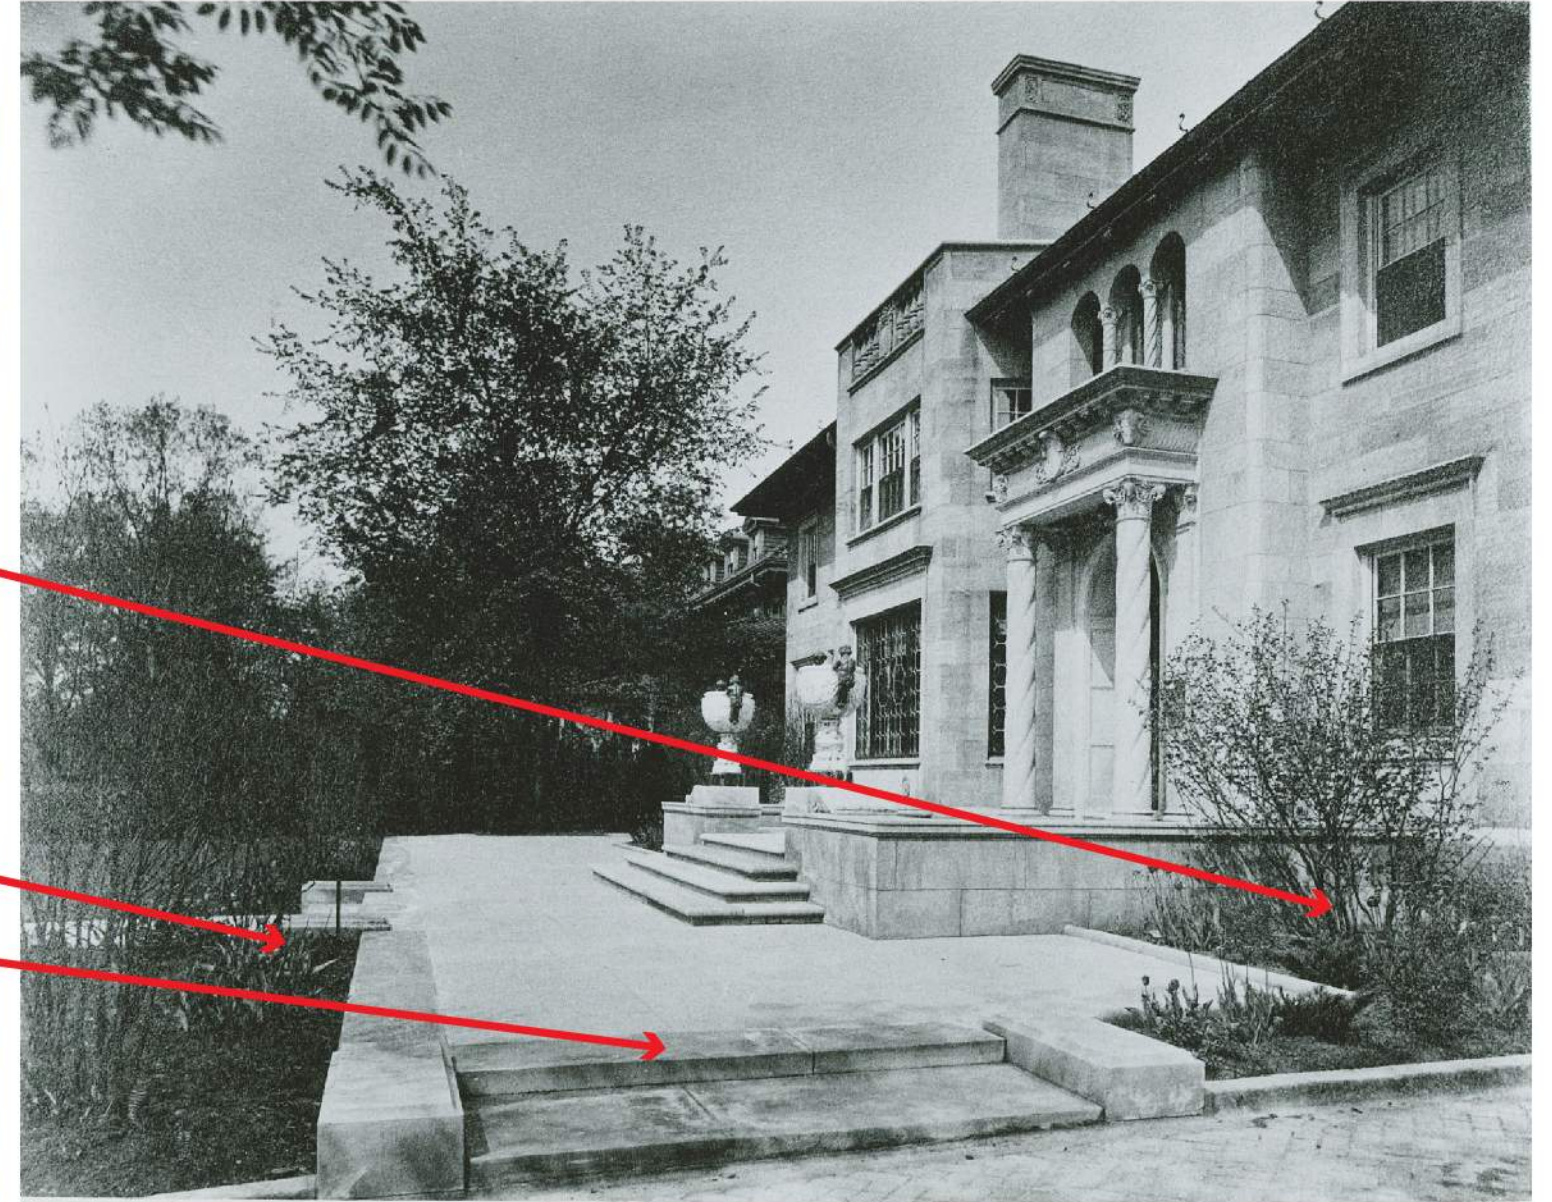
- 1.) Originally open space. Currently is enclosed with large vegetation.
- 2.) Current steps & porch are original (now in poor condition)

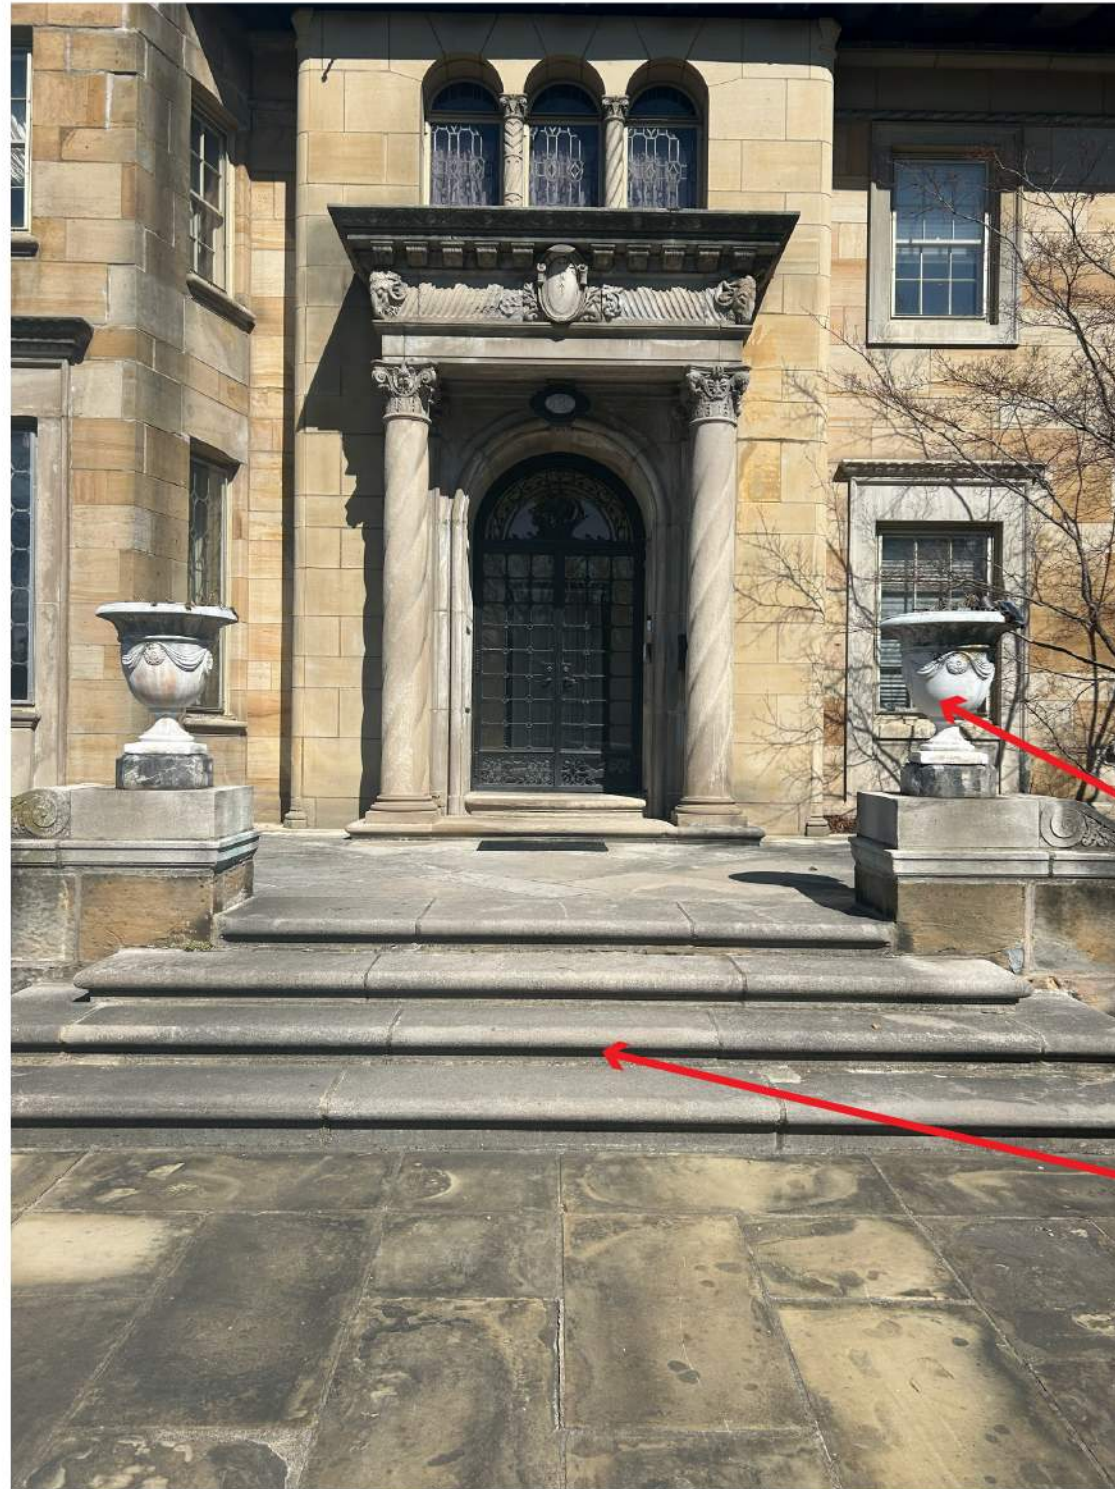
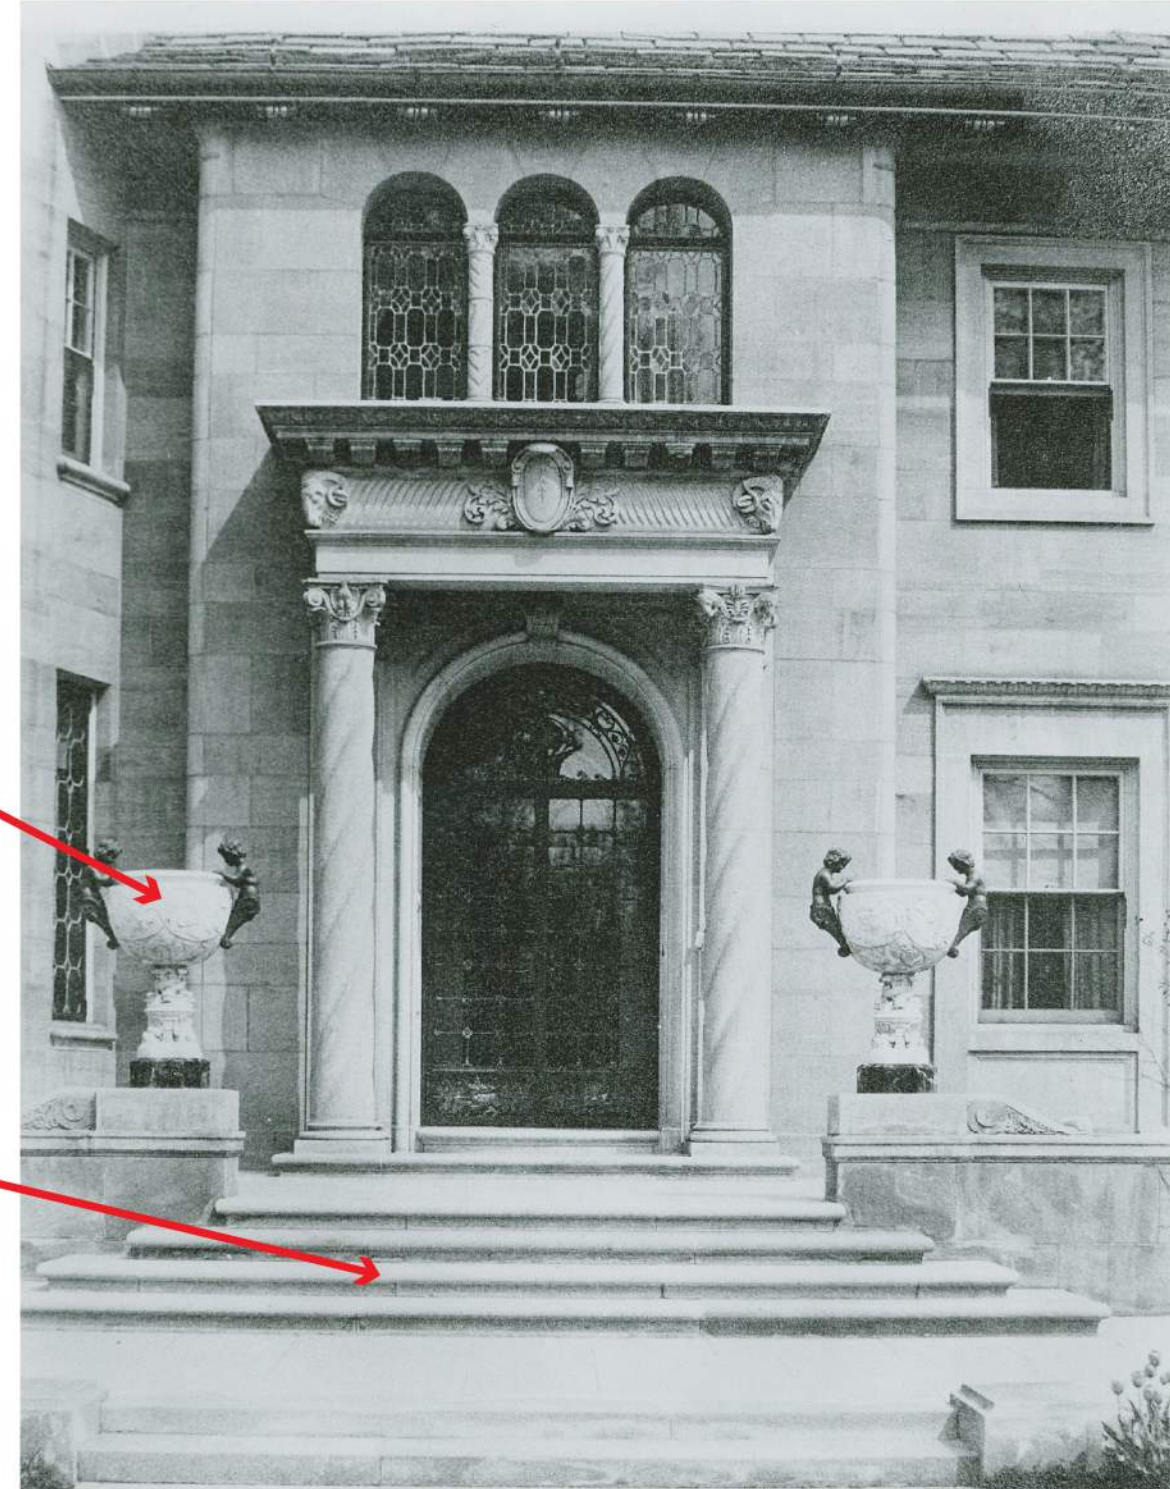
- 1.) Current planters are not original, however, the blocks they sit on are original.
- 2.) Current steps & entry porch are original (now in poor condition)
