HISTORIC DISTRICT COMMISSION APPLICATION FOR WORK APPROVAL

APPLICATION ID
HDC2026-00039

ADDRESS(ES): 892 W. Boston Boulevard
HISTORIC DISTRICT: Boston-Edison

<p>BRIEF PROJECT DESCRIPTION:</p> <p>New swimming pool, restoration of hardscape surfaces (walks, terraces, driveway), landscape, and lighting.</p>
--

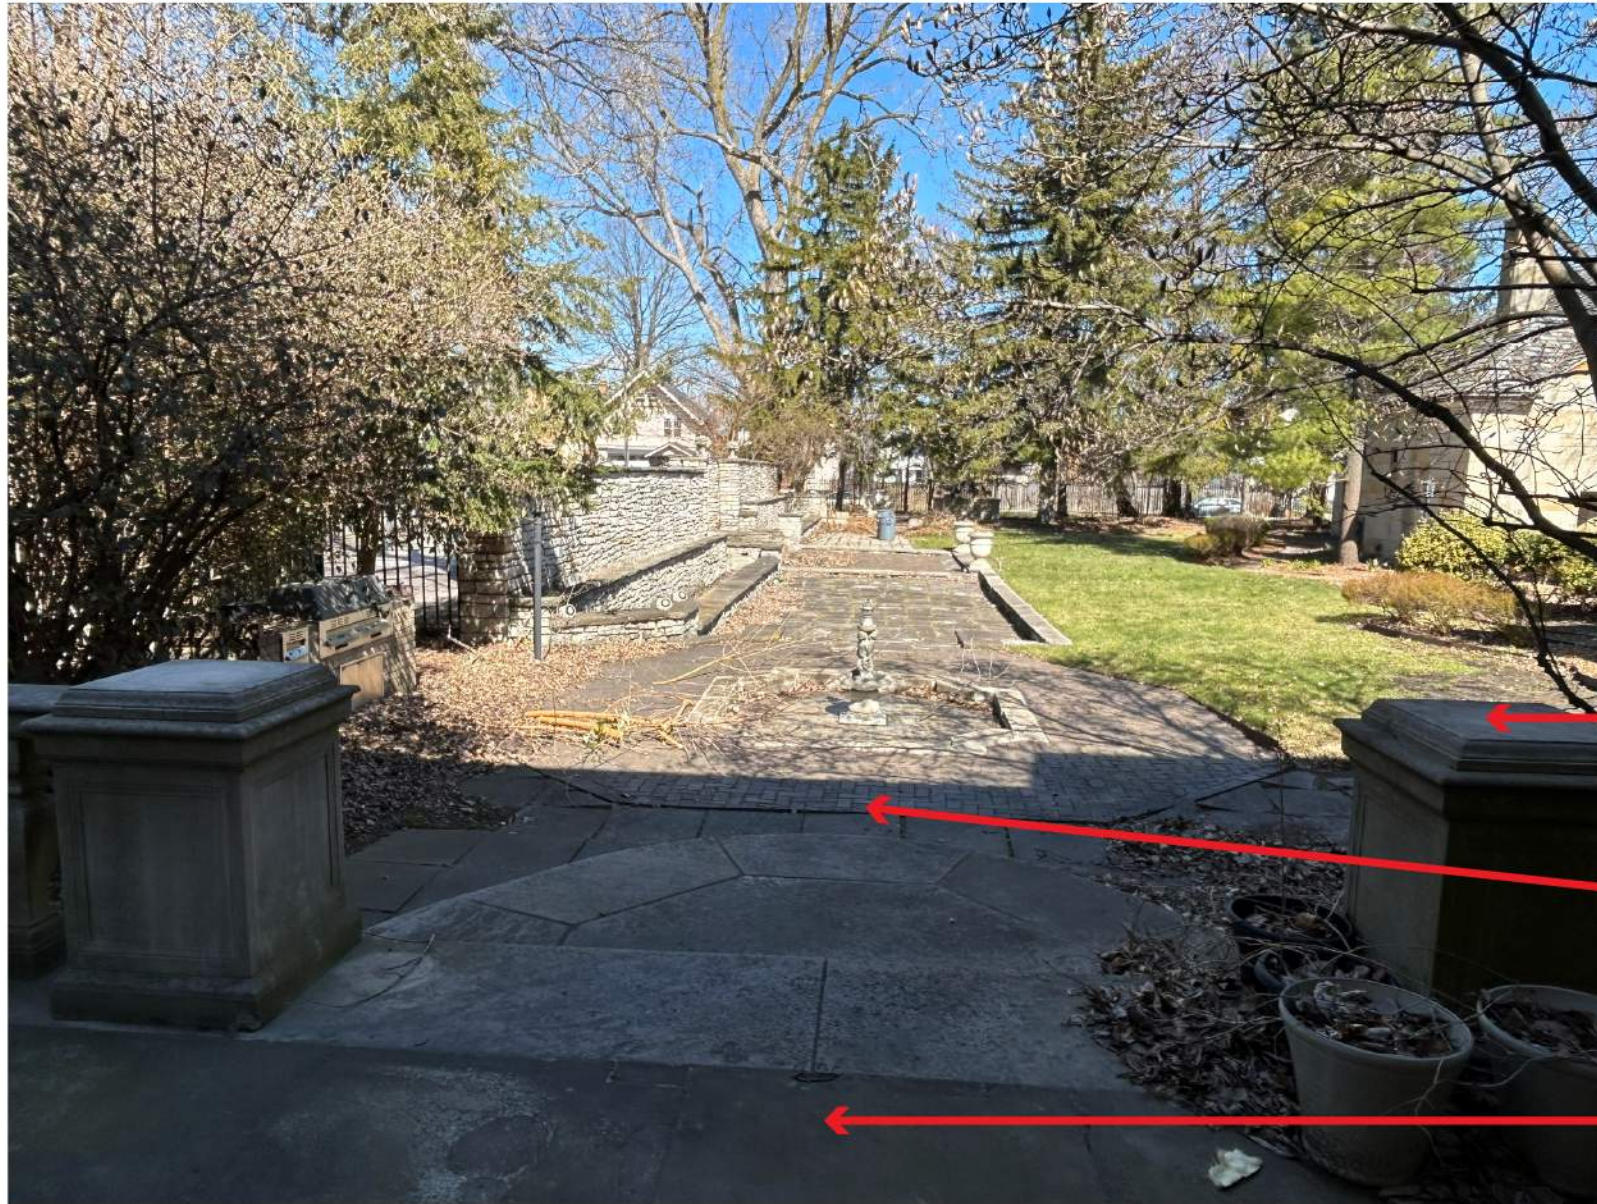
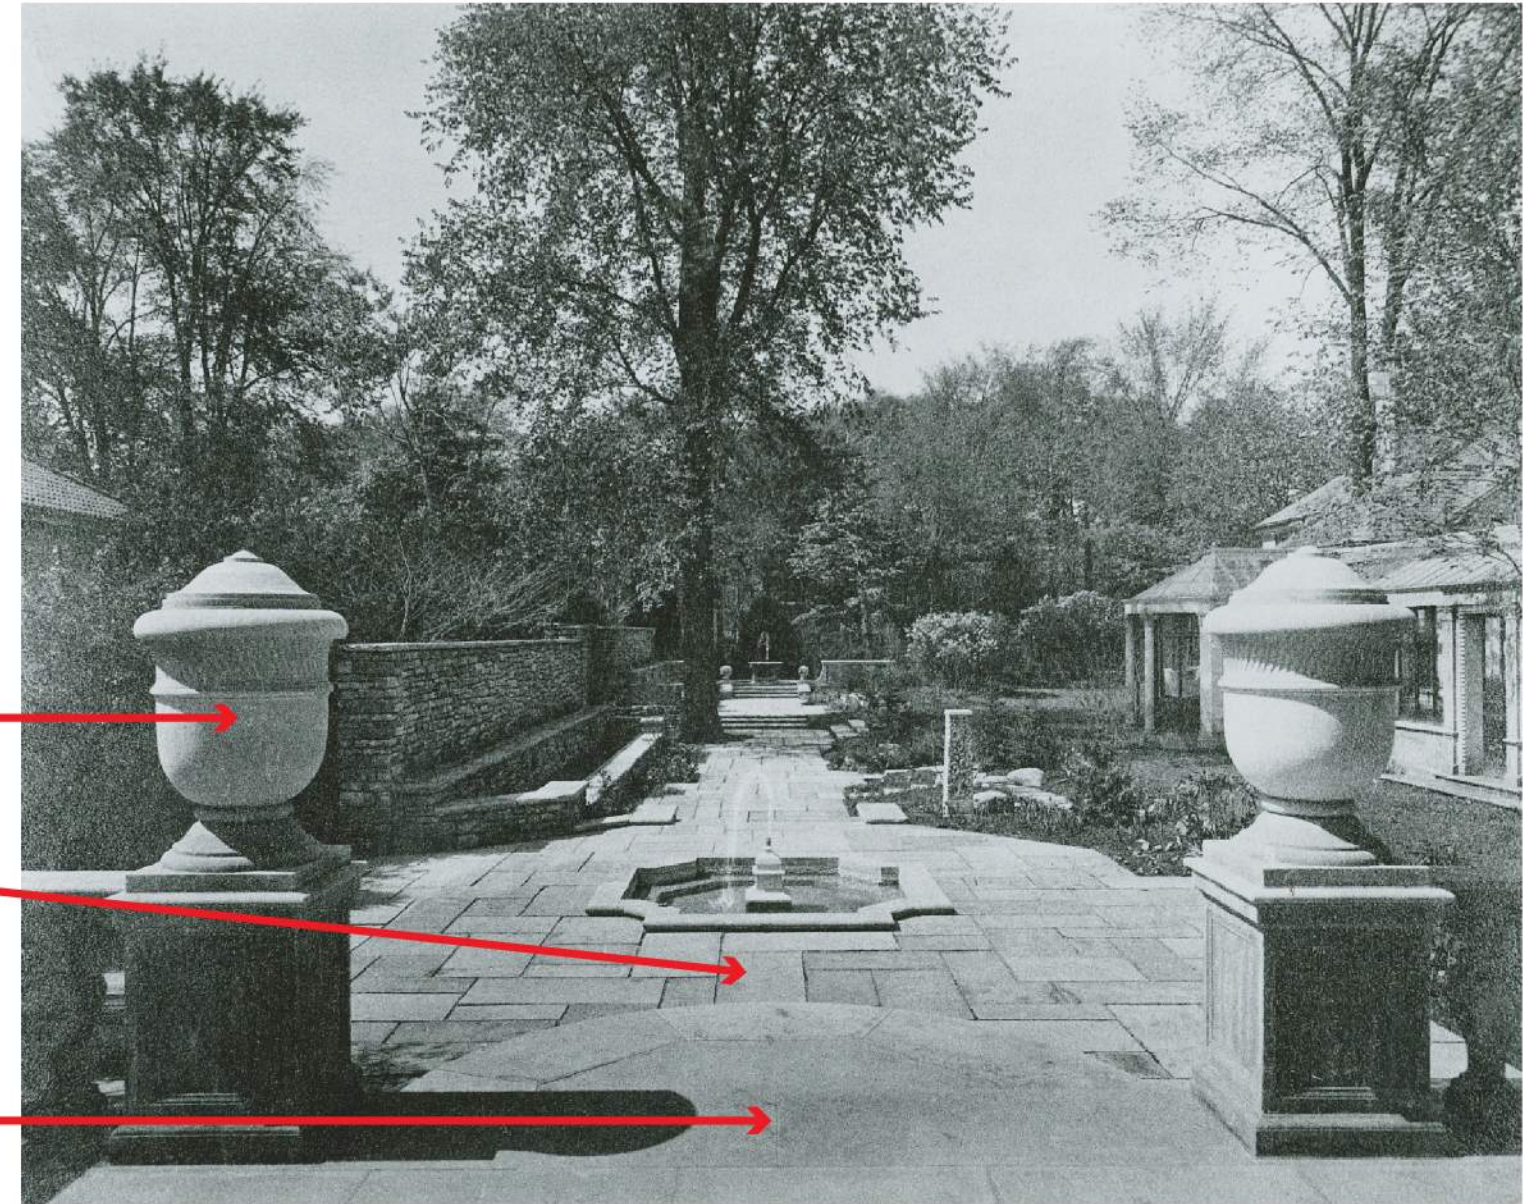
- 1.) Original urns are not located on pedestals (placed elsewhere on site).
- 2.) Upper terrace paving and steps are original (now in poor condition and failing).
- 3.) Paving at bottom of steps are not original.

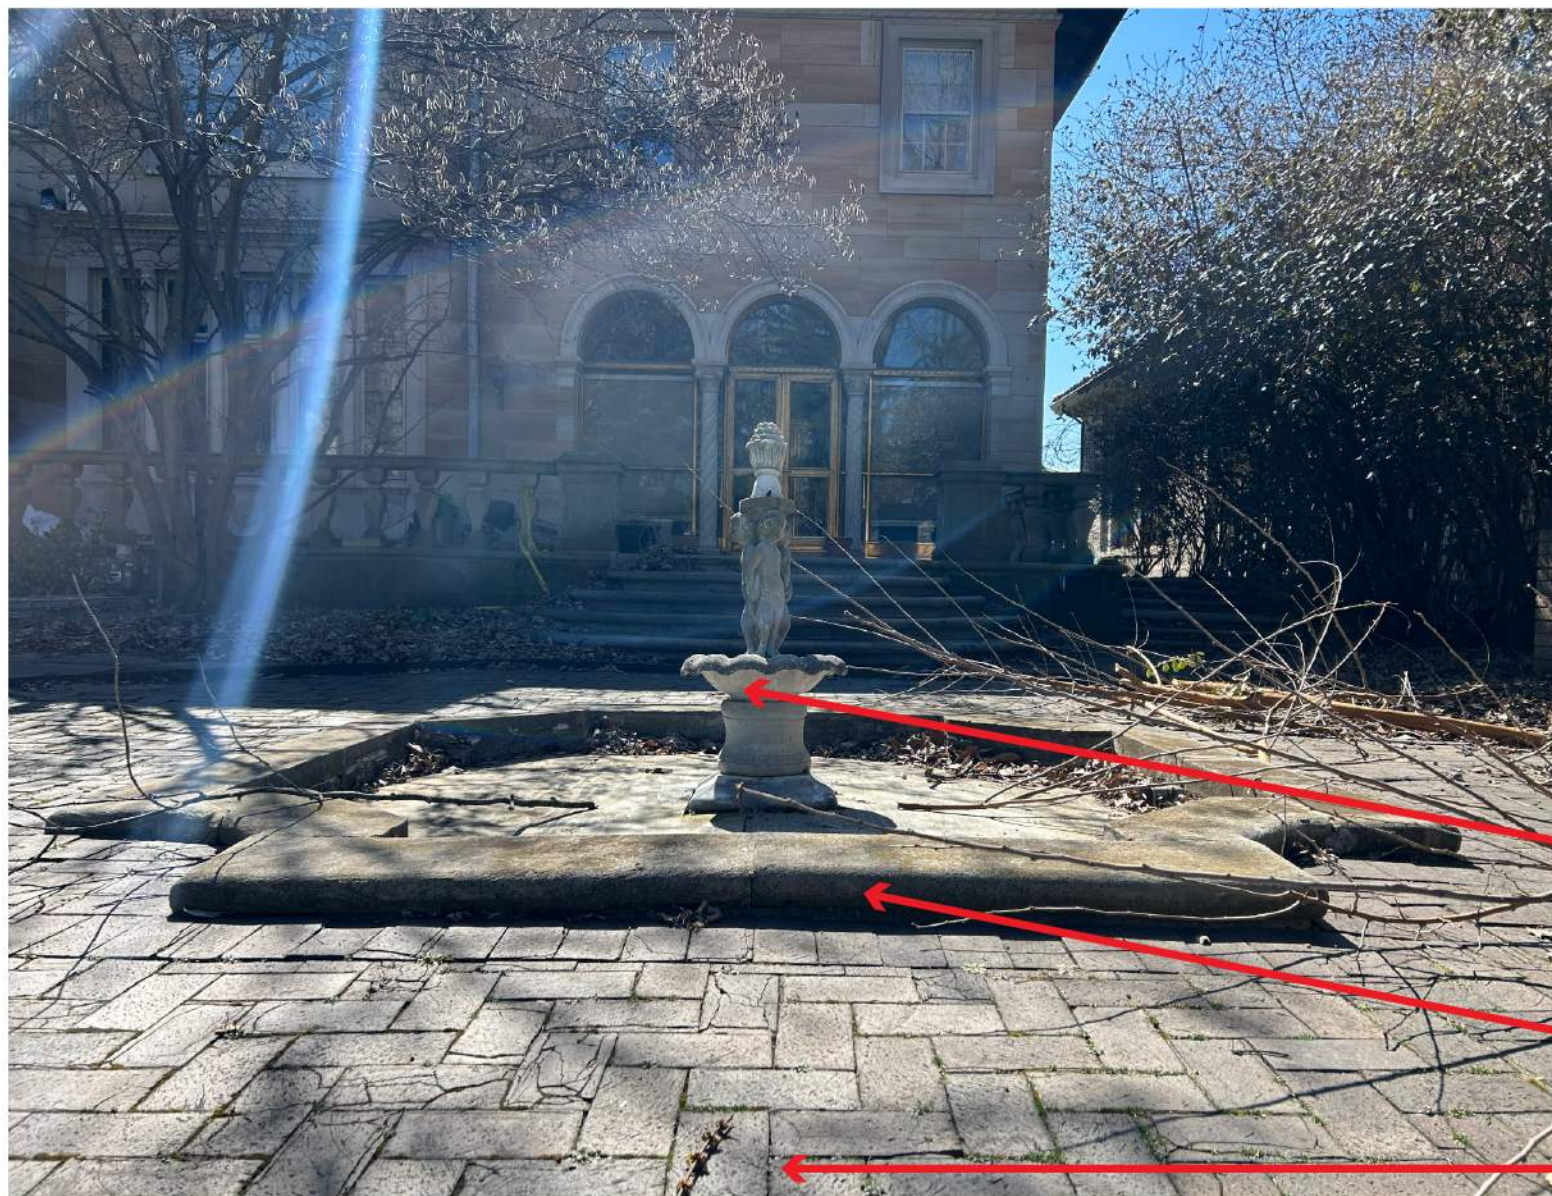
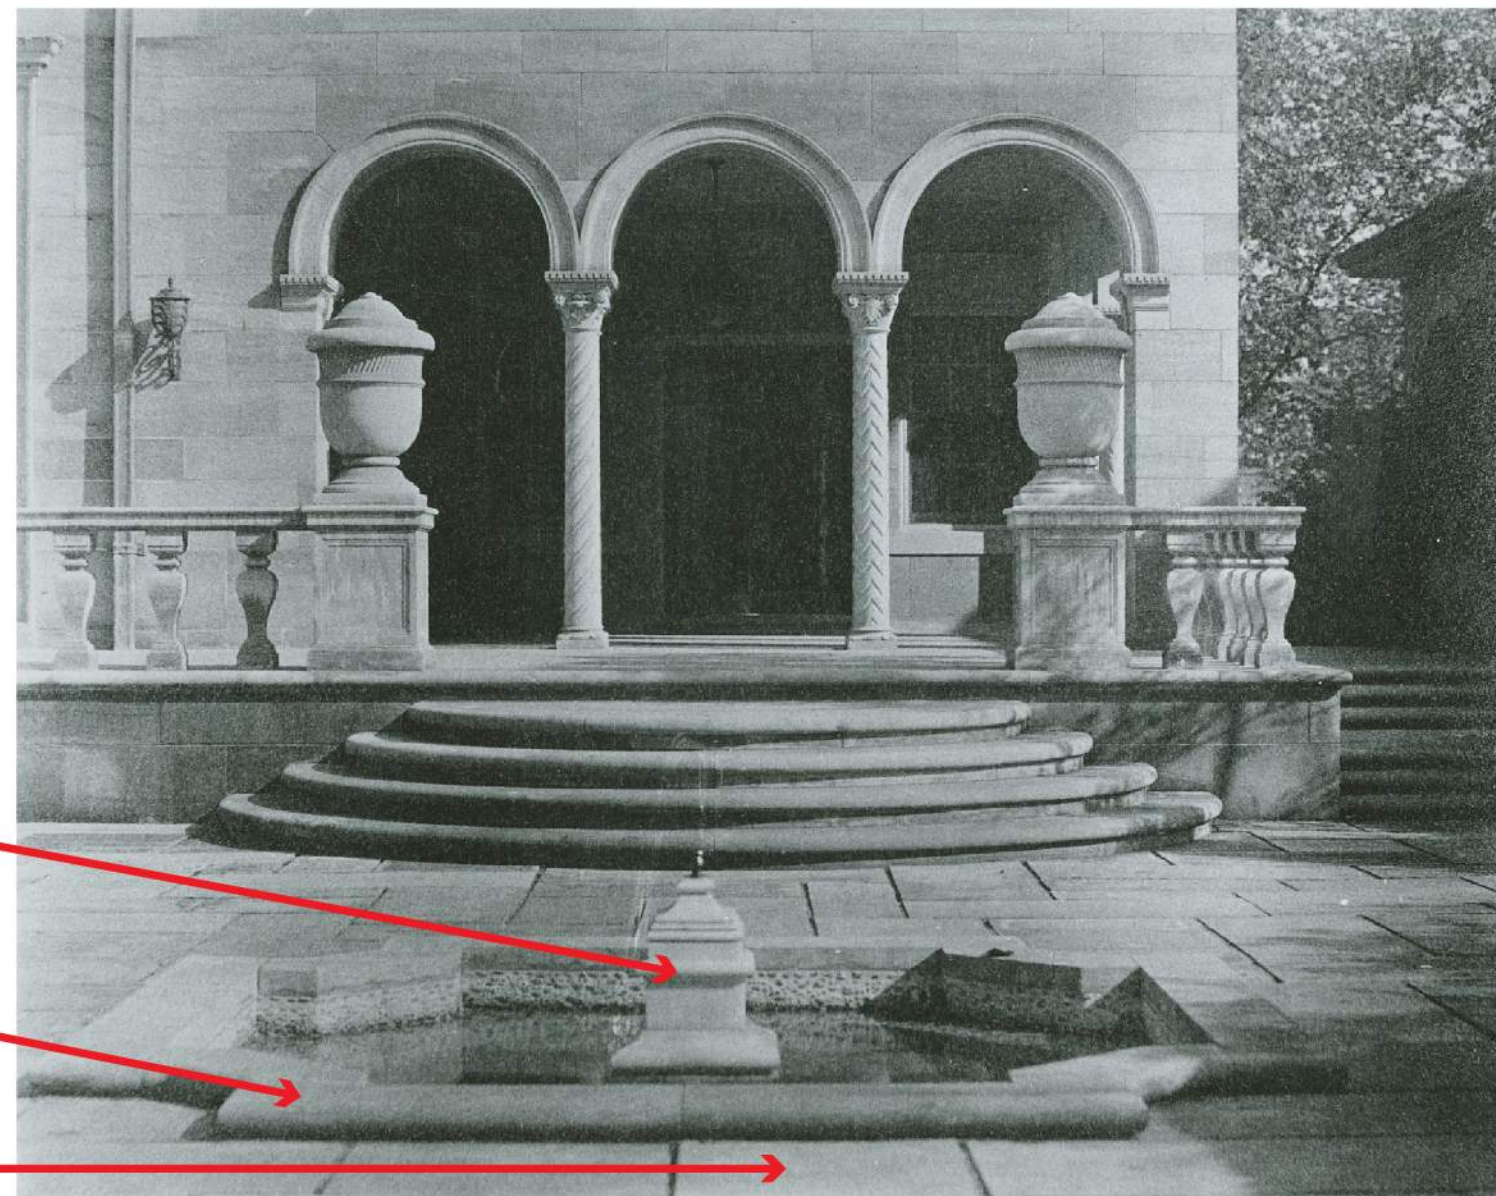
- 1.) Fountain coping is original (now in poor condition and failing).
- 2.) Current fountain is not original.
- 3.) Current paving around fountain is not original.

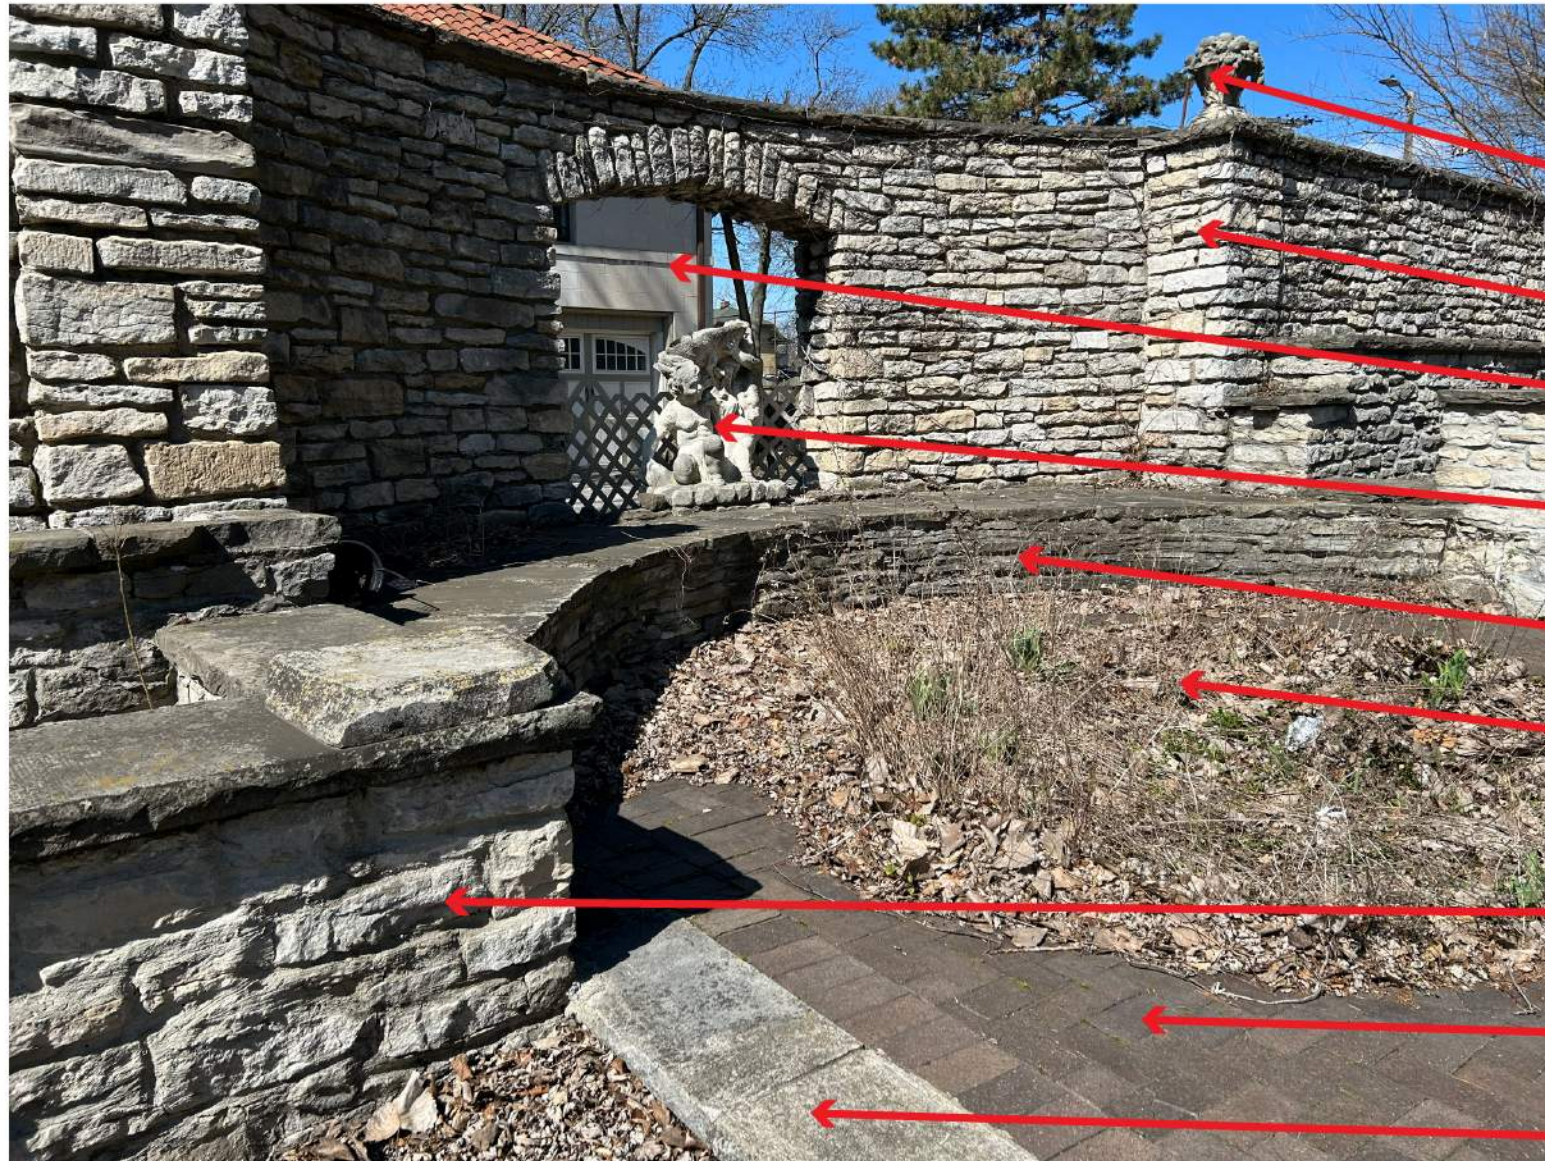
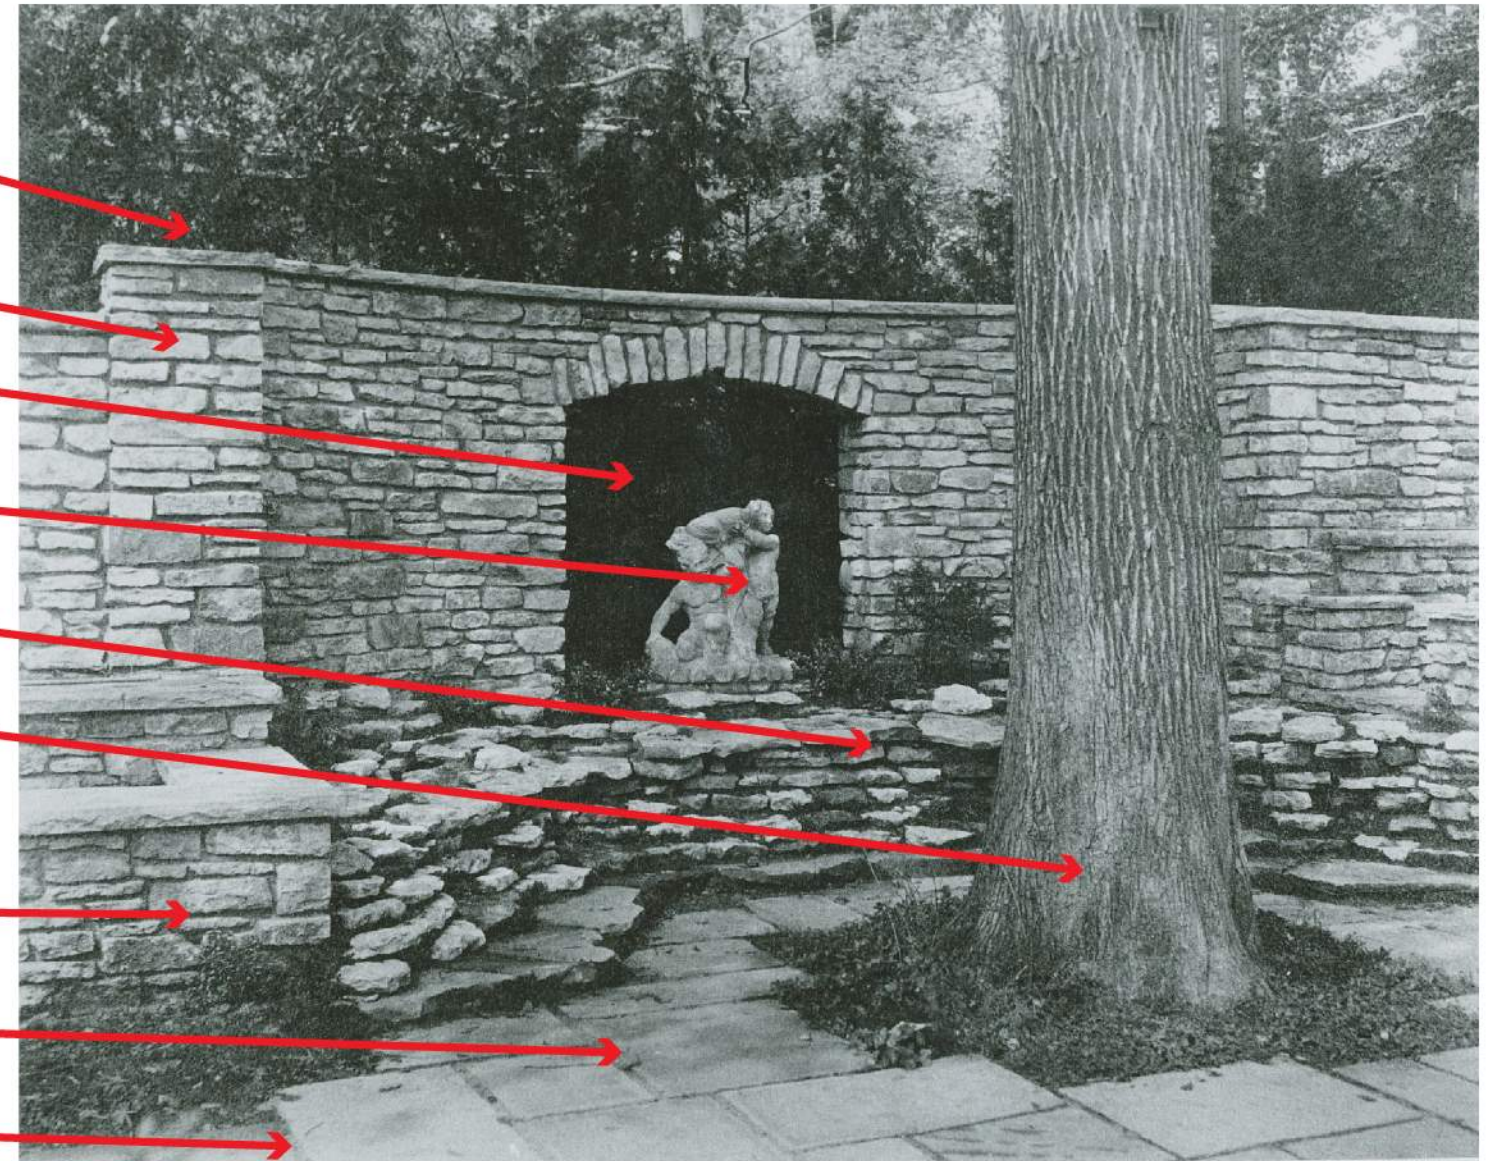
- 1.) Statue is original.
- 2.) Low radial wall is not original.
- 3.) Low linear fountain is original.
- 4.) Tall back wall is original.
- 5.) Current paving is not original.
- 6.) Step is not original.
- 7.) Evergreen Arborvitae screen behind wall and large tree in center no longer exists.
- 8.) Planters are original - have been relocated to current position.

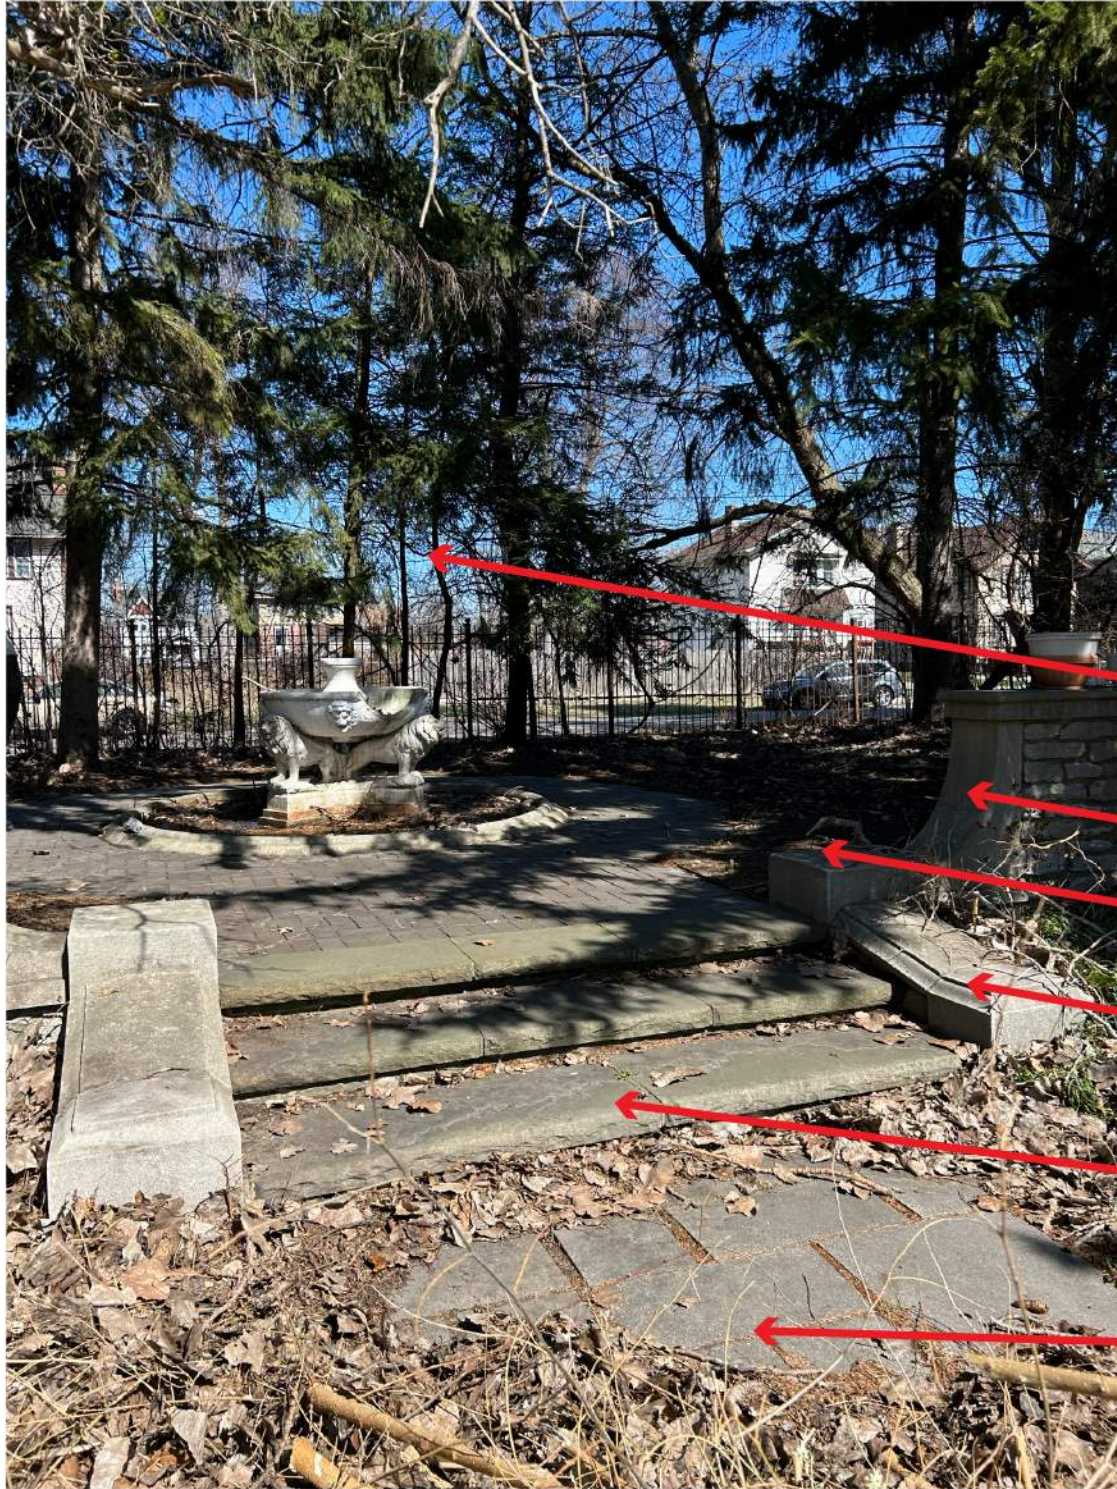
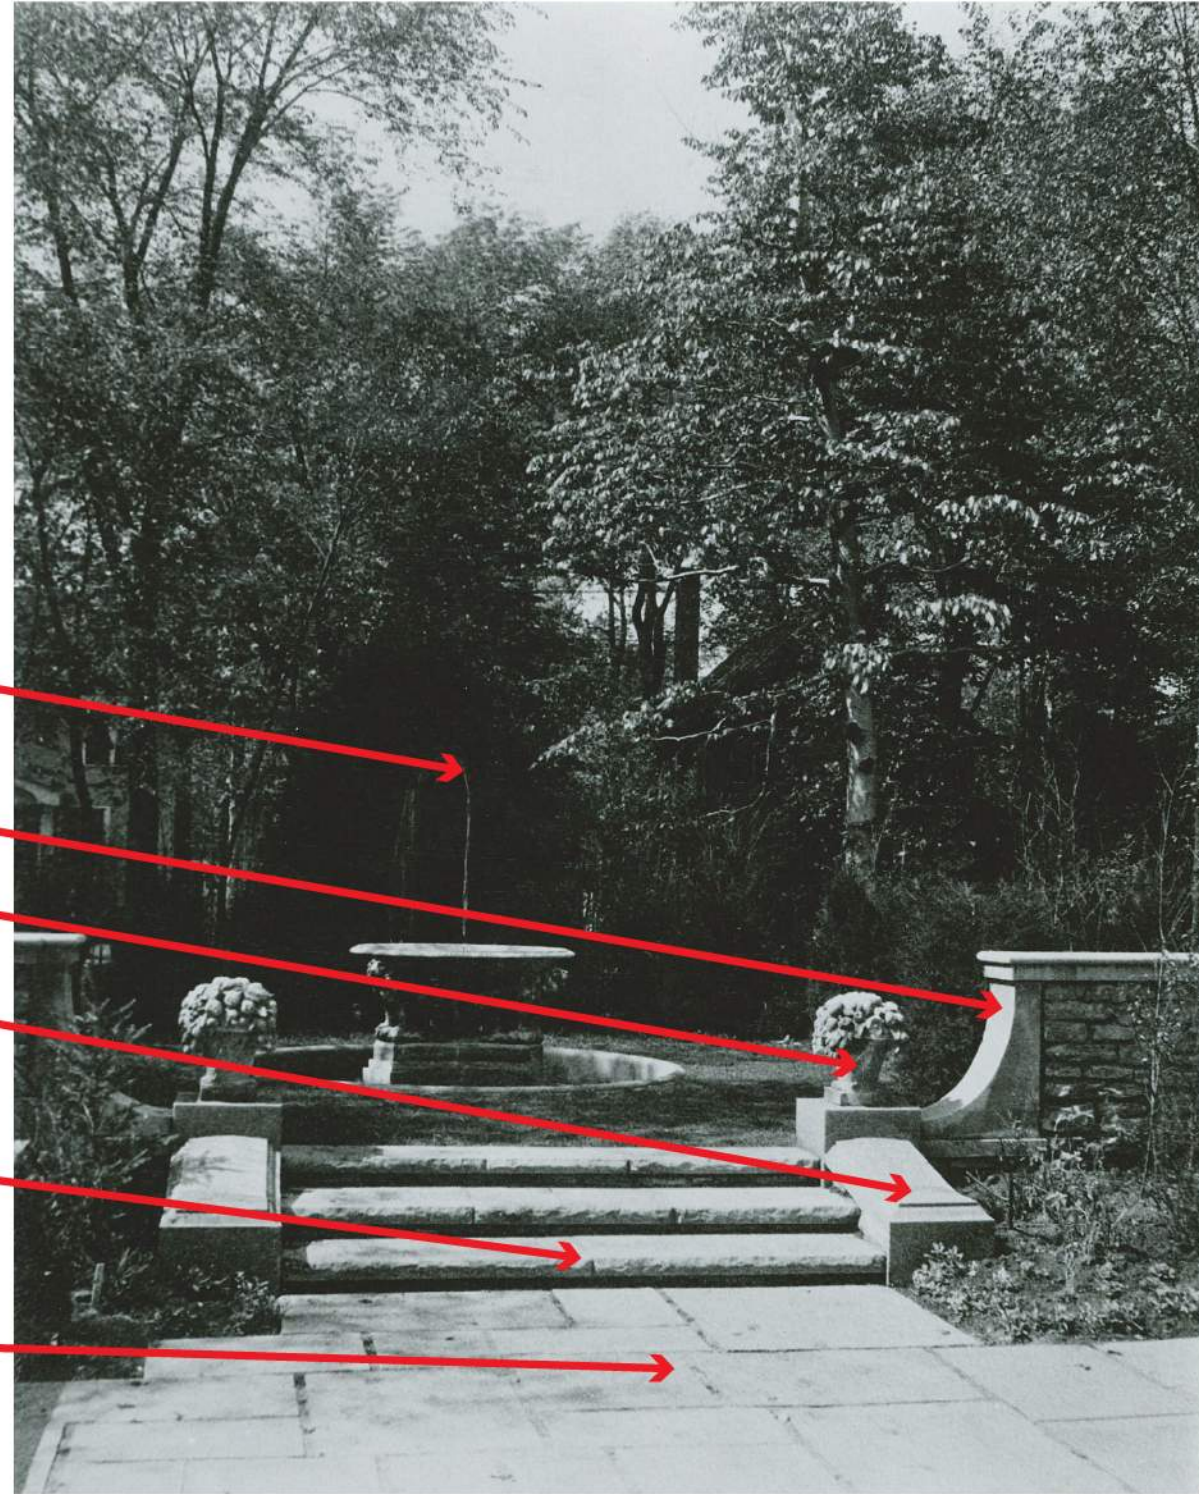
- 1.) Current steps are not original.
- 2.) Masonry piers are original.
- 3.) Current paving is not original.
- 4.) Planters have been relocated on site.
- 5.) Evergreen screen wall no longer exists.

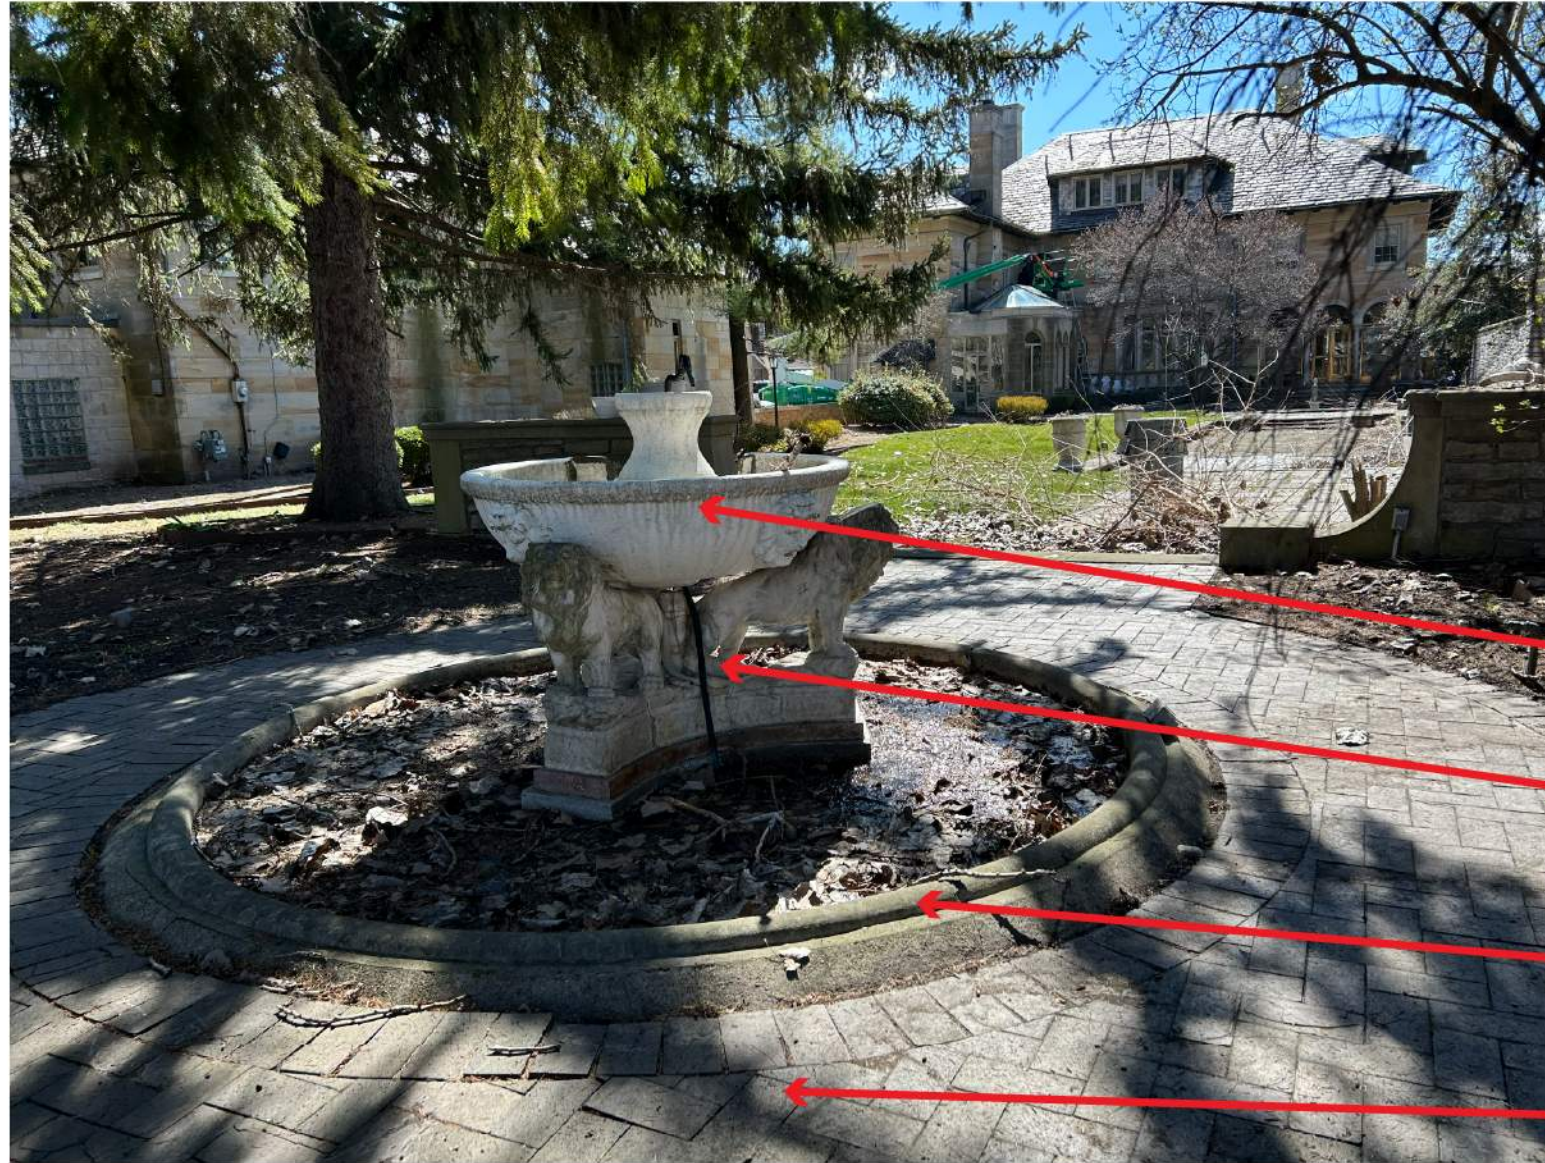
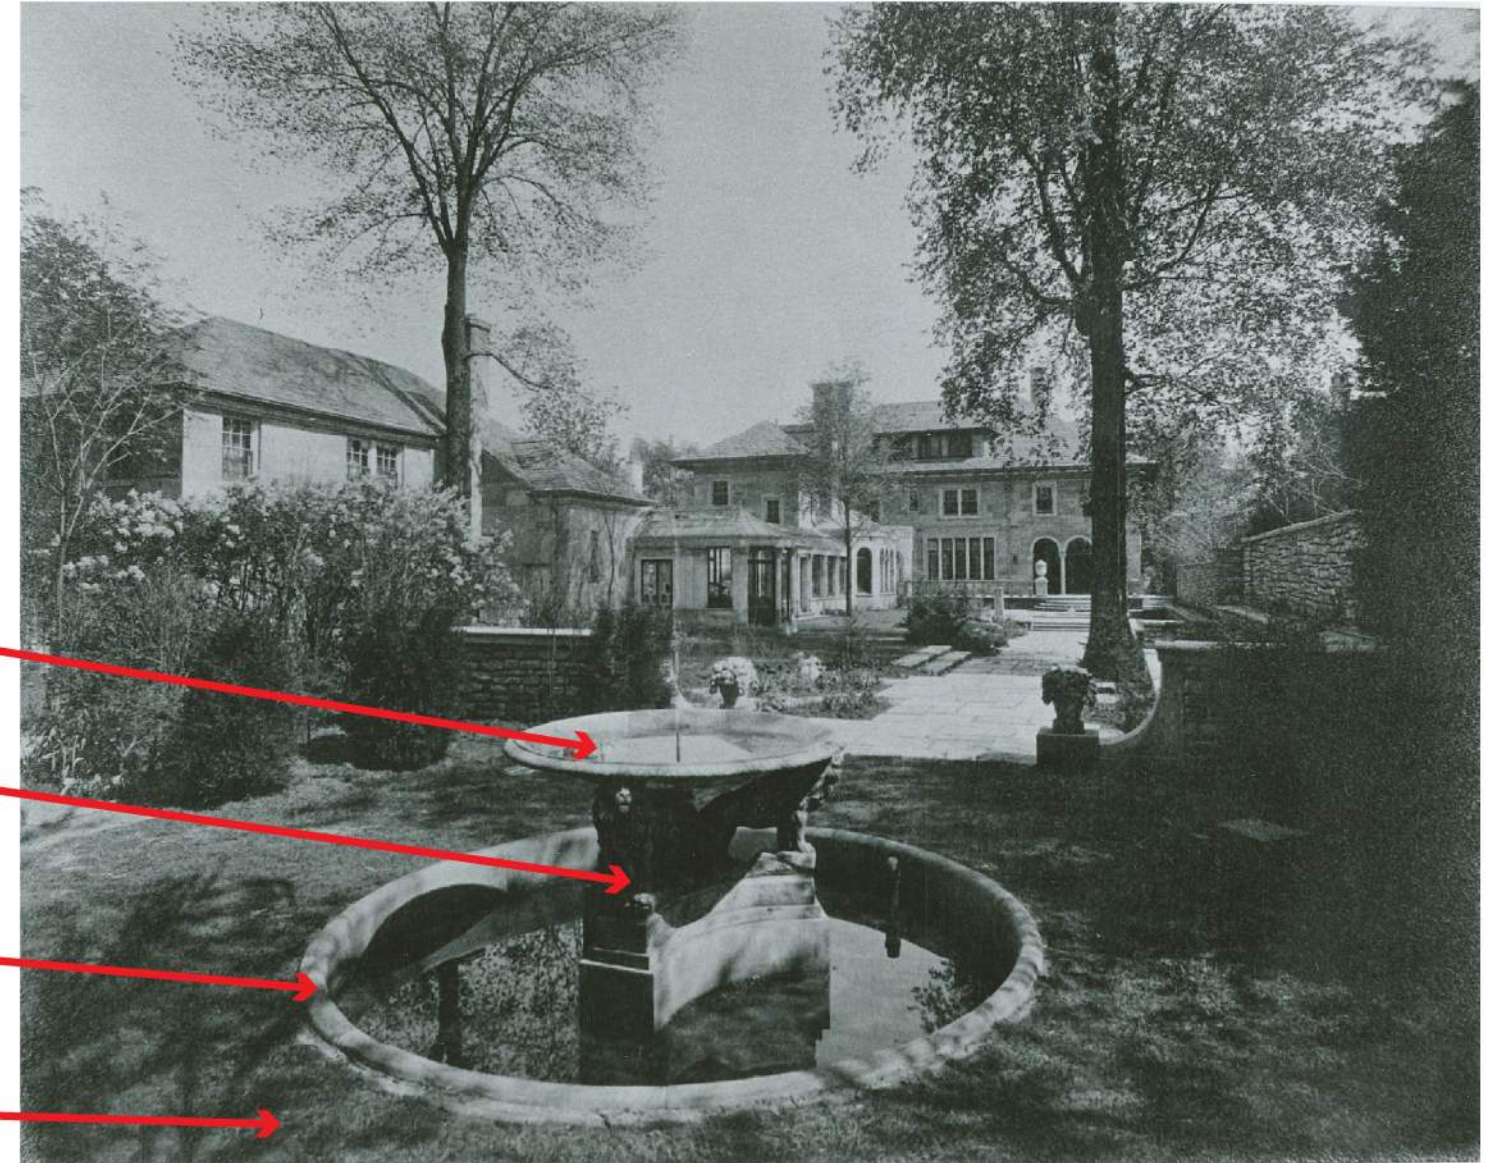
- 1.) Current paving is not original.
- 2.) Curb around fountain is original (now in poor condition and failing).
- 3.) Fountain base is original.
- 4.) Fountain bowl is not original.

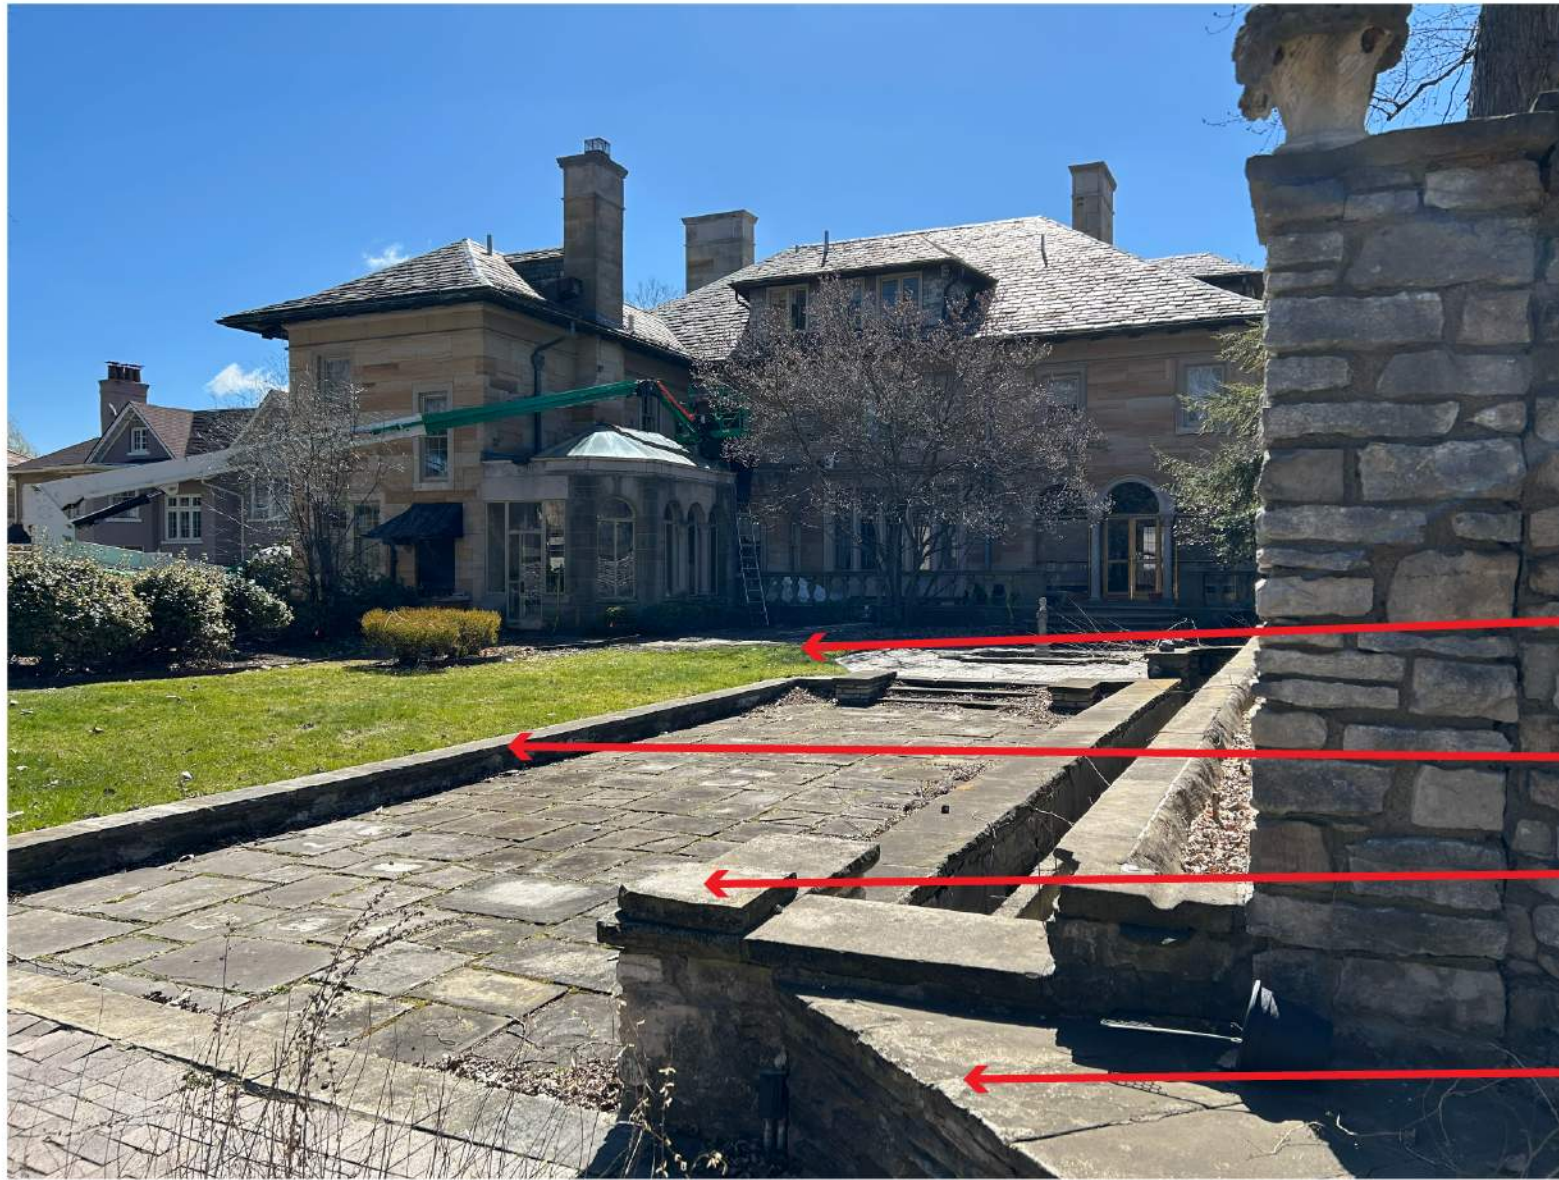
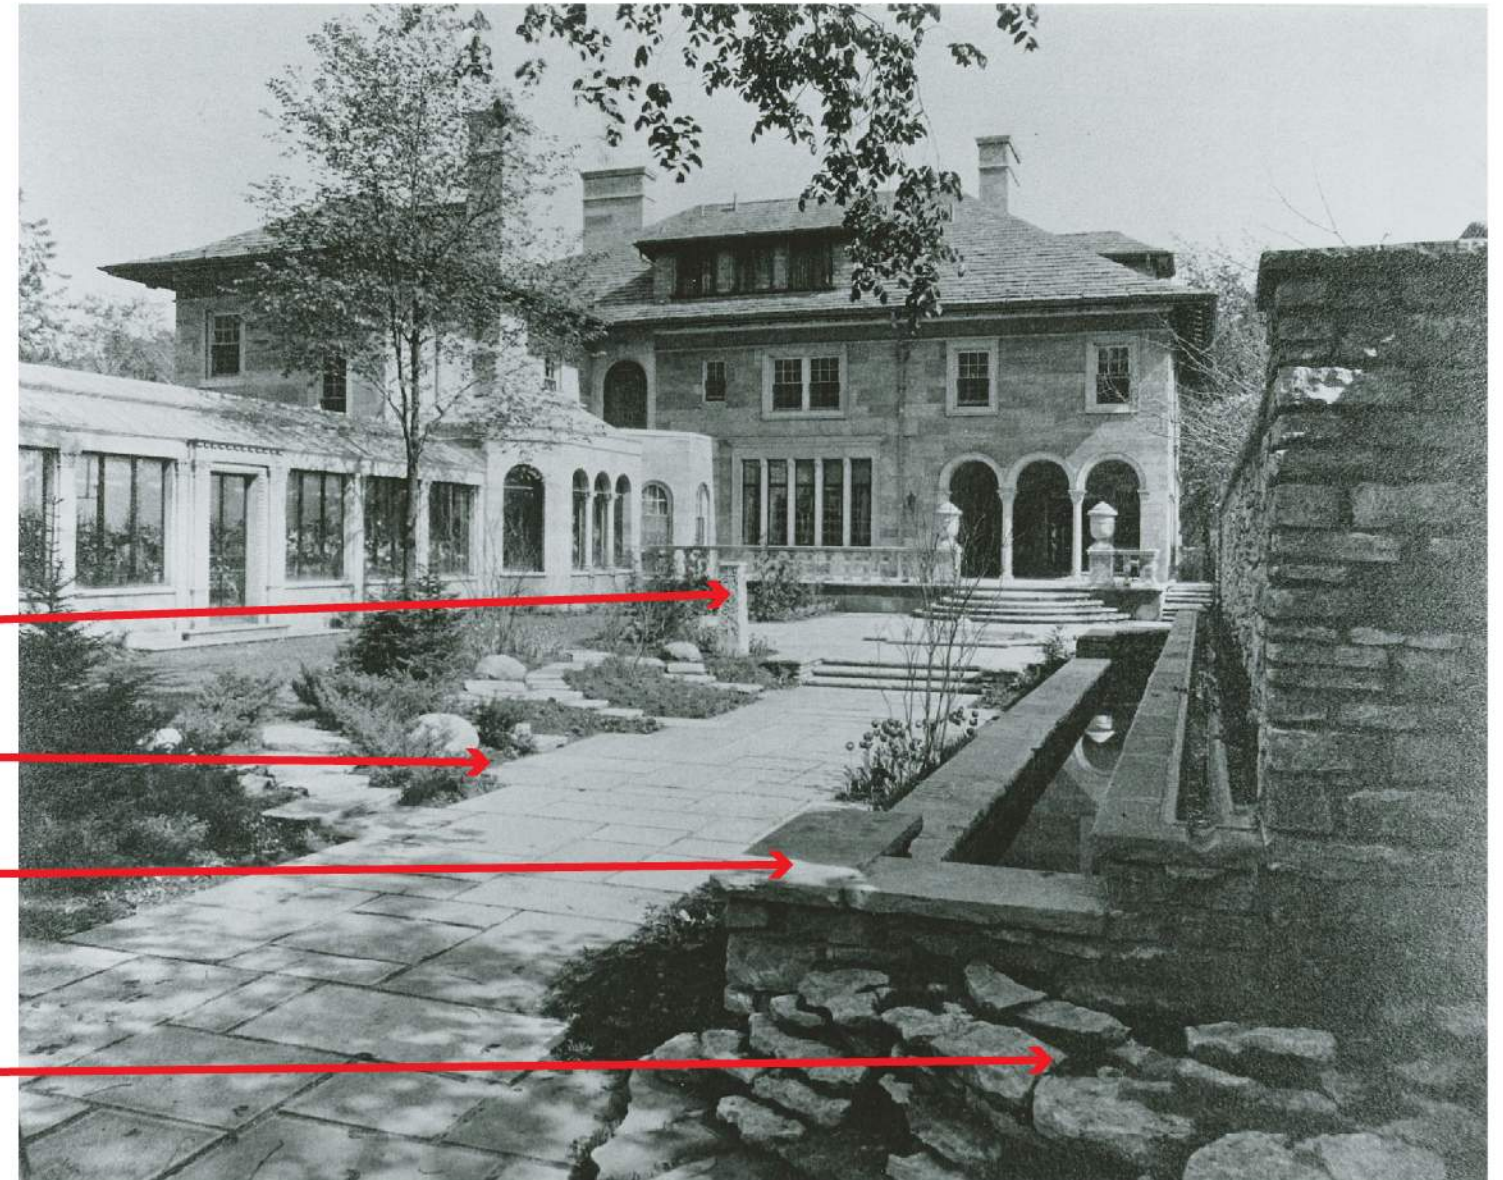
- 1.) Current paving is not original.
- 2.) Current pedestal is not original.
- 3.) Current linear masonry wall is not original.
- 4.) Masonry column no longer exists.
